DOCKET NO. SA 509

SYSTEMS GROUP CHAIRMAN'S FACTUAL REPORT

SYSTEMS GROUP CHAIRMAN'S FACTUAL REPORT OF INVESTIGATION

- A. ACCIDENT :** DCA-94-MA-065
- Location : Charlotte, NC
Date : July 2, 1994
Time : 1842 Eastern Daylight Time
Airplane : USAir flight 1016, McDonnell Douglas DC-9-31, N954VJ
- B. SYSTEMS GROUP**
- Chairman : John W. DeLisi
Aerospace Engineer
National Transportation Safety Board
Washington, D.C.
- Member : Don Gardner
Aviation Safety Inspector
Federal Aviation Administration - Flight Standards Service
Charlotte, NC
- Member : Terry Kleiser
President/Flight Safety Committee
International Association of Machinists - Lodge No. 2294
Indianapolis, IN
- Member : Dave Ordorica
Captain - USAir
Air Line Pilots Association
Boston, MA
- Member : Walt Winkler
Manager - Airframe Engineering Systems
USAir Engineering
Pittsburgh, PA

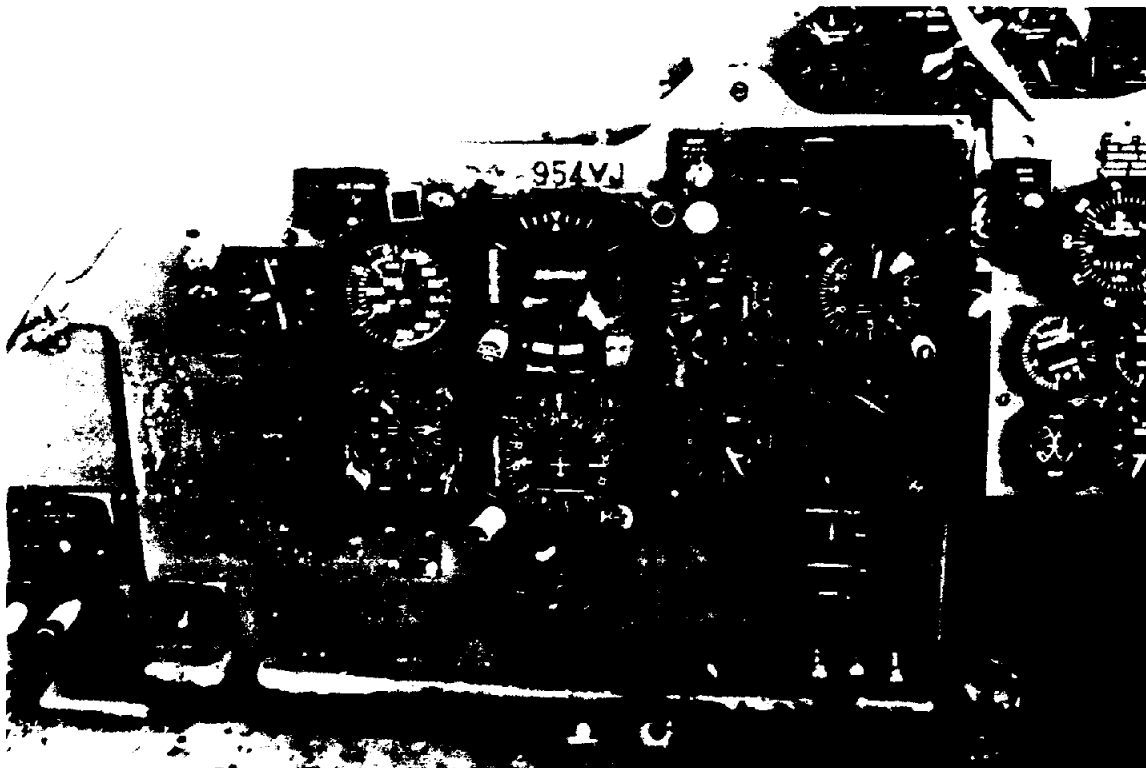
Due to impact damage to the main instrument panel, the landing gear handle appeared to be between the DOWN and UPLATCH positions. When the handle was removed and inspected, the linkage was found to be in the DOWN position.

Figure 2. Captain's Main Instrument Panel

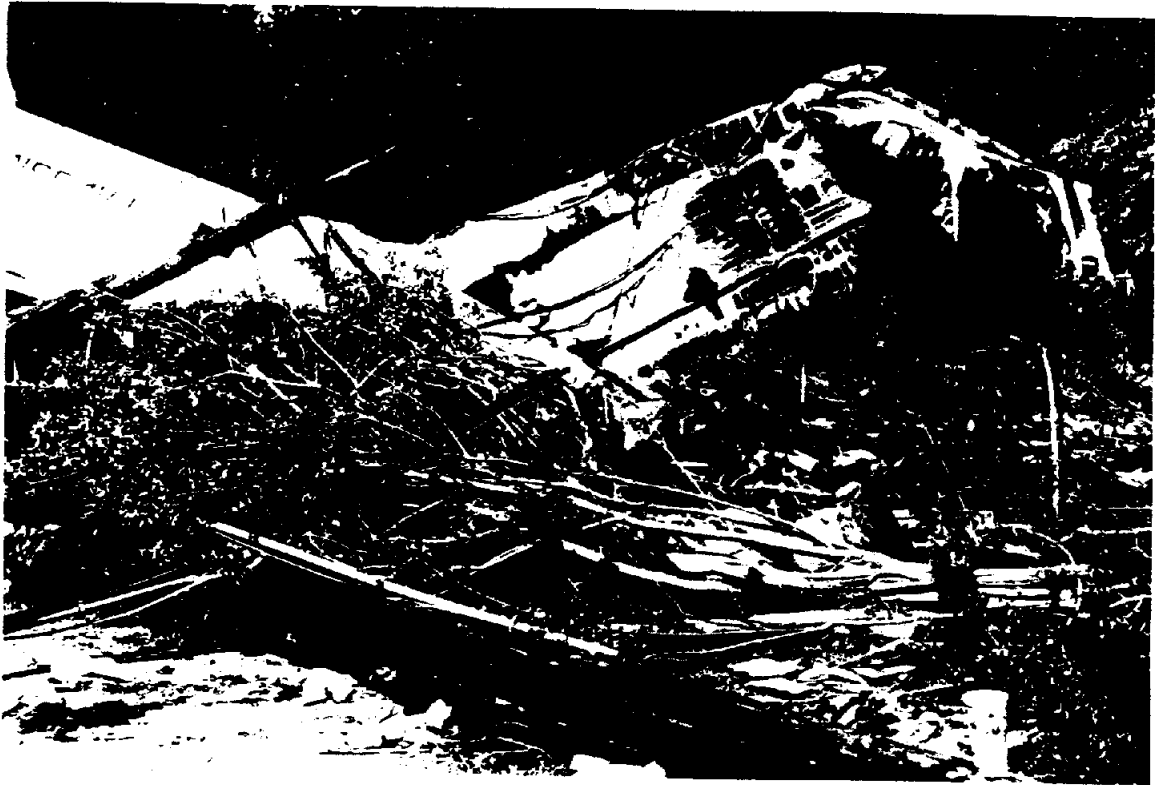
The horizontal stabilizer remained attached to the vertical fin. The right outboard portion of the stabilizer and elevator were missing. The right elevator was free-floating and the control tab was moveable and operated smoothly. The left side of the horizontal stabilizer was severely fire-damaged and the elevator was destroyed. According to diagrams in the Maintenance Manual, the horizontal stabilizer trim jackscrew "BG" dimension was 5.75 inches. According to McDonnell Douglas, this measurement corresponded to a trim setting of 3.9° aircraft nose up.

The majority of the rudder was missing and the portion which remained was severely fire-damaged. The rudder was moveable. The right aileron was attached to the right wing and moved freely. The control tab was moveable and the trim tab was locked in place as normal. The left aileron was damaged and torn.

Figure 5. Left Side View of Tail Section.

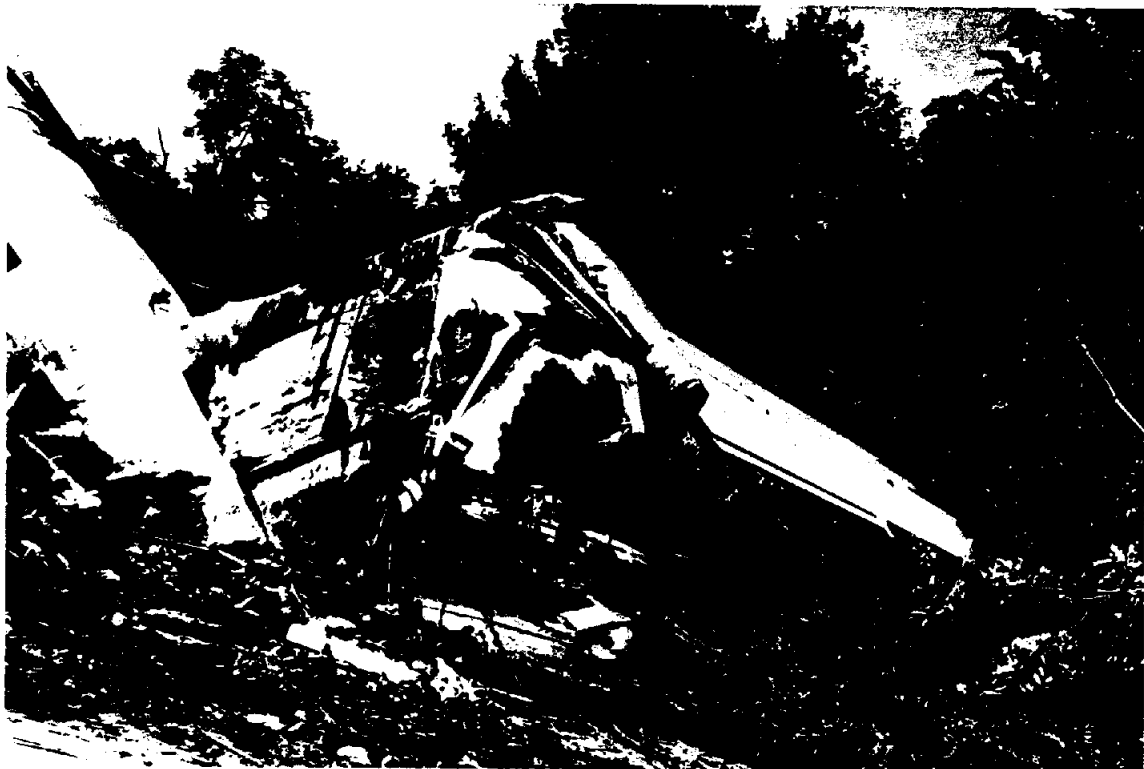
Figure 6. Aft View of Tail Section

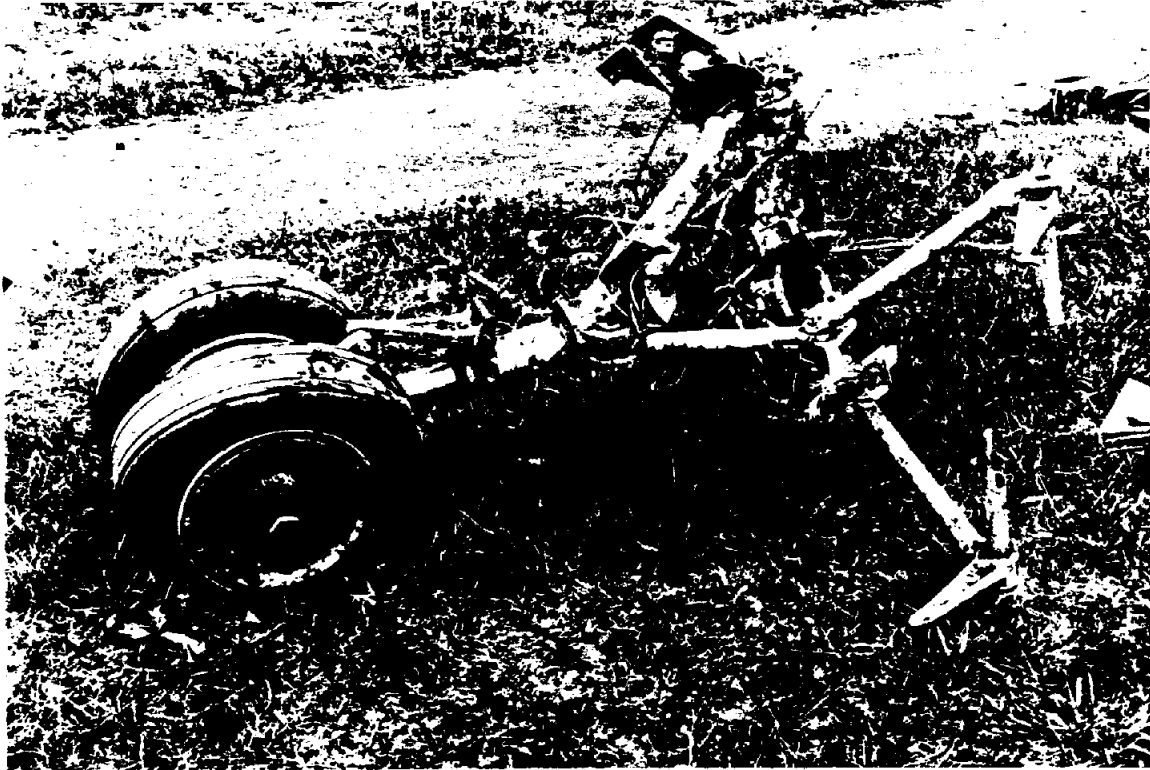
Figure 9. Nose Landing Gear.
