DOCKET NO: SA-510

**NATIONAL TRANSPORTATION SAFETY BOARD
WASHINGTON, D.C.**

**BOEING CORRESPONDENCE
REGARDING CONTINENTAL
AIRLINES UPSET**

CAL-IAH-94-0073RR 12 APR 94
ATA 2217-00 MODEL 737-300
AUTOPILOT, AILERON, AND RUDDER ANOMALIES ON PP715
REF TELECON R. RUWARD/G. BEDOYA ET AL TO J. RINGBLOOM/J.
HAMILTON, DTD 12 APR 94

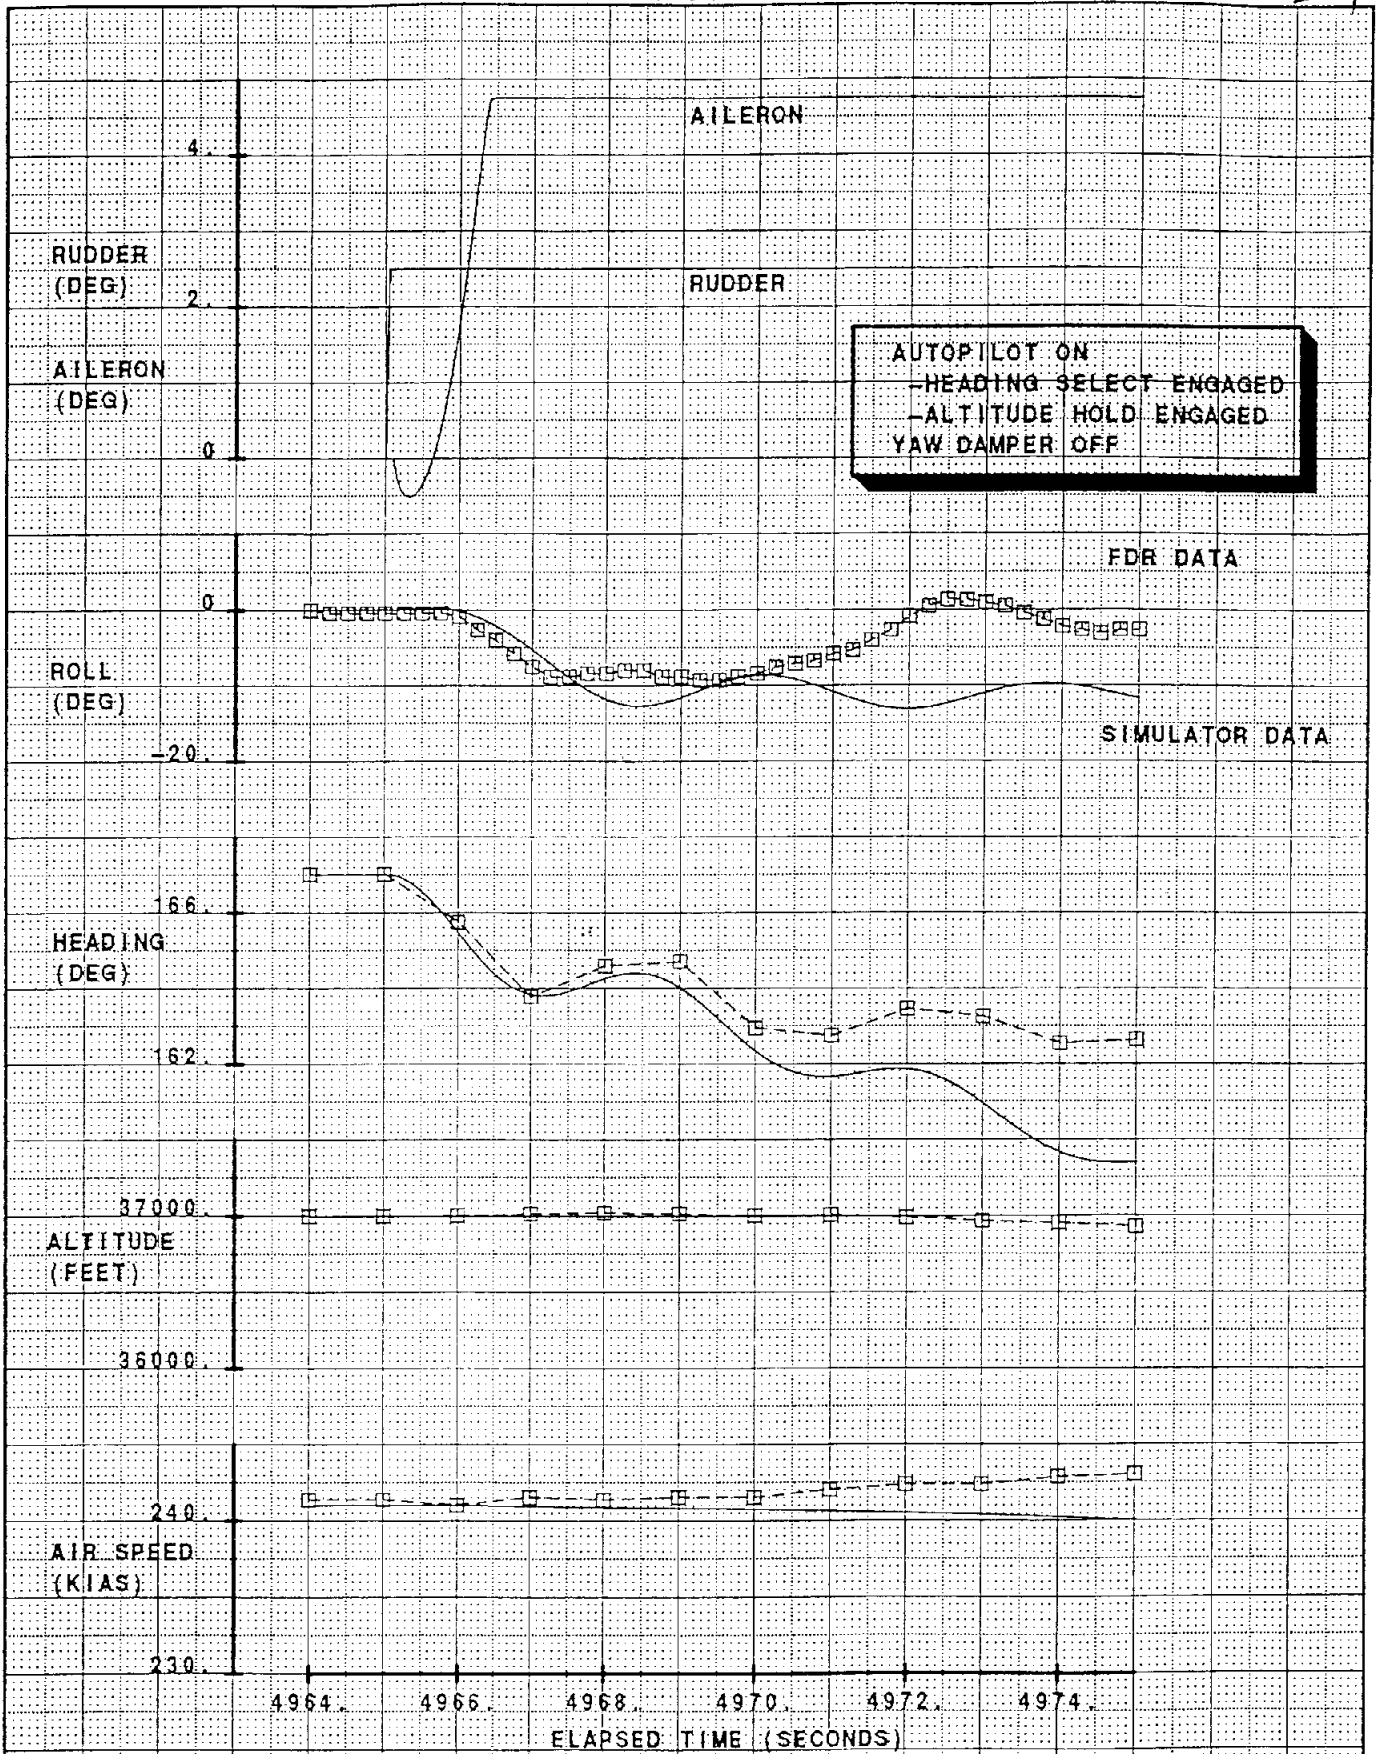
CALC	KERRIGAN	29JUN94	REVISED	DATE	PRELIMINARY FDR DATA CONTINENTAL PP715	737-300 FIGURE
CHECK			S LEWIS	29JUN94		
APPD						
APPD

Preliminary analysis of the flight data recorder (FDR) from the Continental Airlines 737-300 that experienced uncommanded roll and yaw enroute from Houston to Tegucigalpa, Honduras has been completed. The crew diverted to San Pedro Sula, Honduras for an emergency landing.

At an altitude of 37000 feet and an indicated airspeed of 241 knots the airplane rolled to the left approximately nine degrees. It was reported that the the autopilot was engaged when the incident occurred. Using the simulator, the roll and heading experienced during the incident have been duplicated. Preliminary analysis shows that the event is consistent with a sustained rudder input of approximately 2.5° . This is equal to the yaw damper authority at that flight condition. A comparison of the simulator to FDR traces is attached. Bank angle can be matched for only a few seconds, probably because of pilot lateral control input following the initial occurrence. Note that rudder and lateral control inputs were not recorded on the FDR. A rudder hardover to the blowdown limit ($\delta_r = 8.84^\circ$) could not have occurred since the event was matched with only 2.5° of rudder. The possibility of an autopilot hardover was also evaluated using the simulator, but the traces of roll and heading angle did not resemble the FDR traces. Analysis of the portion of the flight after the initial event occurred is continuing.
