DOCKET NO. SA 509

EXHIBIT NO. 9B

ANALYSIS OF USAir FLIGHT 1016

**SUBMITTED TO THE NATIONAL TRANSPORTATION SAFETY BOARD
31 AUGUST 1994**

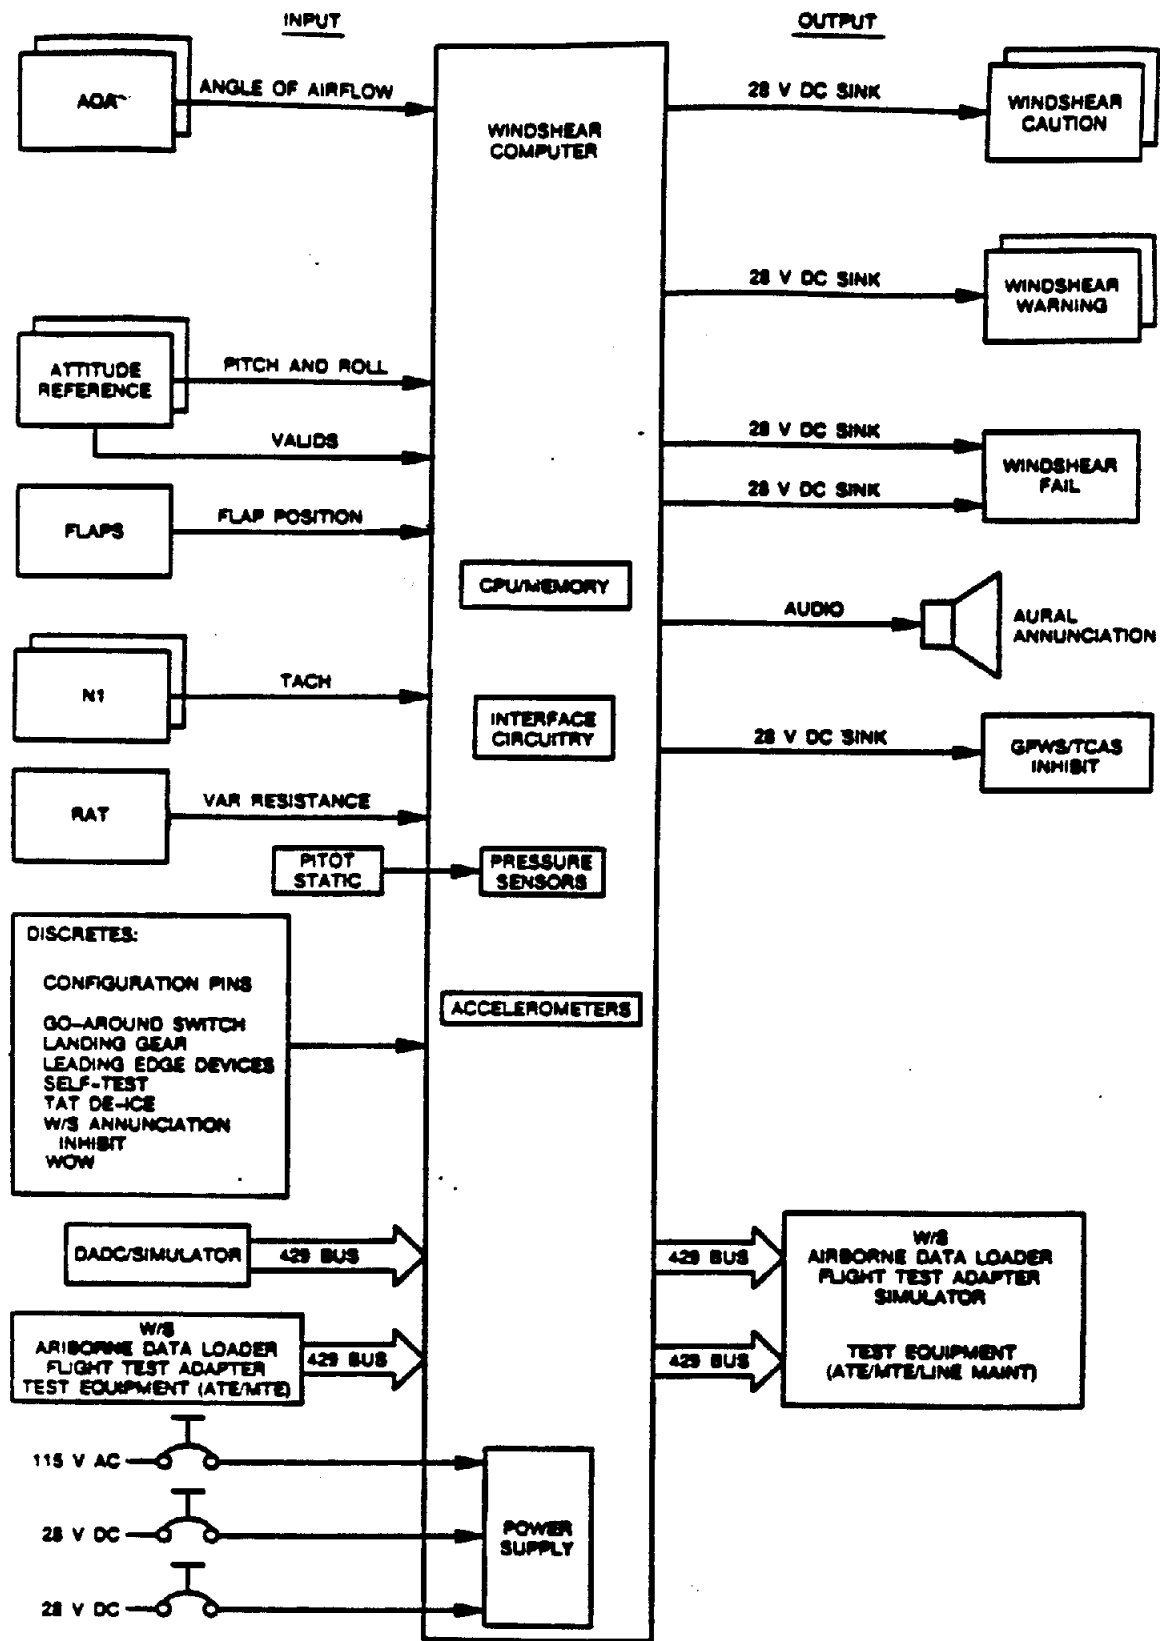
FIGURE A

The Windshear Computer has its own self-contained accelerometers and air data functions, but is dependent on other sensors on the aircraft, including the aircraft's attitude reference, ram air temperature probe, engine tachometers (N1), angle of attack vanes, and flap position. It also receives discrete signals from the go-around switches, landing gear, leading edge devices, and weight-on-wheels sensor. A functional block diagram of the system for DC-9-30 aircraft is shown on Figure A.
