NATIONAL TRANSPORTATION SAFETY BOARD

Metallurgist's Factual Reports
95-42 Standby Rudder Input Shaft
95-43 Rudder Pedal Assemblies

METALLURGIST'S FACTUAL REPORT

Place : Aliquippa, Pennsylvania
Date : August 8, 1994
Vehicle : Boeing 737-3B7, N513AU
NTSB No. : DCA 94-M-A076
Investigator : Gregory Phillips, AS-40

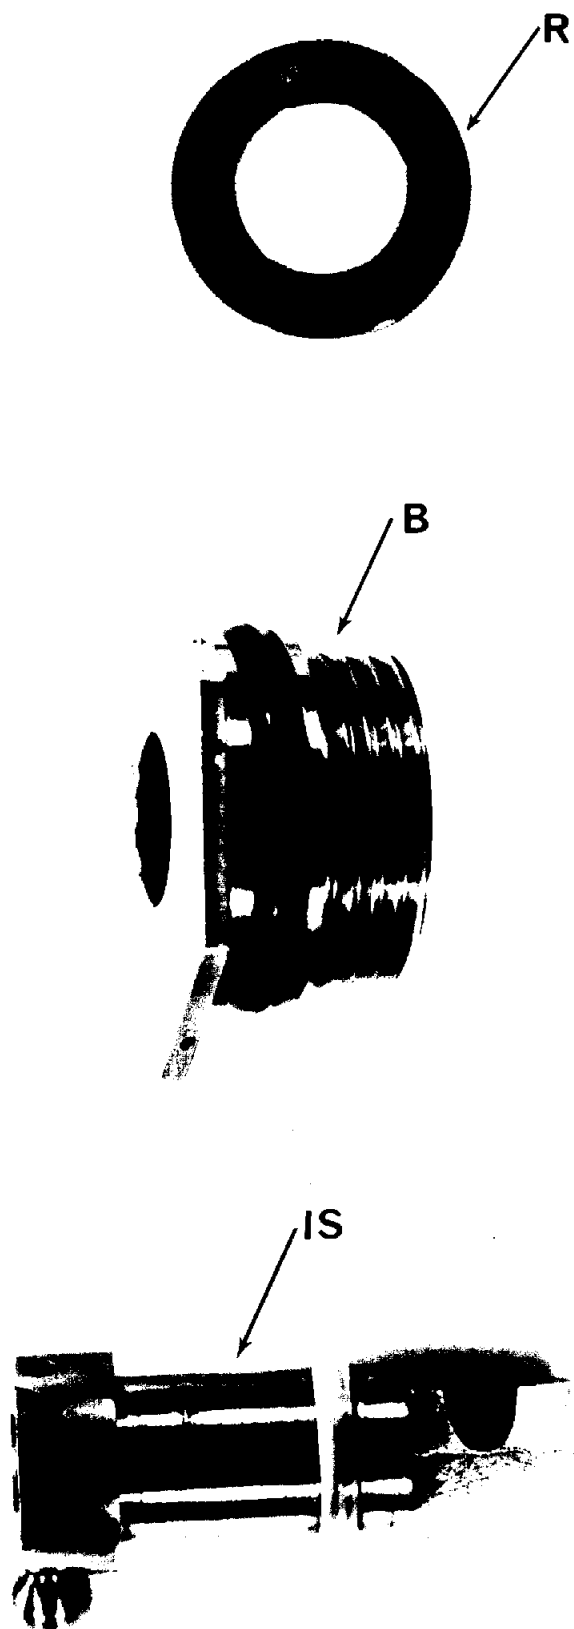
An overall view of the submitted components from the standby rudder actuator is shown in figure 1. Arrow "IS" in this figure indicates the input shaft, arrow "B" indicates the bearing, and arrow "R" indicates the race.

Figure 1: Overall view of the as received components: Arrow "IS" denotes the input shaft, arrow "B" - the bearing, arrows "R" - the race.

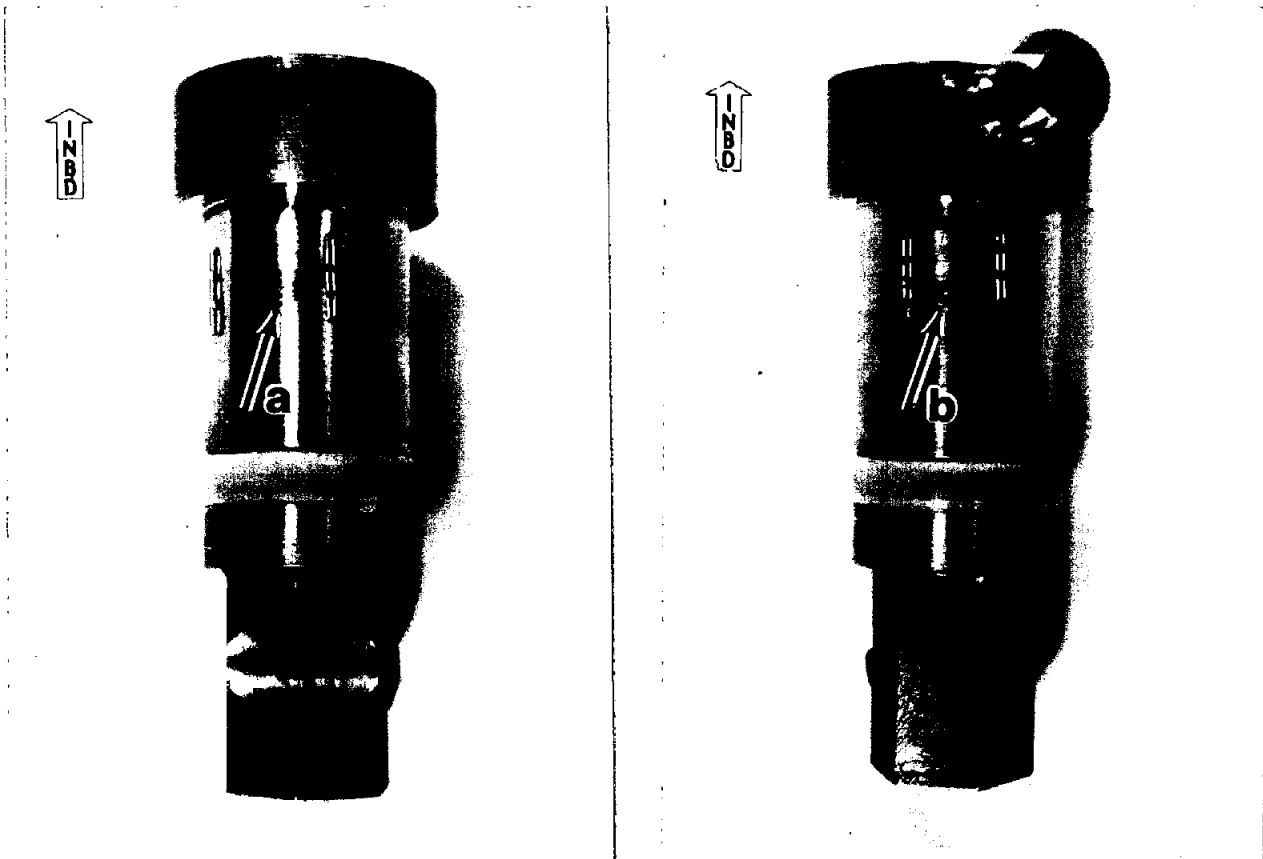
Examination showed that the surface of the shaft in Land 1 contained two distinct bands of galled metal¹. Areas of galling were located roughly opposite to each other across the diameter of the shaft and are shown by arrows "a" and "b" in the two photographs of figure 3.

Measurements indicated that the galled areas extended through an arc of about 60 degrees at the location denoted by arrow "a" in this figure and through an arc of about 50 degrees at the location denoted by arrow "b". Examination also revealed that galling band "a" had a greater total width and a greater built-up of material compared to galling band "b".

Figure 3: Appearance of the galled areas (arrows "a" and "b") on the surface of the shaft. Magnification 2X.

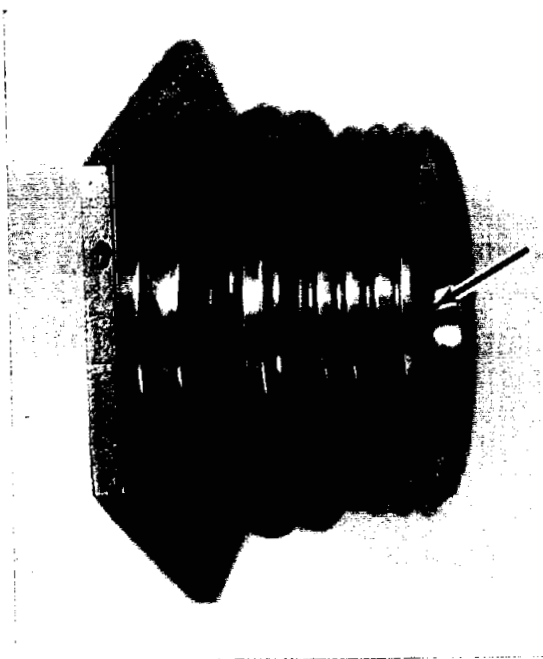
Figure 6 depicts a lateral view of the bearing showing the axial location of galling by the unmarked arrow. The two photographs in figure 7 are close-up oblique views of the bearing bore illustrating the appearance of the galled areas: the left photograph corresponds to the galled area on the shaft denoted by arrow "a" in figure 3, and the right photograph corresponds to the galled area denoted by arrow "b". The longitudinal marks (arrows "d" in figure 7) and circumferential marks (arrows "c") found in the galled area appeared to be secondary damage which had been produced during the extracting of the shaft from the bearing. Figure 8 shows the hexagonal head of the bearing (looking inboard on the shaft-bearing assembly) and the head of the shaft (looking outboard on the assembly). Arched arrows "a" and "b" in this figure denote the circumferential extent of the areas of galling in both parts.

Figure 6: A view of the bearing showing the location of galling on the bearing bore by the unmarked arrow. Magnification 2X,

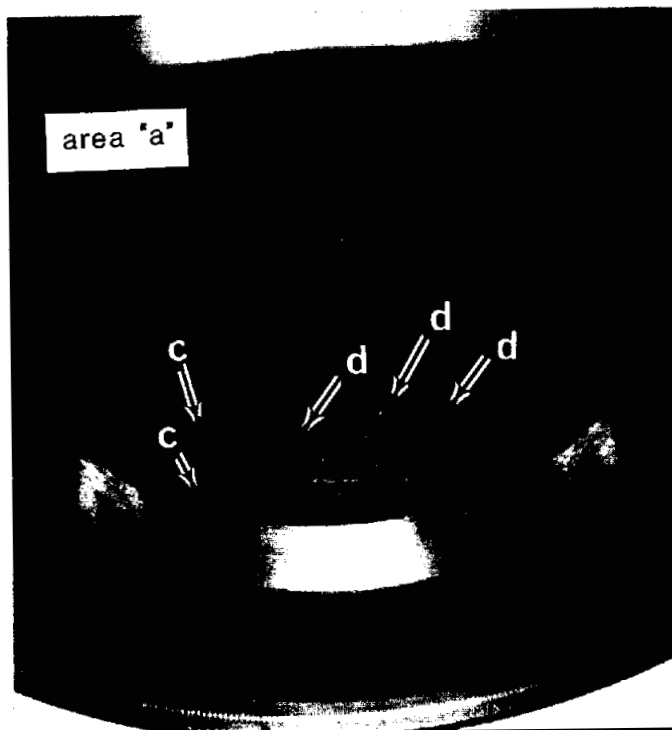
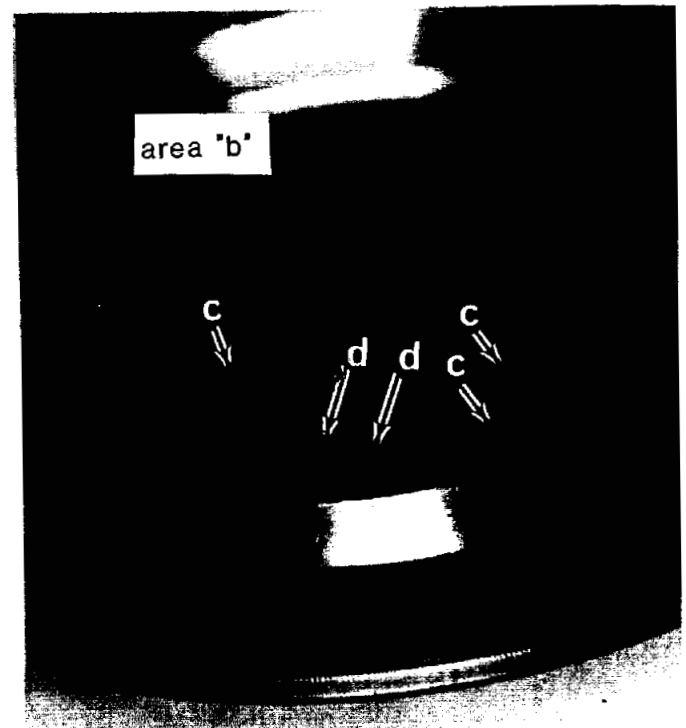
Examination of the bearing bore revealed the two shallow cavity areas corresponding in orientation, size, and shape to the two areas on the shaft that contained deposited metal.

Figure 7: Close-up oblique views of the galled areas on the surface of the bearing bore. Arrows "d" and "c" denote secondary scoring. Magnification approximately 5X.

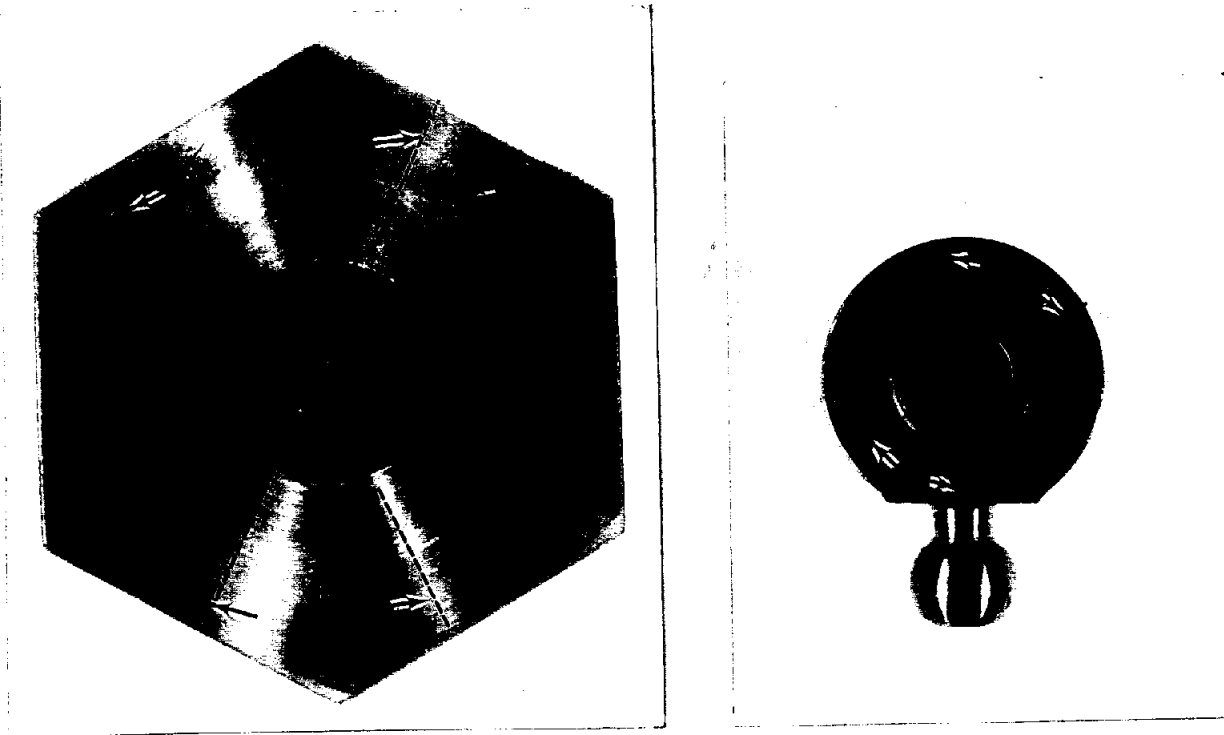
Figure 8: Locations of the galling damage projected on the hexagonal head of the bearing (left photograph) and the head of the input shaft (right photograph). Magnification 2X.

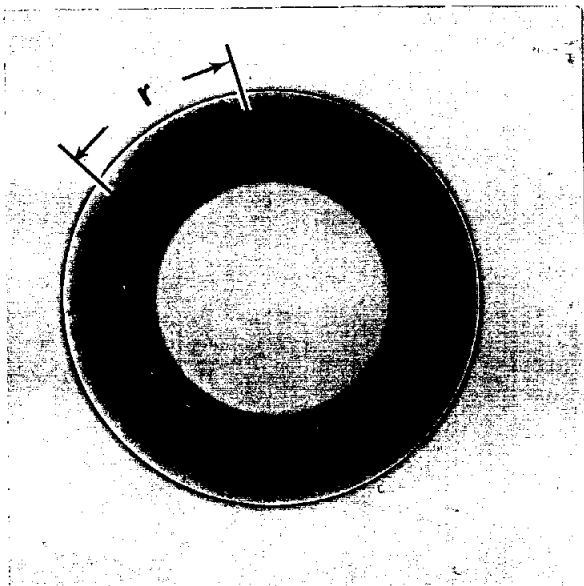
Examination of the submitted bearing race (see figure 9) revealed a non-uniform roller contact pattern. In the area indicated by the curved arrow "r", the roller contact appeared to be lighter than on the rest of the race surface.

Figure 9: Needle rollers contact pattern on the submitted thrust bearing race. Magnification 2X.
