Docket No.: SA-510
Exhibit No.: 9F

NATIONAL TRANSPORTATION SAFETY BOARD

Airworthiness Directive (AD) 94-01-07
Boeing 737 Service Bulletin 737-27-1185
Boeing 737 Service Letter 737-SL-27-57
AD 94-01-07 Final Rule NPRM Comments
AD 80-07-02 Fortner Engineering Control Valve

**SUBJECT: FLIGHT CONTROLS - RUDDER AND TAB - RUDDER POWER CONTROL UNIT -
REPLACEMENT OF THE DUAL SERVO VALVE**

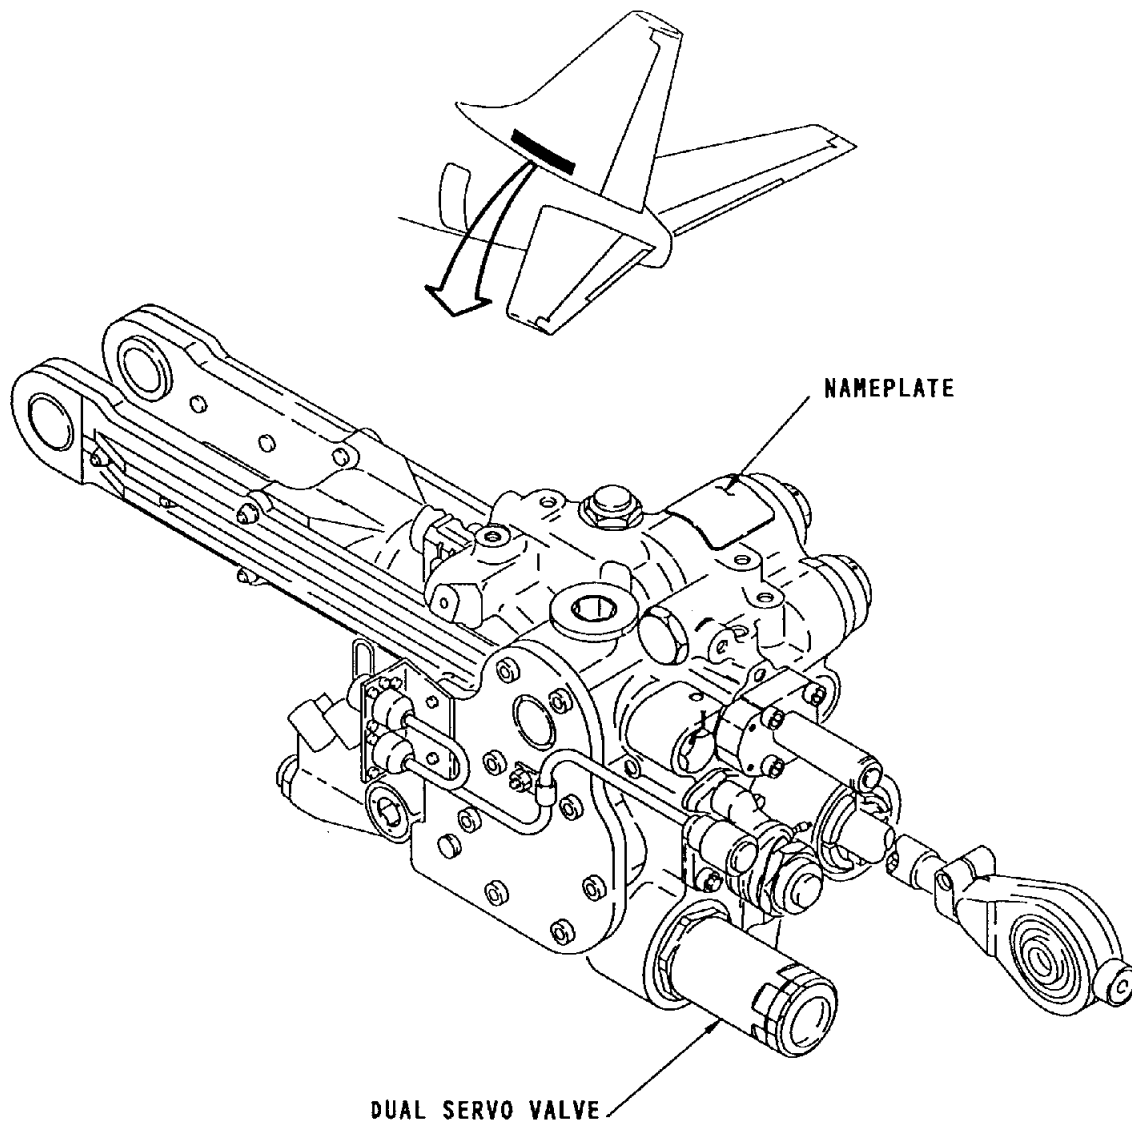
FIGURE 1. REPLACEMENT OF THE DUAL SERVO VALVE IN THE RUDDER PCU

This service bulletin gives instructions to replace the dual servo valve on the rudder power control unit (PCU).

Under certain conditions, the secondary slide in the servo valve can go past the intended maximum-travel position. On some PCUs, this can cause the rudder actuator piston and the rudder to move opposite to the intended direction.

NOTE: Put the original serial number and the new part number on the nameplate.

- D. (This step is removed.)
- E. Do the hydraulic and operational tests of the rudder PCU. Refer to Overhaul Manual 27-20-01, with the March 1, 1993 (or later) Temporary Revision.
