Excerpts from NTSB Aircraft Accident Report AAR-92/06
United Airlines Flight 585
Colorado Springs, Colorado
March 3, 1991

UNITED AIRLINES FLIGHT 585
BOEING 737-291, N999UA
UNCONTROLLED COLLISION WITH TERRAIN
FOR UNDETERMINED REASONS
4 MILES SOUTH OF
COLORADO SPRINGS MUNICIPAL AIRPORT
COLORADO SPRINGS, COLORADO
MARCH 3, 1991

**Adopted: December 8, 1992
Notation 5498B**

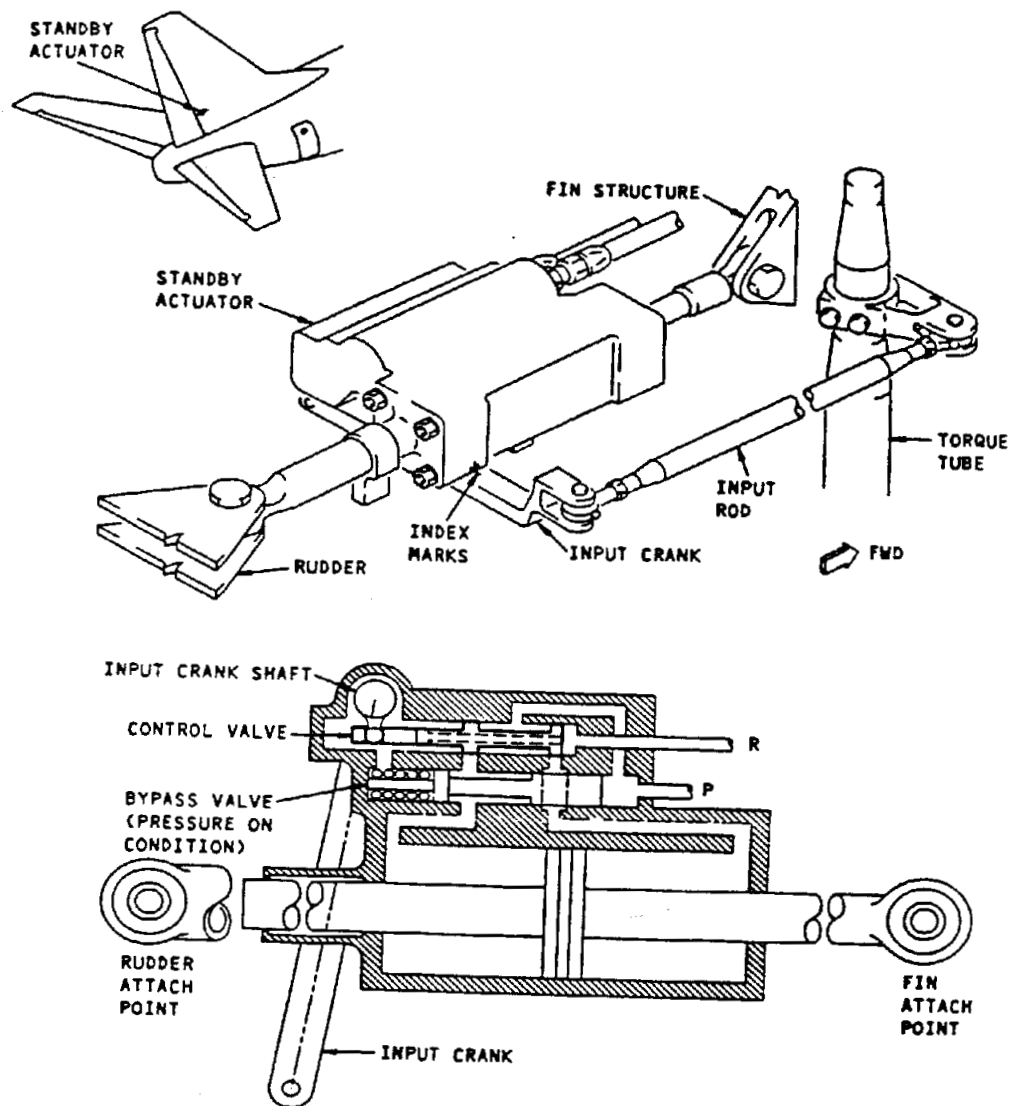
Figure 5.--Standby rudder actuator.

During the initial disassembly of the standby rudder actuator, it was noted that the bearing through which the shaft connecting the input crank to the control valve slide passes was difficult to remove. Subsequent examination revealed evidence of galling on the bearing surface of the input shaft (P/N 1087-23) and mating bearing nut (P/N 1087-22). Normally, the standby actuator is not used and the input lever arm is free to rotate as required to accommodate the relative motion between the rudder and torque tube. The shaft extends through the bearing which is threaded into the body of the standby rudder actuator. The bearing is torqued and safety wired into position. A 6.72-inch input lever is attached to the end of the shaft. According to the manufacturer, the maximum force to move the input lever should not exceed 0.5 pound. The shaft and bearing are a matched pair because of the requirements for ease of operation and tight tolerance. The presence of galling could cause the shaft to bind.

A review of the design of the B-737 rudder control system revealed that binding of the input shaft to the bearing that is threaded in the actuator body could potentially cause flight control problems even though the standby rudder hydraulic system is not pressurized. In the rudder control system, the pilot pedal movement is applied through a mechanical control system to a lever arm to rotate a torque tube in the empennage. Other lever arms attached to the torque tube transmit linear motion to the ends of the input cranks for both the MPCU and the standby rudder actuator. (See figure 5).

change the length of this link by rotation of the standby rudder actuator input crank within the actuator housing will affect the feedback mechanism between the rudder position and the MPCU input crank. This condition can result in problems ranging from high pilot control force necessary to move the rudder to uncommanded rudder deflections.

The worst case condition would be one in which a pilot applies a rapid rudder pedal movement that is transmitted through the torque tube to move the input crank on the MPCU to its mechanical stops before the rudder begins to catch up to the commanded pedal position. Concurrently, the input crank on the standby rudder actuator would be rotated about 4 degrees from its null position. If the input crank were bound to the actuator housing in this position, the geometric relationship to null the MPCU would not be achieved. Theoretically, the MPCU will continue to move the rudder hydraulically, and the rudder movement will be transmitted through the rigid link created by the bound crank in the standby actuator to produce continued rotation of the torque tube so that the input command to the MPCU is perpetuated until the rudder reaches its full deflection mechanical stop in the direction originally commanded. If this should occur, the continued rotation of the torque tube will move the pilots' pedals and will react against a proportionally greater restoring moment provided by the rudder centering unit.

As a result of its concern about galled standby rudder actuator bearings on other B-737s and B-727s, the Safety Board issued Safety Recommendation A-91-77 to the FAA on August 20, 1991 (See section 4).

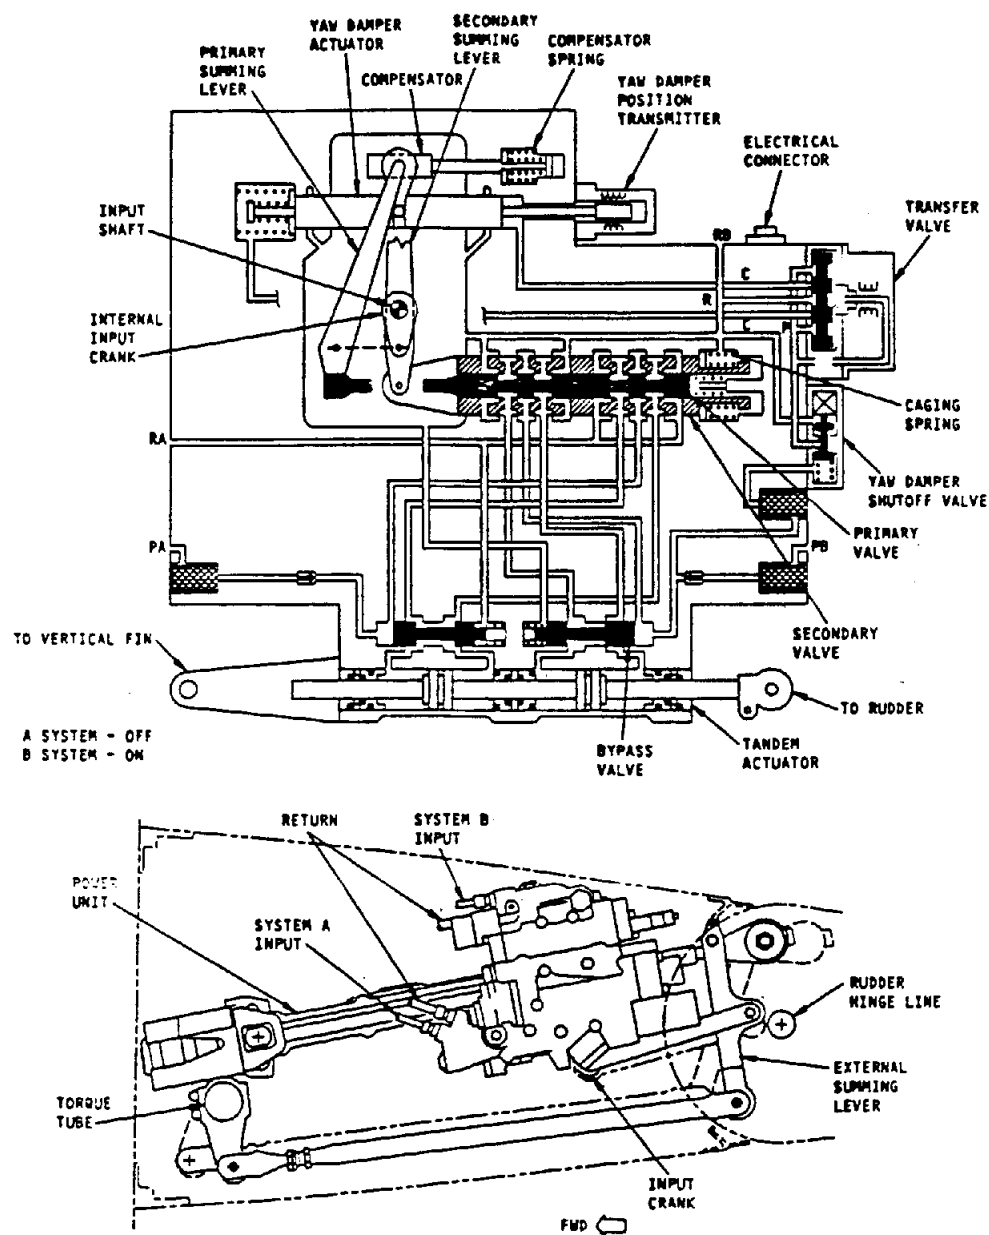
Figure 6.--Main rudder power control unit schematic extracted from B-737 maintenance training manual.

During the subsequent testing of the rudder MPCU, anomalous actions were observed when the input crank was held against the MPCU body stops and the yaw damper piston was in the extend position. The results ranged from sluggish

movement of the actuator piston to a full reversal in the direction of piston travel opposite to the direction being commanded. High internal fluid leakage was also noted. The capability of the MPCU to produce force to move the rudder against aerodynamic loads was not measured. The interaction of the yaw damper and the observed MPCU operation is not fully understood. In addition, it is unknown whether the yaw damper was commanding rudder movement at the time that the UAL captain performed the rudder control check. Tapping on the dual servo valve body or actuator summing levers prompted the MPCU to return to normal operation. Releasing the force on the input crank also returned the MPCU to normal operation.

An examination of the servo valve components and analysis by Boeing and Parker Hannifin showed that the anomalous operation of the MPCU was caused by aberrant movement of the servo valve slides. (See figures 6 and 7). During normal operation, the primary slide moves about .045 inch relative to the secondary slide. Further movement of the input crank will produce simultaneous movement of both slides for another .063 inch relative to the housing. In testing the subject MPCU, it was originally believed that initial movement of the primary slide caused simultaneous movement of the secondary slide as if the two slides were bound together. This would have resulted in an overtravel of the secondary slide relative to the valve housing. During tests, the overtravel of the secondary slide resulted in unintended and abnormal porting of hydraulic fluid between the pressure, return, and cylinder ports. The initial effect was a high leakage from pressure to return with a reduction of the differential pressure at the cylinder ports for both the A and B systems. However, in the subject MPCU, and potentially in others depending on tolerances, the total travel of the secondary slide before contacting a mechanical stop in the valve resulted in a partial or full (3,000 psi) pressure differential across the actuator pistons that was opposite to the direction of the commanded signal. Thus, a pilot desiring left rudder could conceivably end up with a right rudder movement. This condition could only occur if the rudder pedals were moved rapidly to command a maximum rate of rudder travel or if the pedal was fully depressed to command full deflection of the rudder.

During subsequent tests, it was determined that the overtravel of the secondary slide was not a result of binding, but rather a result of a failure of the secondary summing lever to make contact with its respective stop. The failure was attributed to a manufacturing out of tolerance condition which permitted the secondary summing lever to miss the external stop.

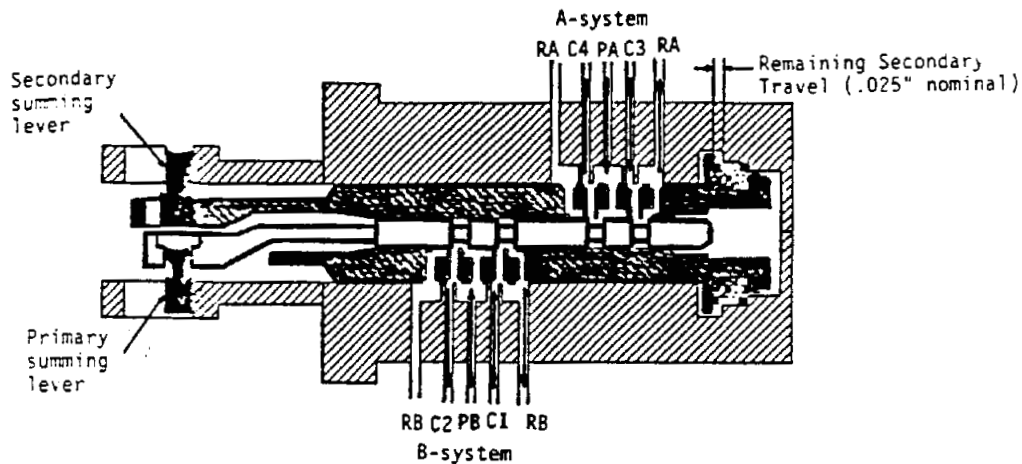
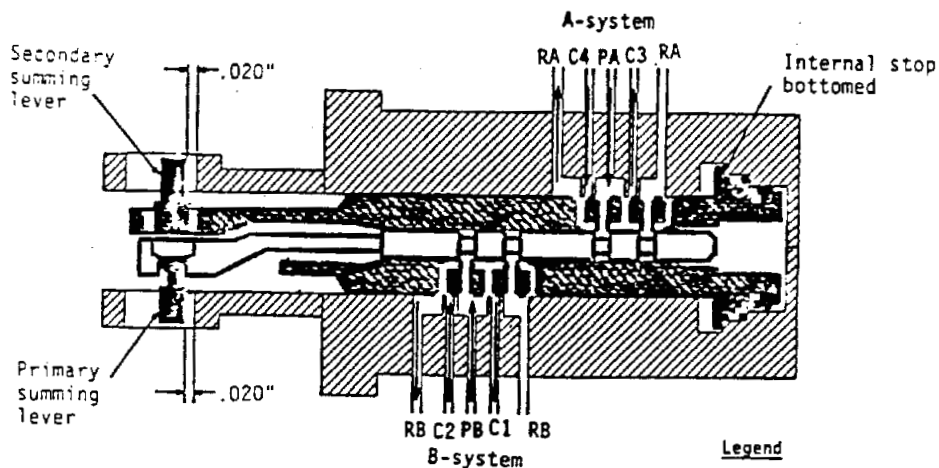
Normal Operation
Maximum Rate Extend Command
Primary slide moves .045" (relative to secondary)
Secondary slide moves .063" (relative to housing)

Abnormal Operation
Primary slide jammed
Both slides move .088"
relative to housing
