**Metallurgist's Factual Report
95-54 Servo Valve s/n 2956 Examination**

Report No. 95-54

Place : Aliquippa, Pennsylvania
Date : September 8, 1994
Vehicle : Boeing 737-3B7, N513AU
NTSB No. : DCA94-M-A076
Investigator : Gregory Phillips (AS-40)

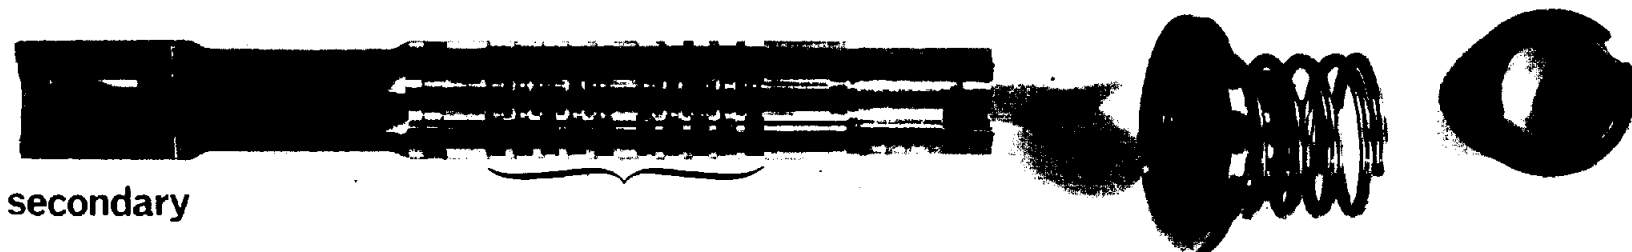
Figure 1 shows an overall view of the S/N 2956 servo valve after disassembly in the laboratory. As disassembled, the primary and secondary spools were examined with the aid of a bench binocular microscope for evidence of damage to the metering edges on the outside diameter of the primary and secondary spools (areas indicated by unmarked brackets in figure 1). Small areas indicative of chipping of the nitrided case were noted on the primary spool on two of the lands¹ adjacent to the metering edge. However, examination disclosed no evidence of distortion or deformation to the metering edges.

Figure 1. Overall view of the components of the S/N 2956 servo valve after disassembly.

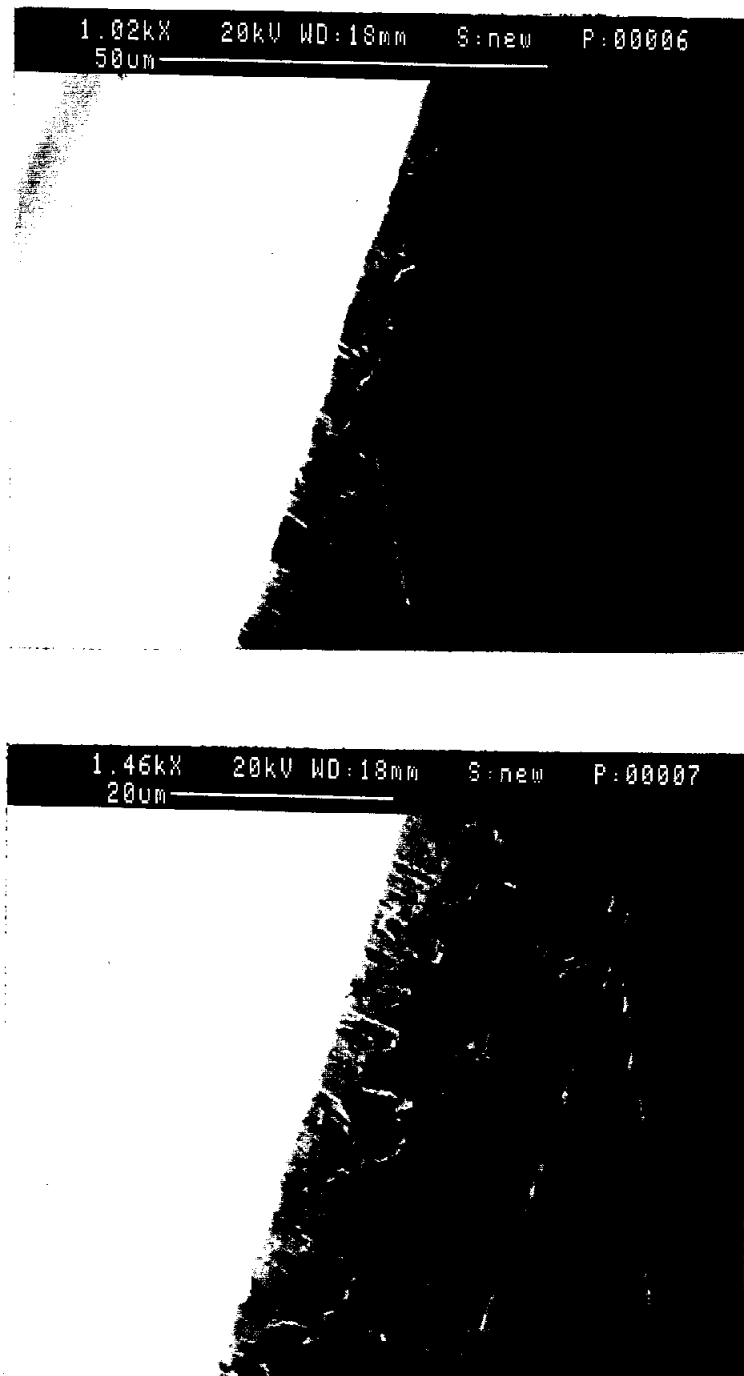
The primary and secondary spools S/N 4375 were identified as being removed from an in-stock new rudder power control unit at Boeing. SEM examination of the primary spool disclosed material smears similar in shape, extent, and chemical composition (as found by EDX spectra) to those found on the primary spool of the accident airplane. Examples of these material smears are depicted in figure 3. Also found were small chip-outs of the nitrided case land adjacent to the metering edge.

Figure 3. Examples of material smearing found on S/N 4375 primary (spool indicted as new).
