Federal Aviation Administration

B737 Flight Control System
Critical Design Review Report
May 3, 1995

**B737 FLIGHT CONTROL
SYSTEM
CRITICAL DESIGN REVIEW
-REPORT-**

MAY 3, 1995

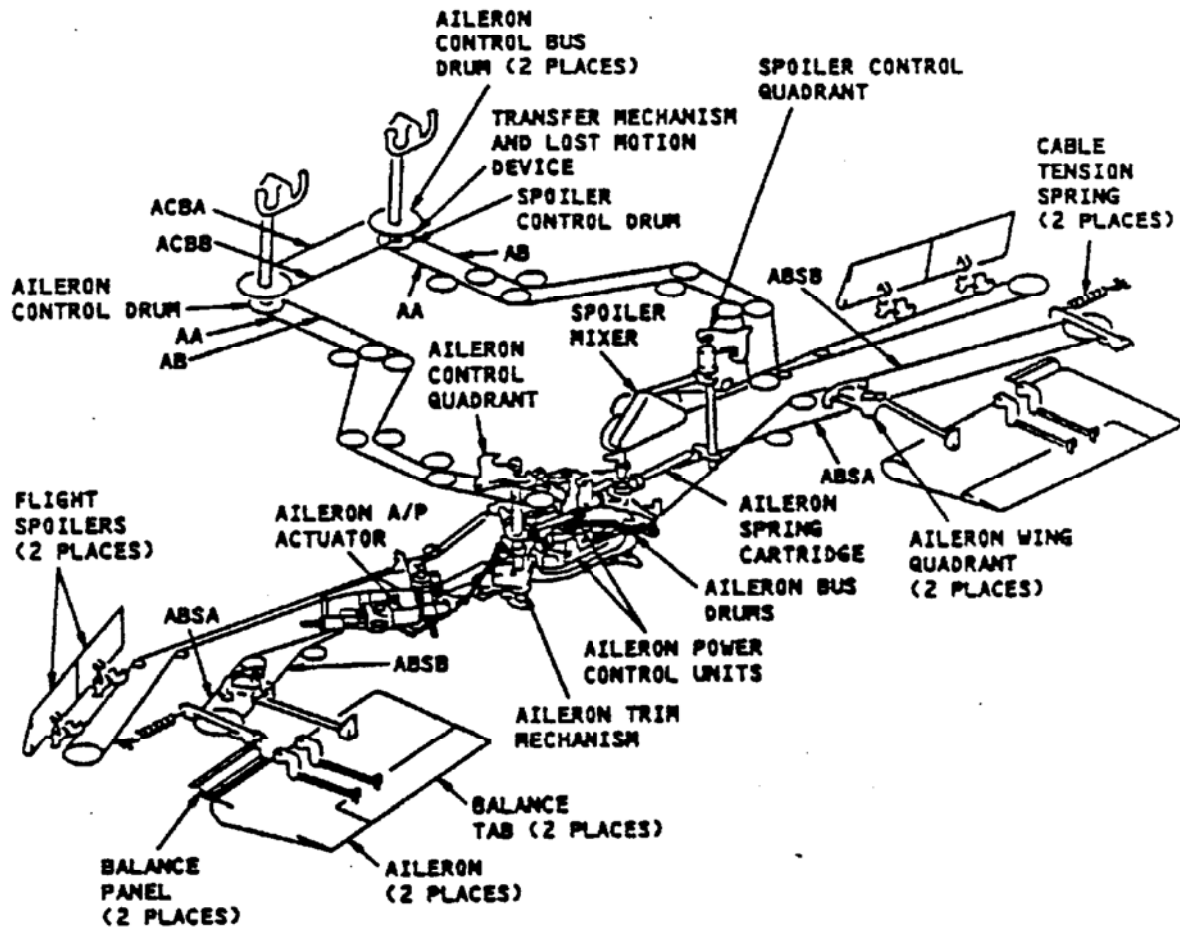
AILERON CONTROL SYSTEM

a. Single Failures, Aileron - The failure mechanisms identified in Table 1 suggest there are a number of ways for a failure to result in a sustained aileron hardover. The significance of the aileron failure conditions resulting in a jam of the aileron is the importance of the alternate means for controlling the airplane. The designed alternative means is the aileron transfer mechanism.

As was experienced in the "M" Cab exercise, flight path control through the aileron transfer mechanism may be very difficult due to the high wheel forces. It is believed that if a full aileron hardover was to be countered for any reasonable length of time, continued safe flight and landing in a B737 would be very difficult. (See "Recommendations For FAA Action," Section 15. Recommendation -8).
