Boeing Stabilizer Trim Mechanism Examination Report

**TO:** Air Safety Investigations (ASI) **EQA NUMBER:** AS12067  
**DATE:** July 14, 2014  
**MODEL NUMBER:** 747-400BCF  
**AIRPLANE NUMBER:** RT075

**SUBJECT:** *Examination of Stabilizer Trim Drive Mechanism Assembly*

**FRACTURE ANALYSIS REPORT****Engineering Report No: MS 22997****Date: 3/21/2014****Lab WR Number: 031-2014-01-20-00034****Part Information:**

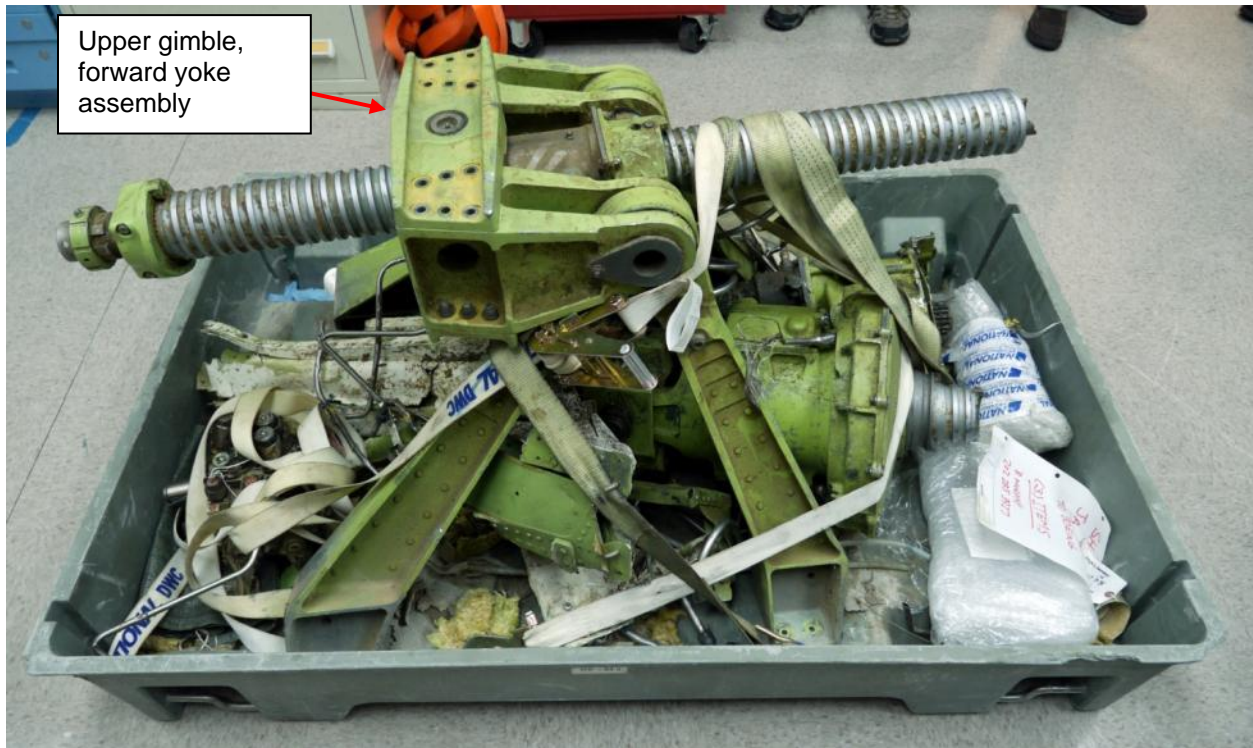
After removing the container cover, it was observed that there were no bolts attaching the forward yoke assembly, P/N 65880708-2, to the upper gimble assembly; see red arrow in Figure 7.

**Figure 7:** Container cover removed, side view

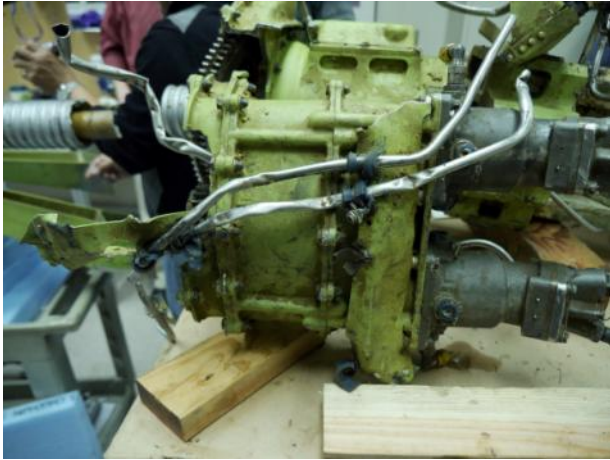
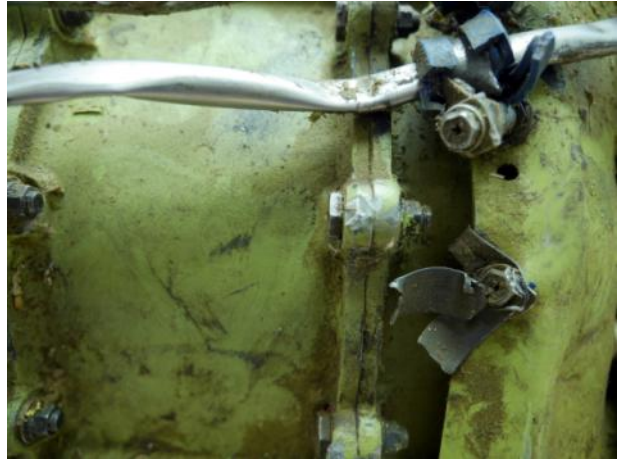
The differential assembly had extensive damage on the forward side; see Figure 17 through Figure 19.

**Figure 17:** Differential assembly, forward surface

**Figure 18:** Differential assembly, forward surface

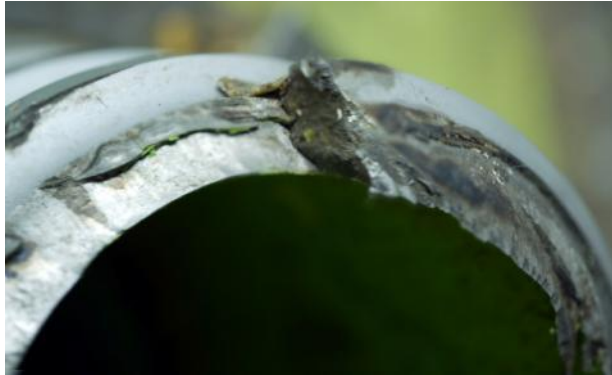
Figure 23 shows a magnified view of a portion of the fractured ballscrew surface. A witness mark on the ballscrew, one thread from the fracture surface, is shown in Figure 24. The area within the red box in Figure 24 is shown magnified in Figure 25.

**Figure 23:** Fracture surface

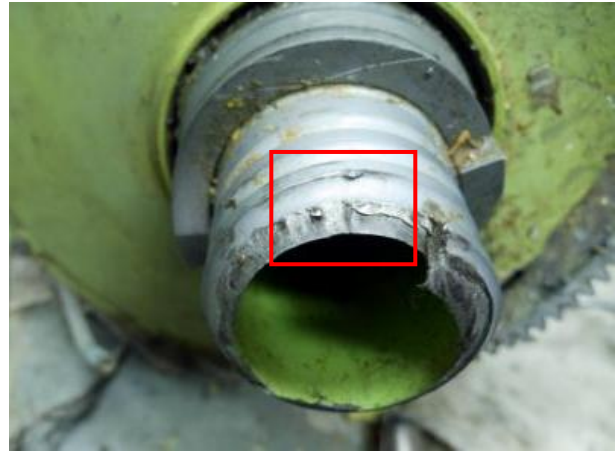
**Figure 24:** Witness mark near fracture surface

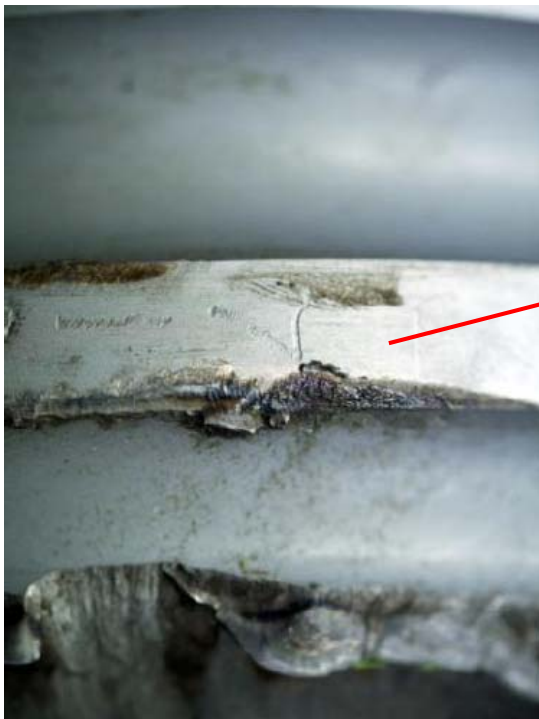
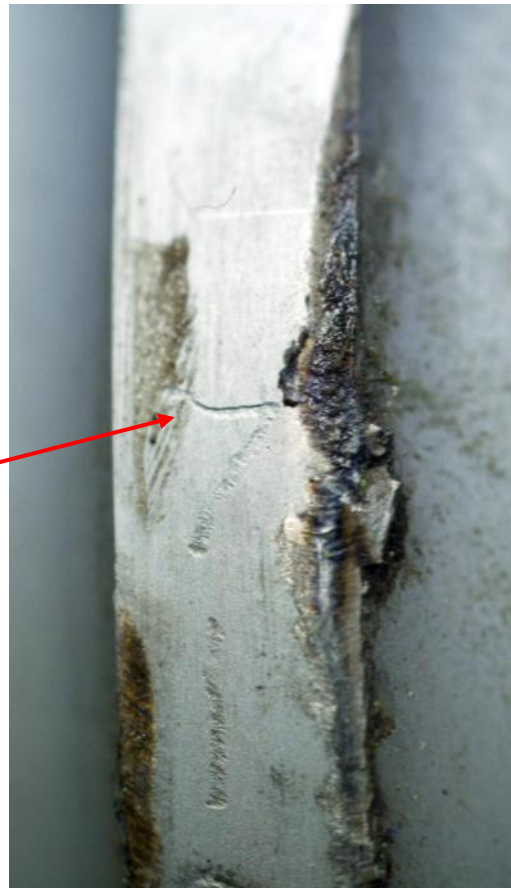
Figure 26 is a rotated and magnified view of the mark shown in Figure 25.

**Figure 25:** Witness mark

**Figure 26:** Witness mark

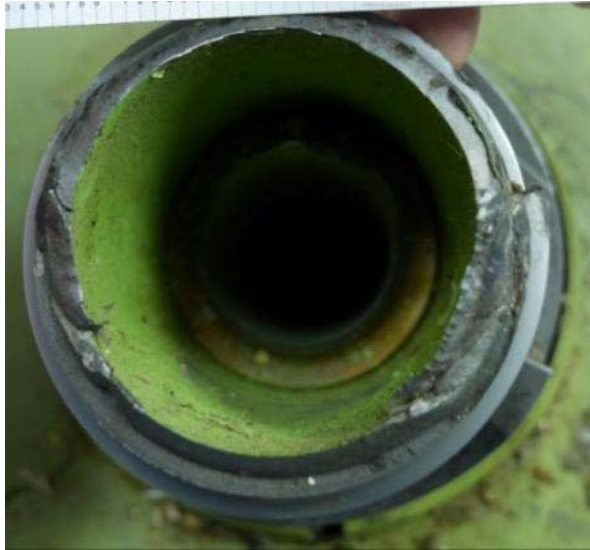
An end view of the fractured ballscrew that remained in the actuator assembly is shown in Figure 27. Figure 28 shows the end of the fractured safety rod, within the ballscrew.

**Figure 27:** End view of fractured ballscrew

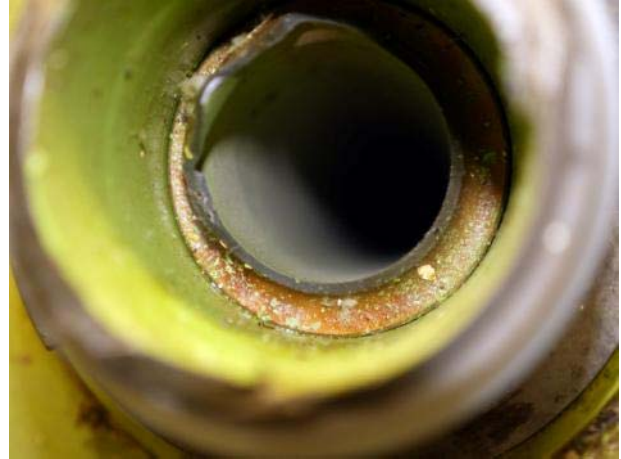
**Figure 28:** End view of fractured safety rod

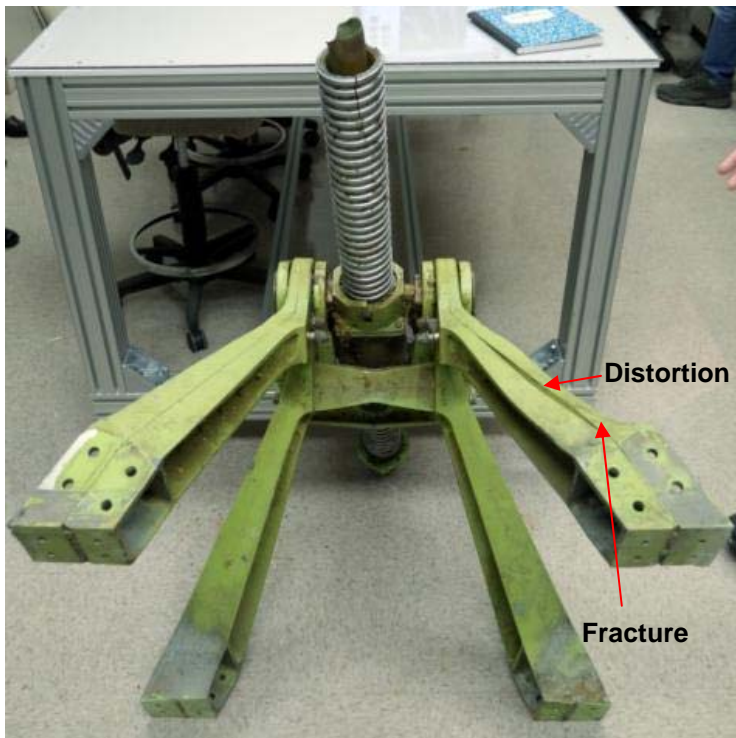
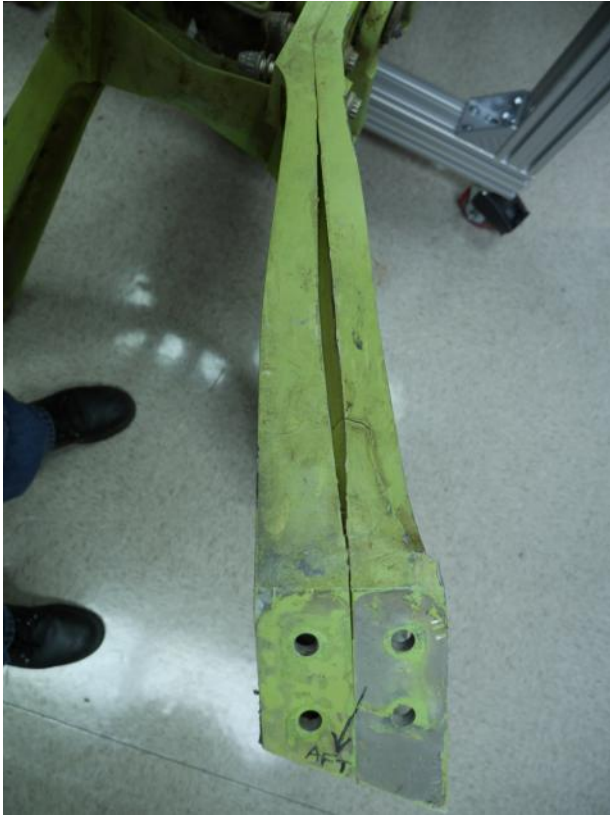
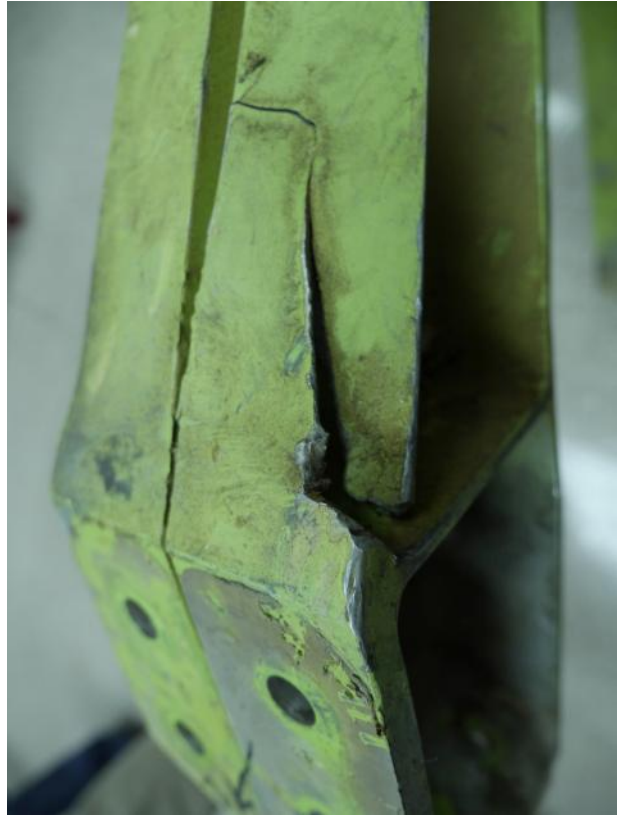
One of the legs of the upper gimble support structure was distorted and fractured; see Figure 29, Figure 31 and Figure 32. The majority of the ballscrew remained in the upper gimble and ballnut assembly. A longitudinal fracture extended approximately eight threads beyond the primary ballscrew fracture; see Figure 30.

**Figure 29:** Upper gimble support structure

**Figure 31:** Upper gimble support structure, distorted and fractured leg

**Figure 32:** Upper gimble support structure, fractured leg

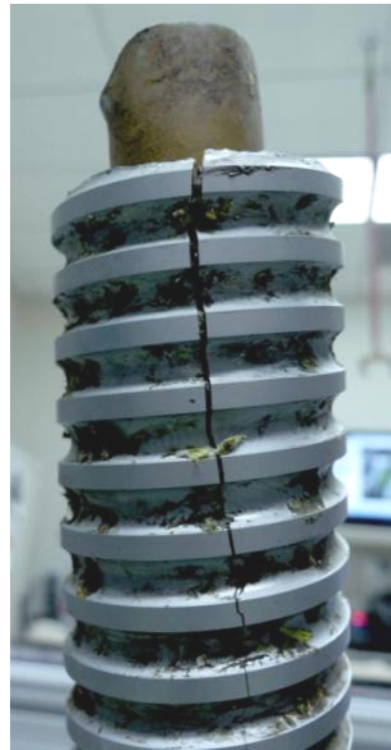
**Figure 30:** Longitudinal fracture

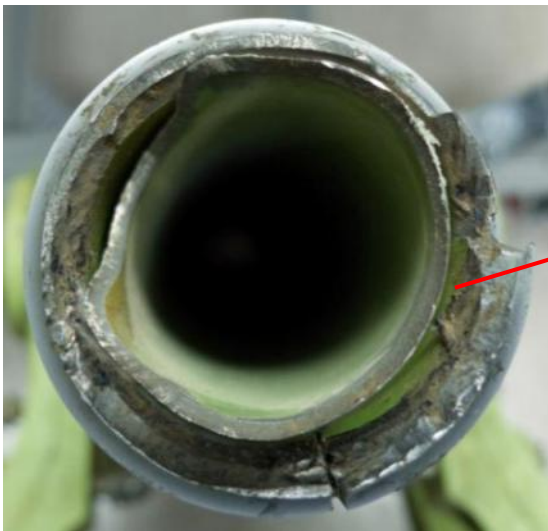
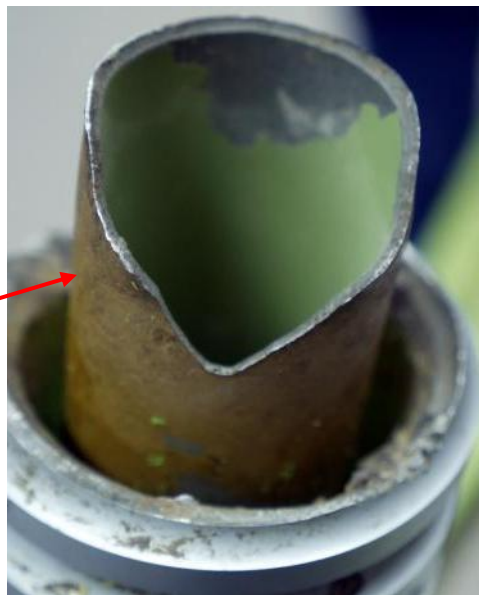
The safety rod remained within the ballscrew and was fractured; see Figure 33 and Figure 34.

**Figure 33:** Fractured safety rod

**Figure 34:** Fractured safety rod

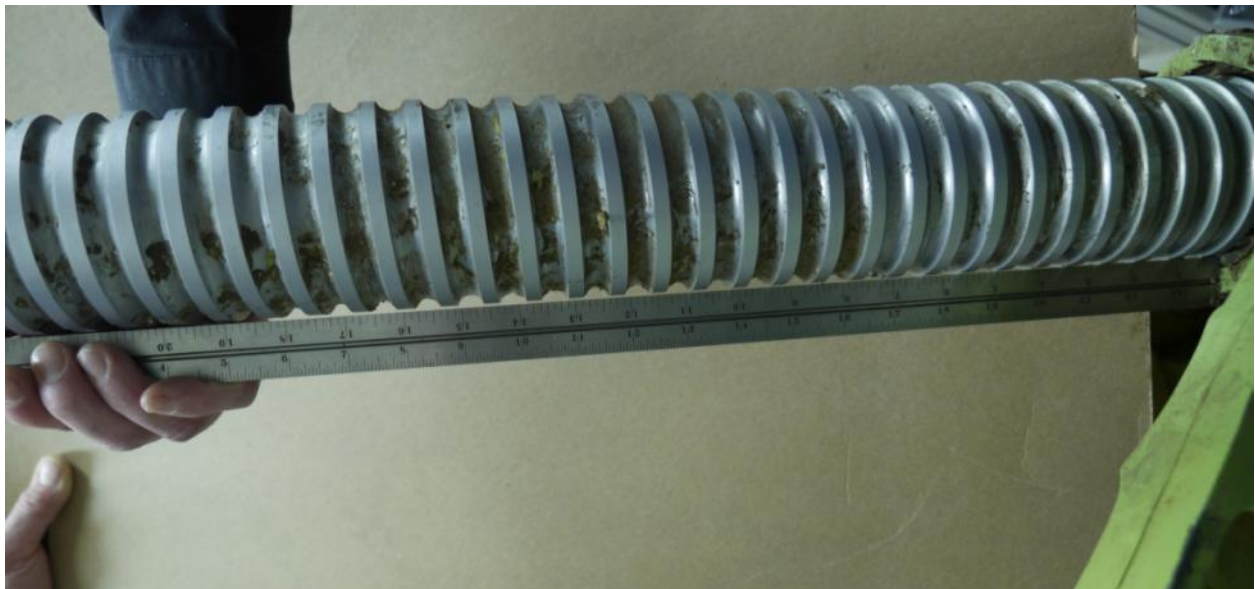
The ballscrew was deformed, exhibiting a slight bend. A straight-edged ruler was laid against the ballscrew to show the extent of the deformation; see Figure 42. The greatest gap between the ballscrew and the ruler occurred approximately fifteen threads from the fractured end of the ballscrew. The distance between the ruler and the ballscrew was approximately 0.04 inch at the fifteenth thread.

**Figure 42:** The ballscrew exhibited bending

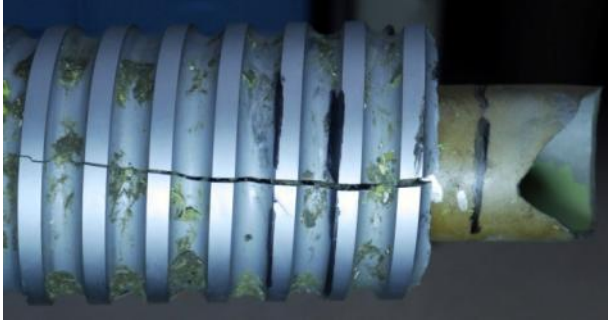
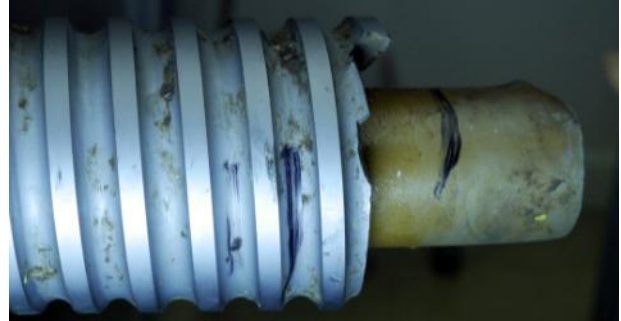
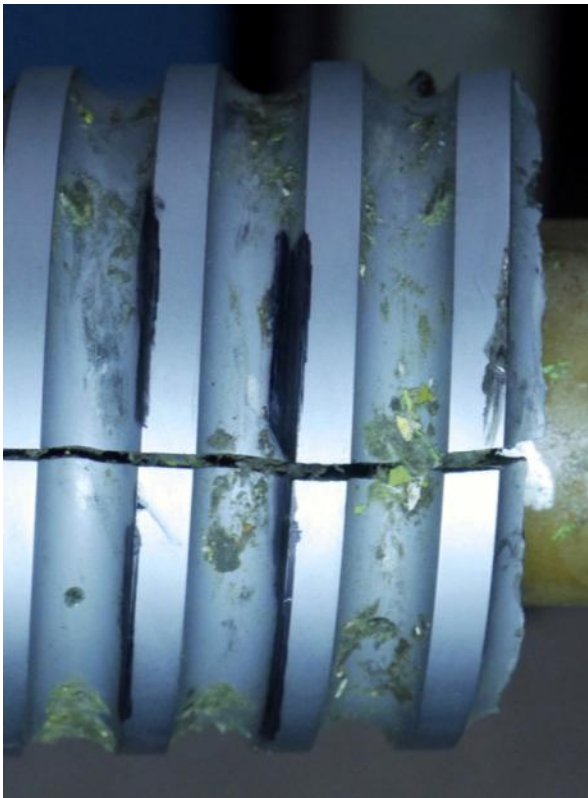
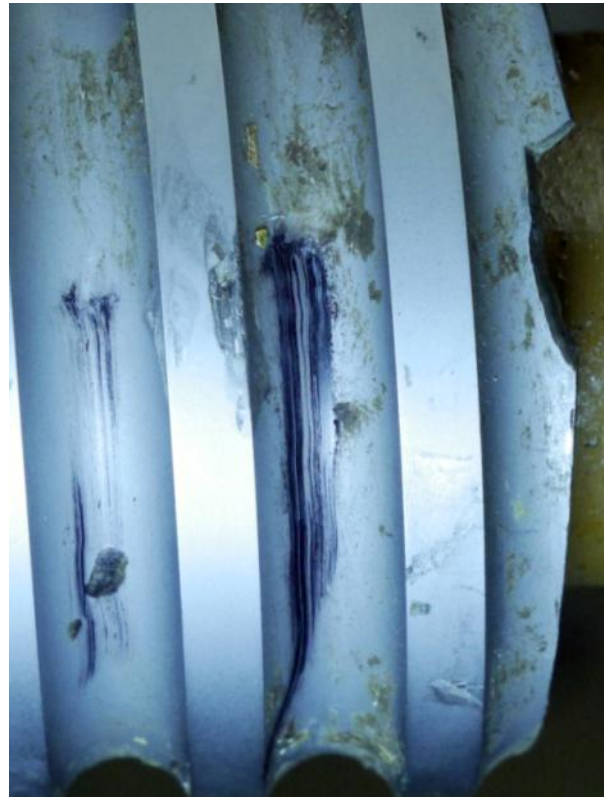
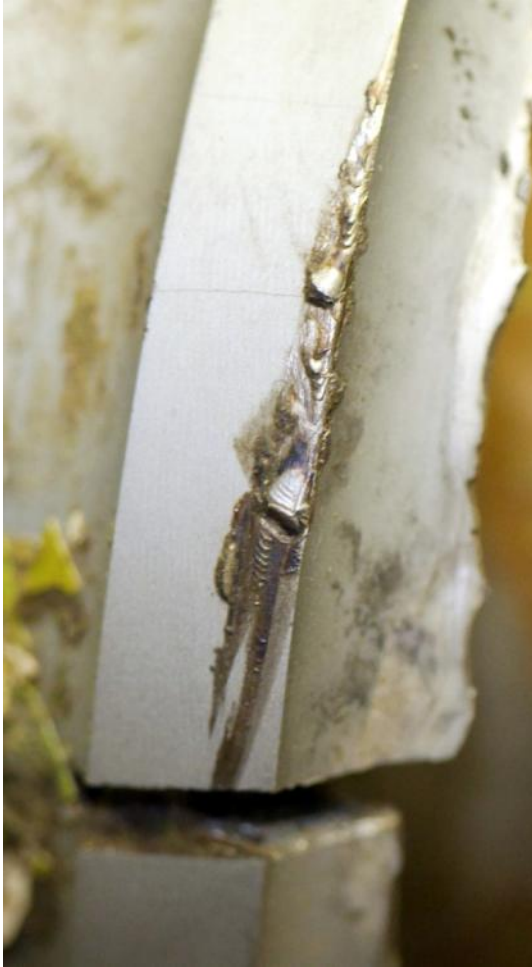
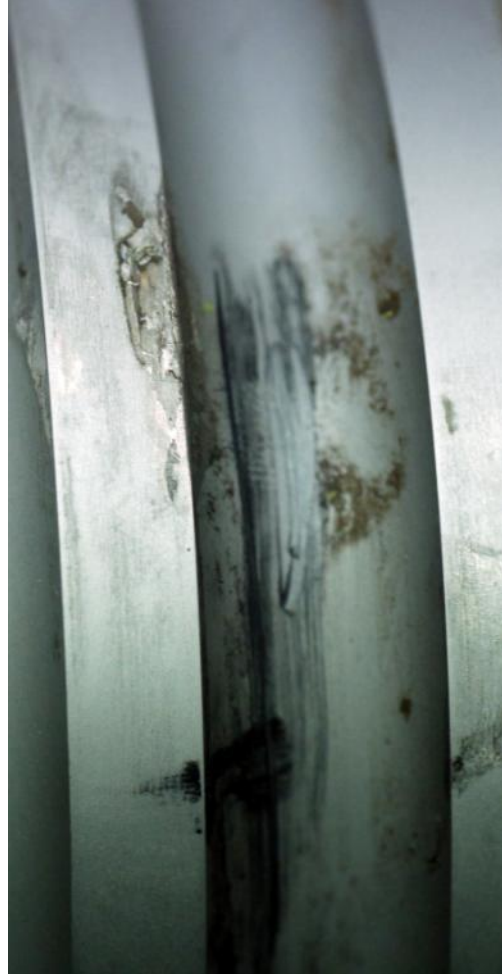
Witness marks were noted on the longer portion of the ballscrew near the fractured end. Figure 43, Figure 45 and Figure 47 show a witness mark adjacent to the longitudinal fracture. Figure 44, Figure 46 and Figure 48 show a witness mark approximately 180 degrees from the longitudinal fracture.

**Figure 43:** Witness marks on ballscrew

**Figure 44:** Witness marks on ballscrew, 180 degrees from longitudinal fracture

**Figure 45:** Witness marks on ballscrew

**Figure 46:** Witness marks on ballscrew, 180 degrees from longitudinal fracture

**Figure 47:** Witness mark on ballscrew

**Figure 48:** Witness mark on ballscrew, 180 degrees from longitudinal fracture

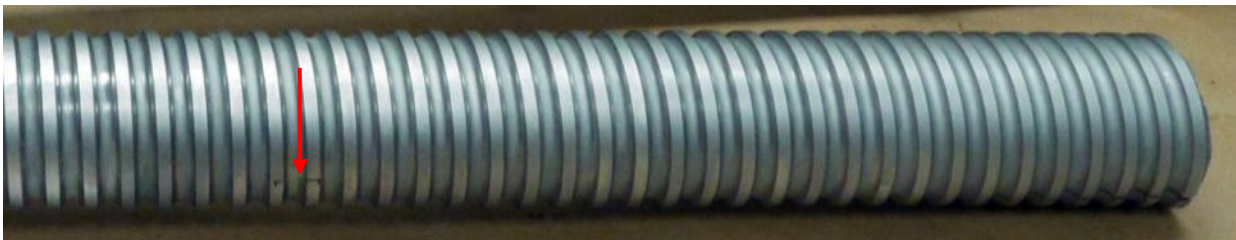
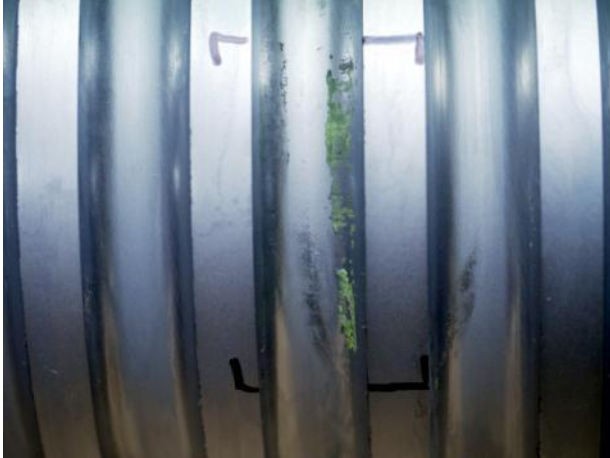
Green paint, from an unknown origin, was found adhered to a thread root 26 threads from the fractured end of the ballscrew and was on the same side of the ballscrew as the longitudinal fracture; see Figure 49 and Figure 50. The thread containing the paint was five threads from the lower ballnut stop, once the ballscrew was positioned as it had been reported to have been found at the accident site. The onsite measurement between the upper ballnut stop and the ballscrew end stop was nine and 9/16 inches.

**Figure 49:** Paint mark on ballscrew

**Figure 50:** Paint mark on ballscrew

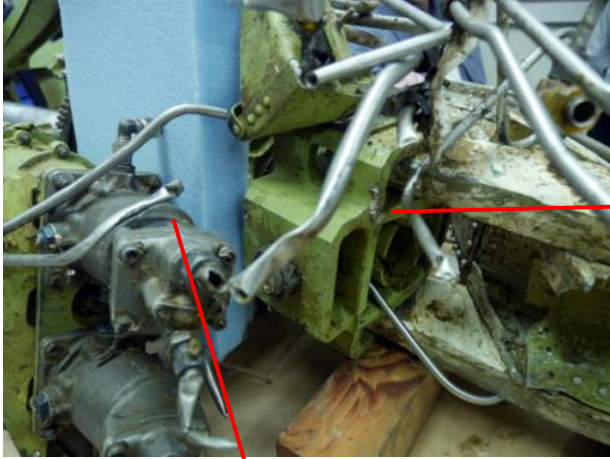
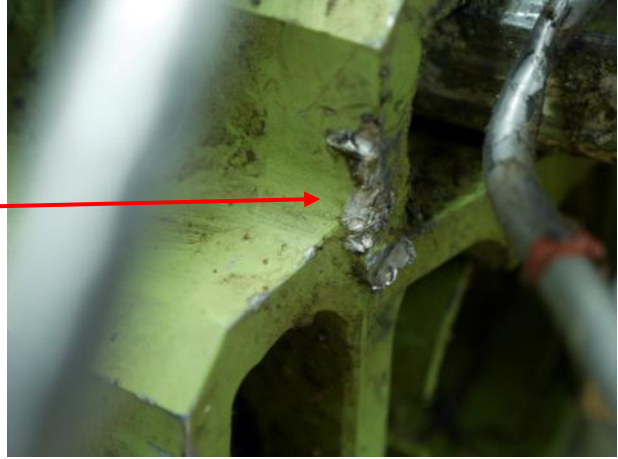
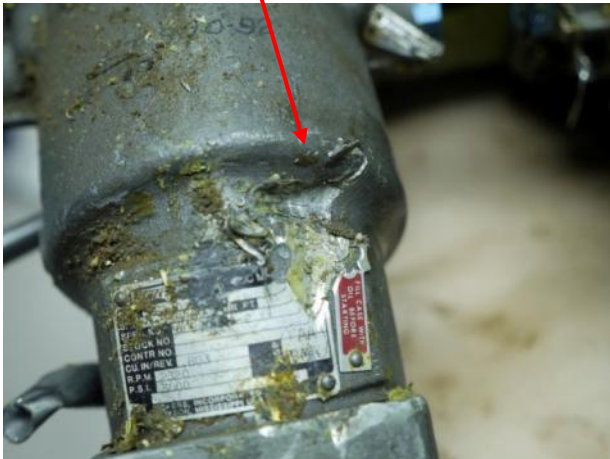
The left hand hydraulic drive motor and the forward surface of the lower gimble had impact marks that appeared to coincide with each other; see Figure 53 through Figure 55. Green paint was evident within the impact mark on the motor. The right hand hydraulic motor had several fractures in the area of the mounting flange; see Figure 56.

**Figure 53:** Hydraulic motors and lower gimble

**Figure 54:** Lower gimble damage

**Figure 55:** Left hand hydraulic motor damage

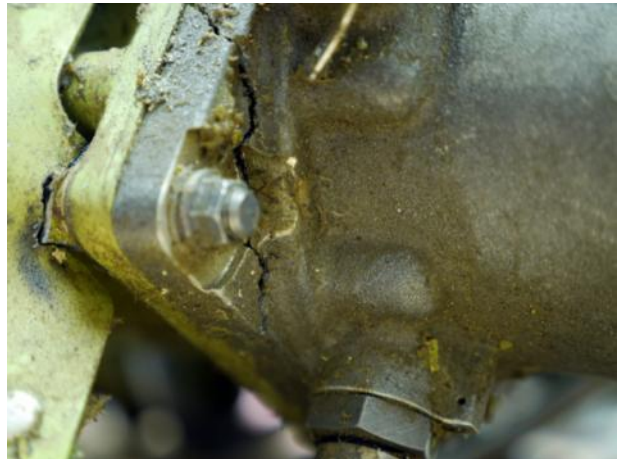
**Figure 56:** Right hand hydraulic motor flange crack

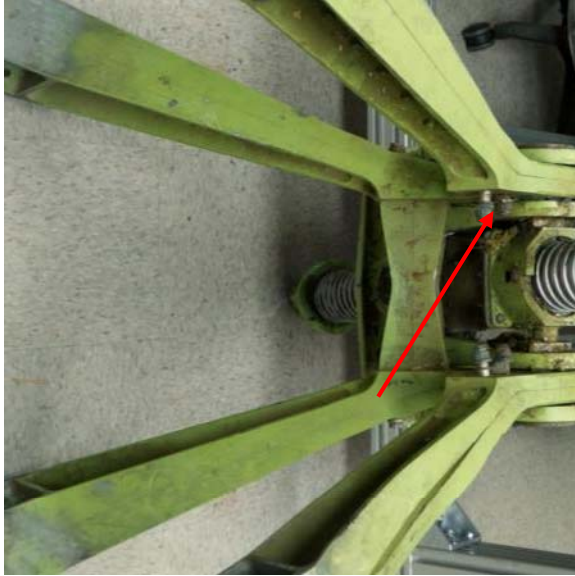
A piece of mettalic material remained trapped by an attachment bolt on one of the legs of the gimble support structure; see red arrow in Figure 57. The structural member of the gimble support that the small piece had fractured from was missing. Figure 58 shows a close-up image of the piece of structure material, prior to removal.

**Figure 57:** Location of trapped piece of structure material

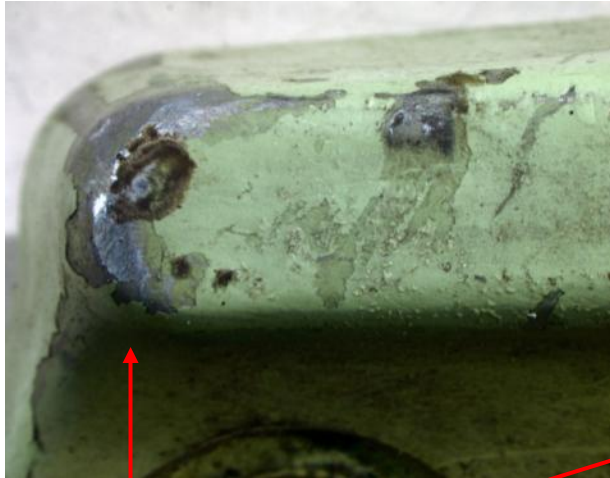
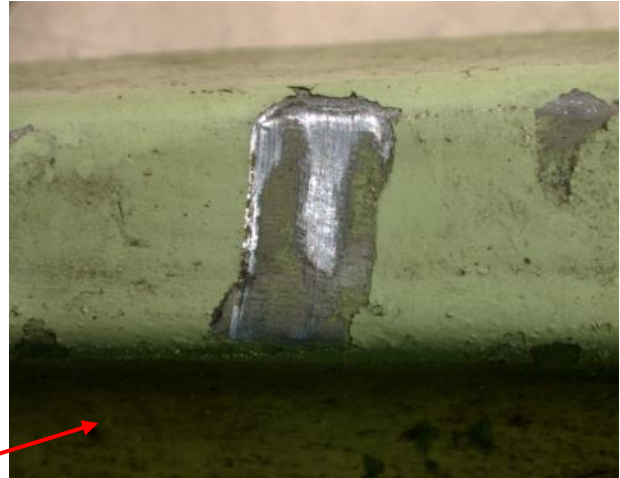
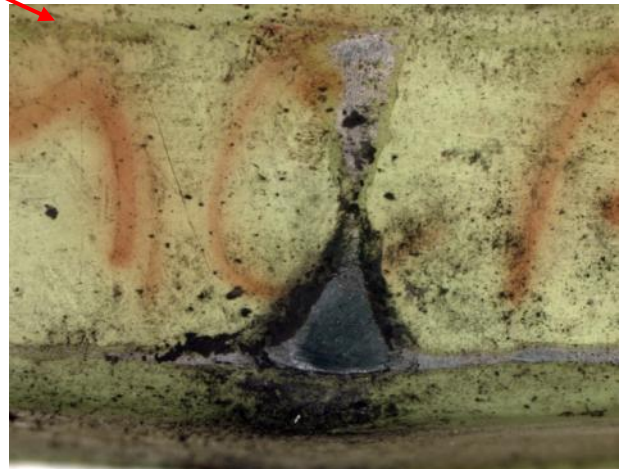
The forward yoke was examined and several witness marks were identified; see Figure 62 through Figure 66.

Figure 62: Forward yoke witness marks

Figure 63: Forward yoke witness mark

Figure 66: Forward yoke witness mark

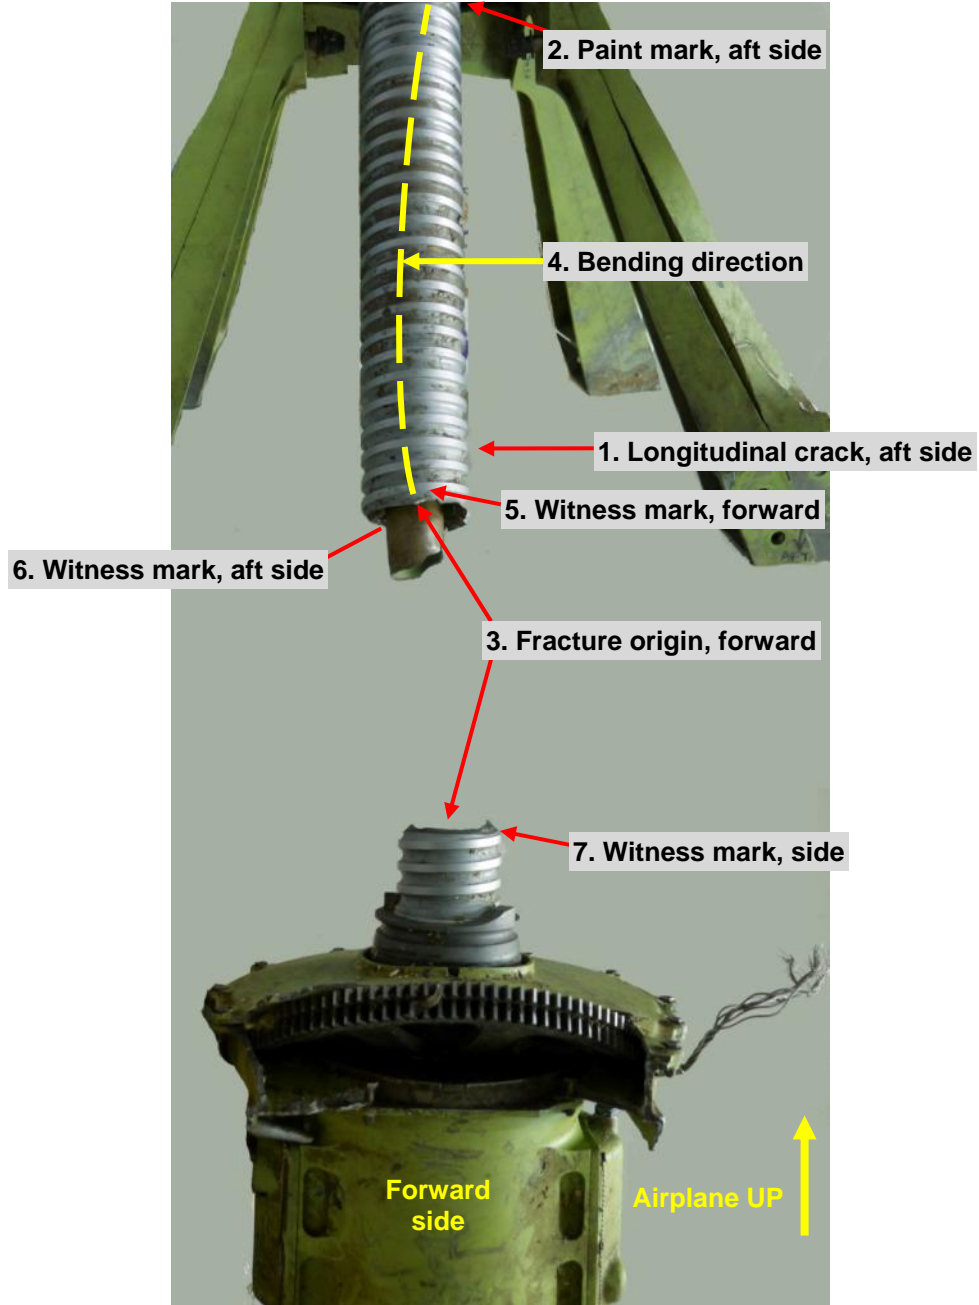
The purpose of this discussion section is to help understand the relative locations of the items of interest found during the EQA examination and the BR&T analysis. Figure 74 was rotated so that the stabilizer trim drive mechanism assembly would appear in a vertical orientation to more closely represent its installation in the airplane. In Figure 74, the ballscrew had been positioned within the ballnut with the same dimension between the upper stops (nine and 9/16 inches), as it was recorded to be at the accident site. The two ballscrew fracture surfaces were then aligned with each other. The image of the reconstruction was captured as if looking aft, as installed on the airplane and with the forward surfaces in view. This reconstruction is solely based upon the condition and position of the components as reportedly found on the ground at the accident site. The noteworthy items associated with Figure 74 are listed below:

1. The longitudinal crack is on the aft side of the ballscrew.
2. The paint mark is on the same side as the longitudinal crack, but beyond view.
3. The approximate fracture origin (forward side).
4. The bending is ninety degrees to the fracture origin; the yellow arc in Figure 74 is exaggerated arc to show the direction of the bending.
5. The witness mark near the fracture surface on the longer section of the ballscrew is located on the side with the fracture origin.
6. Another witness mark near the fracture surface on the longer section of the ballscrew is located on the side with the longitudinal crack (180 degrees to the fracture origin).
7. The third witness mark near the fracture surface on the shorter section of the ballscrew is located on the side of the ballscrew (90 degrees to the fracture origin).

**Figure 74:** Reconstruction with ballscrew repositioned and aligned. This image is oriented as if looking aft, as installed on the airplane.

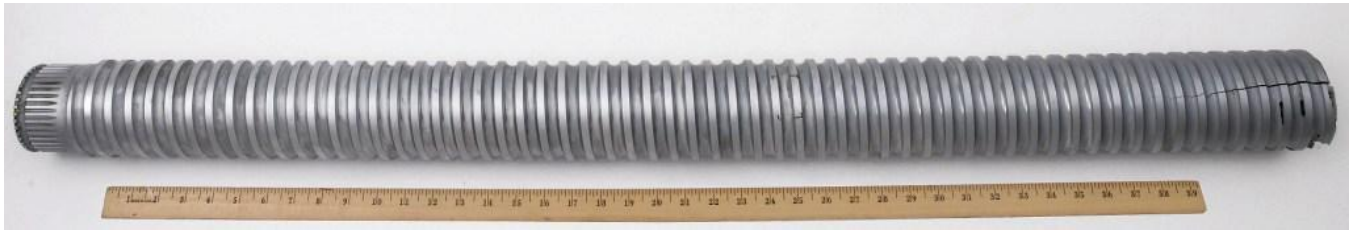
Figure 1 shows the as received fractured ballscrew, with the fractured region at the right side of the image. Figure 2 shows an end on view of the fracture surface. Secondary cracking is observed running lengthwise on the shaft from the main fracture surface and significant amounts of post-fracture damage and contamination obscure the fracture surface. The mating half of the fracture surface was excised from the components and is shown after cleaning in Figure 3. A region of origin is apparent on the OD of the screw at the base of a thread and is in a relatively flat region of the fracture surface

Figure 1. As received photograph of the fractured ballscrew. The fracture location is the right side of the screw and the distortion is exaggerated by the camera..

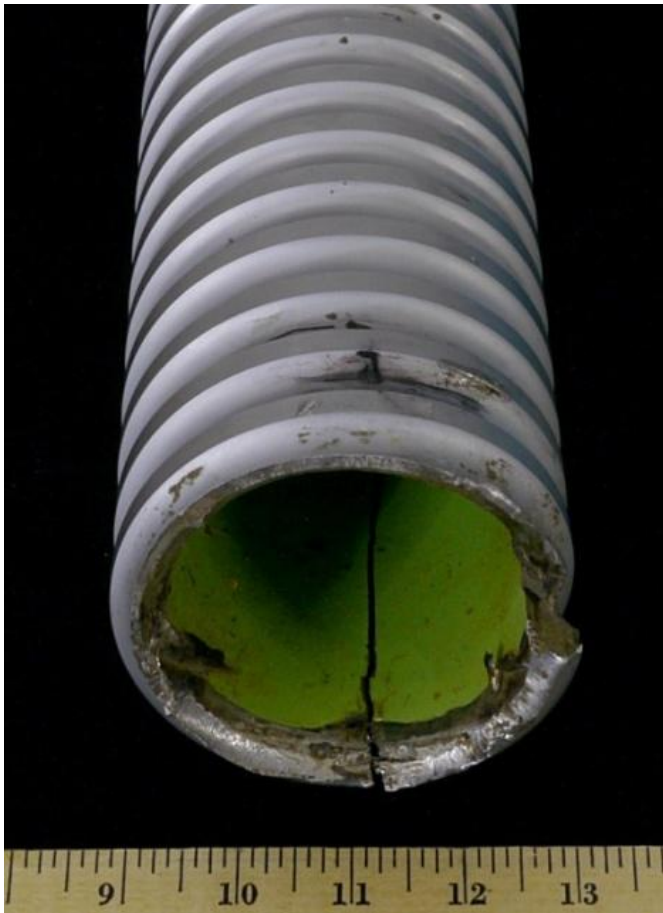
Figure 2. End on view of the fracture of the largest piece of the ballscrew.

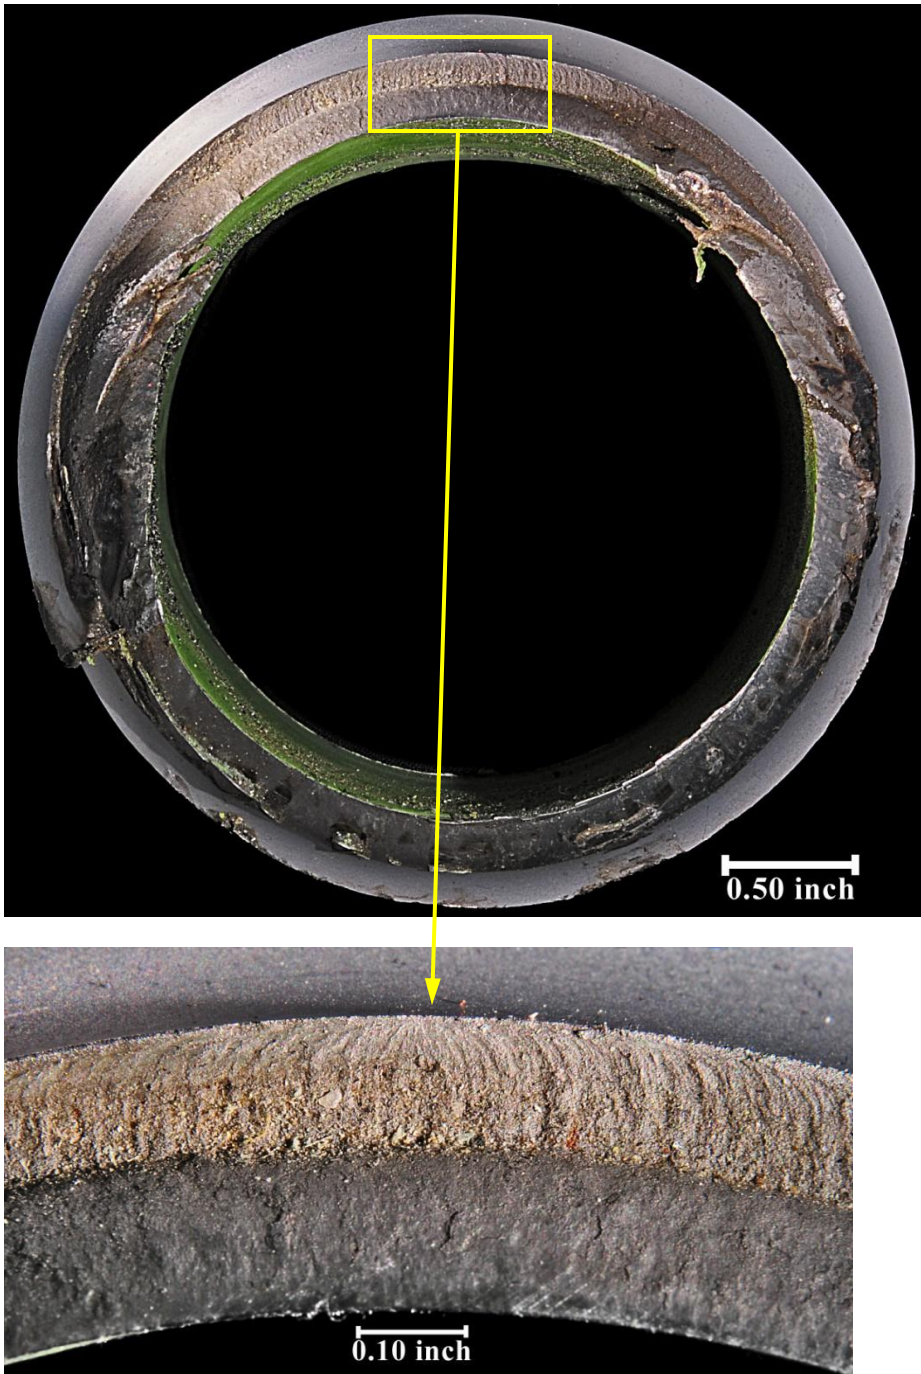
Figure 3. Images of the fracture surface of the mating half after cleaning. An origin can be seen on the OD at the root of a thread in the top of the images.

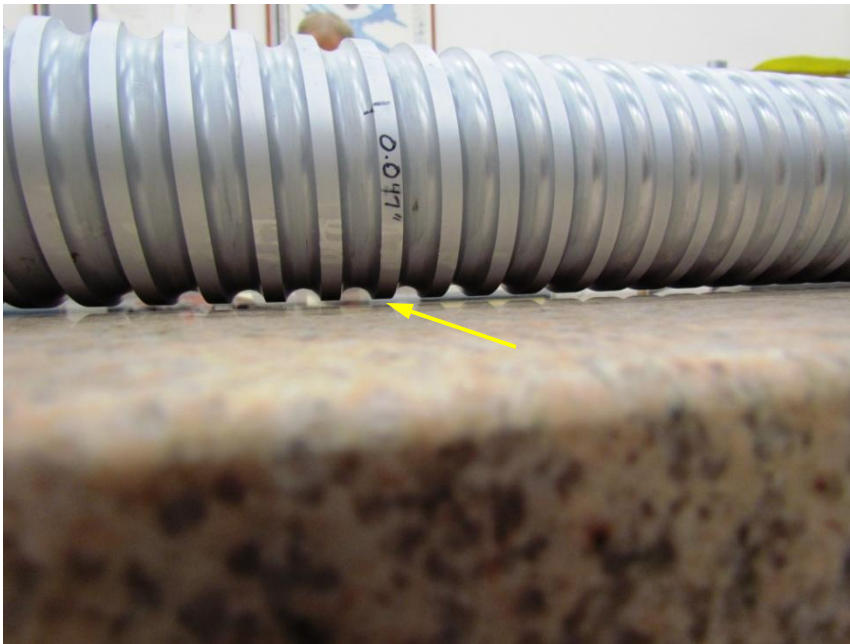
Plastic deformation was observed along the length of the screw. The screw was laid on a precision table and rotated and measured with feeler gages to find the magnitude and direction of the maximum direction (Figure 4). A deflection of 0.0455 inch was measured at an angle approximately 90 degrees to the origin of the fracture (Figure 5).

Figure 4. The ballscrew was laid on a precision table and 0.0455 inch of plastic deformation was measured with feeler gages.

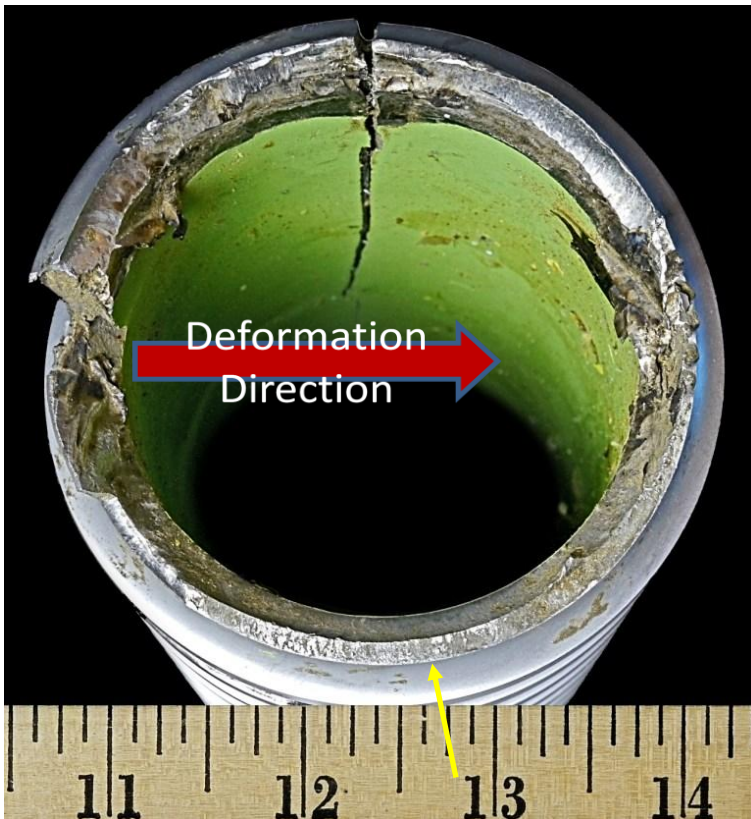
Figure 5. Optical image of the direction of the plastic deformation of the ballscrew (red arrow) relative to the origin of the fracture (yellow arrow).

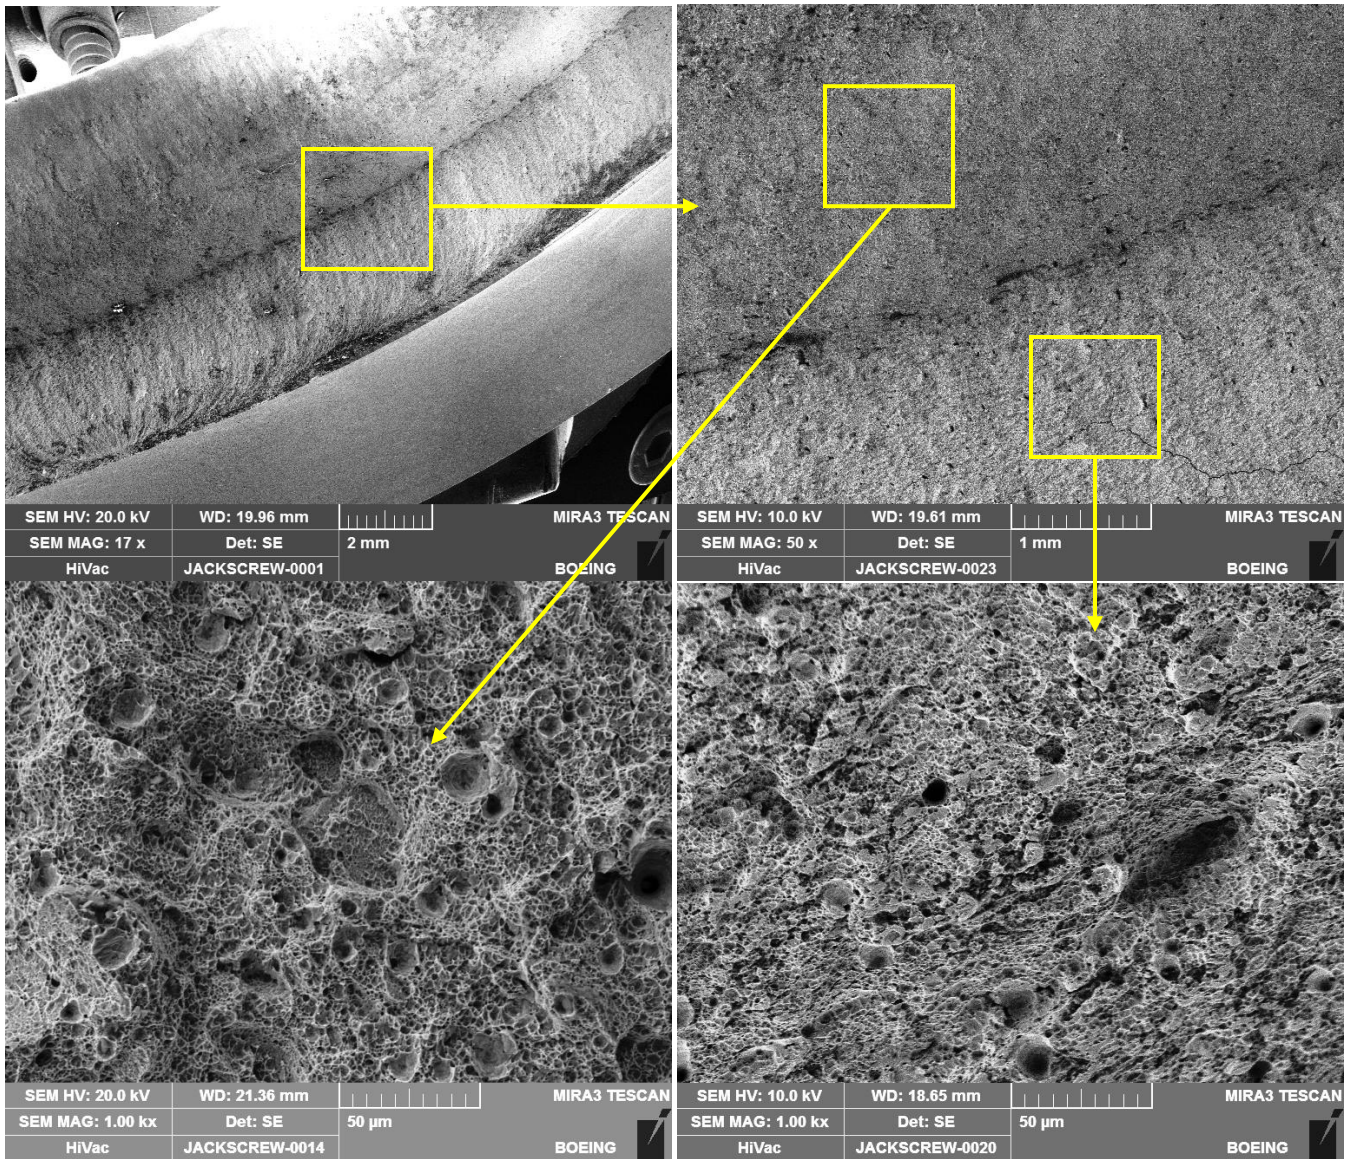
The fracture surface was examined in the SEM for further analysis. The surface showed significant corrosion and had to be chemically cleaned to evaluate the features. Dimple rupture morphologies were seen on all surfaces of the fracture, consistent with single event, ductile failure (Figure 6).

Figure 6. SEM images of increasing magnification showing the fracture surface near the region of origin. The bottom images show dimpled rupture morphology.

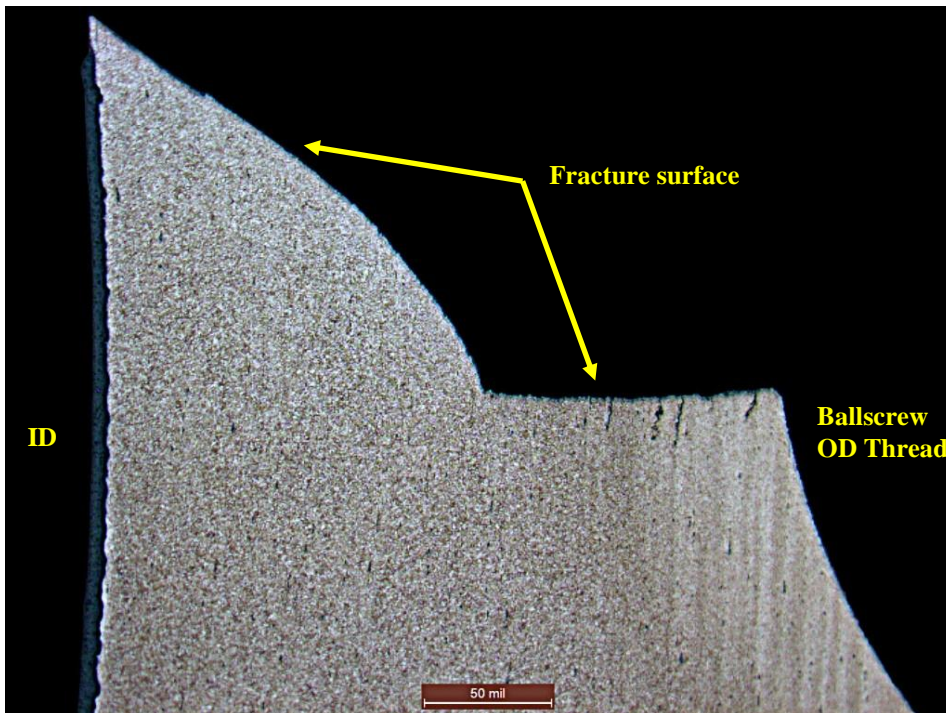
Figure 7. Micrograph of a cross section of the screw near the fracture, showing a microstructure typical of alloy steel.

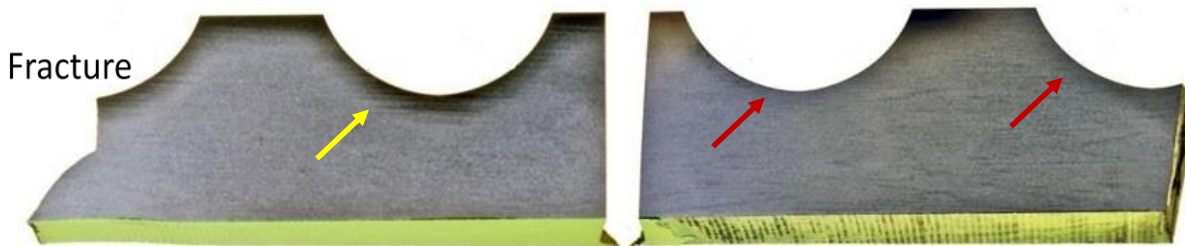
A metallurgical cross section of the ballscrew through the fracture is shown in Figure 7. Additional metallographic cross sections are shown in Figure 8. After etching, it was apparent that the threads of the screw were not uniformly case hardened. Hardness values at the surface did not meet the drawing requirement of HRC 58 – 62 in these regions, confirming the lack of case hardening. Figure 8 illustrates the variable case hardening. Despite failing to meet the drawing requirements, the fracture occurred at a hardened location and this did not appear to contribute to the fracture. The surface of the ballscrew threads showed normal burnishing from contact with the ball nut but no indications of significant thread wear. The core hardness of all ball screw sections evaluated met the drawing requirement of 160 – 200 ksi.

Figure 8. Metallurgical cross sections of several threads near and including the fracture. A case hardened region is shown with the yellow arrow and regions that are not case hardened are indicated with red arrows.
