NATIONAL TRANSPORTATION SAFETY BOARD

System's Group Chairman's Factual Report

NTSB ID No.: CEN17FA168

Location: Amarillo, Texas
Date: April 28, 2017
Time: 2348 Central Daylight Time
Aircraft: Pilatus PC-12, N933DC

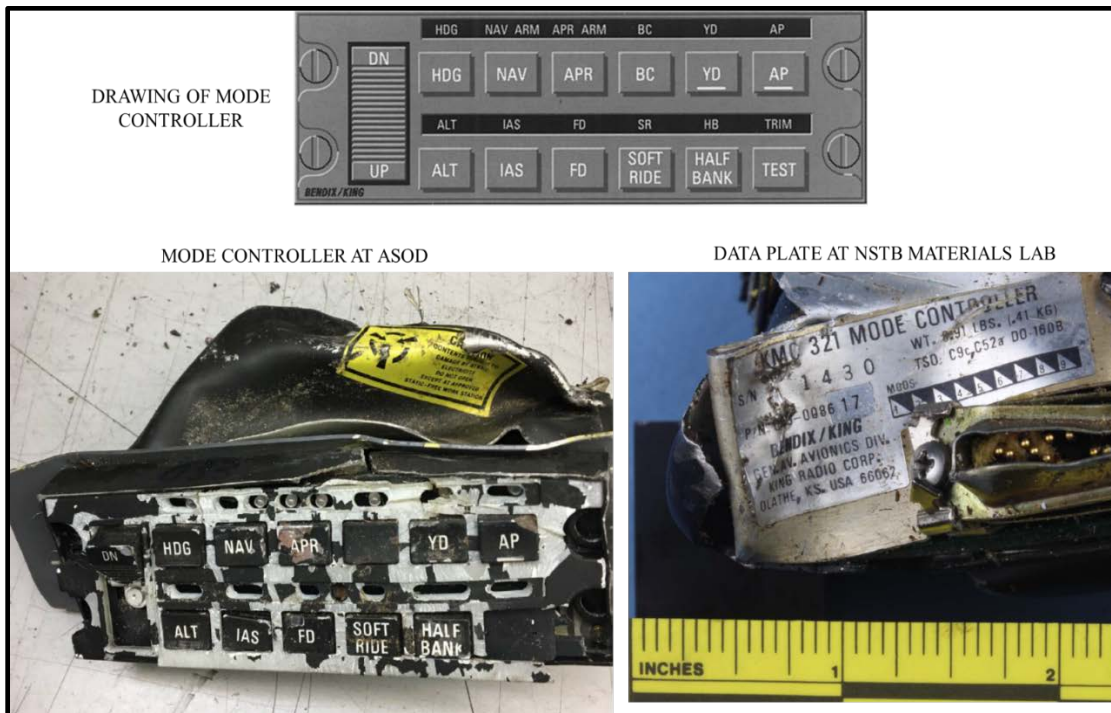
Figure 2 Photos of the mode controller

During the May 22, 2017 examination of the wreckage at ASOD, the Bendix King KMC321 Mode Controller, S/N 1430, was removed from its respective storage bag and visually inspected. Visual inspection revealed that the unit's case was crushed, its front plate was missing and many of the light bulbs remained in place. (Reference Figure 2) The unit was retained for lightbulb filament analysis; it was placed into a shipping container and shipped to the NTSB Materials Laboratory located in Washington D.C.

On June 21, 2017, a light bulb filament analysis was conducted on the unit at the NTSB Materials Laboratory by a Materials specialist. Except for the "HB" and "TRIM" annunciators, the analysis revealed that each annunciator light had one bulb. Each bulb was examined using a 5X to 50X zoom stereomicroscope. The status of the filament of each bulb is listed in Table 3 below

Annunciator	Filament Analysis
HDG	Broken, not stretched, possible age-related sag
NAV - NAV	Broken bulb glass, no filament present
NAV - ARM	Broken, not stretched, possible age-related sag
APR - APR	Broken, not stretched
APR - ARM	Broken, not stretched
YD	Broken, not stretched
AP	Broken, not stretched
ALT	Broken, not stretched
IAS	Broken bulb glass, no filament present
FD	Broken bulb glass, no filament present
SOFT RIDE (SR)	Broken, not stretched, possible age-related sag
HALF BANK (HB)	Broken, not stretched
TRIM	Both bulbs-broken bulb glass, no filament present

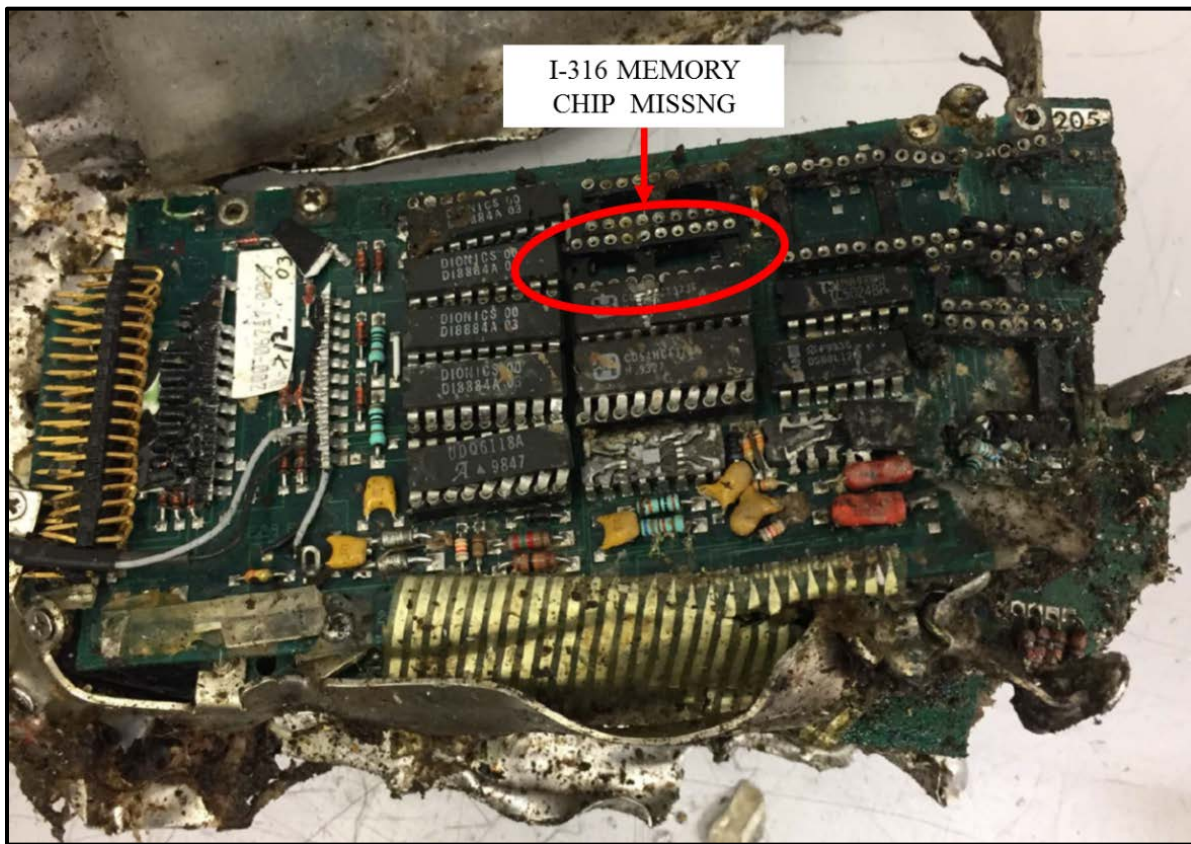
Figure 4 Circuit board from the altitude preselector

As shown in Figure 4, the inspection revealed that the I-316 chip was missing; it was not found attached to the circuit board.

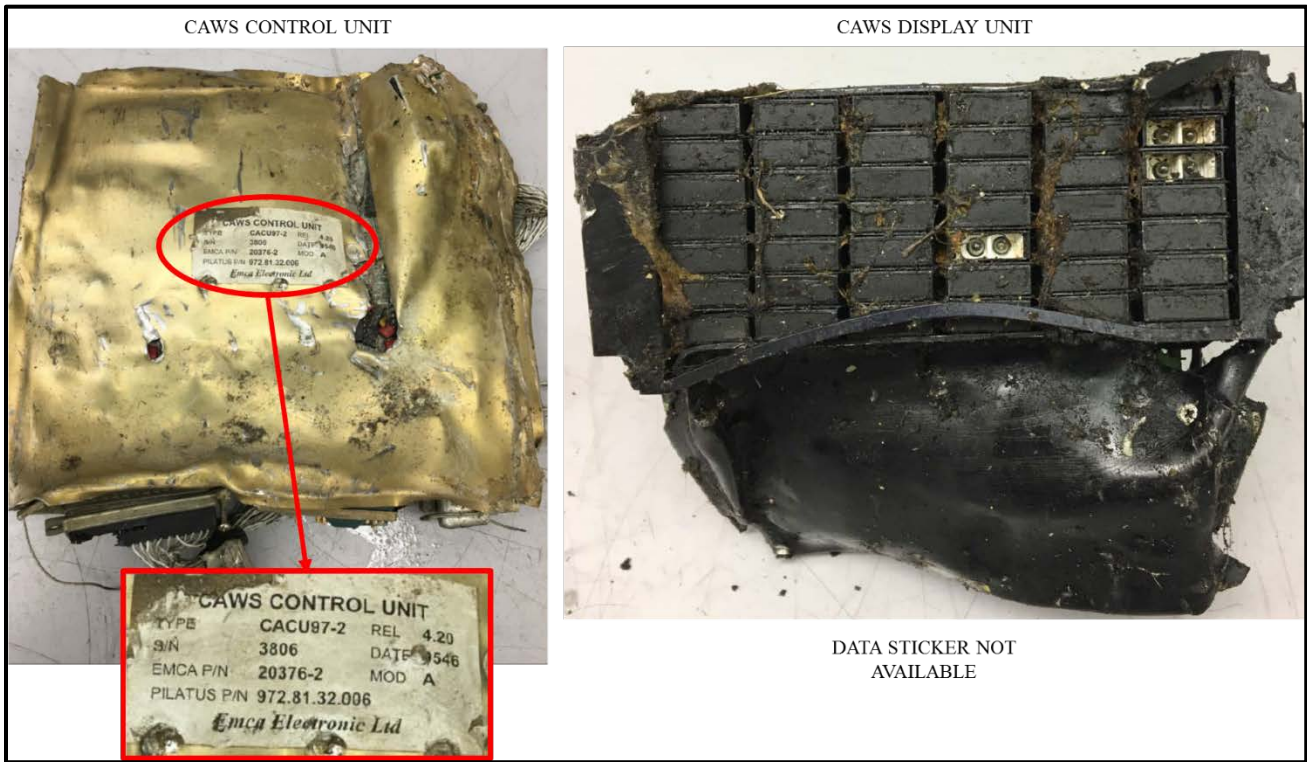
Figure 7 CAWS Components

As shown in Figure 7, the CACU97-2, S/N 3806, was found damaged (crushed) such that it could not be functionally tested.

The casing of the CADU, S/N 7060, was found severely distorted and three annunciation covers were found missing. The unit was submitted to the NTSB Materials Laboratory located in Washington D.C. for filament analysis on each of the annunciator lights.

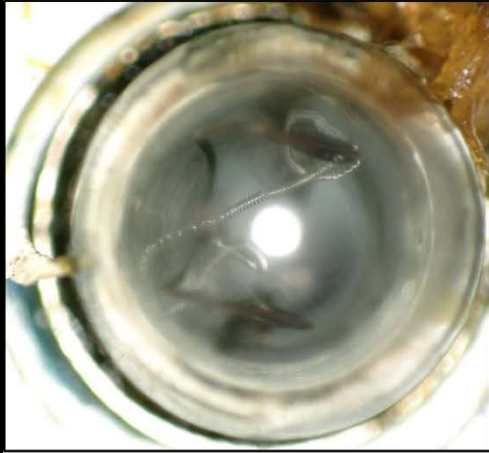
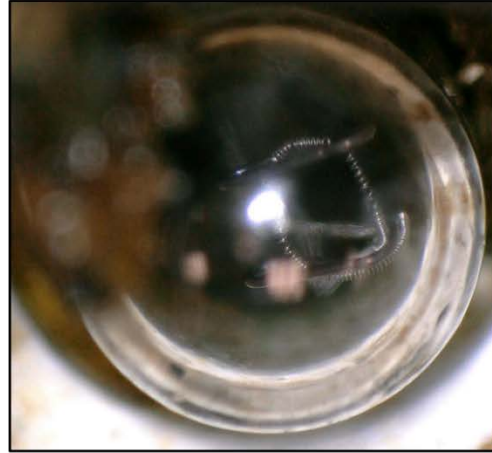
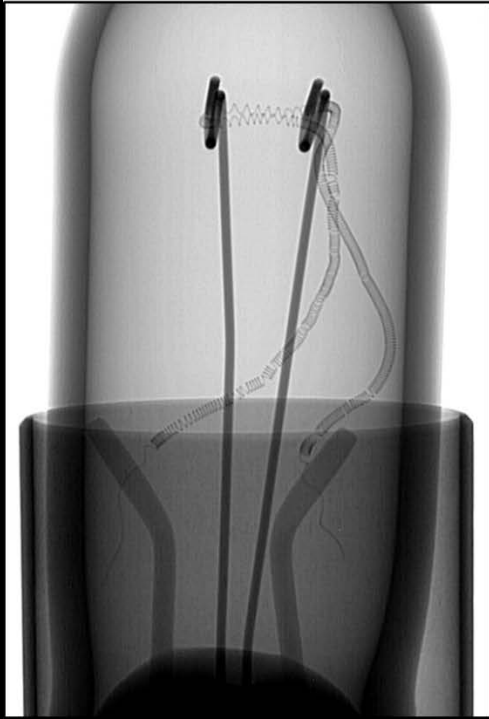
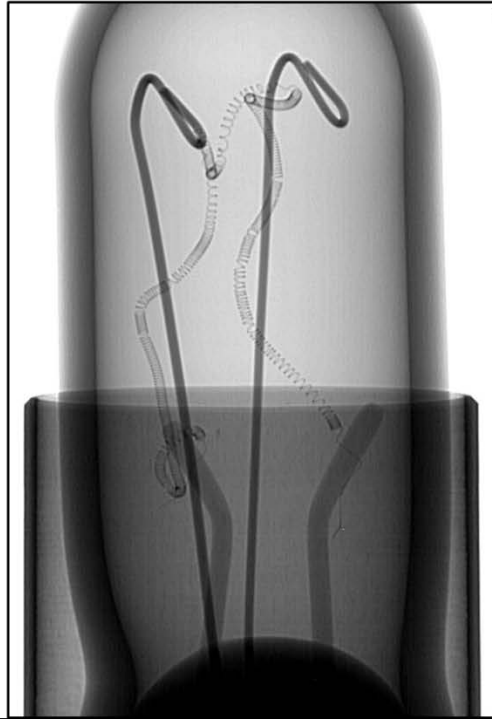
Figure 8 Photos of A/P DISENG lightbulbs

On June 21, 2017, a light bulb filament analysis was conducted on the CADU at the NTSB Materials Laboratory by a Materials specialist. The analysis revealed that each annunciator light had two bulbs. Because of the arrangement of the lights (seven rows), radiography of the panel was not possible. Each bulb was therefore examined using a 5X to 50X zoom stereomicroscope and the results of the examination are described in Table 5. For the annunciators in which the filaments were identified as being stretched and possibly stretched, Table 6 provides information on the condition(s) that would have to occur for the filaments to be stretched. Additionally, Figures 8, 9, and 10 show photos of the A/P DISENG, PUSHER, and A/P TRIM (RED) lightbulbs respectively.

NOTE: For the bulb filaments labeled, “BROKEN, POSSIBLY STRETCHED”, the filament was totally fragmented and there were insufficient coil sections to make a firm conclusion as to the state of the filament.

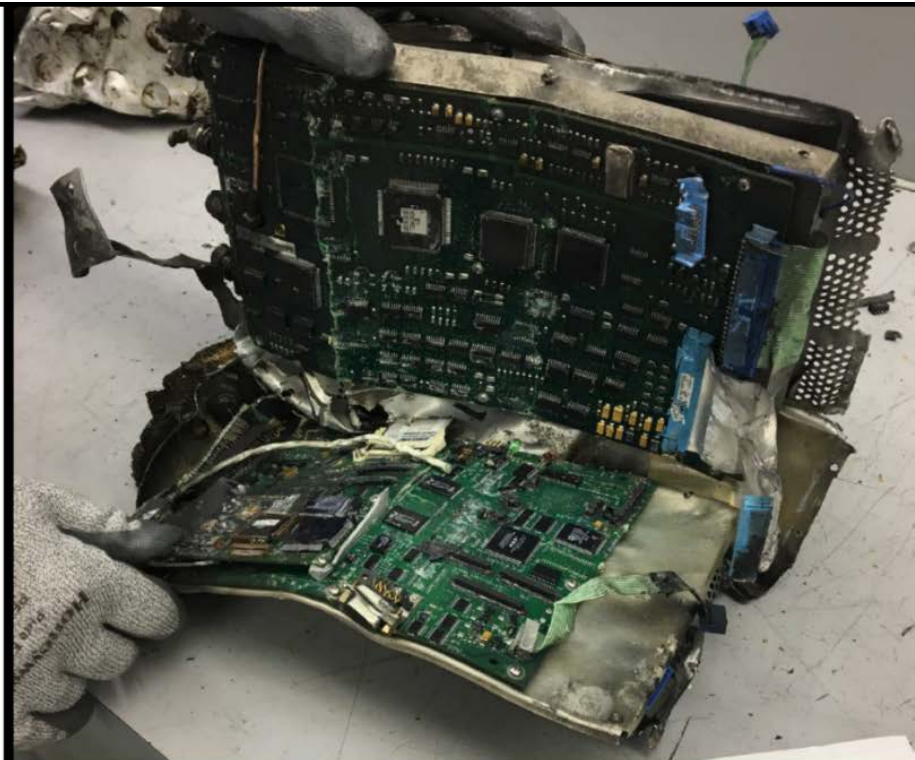
KMH 820
OBSERVED DAMAGE

On June 8, 2017, the examination of the KMH-820 computer was conducted by Honeywell in the presence of the NTSB at the Honeywell facility located in Redmond, Washington. Because the KMH-820 computer could not be powered up or functionally tested¹⁵, the examination consisted of disassembling it with the purpose of locating the memory chip (U28) where event codes are stored and then downloading any event codes that may have been recorded during the accident flight. Visual examination revealed that the KMH-820 computer was compromised due to impact damage and heat distress; the outer case was structurally distorted and internal circuit boards were found bent with missing components. The serial number of the unit was not visible due to heat distress. Investigators observed that the U28 chip, the flight history flash memory chip, remained attached to its corresponding pad on the circuit board.

¹⁵ The KMH-820 computer could not be functionally tested due to the impact damage it sustained.

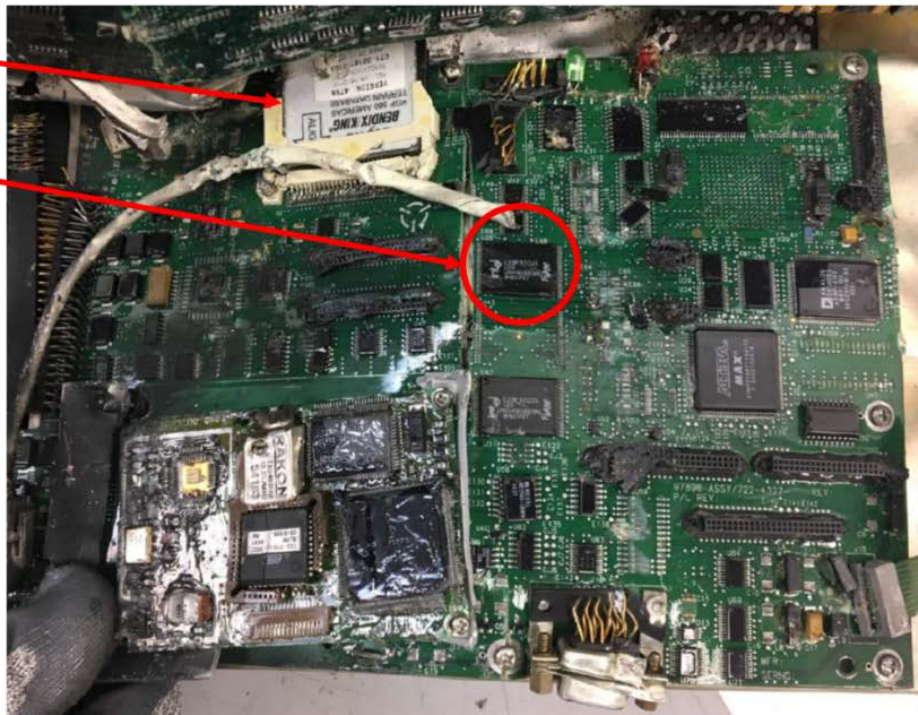
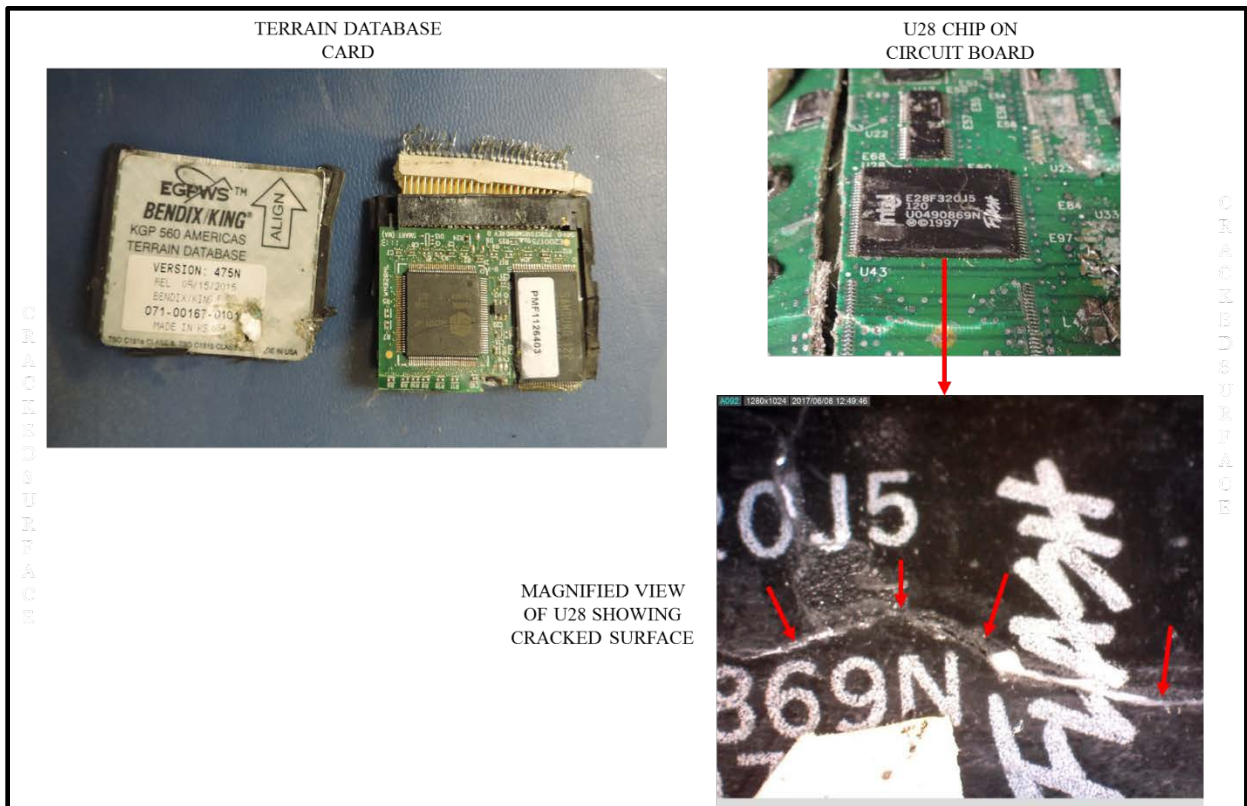
Figure 12 Terrain database card and U28 chip

The micro integrated hazard avoidance system (IHAS) circuit card assembly (CCA) was removed via screws. The GPS card, which was damaged during impact, was removed to allow removal of the IHAS assembly. Terrain Database Version installed: 475N, with a release date of 9/15/2015. The U28 Non-Volatile Memory (NVM) chip was found with a crack on its upper surface. Because of this mechanical damage, the investigators determined to not remove from the chip from the circuit board (Figure 12). The unit was repackaged in its shipping container and provided to the NTSB.

- X-ray inspection revealed that the flash memory package has a wire bonded silicon die. It showed a detailed extent of the cracks in the package and possibly in the memory die. At least 4 wire bonds to the memory die are broken along the line of a crack.
- Acoustic images confirmed that the memory die is severely cracked from the impact damage.
- Since the die is cracked, no digital data can possibly be retrieved from this flash memory package.
