ATTACHMENT 1

DEEC Circuit Card Examination – Honeywell Report

This report is the documentation associated with the DEEC CCA Download attempt that occurred on March 29, 2016 at the HON Tucson facility. Oversight was provided by the NTSB.

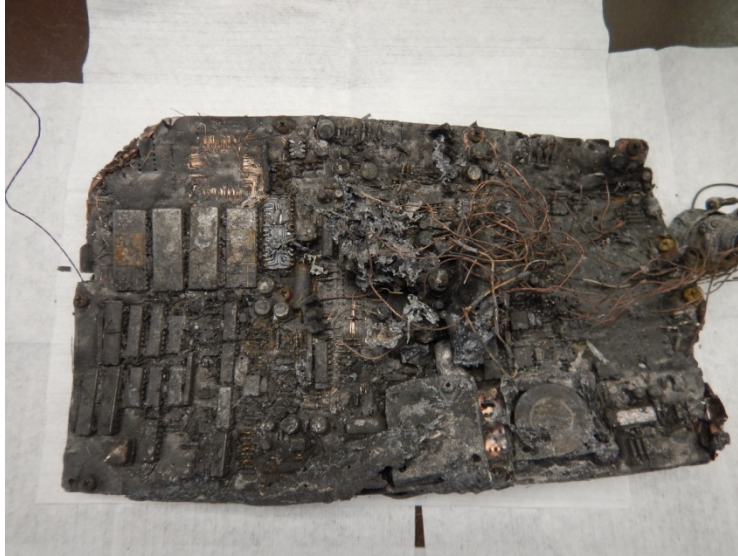
The first Digital Electronic Engine Controller (DEEC) Circuit Card Assembly (CCA) examined was the one located during the wreckage review at Hanger 6.

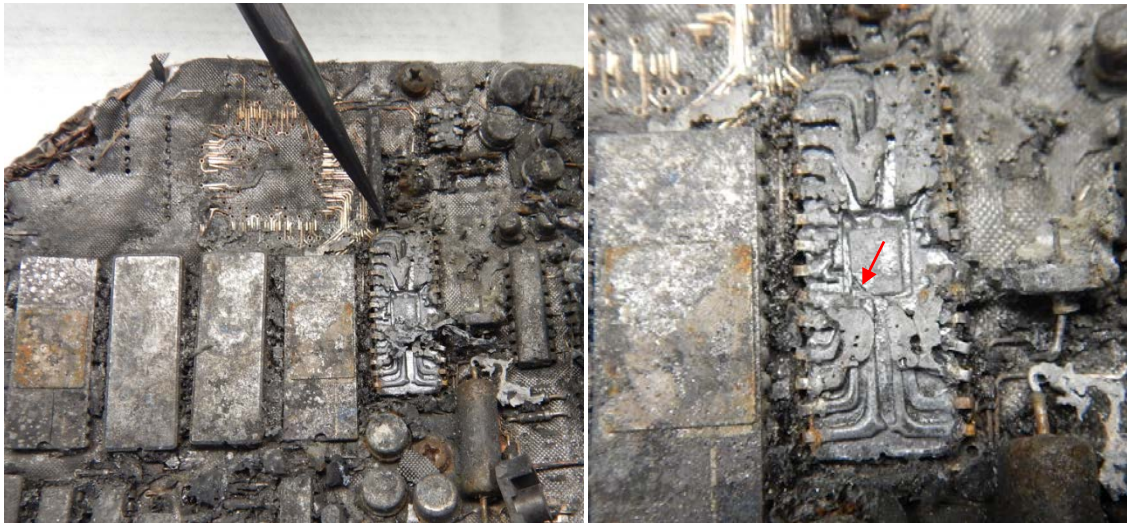
The U26 Integrated Circuit (IC) chip was damaged. The Plastic was melted and appear to have been partially consumed by the post-crash fire. A crack was identified in the IC die.

The IC manufacturer could be consulted to assess the die damage and the possibility of data retrieval at the die level. The IC is a ATMEL AT28C256.

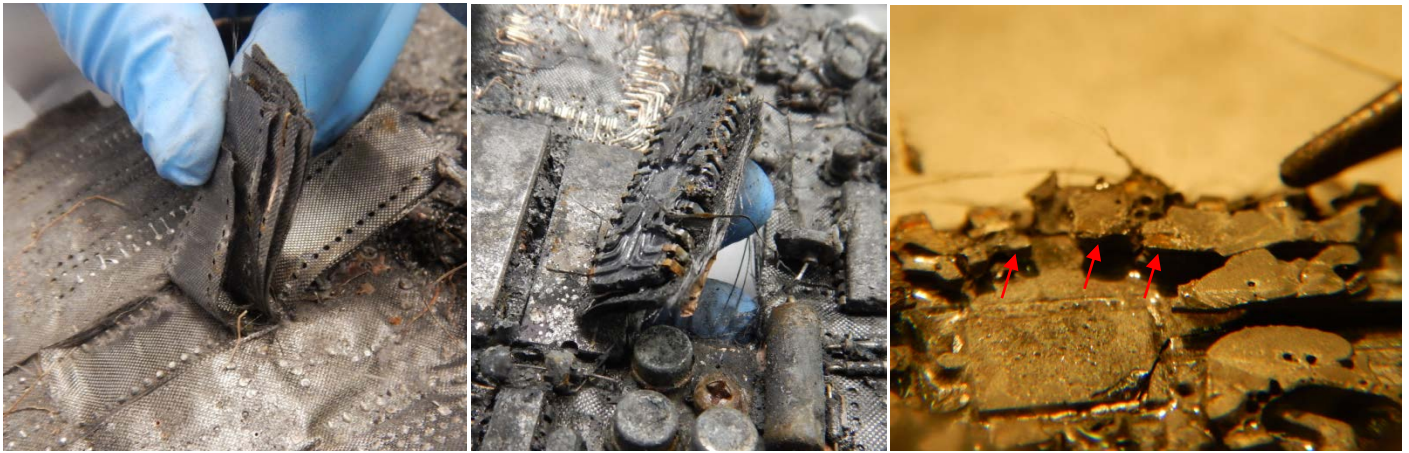
The U26 chip was removed by cutting through the CCA fiber layers from the backside (opposite of the attachment) in effort to maintain as much structural integrity of the IC leads. Upon removal it was noted that IC leads 3,4,6,7 & 8 were loose from their attachment point on the IC due to material loss.

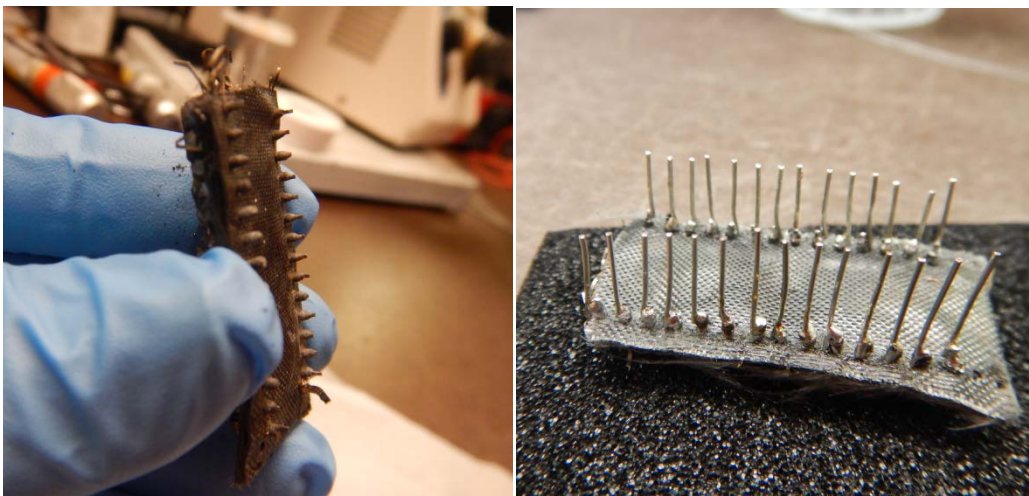
The U26 chip was installed in the Data I/O 3980 XPI with a resulting lack of connection in the socket due to the additional material on IC leads. Lead extensions were soldered onto the IC leads in order to interface with the Data I/O 3980 XPI socket.

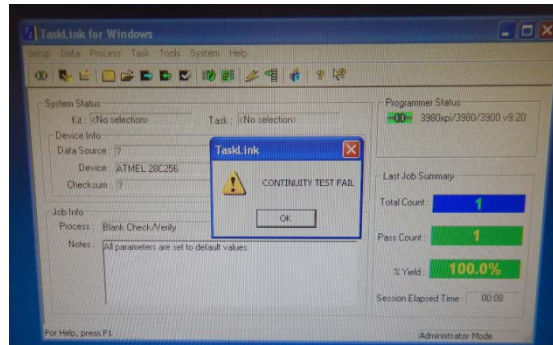
- 1st attempt: “Continuity Test Fail” Message received.

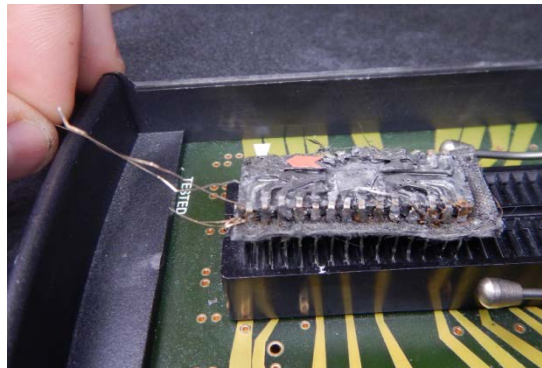
- The copper tracks remaining within CCA material were removed to eliminate the possibility of short circuits between the leads.

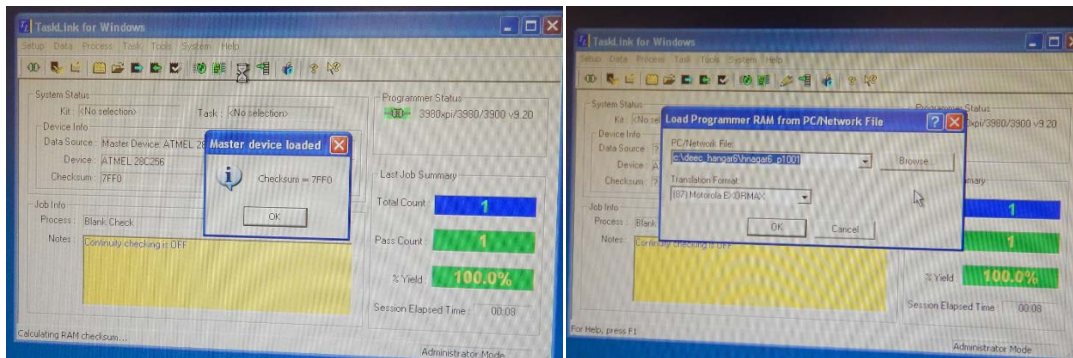
- 2nd attempt: “Continuity Test Fail” Message received.
 - Reseated IC in test socket
- 3rd attempt: “Continuity Test Fail” Message received.
 - Disabled Continuity Test in software
 - Software identified IC Data CHECKSUM 8000 (Equivalent to empty device)
- 4th attempt:
 - Reseated IC in test socket
 - Software identified IC Data CHECKSUM 7FF0 (Small amount of data) – File saved “DEEC_hanger6\hanger6_P1001”

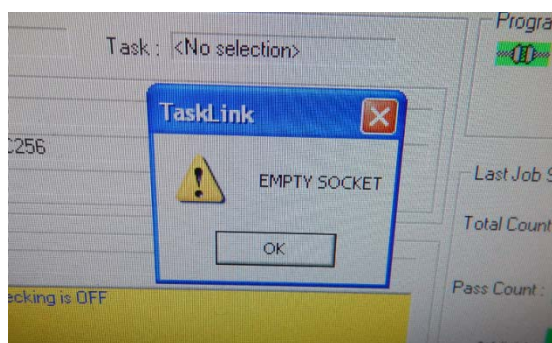
- Enabled Continuity Test in software
- 5th attempt: “Continuity Test Fail” Message received.
 - Attempted to hold IC in socket with light pressure in effort to make contact with leads.
 - “Empty Socket” message – Executed query operation 4 times with repeated failure message.

Additional review at this time appeared to show that all leads were loose to some degree. Download attempt terminated.

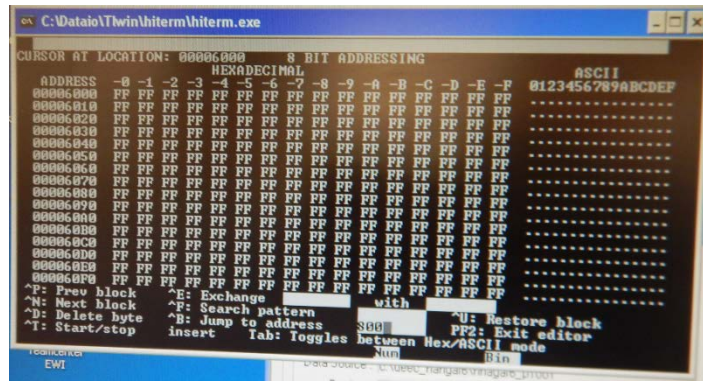
Data reviewed manually. A minimal amount of bytes were Zeros. The data appeared to be invalid.

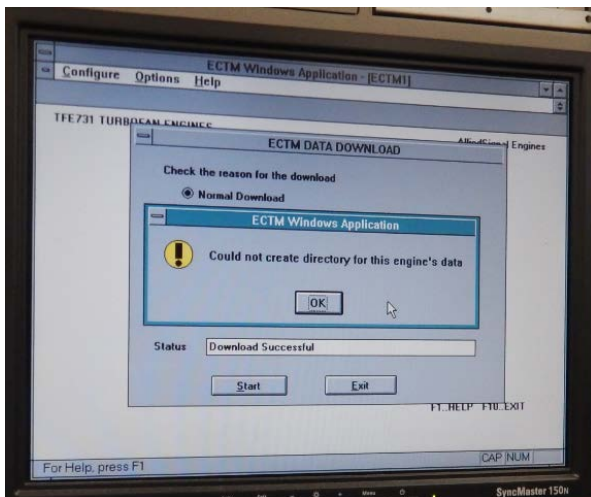
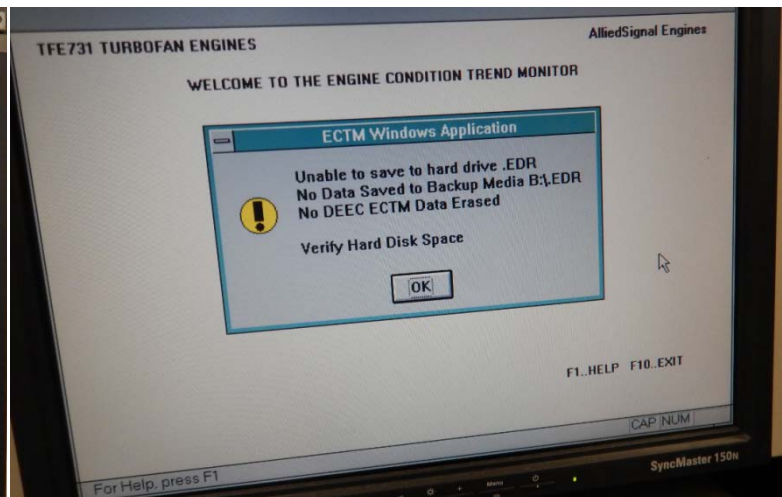
ECTM stated the download operation was successful. However, the operation of creating and saving the directory (output) failed during multiple attempts.

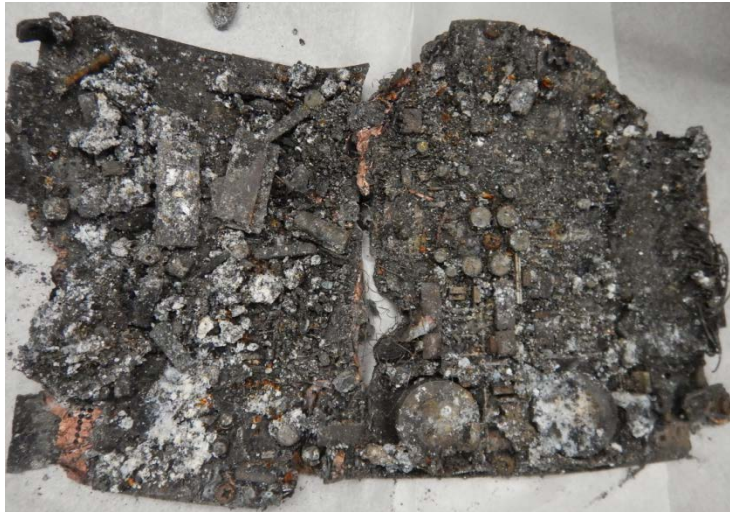
The "On-Scene" located DEEC CCA was examined.

- It was identified that the U26 IC was not present on the CCA.
