NATIONAL TRANSPORTATION SAFETY BOARD

SYSTEMS GROUP CHAIRMAN'S FACTUAL REPORT

CEN13FA038

Location: Boyne City, MI
Date: October 31, 2012
Time: 0930 local
Aircraft: Piaggio P180, N401WS

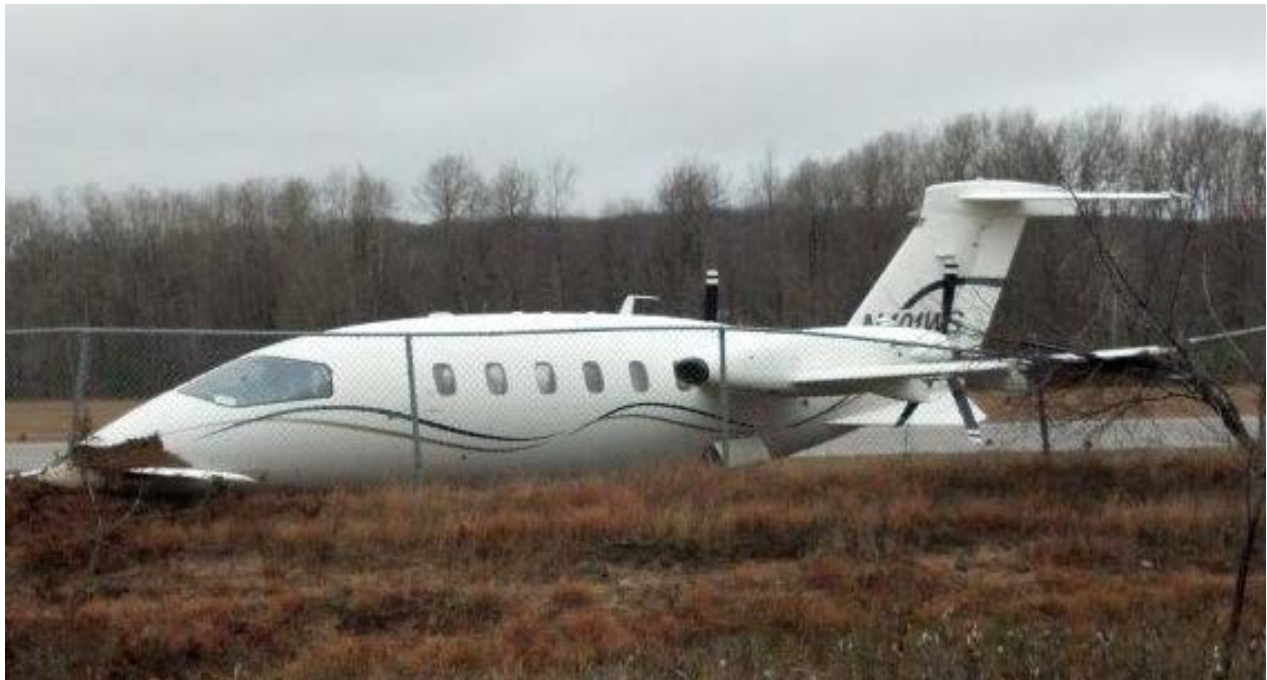
The pilot stated that after the airplane touched down, it made an uncommanded turn to the left and continued off of the runway. The airplane struck the airport perimeter fence and came to rest in the same location (See Figure 1).

Figure 1: Condition of Airplane After it Came to Rest

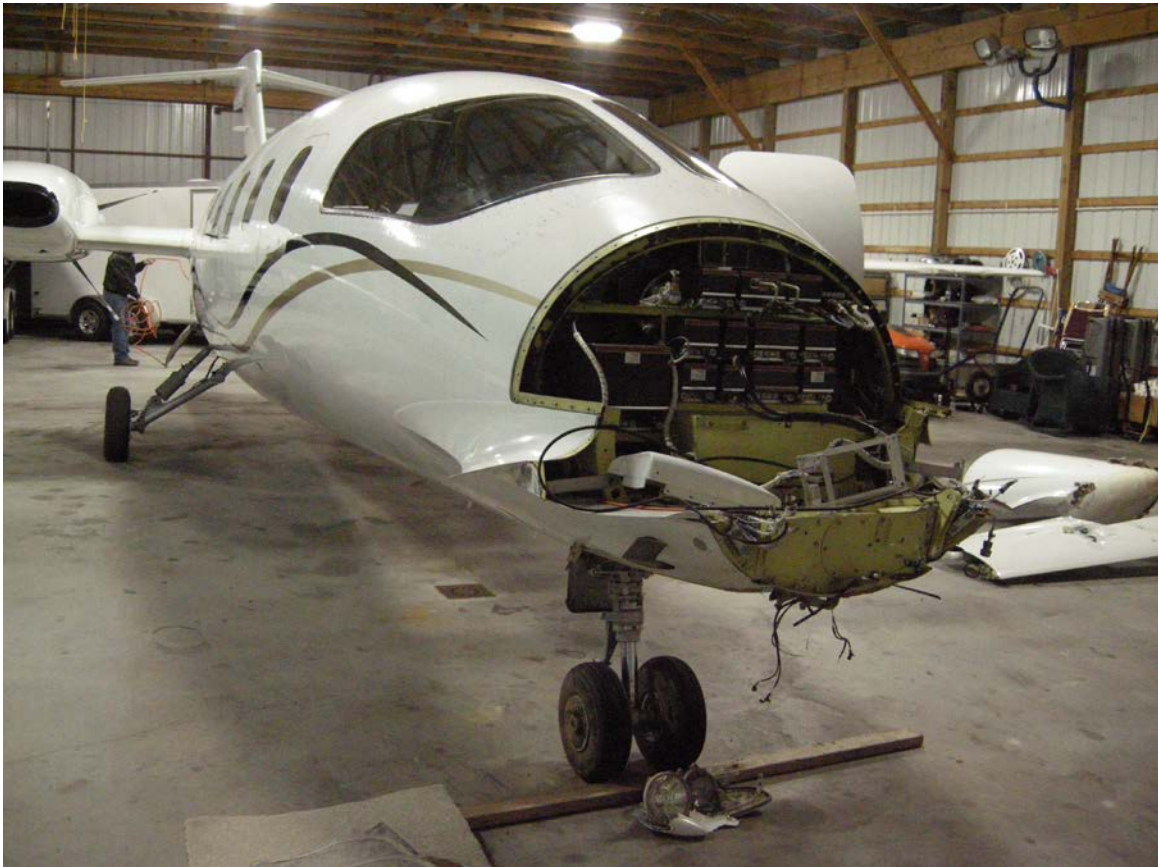
Figure 3: Condition of Airplane During On-Scene Testing

The front of the nose cone was dirty, fractured, and broken. The structure on the underside of the fuselage in the area around the nose taxi/landing light cavity was buckled and the light assembly was detached and damaged. The inboard aft corner of the left forward wing flap was bent and the leading edge outboard corner of the left forward wing was broken off. The left wing leading edge had a dent approximately 3 ft in length that was centered approximately 4 ft inboard of the outboard edge.

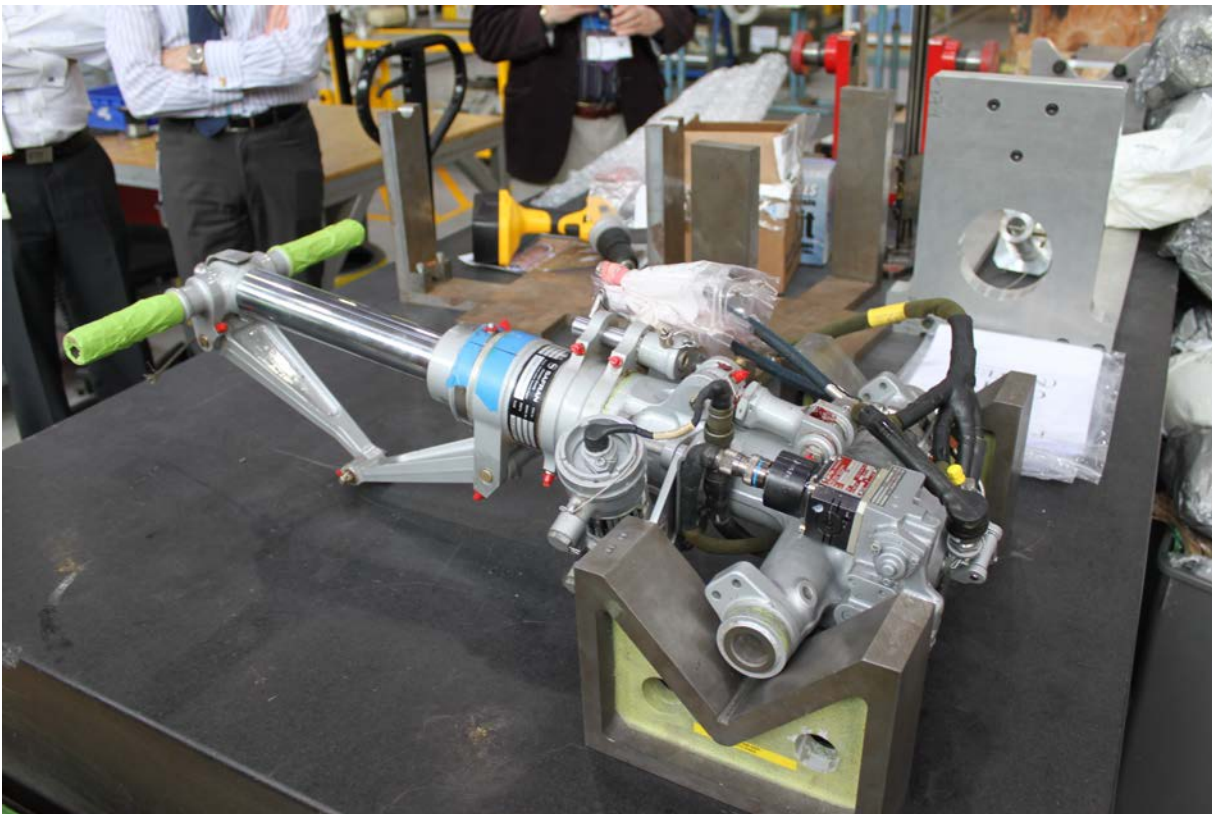
Figure 4: Nose Landing Gear Assembly During Testing at MBD

The metal hydraulic tubing was removed and the landing gear was attached to a test bench to perform Piaggio Service Bulletin 80-0249, Rev 1, Part A. When the assembly was first installed the hydraulic power was activated and the electrical power was off, the actuator slowly extended. After cycling the unit multiple times to clear air out of the hydraulic lines, the electrical power was engaged and the nose wheel centered as expected. Electrical power was turned off and the actuator extended. Electrical power was then turned on and the nose wheel centered correctly. Electrical power was again turned off and the actuator retracted. This test sequence was run two times with identical results. The actuation rate varied each time, ranging from a slow creep to an easily noticeable speed. These results failed the requirements of SB 80-0249.

During Step 3.E.5 it was found that in order to obtain the feedback potentiometer centered position (4.91/4.93 Volts reading on the potentiometer test set), the axle had to be rotated 3.9 degrees to the left of the axle center position as identified by extending the strut to engage the cam. There was approximately 1 degree of play in this position that appeared to be originating from where the steering actuator rod end was connected to the nose wheel steering linkage. Following all testing the axle had to be rotated 2.5 degrees to the left of the center position as identified by extending the strut to engage the cam in order to obtain the feedback potentiometer centered position.

The unit failed step 3.J.4. This step required that the weight-on-wheels lamp and the steering-on lamp on the test bench went off when the sliding tube sub-assembly was between 0.080 and 0.100 inch of the fully extended position. During testing the lights went off when the sliding tube sub-assembly was 0.940 inch from the fully extended position.

The unit failed step 3.K.8. This step required that there was no change in the steered angle when 1000 psi hydraulic pressure was supplied to the assembly, the steered input command was 34 degrees, and the solenoid valve was powered off. The unit under test steered to a hard-over position. It was noted that this test was added to the manual at Revision 11 and was not available when the subject unit was last overhauled.

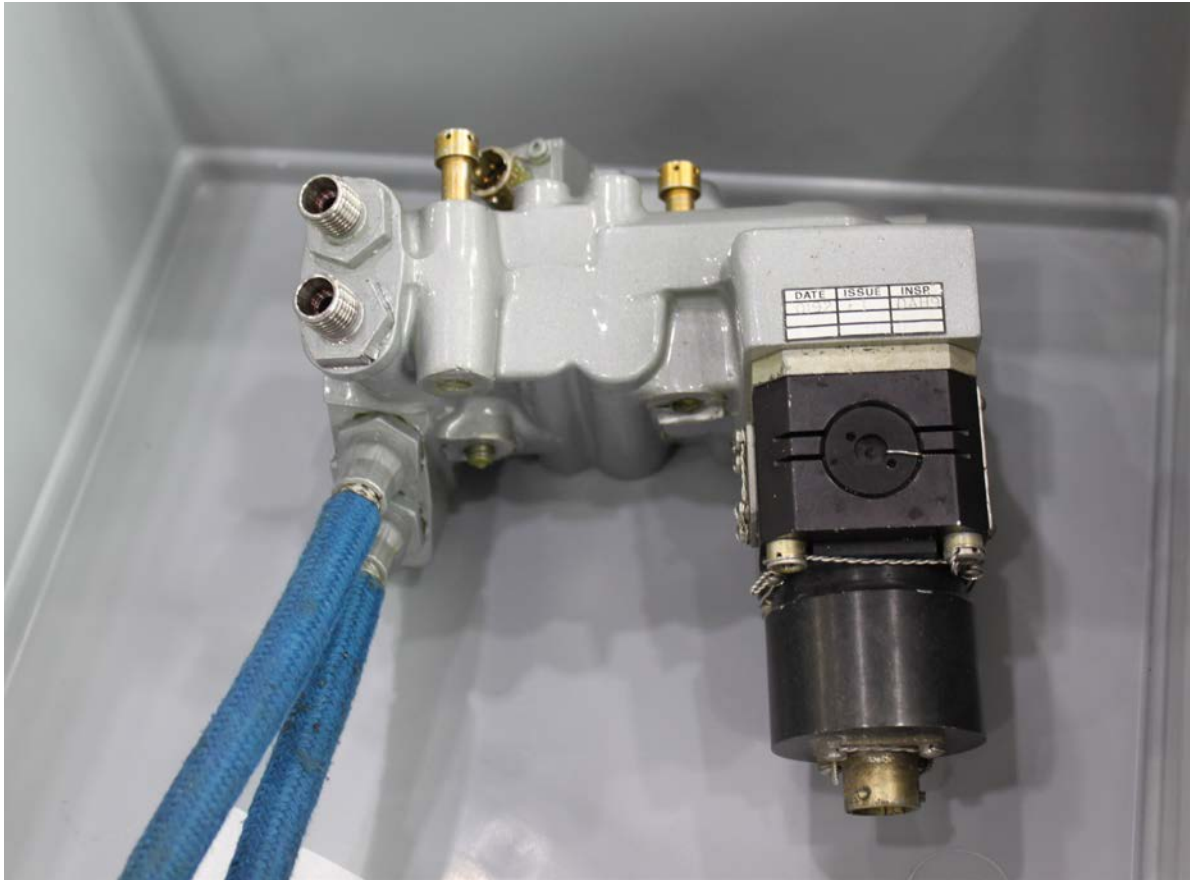
Figure 5: Steering Manifold Assembly with Servo Valve Attached

The manifold assembly was removed from the landing gear assembly. To the extent possible, the manifold assembly was tested per portions of the Testing and Fault Isolation Chapter of CMM 32-50-50, Rev 6. It was noted that Rev 8 was the current revision available at the time of testing but that Rev 6 was the current version available at the time the subject landing gear assembly was last overhauled. The test procedure had to be performed in reverse order as the procedure was designed to be accomplished during manifold build. The first phase of testing was Step 3.G-3.H. The servo valve was then removed from the manifold and steps 3.D-3.F were performed. The solenoid valve was then removed from the manifold and steps 3.A(1) – 3.A(9) were performed. The remaining steps in section 3.A were not performed as failures were identified in steps 3.A(6) and 3.A(9).

- Two parallel and uniform gouges were found on the outside diameter of the spool stop (P/N 101459603) near the end opposite the nozzle. The ring (P/N 100668608) was scored in multiple places along the inner diameter edge on the face that is adjacent to the armature. In addition, the armature (P/N 100668609) exhibited a nozzle imprint in its center and multiple scratches on the side facing the return. The side of the armature facing the sleeve and spool exhibited a nozzle imprint in the center, a half nozzle imprint on the edge of one of the smaller center holes and a gouge connecting two of the larger holes on the outer circumference. Although these components are not specifically called out for special inspection in CMM 32-50-50, Rev 6, these surfaces should be free of visual defects.

- When the select/bypass valve armature was placed inside of the ring, the gap from the top of the ring edge to the armature surface measured 0.0023 inch. This is outside of the required limit of 0.0032 inch to 0.0035 inch per CMM 32-50-50, Rev 6, page 702, step 2.B.2.

- The lap tip of the return nozzle projection in the select/bypass valve measured 0.0003 inch. This is outside of the required limit of 0.0004 inch to 0.0006 inch per CMM 32-50-50, Rev 6, step 2.C.3 on page 702.
