NATIONAL TRANSPORTATION SAFETY BOARD

Group Chairman's Factual Report – Airplane Systems and Powerplants

A. ACCIDENT DCA13MA081

Location: Bagram Air Field, Afghanistan
Date: April 29, 2013
Time: 1527 Local Time
Aircraft: National Airlines flight 102, a Boeing 747-428BCF, registration
 N949CA

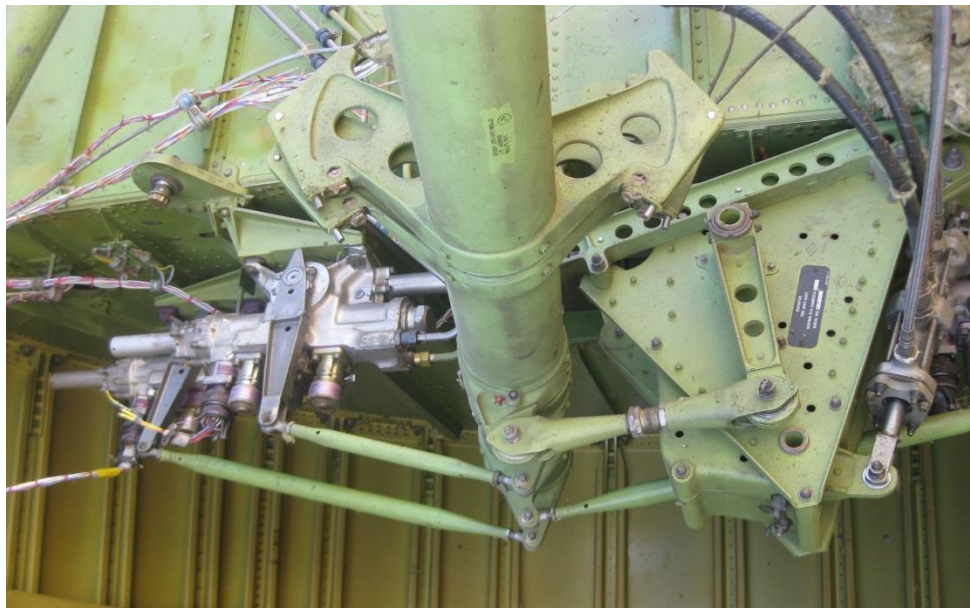
Figure 1 - Elevator Torque Tube, Elevator Auto Pilot, and Elevator Feel Unit Connections

Each of the 3 elevator auto pilot actuators appeared undamaged and connections to the elevator torque tube were intact. The Elevator Feel Unit Assembly also appeared undamaged and its connections to the elevator torque tube were intact.

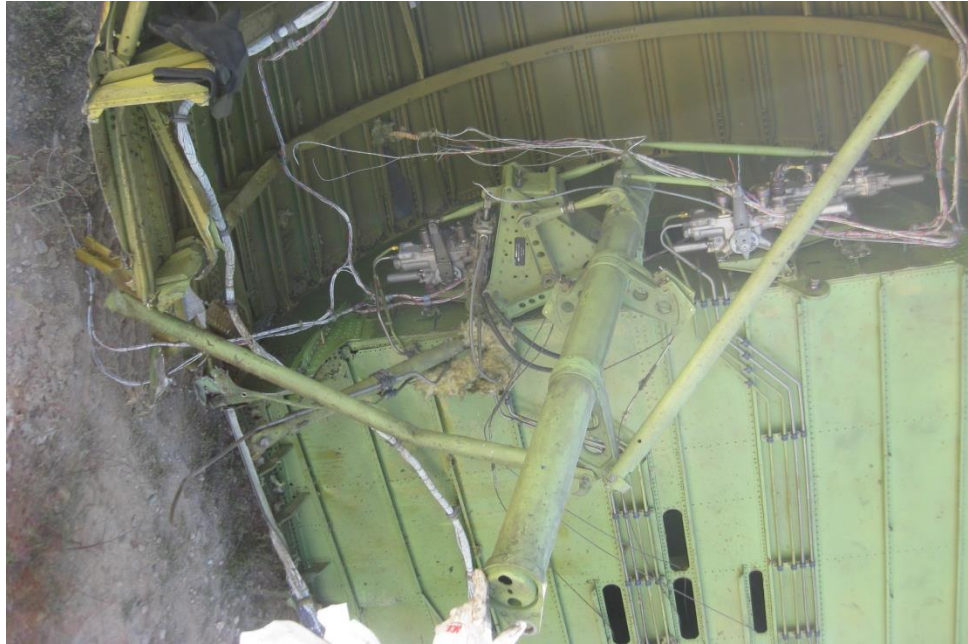
Figure 2 - Elevator Torque Tube and Connections

Examination of the aft elevator torque tube (common aft elevator quadrant) noted that the tube was bent and the push rod attach bearings were damaged. In addition (as noted above), the three auto pilot servos and the elevator feel computer input rods were still attached to the torque tube. The push rods from the torque tube to the horizontal stabilizer were still connected to the tube but were severed at approximately the stabilizer bulkheads on each side. The tube could be moved through its assumed full range of travel (by hand). The torque tube was removed, with attaching push-pull rods and control cables still attached, from the wreckage and retained for further evaluation and reference.¹

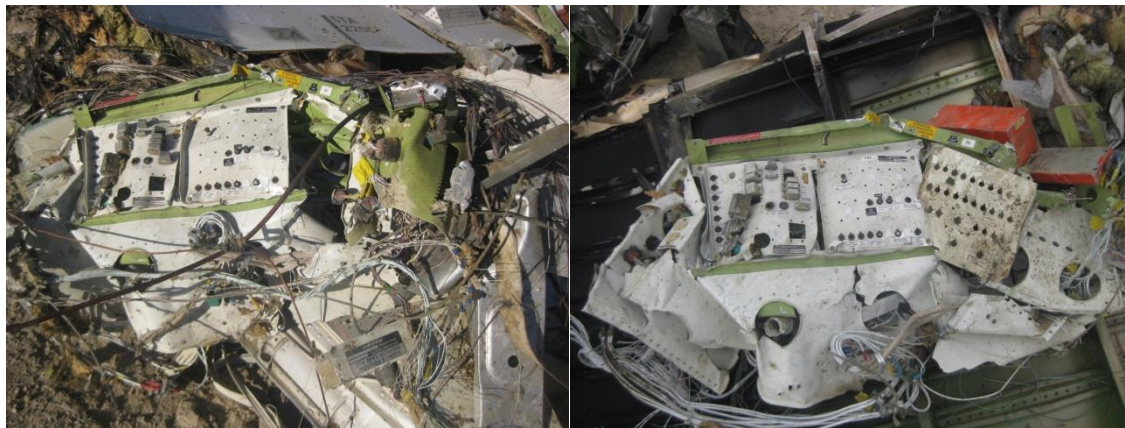
Figure 3 - E8 Shelf and associated electrical panels (Left) and partially-reconstructed E8 shelf (Right).

The P83, P84, and P85 electrical panels, connected to the E8 shelf, were located in the wreckage, near the initial impact zone and in an area of the debris field that was not subjected to post-impact fire. Each panel was bent, crushed and/or separated from the shelf, but did not exhibit any visual evidence of fire damage.

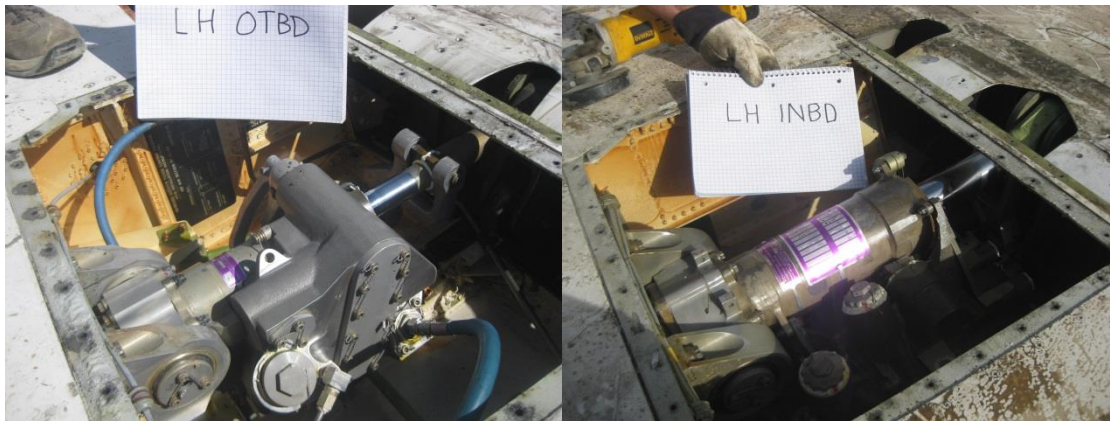
Figure 4 - Left Outboard PCU (Left) and Left Inboard PCU (Right), after access panels were removed.

In general, a visual inspection of each of the 4 elevator power control assemblies did not reveal any physical damage. In addition, no foreign objects were noted in any of the elevator PCU access areas.

A visual inspection was performed and the unit appeared in good condition. Safety wires were all in place. The PCU exhibited minor scratches and abrasions typical of an in-service unit.

The test was accomplished on the Left Outboard PCU with no faults found except for Test Reference 9.A.(4) – Neutral Adjustment (the value was +0.007 inches outside specifications) and 9.A.(20).

A visual inspection was performed and the unit appeared in good condition. Safety wires were all in place. The PCU exhibited minor scratches and abrasions typical of an in-service unit. Rubbing was noted on the external surface of the floating side of the external summing lever. The rubbing did not bind or freeze the linkage or the operation of the PCU. When the linkage was removed and opened, the staked bearing of the linkage was noted to be extended from its installed position, causing the floating side of the linkage to rub.

The test was accomplished on the Left Inboard PCU with no failures except for the 11.D Clearance Check (due to external summing lever rubbing), 11E. and F. Input/Output Rig Neutral test (rig was off in return direction), 11.L. Input Force (Extend force exceed max value), and 11.Q.(17) Actuator Stroke (in Extend direction).

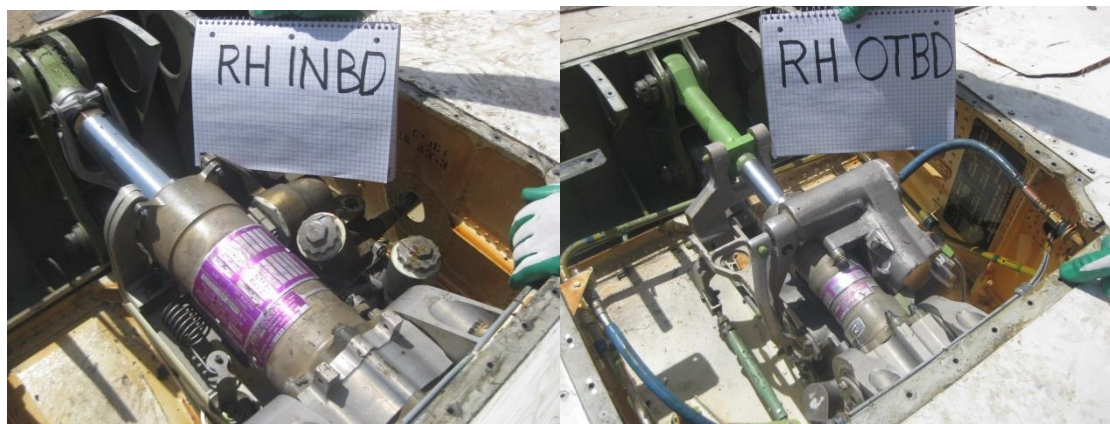
Figure 5 - Right Inboard PCU (Left) and Right Outboard PCU (Right) after the access panels were removed.

A visual inspection was performed and the unit appeared in good condition. Safety wires were all in place. The PCU exhibited minor scratches and abrasions typical of an in-service unit. Dirt was noted inside the return and pressure ports on the inboard side of the PCU.

The test was accomplished on the Right Inboard PCU with no faults found except for Test 11.E. and F.(17) - Input/Output Rig Neutral (the main rig neutral exceeded maximum allowed rig from neutral).

A visual inspection was performed and the unit appeared in good condition. Safety wires were all in place, but there were no Parker witness seals on the safety wires. The PCU exhibited minor scratches and abrasions typical of an in-service unit.

The test was accomplished on the Right Outboard PCU with no failures noted.

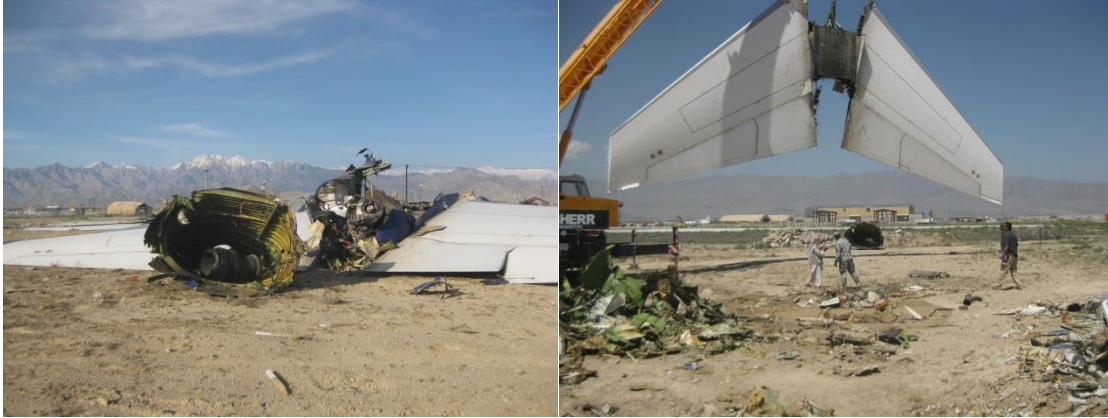
Figure 6 - Elevator and Horizontal Stabilizer segment as found (Left) and being overturned (Right)

The horizontal stabilizer structure was found in the aft section of the airplane wreckage, clear of the area of post-impact fire. The assembly was aft of the vertical stabilizer, with the lower surface of the stabilizer and trailing edges of elevator contacting the ground. The surface position of the elevators was trailing edge down with respect to the horizontal stabilizer.

A visual examination of the elevator control surfaces revealed minor physical damage to the outer areas, and a minor deformation of the leading edge ribs of the left outboard assembly, and deformed trailing edges. Each of the 4 elevator surfaces could be moved by hand once the PCUs were removed. The severed elevator push-pull rods attached to the elevator torque tube, severed at the bulkheads, were intact from the bulkheads outboard, and operated smoothly when moved by hand. The push-pull rods would also hold the elevators in position until the inboard input rods and the slaved outboard rods were moved.

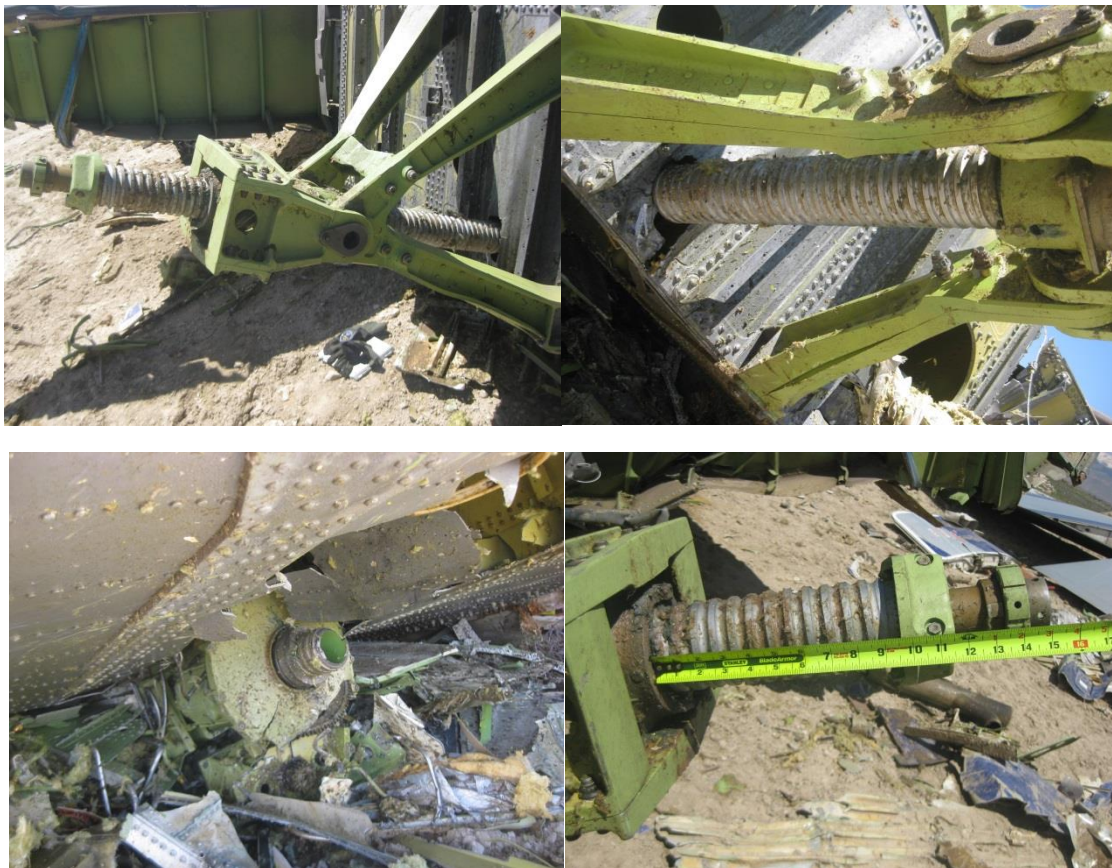
Figure 7 - Horizontal Stabilizer jackscrew segments as found

The horizontal stabilizer jackscrew and associated mounting structure and gearing were identified within the horizontal stabilizer segment of wreckage. The upper mount assembly was noted attached to the forward bulkhead of the horizontal stabilizer structure. The jackscrew mounts attaching the jackscrew to the forward side of the stab structure were bent and cracked. The upper yoke forward gimbal mount plate was gouged in two places on the forward surface. The plate was removed from the wreckage for further examination of differential metal and/or paint transfer.

The jackscrew was severed approximately 1 ½” above the drive assembly. A 4” crack (approximate) was noted from the bottom of the jackscrew fractured end which extended longitudinally “up” the jackscrew, towards the upper mount assembly. The jackscrew was covered with lubricant. The jackscrew drive assembly was located beneath the horizontal stabilizer structure. The drive assembly was aft of its normal location and was imbedded in the

An NTSB Senior Materials Engineer, along with other group members, examined the trim drive mechanism. The engineer examined the jackscrew fracture faces, the drive mechanism, and attachment structure. A preliminary examination of the jackscrew indicated a potential bending fracture. According to the NTSB Senior Materials Engineer, the jackscrew fractures appeared to be overstress in nature with no indication of pre-existing cracking in any examined component.

- Impact on the white structure on the base of the stabilizer mechanism appears as crush aft. The support structure did not exhibit any visual evidence of column impact in the vertical direction (as installed).
- Structural damage on the aft portion of the threaded portion of the jackscrew, in the area of the jackscrew fracture, is indicative of jackscrew impact.
- Given the length of the jackscrew and the as-found location and position of the jackscrew, if the bottom support structure of the horizontal stabilizer actuator was compromised and the structure moved aft, the jackscrew could impact the horizontal stabilizer structure.
- The jackscrew fracture suggests the jackscrew was bent aft at failure.

The Boeing reports revealed that the materials identified were verified to be correct, as specified on the manufactures engineering drawings. The examination further revealed that the fracture that separated the jackscrew into two pieces was consistent with a single overload event.

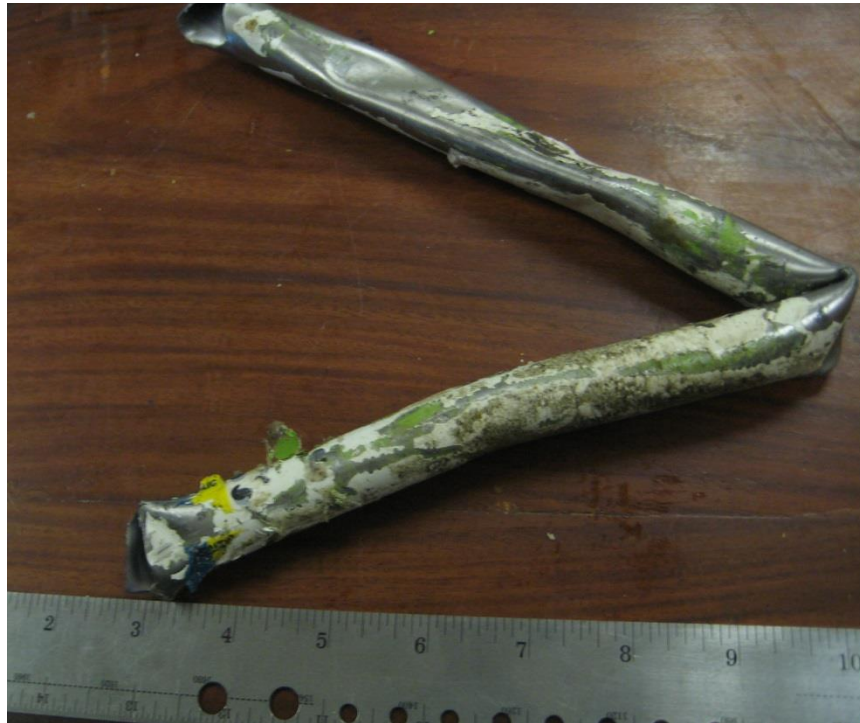
Figure 8 - Piece of hydraulic line found on Runway 03

Following the accident, the United States Air Force recovered a segment of white hydraulic (return) tubing from Runway 03 in the area of Taxiway C (Charlie). Following an examination of the tubing, Boeing indicated that the tube was part of Hydraulic System #2 and was installed in the area aft of the aft pressure bulkhead.

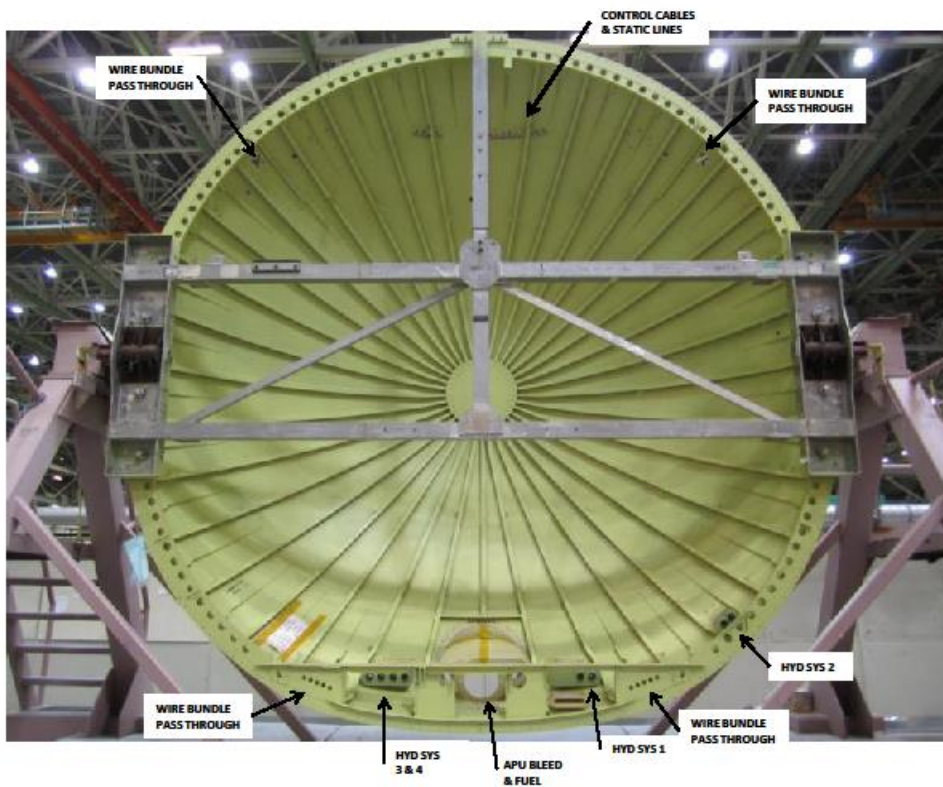
Figure 10 - Aft Pressure Bulkhead and Pass-Throughs, Looking Aft (Courtesy of Boeing)

Each hydraulic system, 1-4, is used by the elevator control system, rudder control, and horizontal stabilizer actuator. Therefore, each hydraulic system has components in the airplane's empennage, aft of the aft pressure bulkhead. Tubing for supply and return for each of the systems runs longitudinally below or near the main cargo deck flooring and through the aft pressure bulkhead to reach the components in the aft end of the airplane. Facing aft, the hydraulic tubing for system 1 pass through the bulkhead at the 5 o'clock position and the tubing for hydraulic system 2 passes through the aft pressure bulkhead in the 4 o'clock area of the aft pressure bulkhead. The hydraulic tubing for systems 3 and 4 pass through the aft pressure bulkhead in the area of 7 o'clock (see Figure 3).

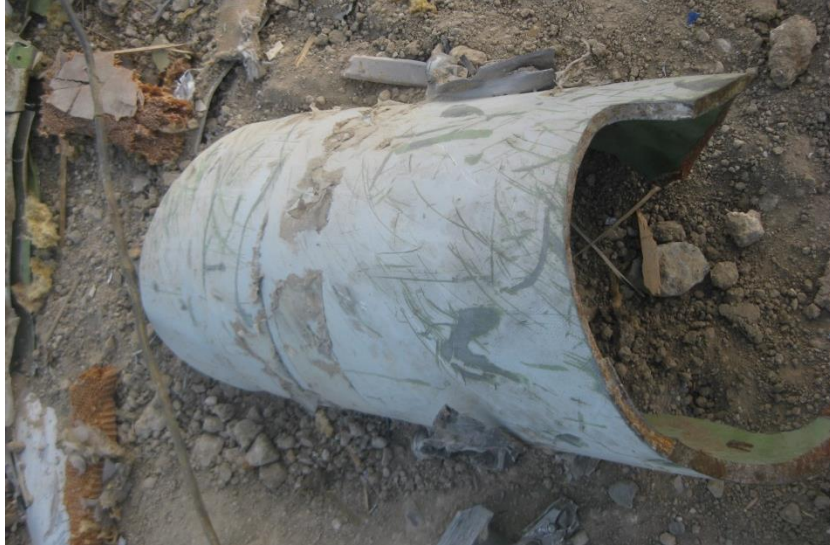
Figure 11 - Segment identified as Nose Gear Upper Cylinder

A segment of the nose gear upper cylinder was identified in the wreckage. A small segment of a component, identified as Honeywell P/N 4061392-90, was found attached to the cylinder. According to Honeywell, the part number corresponds to a component of the Onboard Weight and Balance System, which was attached to the nose gear.
