NATIONAL TRANSPORTATION SAFETY BOARD
Office of Aviation Safety
Washington, DC 20594

Systems Group Chairman's Factual Report

A. ACCIDENT **CEN16MA036**

Location: Akron, Ohio
Date: November 10, 2015
Time: 1452 Local Time
Aircraft: ExecuFlight flight number 1526, a British Aerospace HS 125-700A,
 registration N237WR

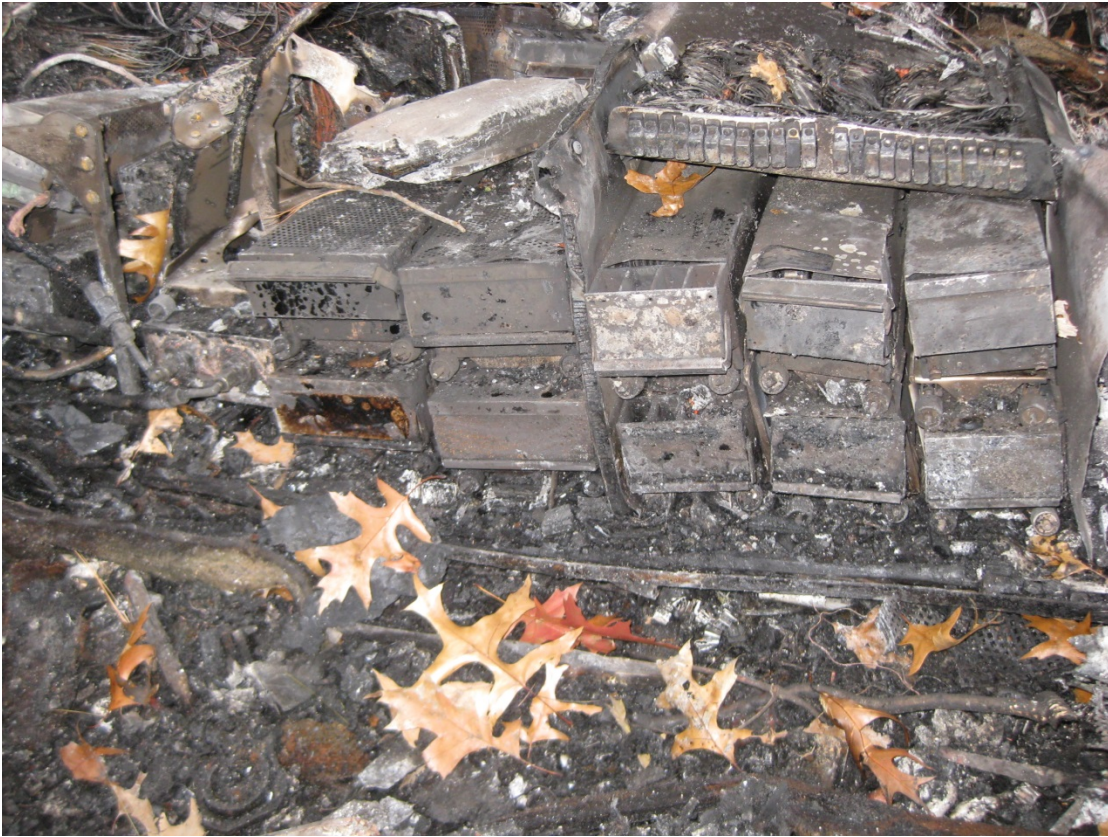
Figure 1 - Avionic Racks and Installed Units

Two avionics racks were noted in the wreckage. The individual avionic boxes were thermally damaged and could not be identified. See Figure 1.

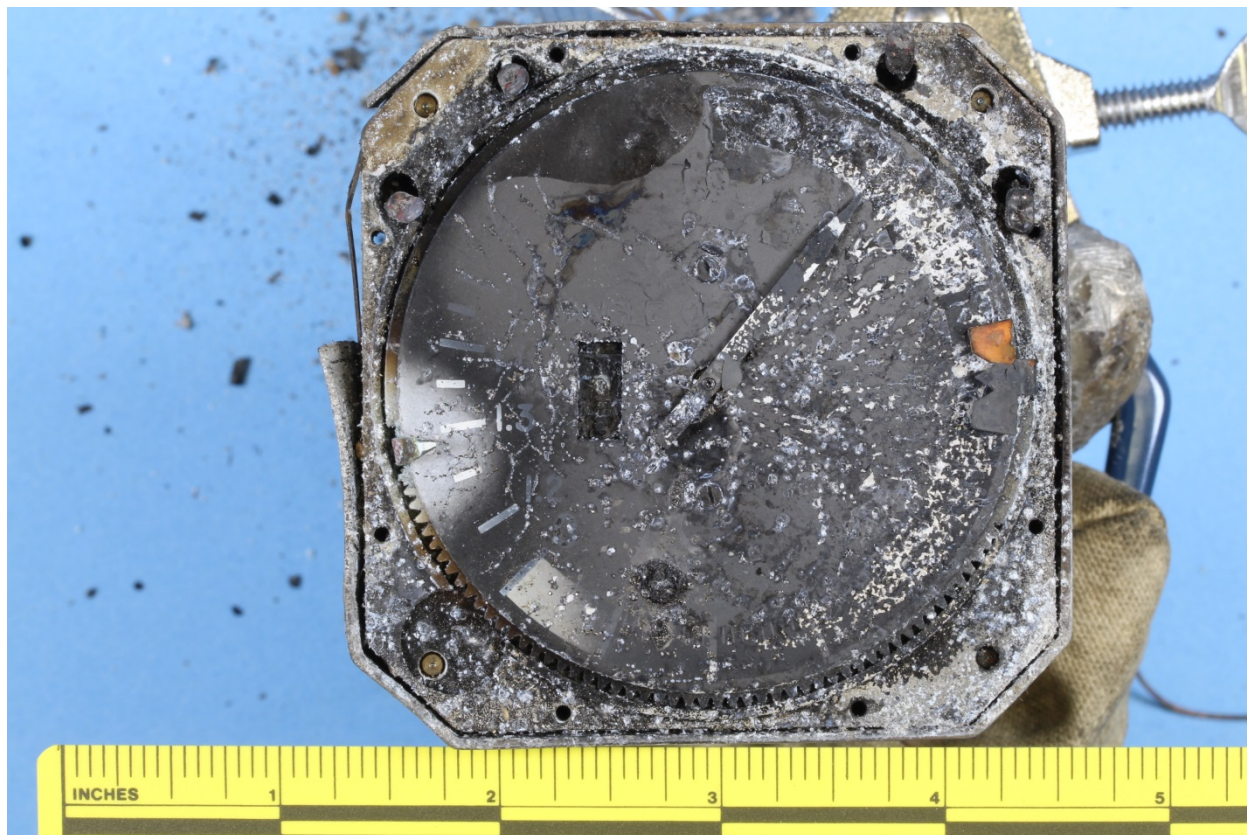
Figure 2 - Angle of Attack Indicator

a) Angle of Attack Indicator (Located on the Captain's side of instrument panel): The Angle of Attack indicator was examined. The glass face was removed from the instrument. The AOA bug appeared to be set at 1.3 degrees (9:00 position). The indicator needle was at the approximately 2:00 position. See Figure 2.

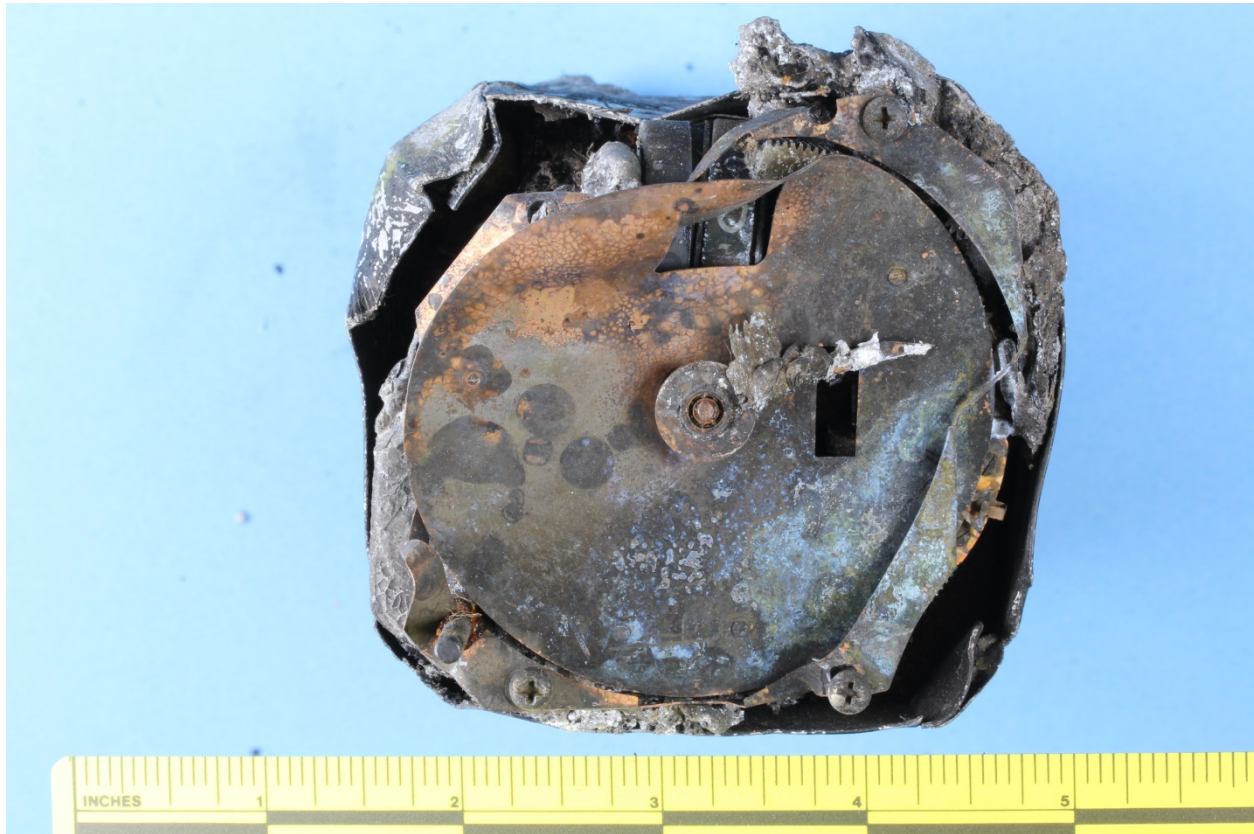
Figure 3 - Captain's (Left-Hand) Mach Speed Indicator

c) Captain's Combined Mach/Airspeed Indicator: The captain's Mach Speed (Airspeed) Indicator indicated either 5 or 50 in the top Mach window. The second needle on the indicator was oriented at approximately the 2:00 position, or 110 knots. See Figure 3.

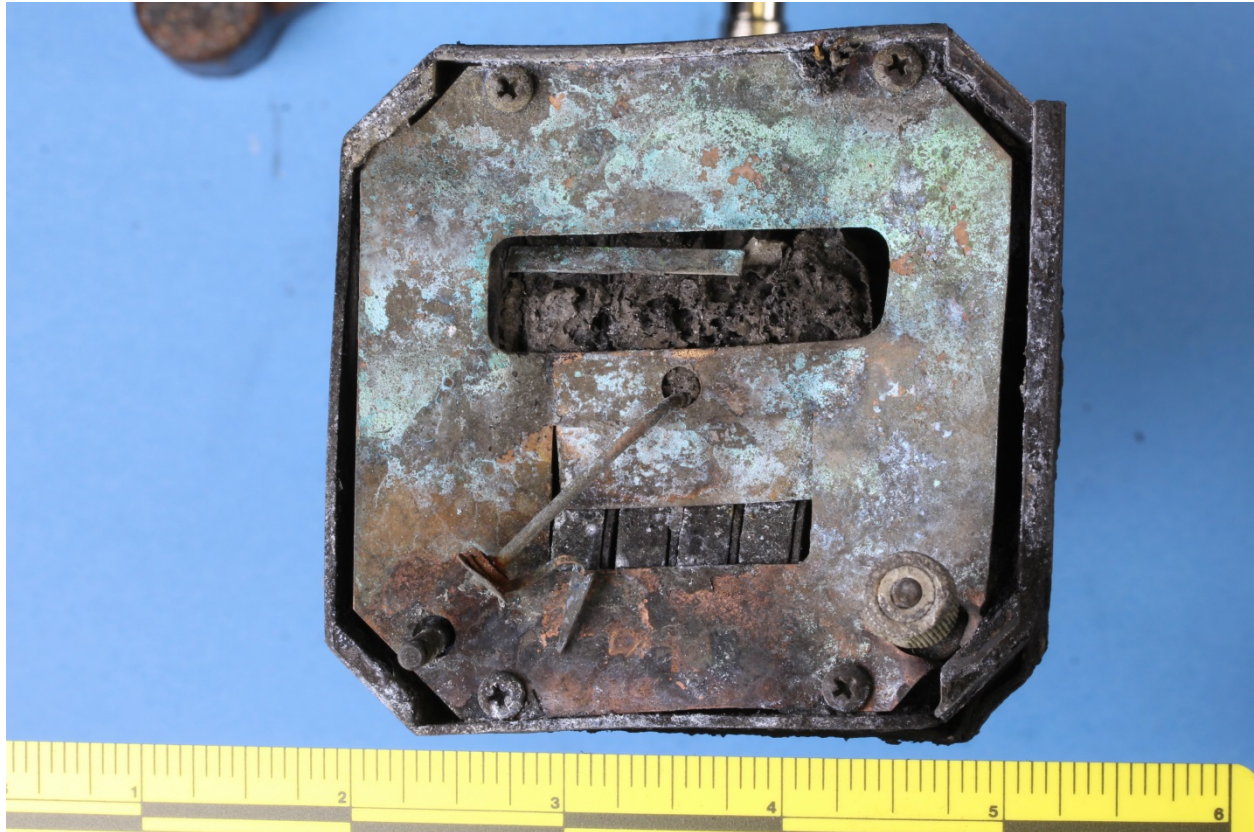
Figure 4 - Captain's (Left-side) Altimeter

f) Captain's Altimeter: Examination of the Captain's Altimeter showed a bar was slightly visible from the top of the altitude window. The bar was not in the fully retracted position. The needle was found protruding from the instrument face and bent. The needle was oriented at approximately the 7:30 o'clock position or approximately 600 feet. See Figure 4.

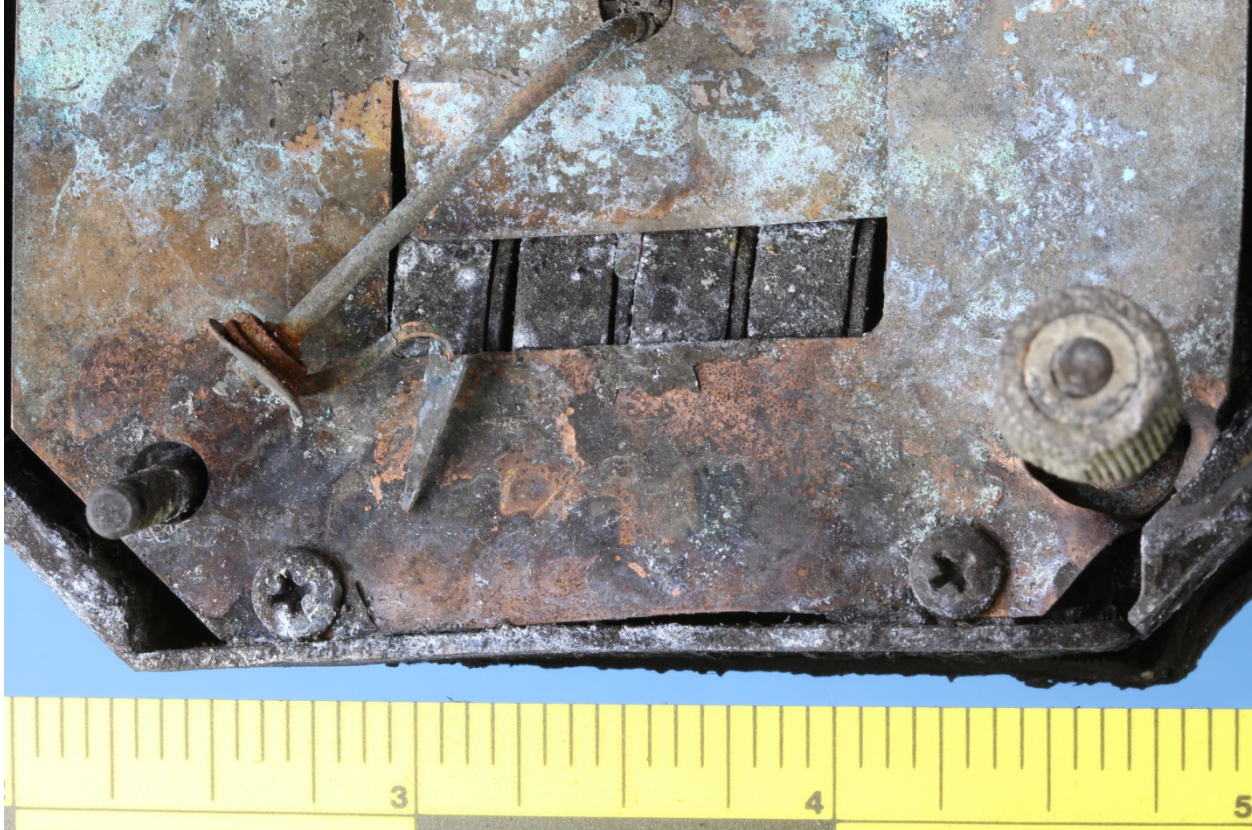
Figure 5 - Close up of Captain's Altimeter

After further cleaning and examination, the Captain's Altimeter setting was found to be "4184". See Figure 5.

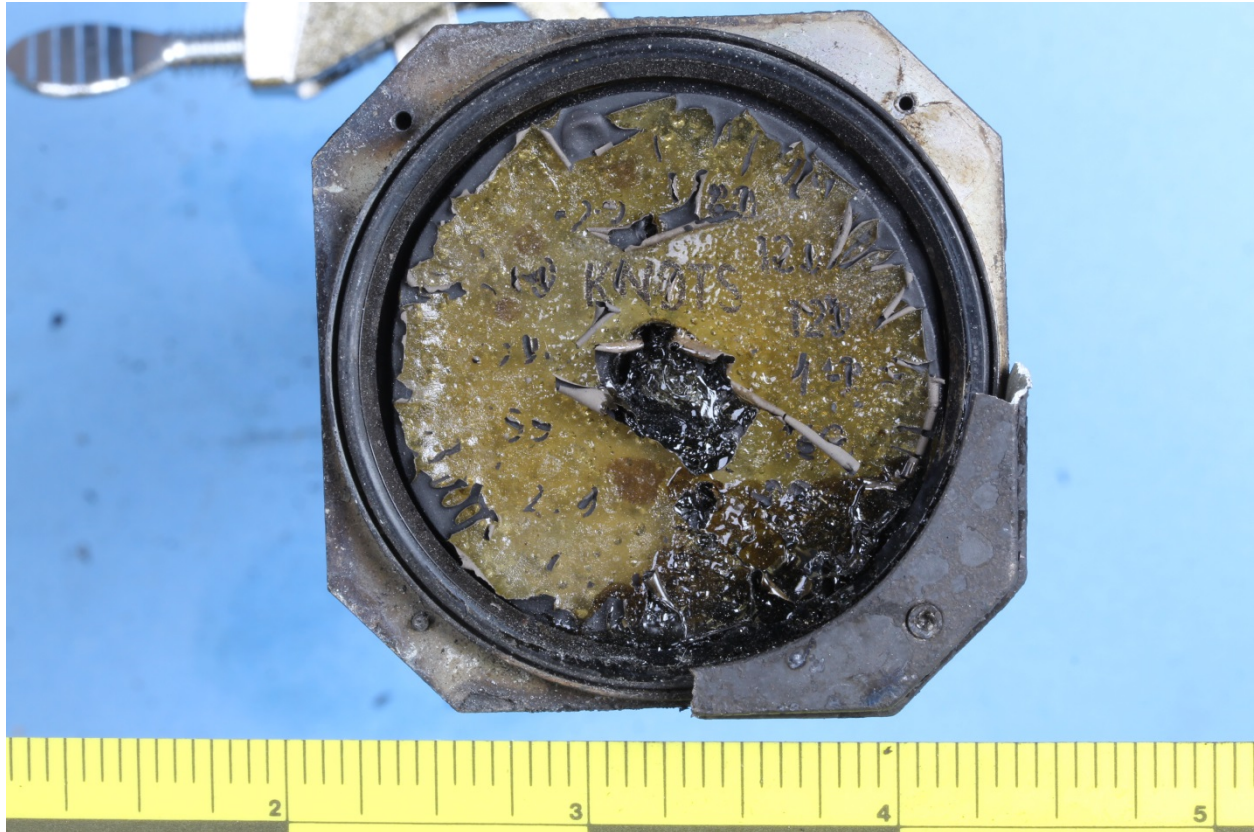
Figure 6 - Stand-by Airspeed Indicator

h) Standby Airspeed Indicator: The examination of the Standby Airspeed Indicator revealed that numbers were visible but no discernable assessment could be made. See Figure 6.

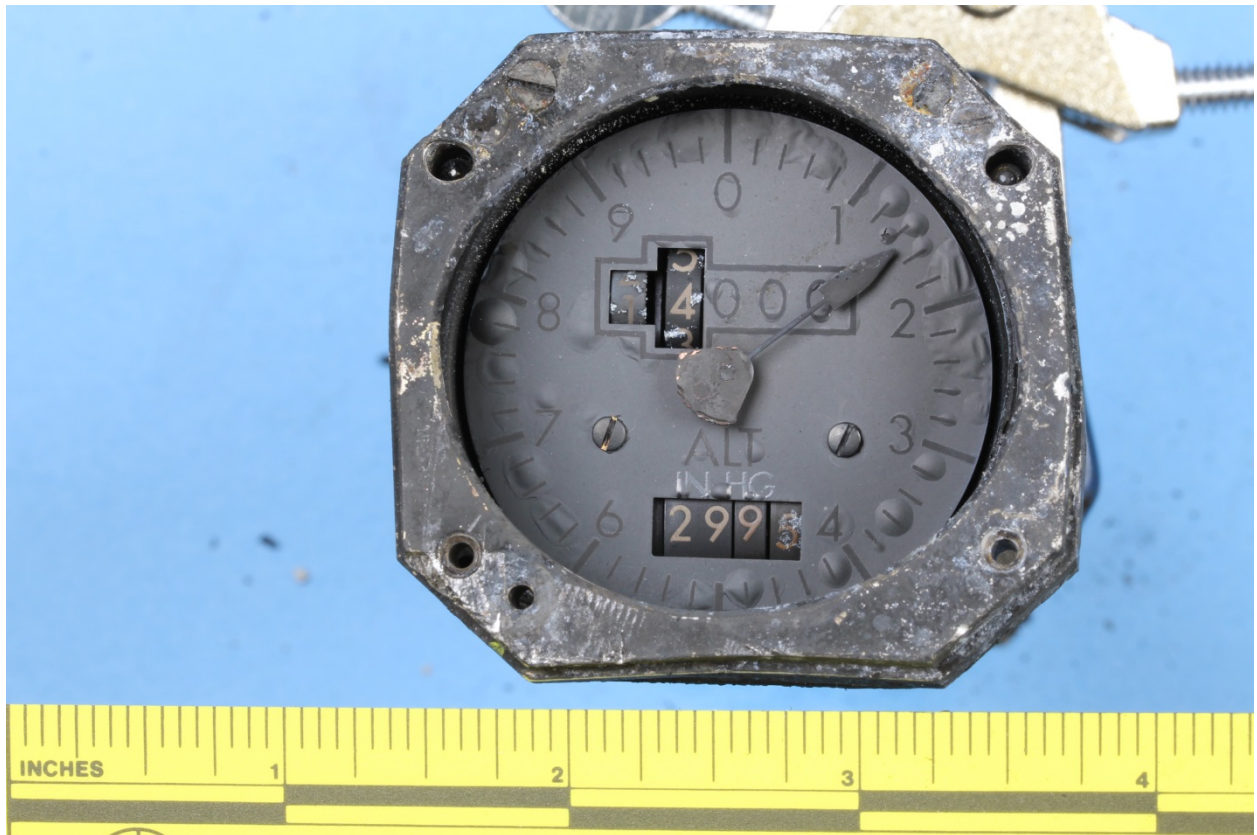
Figure 7 - Stand-by Altimeter

j) Standby Altimeter: The Standby Altimeter indicated approximately 14,140 feet on the dial. The rotating drum indicated 14,000 feet with the needle pointing approximately at 140 for an altitude reading of 14,140 feet. See Figure 7.

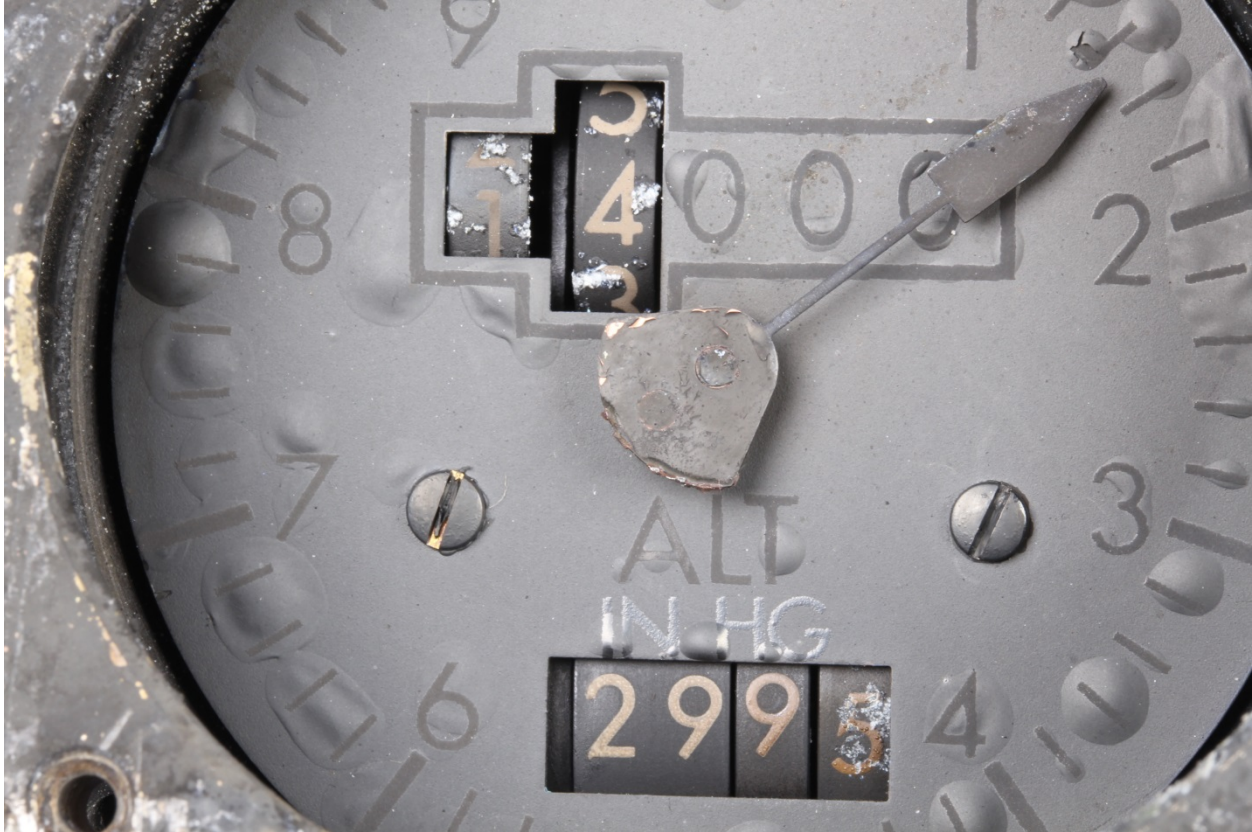
Figure 8 - Close-up of Stand-by Altimeter

Further examination indicated a setting of 29.95 in the Kohlsman window. See Figure 8.

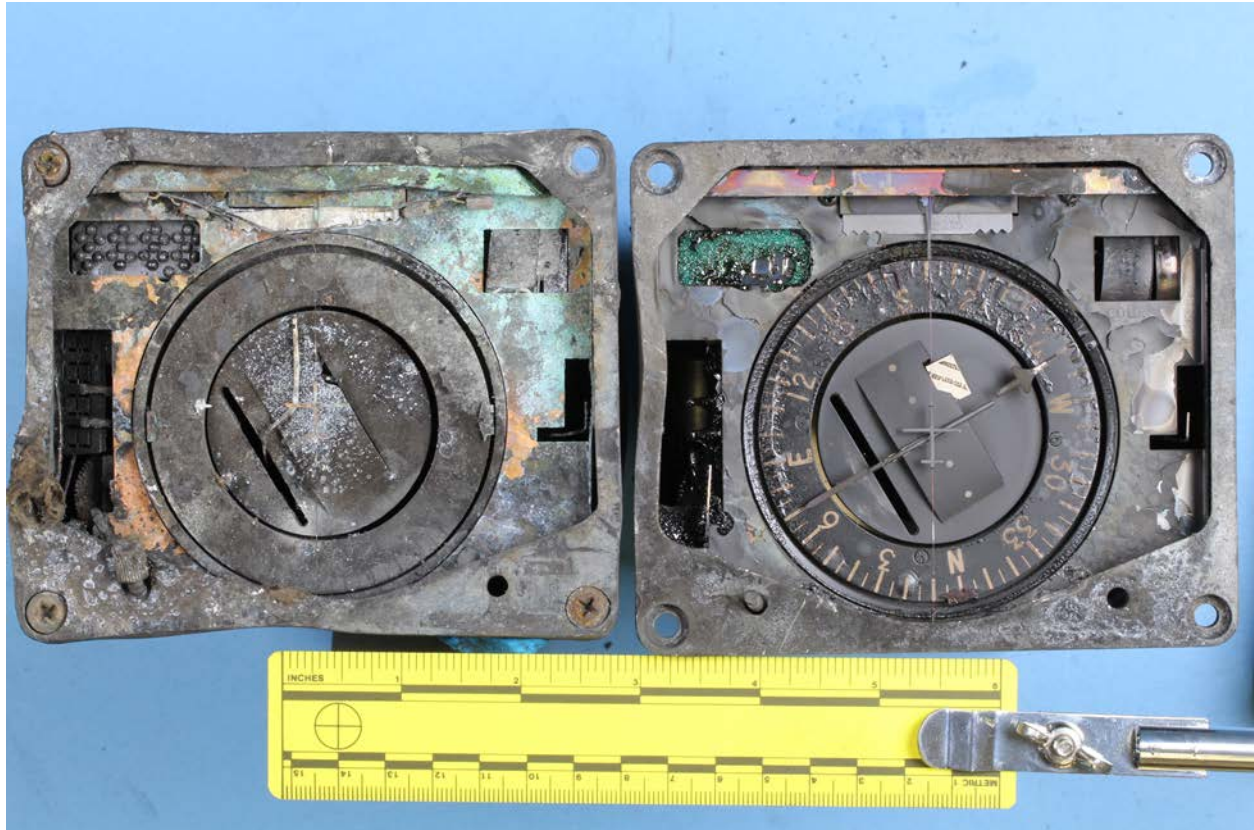
Figure 9 - Comparison of the Captain's (left-side) and First Officer's (right-side) Horizontal Situation Indicators

k) First Officer's Horizontal Situation Indicator: The First Officer's Horizontal Situation Indicator (HSI) was examined. The heading needle indicated 191 degrees with the course selector bug at 249 degrees. The course deviation needle was centered. The right window selected course could only determine the first two of three digits to be 25x. The third digit (x) could not be determined.

In addition, the Captain's and First Officer's HSIs were compared. The two HSIs' back plates appeared to be rotated to the same orientation - 60 degrees clockwise. See Figure 9.

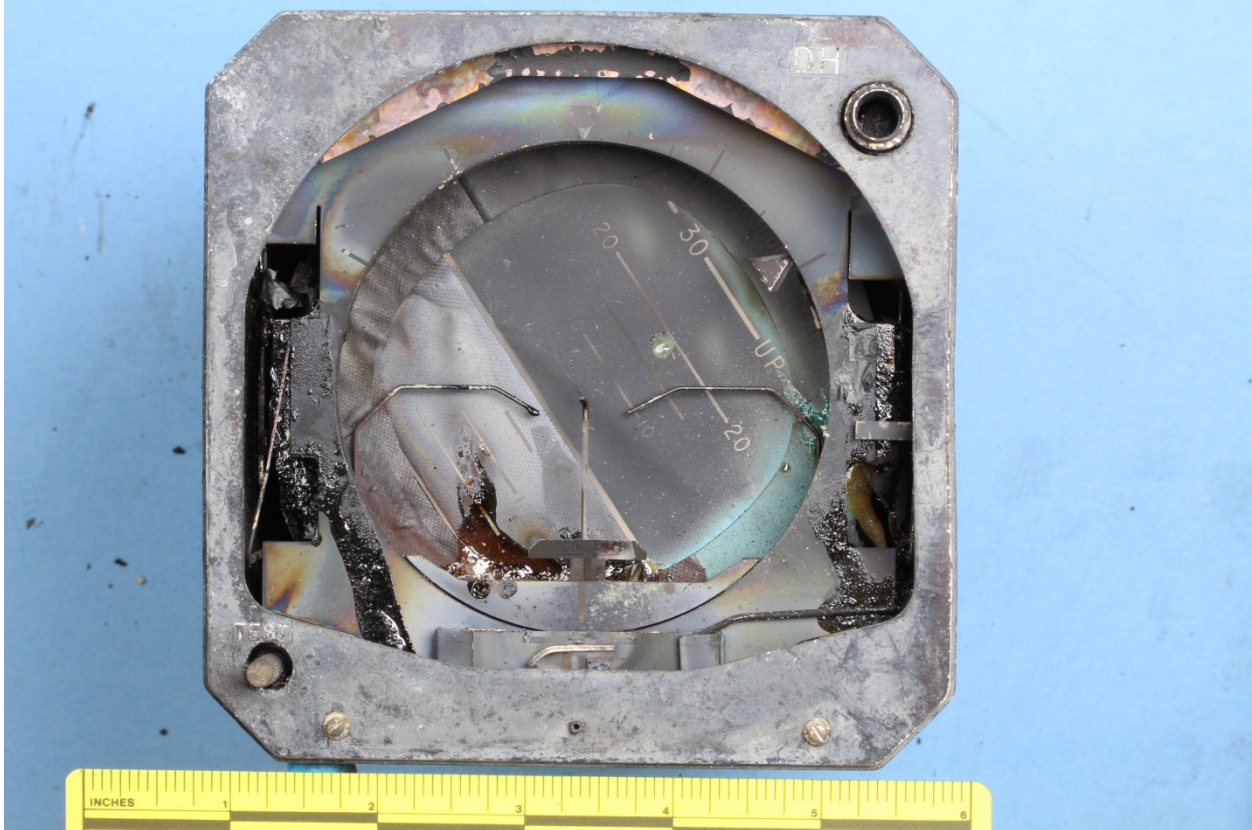
Figure 10 - Right-hand (first officer's) Attitude Indicator

1) First Officer's Attitude Indicator: The First Officer's Attitude Indicator was examined. A 58 degree left bank was indicated. A 5-degree nose up pitch angle was also indicated. See Figure 10.

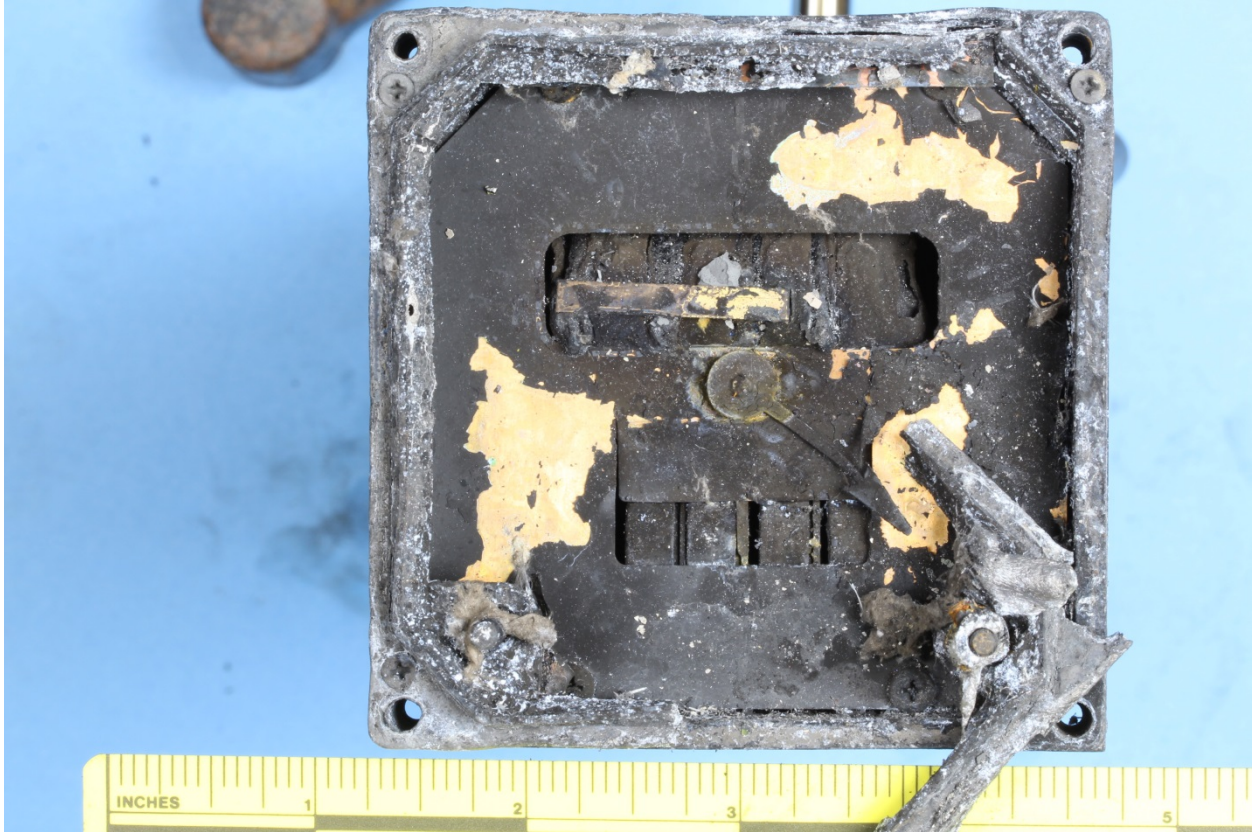
Figure 11 - Right-hand (first officer's) Altimeter

m) First Officer's Altimeter: The First Officer's Altimeter was examined. The bar was in view. The digital output needle was about the 4:00 position (towards the knob located on the lower right hand corner of the instrument). See Figure 11.

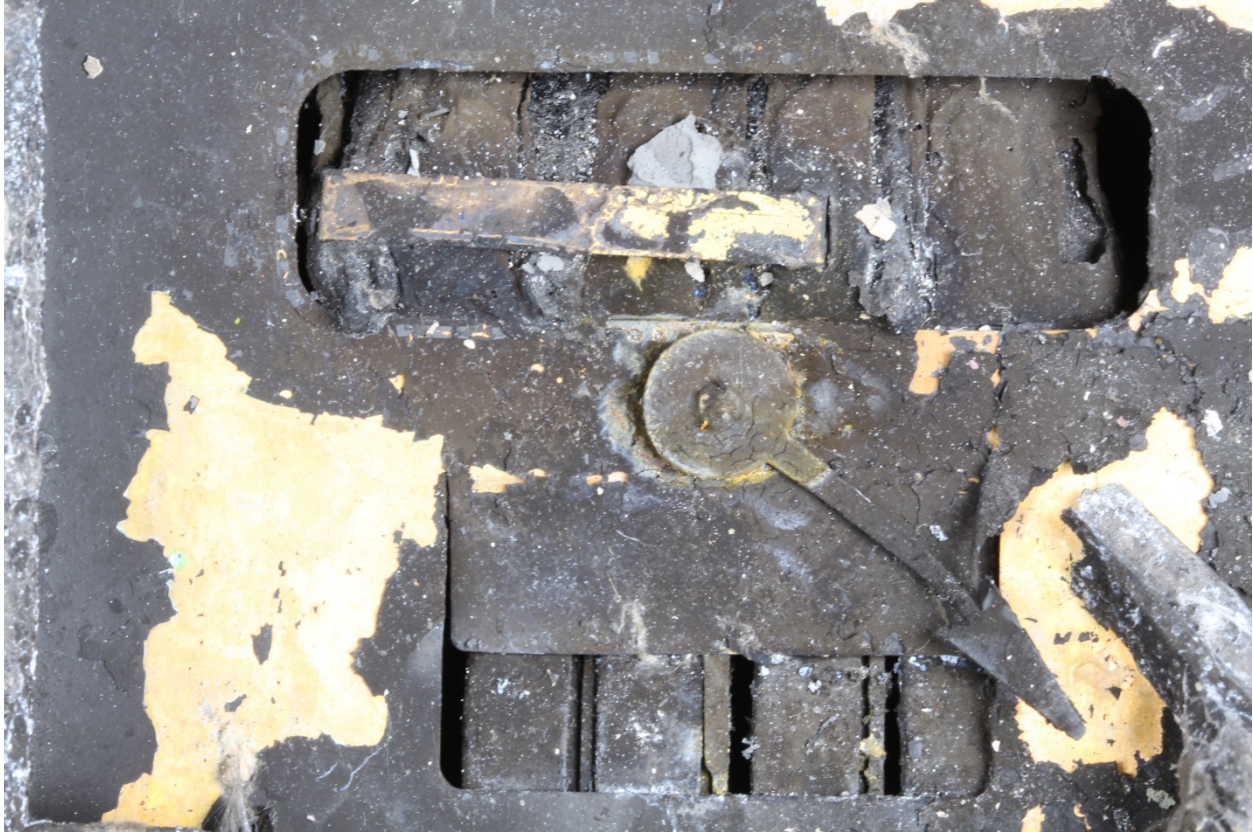
Figure 12 - Close Up of First-Officer's Altimeter

In addition, after cleaning of the face and examination under magnification, the altimeter setting was indicated as “2995”. See Figure 12.

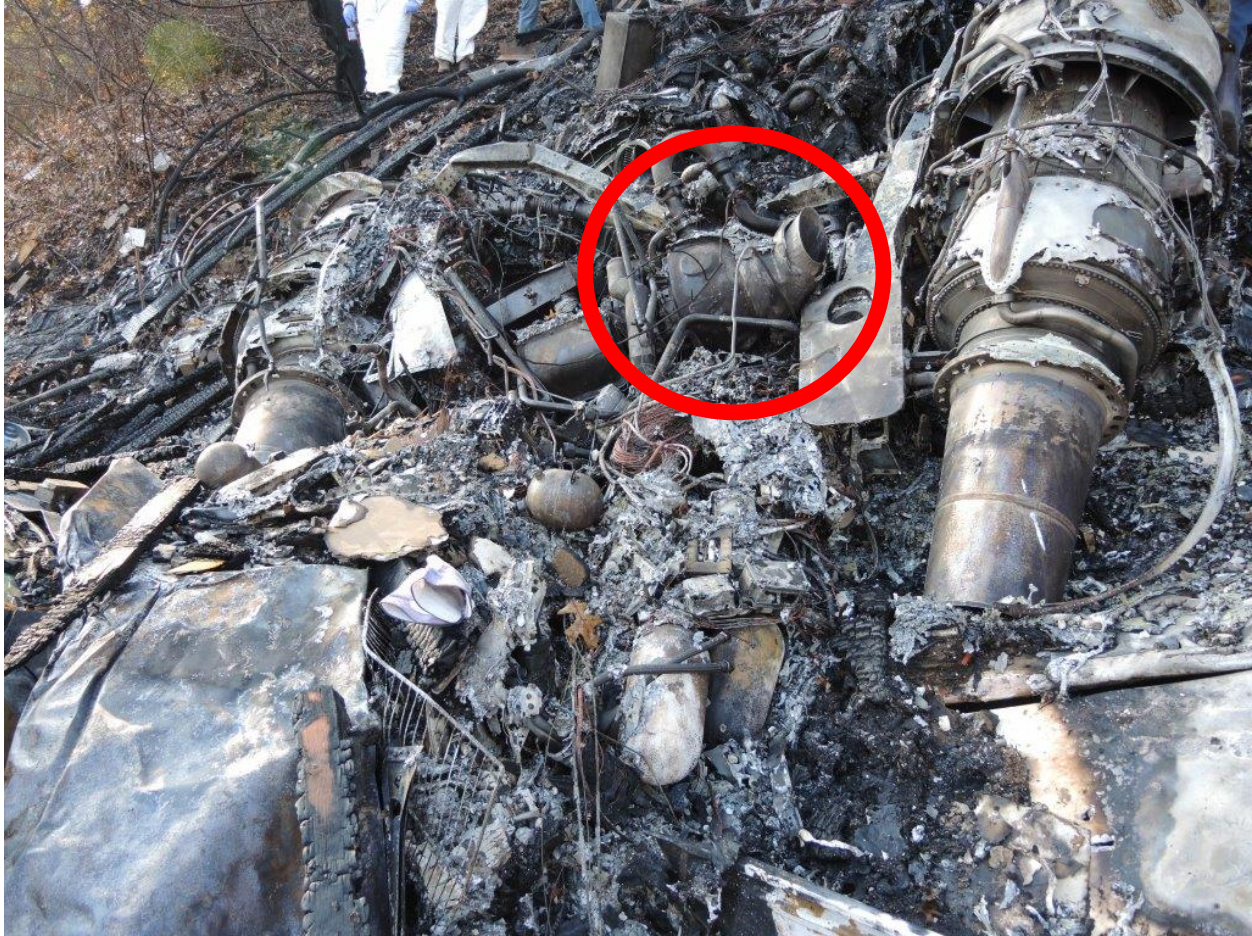
Figure 13 - Auxiliary Power Unit On-Site (Circled)

The airplane's auxiliary power unit (APU) was located in the wreckage. See Figure 13.

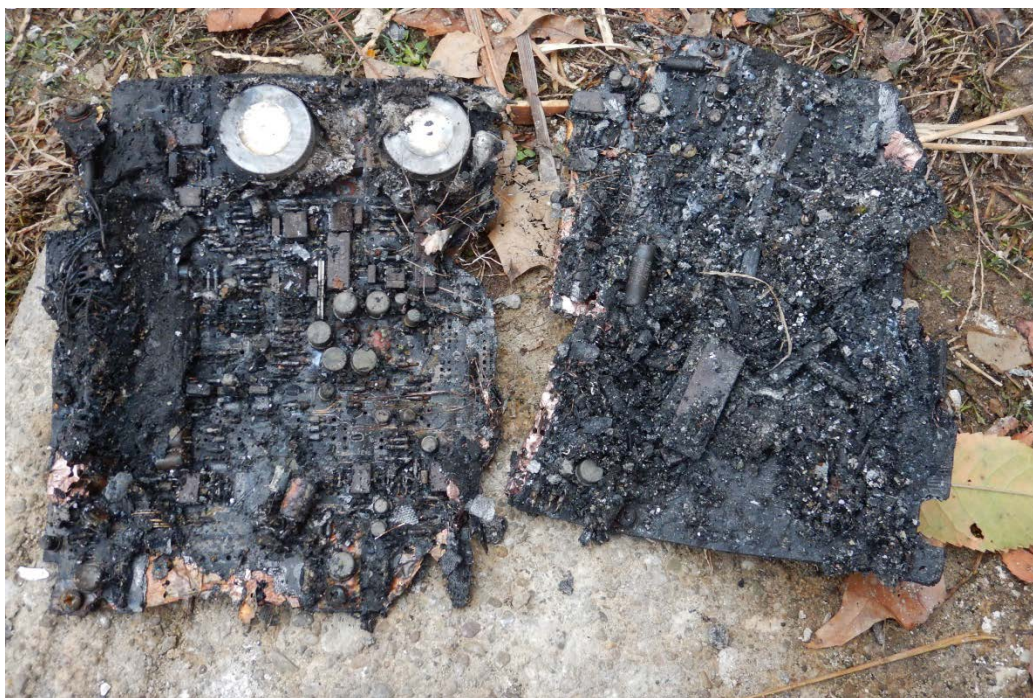
Figure 14 – Pieces of a Suspected DEEC Board at Accident Site.

A search for the airplane's Digital Electronic Engine Controls (DEEC) units (one for each engine) was conducted at the accident site. Two circuit cards pieces were located and initially identified as a DEEC circuit card (See Figure 14). The pieces were significantly damaged by fire. The pieces were retained by the NTSB for further investigation. No other DEEC units or circuit cards (or pieces) were identified.

The attempted download of non-volatile memory was unsuccessful for either board. For one board, the integrated circuit with NVM was too damaged to successfully download readable flight data. The integrated circuit on the other board was missing from the circuit card. See Attachment 1 for Honeywell's report of further details.
