NATIONAL TRANSPORTATION SAFETY BOARD

Systems Group Chairman's Factual Report

WPR-15-IA-046

Operator: Hawkeye Aviation Holdings Ltd
Location: Palm Springs International Airport (PSP), Palm Springs, California
Date: November 23, 2014
Time: 1052 pacific standard time
Vehicle: Embraer EMB-505, C-GJOL

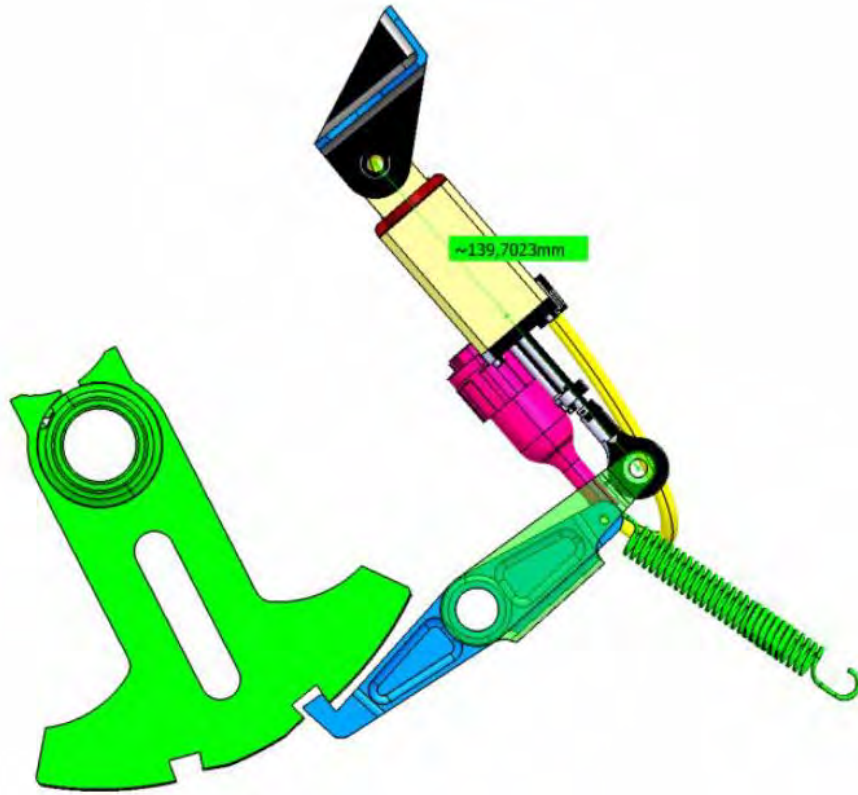
Figure 2
Mechanism condition as found based on actuator stroke (6.8mm shorter than full stroke)

The rudder gust lock actuator dimensional information gathered during the Umbra Cusinetti examination was evaluated by Embraer. Embraer determined that with the screwshaft in the “as found” position, the bellcrank would be in contact with the rudder quadrant. It could also engage in the slots on the rudder quadrant (see figures 2, 3, and 4).

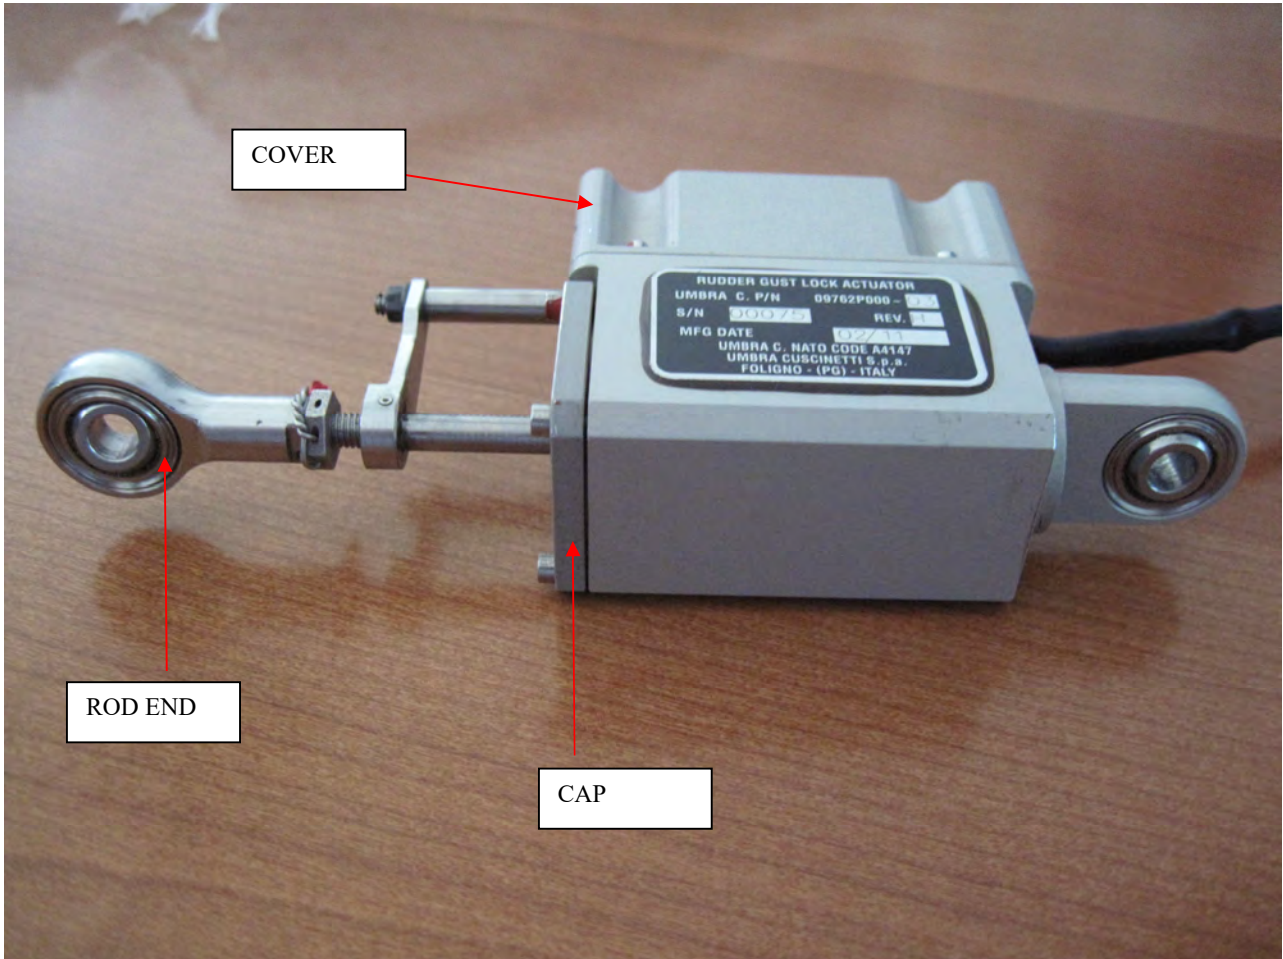
Photo 1

Customer P/N (Assy): -	Umbra P/N (Assy): 09762P000-03
Nomenclature: Gust Lock Actuator	Serial Number: 00075 (see photo 1)

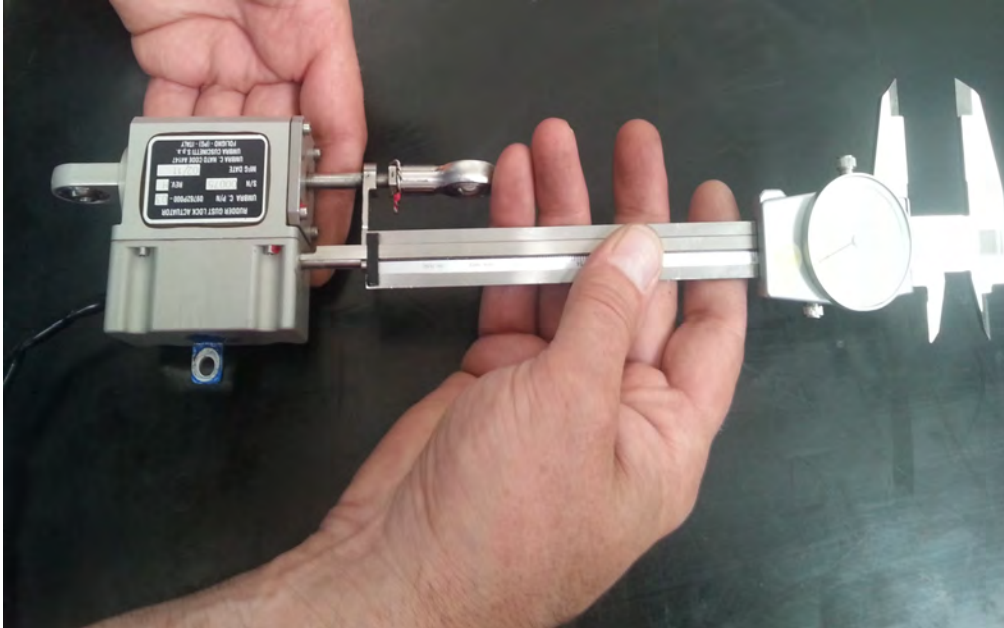
Photo 4 – S/N 00075

<p>DIMENSIONAL CHECKS / VISUAL INSPECTION</p> <p>Check of pin to pin distance Scope To verify if the Actuator is at its end stroke position or locked in an intermediate one. Check The Actuator has been installed in the test rig (see photo 2 and 3), which is tuned at the correct pin-to-pin distance, and it was not possible to insert the Pin 2 because the Actuator length is shorter than required. Measurements of the rod end in respect of the Actuator body confirm the pin-to-pin distance is shorter in respect of the full-extended position (i.e. 6.8 mm shorter, 29.2 vs. 22.4 mm, new and 00075 unit respectively). The minimum stroke is 25.4 mm. See photos 4, 5, 6 and 7. Result The Actuator is locked in a position closed to the extended one.</p>

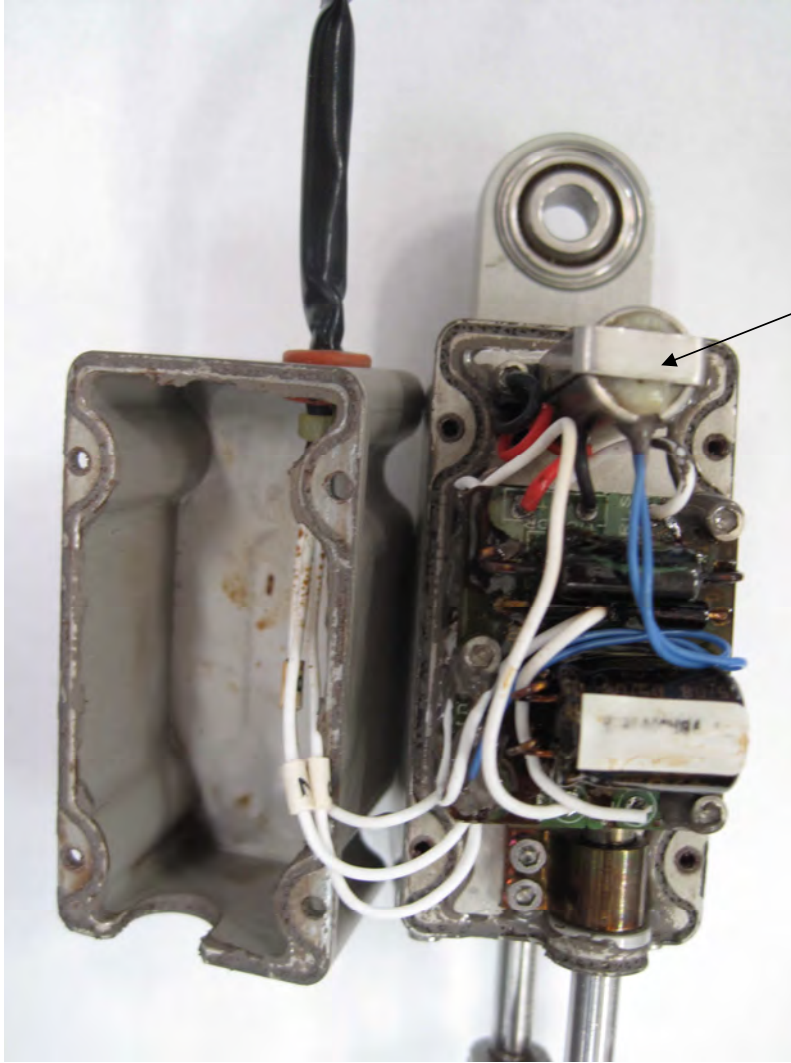
Photo 8

<p>DISASSEMBLY</p> <p>Disassembly Scope To identify the cause of Actuator seizure. Check The Actuator was coupled to the test rig supply and management system and when operated did not move even if the max current at rated voltage was supplied. The Actuator cover (see photo 8) was removed and then the solenoid/locking system. The electronic board was moved on side but kept connected. The cam, which actuates the microswitch, is closed to the microswitch actuating lever but does not operate it. See photo 9. The solenoid was not disassembled. The solenoid/locking system is found locked at extended position or close by (i.e. the locking system engages the ballnut/screwshaft preventing the rod end to move). See photo 10 and a sketch of the solenoid section, figure 4. The reel function is to guide the Pin that, pushed by the solenoid spring, engages the ballnut and locks the screwshaft/rod in position. The Pin resulted to be sized inside the solenoid body, likely due to distortion of the plastic reel heated. The Pin position was closed to the full extension. Measurement of the exact position was prevented by pin misalignment due to distortion of the solenoid plastic reel. The functionality of the microswitches was checked with positive result. Even if with the solenoid/locking system removed the Actuator did not move electrically, even if the max. current at rate voltage was supplied, and manually as well (the load applied was not measured but a new unit would have moved under such load). The cap was then removed and the ballscrew was moving freely. See photos 11, 12 and 13 and a section of the actuator section, figure 5. The Cap is the seat of a bearing, preloads the bearing, is the seat of the dynamic seal and closes the actuator body. The Cap did not show any sign of interference with closed items. The resistance of the three windings have been found between 4.3 and 7.3 ohm, it means that the windings are not short because such figures are acceptable for a new motor. The motor brushes were not checked. The rotor OD shows signs of possible interference with the stator. See photo 14. The part measurements in three axial positions revealed that the gap between rotor and stator is per drawing (i.e. about 1 mm); if any contact between the two parts occurred that happened when the motor was hot. Such signs, which are not measurable, could have been even caused during handling of the rotor. The bearings were found operative with no axial play. Result The Solenoid/locking system was found sized at approximately the full extended position.</p>

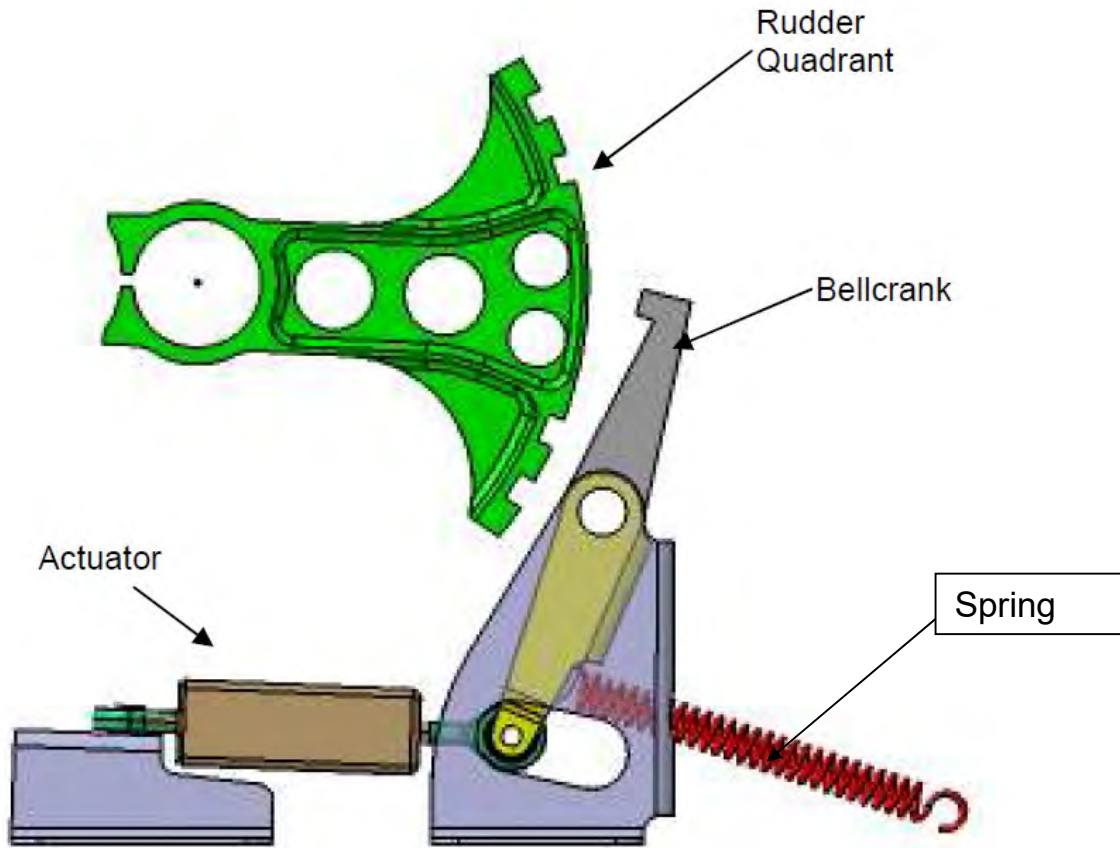
Figure 6

<p>ANALYSIS</p> <p>This investigation determined the following most likely failure scenario:</p> <ol style="list-style-type: none"> a) The Actuator was commanded to retract and reached the retracted position but failed to keep such position under the load applied by the spring (see figure 6); b) The screwshaft/rod end extended under the load applied by the spring but, because the command to retract, the solenoid and the motor were supplied again until the retracted position was achieved over again; c) The sequence depicted in point a) and b) was repeated until the solenoid temperature reached a level such to deform the plastic reel and the winding failed open; the electric motor brushes failed as well; d) The screwshaft/rod end not locked by the solenoid/locking system and with the motor failed was pushed in the found position under the action of the spring; e) The high temperature reached by the solenoid, electric motor and other parts closed to those (i.e. bearings, antirotation rod), could have caused a misalignment of the screwshaft/rod and thickened lubricant; this fact can explain why the actuator did not move after the solenoid/locking system was removed but did it freely after the removal of the cap. f) From figure 38 of the report "<i>Embraer Phenom rudder gust lock actuator - CT factual report – final</i>" supplied by NTSB it seems that the solenoid/locking system is in a position such to engage the groove into the ballnut. It is likely that the locking system, under the force applied by its spring, reached such position while the actuator was cooling down.

<p>COMMENTS</p> <ol style="list-style-type: none"> a) The failed Actuator was found about 6.8 mm shorter – i.e. pin-to-pin distance - than a new Actuator in the extended position. Umbra is not in the position to determine if the bellcrank would be in contact with the quadrant in such Actuator condition (see figure 6). The personnel who assisted at disassembly of the Actuator from the A/C at PS Airport could confirm the respective position between the quadrant and the bellcrank. Embraer could answer to such question from design point of view. b) The Actuator design does not include any "unmistakable warning" of the engaged system. In rev. B (i.e. the latest) of Embraer's Technical Specification there is the requirement for an indication of the extended (i.e. engaged) position. A microswitch in the Gust Lock Actuator was provided to meet such requirement. Later (i.e. January 9th, 2009) Embraer requested Umbra to remove such microswitch. Dash number -03 was then generated and qualified. Dash number -03 is the only production actuator configuration provided by Umbra to Embraer. Umbra do not know if there are means in the whole gust lock system that provides unmistakable warning of the extended (i.e. engaged) position. Embraer could answer to such question. c) The solenoid and electric motor, according the technical specification, are not sized for a continuous duty cycle; the requirement is a cycle (extend and retract) per flight. d) There are no safety requirements for the Actuator: it is a single point failure item; e) The contact in flight of the bellcrank with rudder quadrant in the circumferential area within the indentures, due to a failure of the Actuator, cannot cause the lock in position of the rudder; f) During the meeting on June 16th 2015 in Foligno, Embraer, on the contrary of what is defined into the component technical specification, reported that the quadrant has two indentures instead of four and the indenture position can be reached during the flight if commanded by the pilot. 				
<table border="1" style="width: 100%;"> <tr> <td style="width: 33%;"> Analysis: Marco Nardeschi Engineer </td> <td style="width: 16.5%;"> Date: 11/11/2015 </td> <td style="width: 33%;"> Approval: Luciano Pizzoni V.P. Engineering </td> <td style="width: 17.5%;"> Date 11/11/2015 </td> </tr> </table>	Analysis: Marco Nardeschi Engineer	Date: 11/11/2015	Approval: Luciano Pizzoni V.P. Engineering	Date 11/11/2015
Analysis: Marco Nardeschi Engineer	Date: 11/11/2015	Approval: Luciano Pizzoni V.P. Engineering	Date 11/11/2015

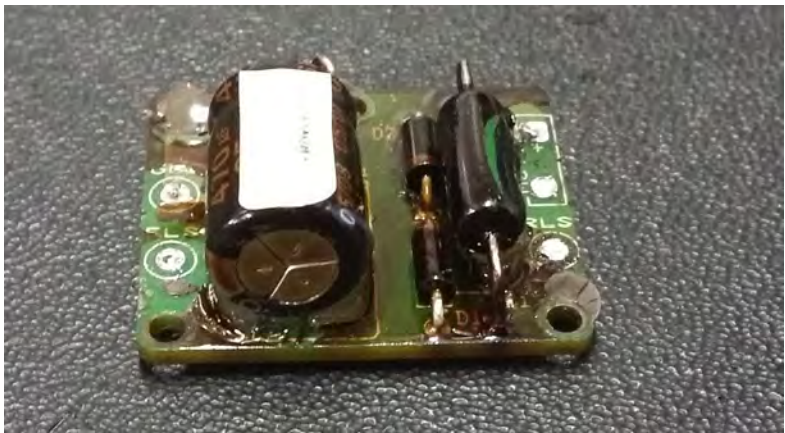
Photo 15

No evidence of mechanical failure on components and PCB. Surface coatings has been found damaged.

The electronic board 09762P019-70 works as expected.
 No evidence of damage or failure has been noted.
 The solenoid 09762P037-01 has been found with a high impedance at the coil terminal.
