-----SYSTEMS GROUP CHAIRMAN'S FACTUAL REPORT -----

Location: McKinneyville, California
Date: July 29, 2016
Time: About 0105 Pacific Daylight Time
Aircraft: Piper PA-31T
Registration: N661TC

C. SUMMARY

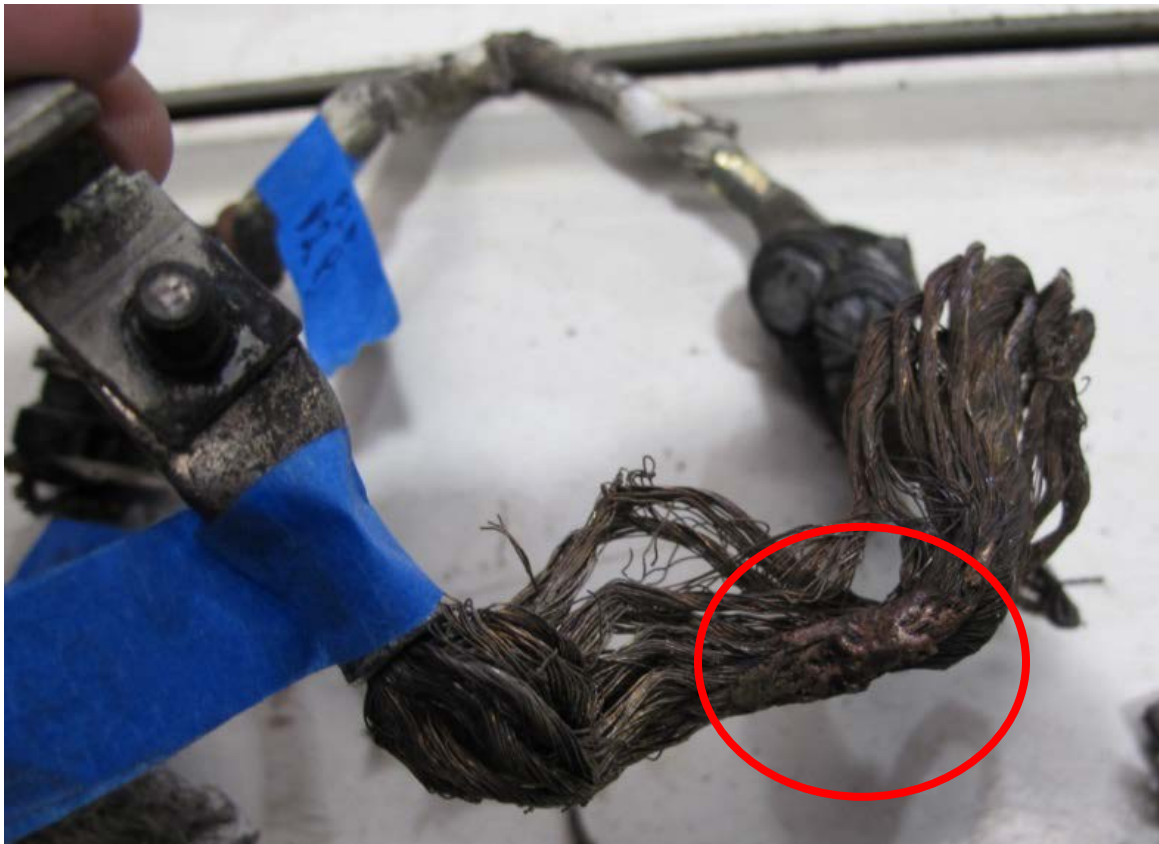
Wire P3H runs between the right starting solenoid and the battery circuit breaker. There was no insulation present on the wire. Terminal lugs and attaching hardware to the remaining portions of the starting solenoid were present. Terminal lugs and attaching hardware to the remaining portions of the battery circuit breaker were present. At approximately mid length of the wire the conductors were fused together.

Figure 7 - Wire "P3H" with area of fused conductors highlighted.

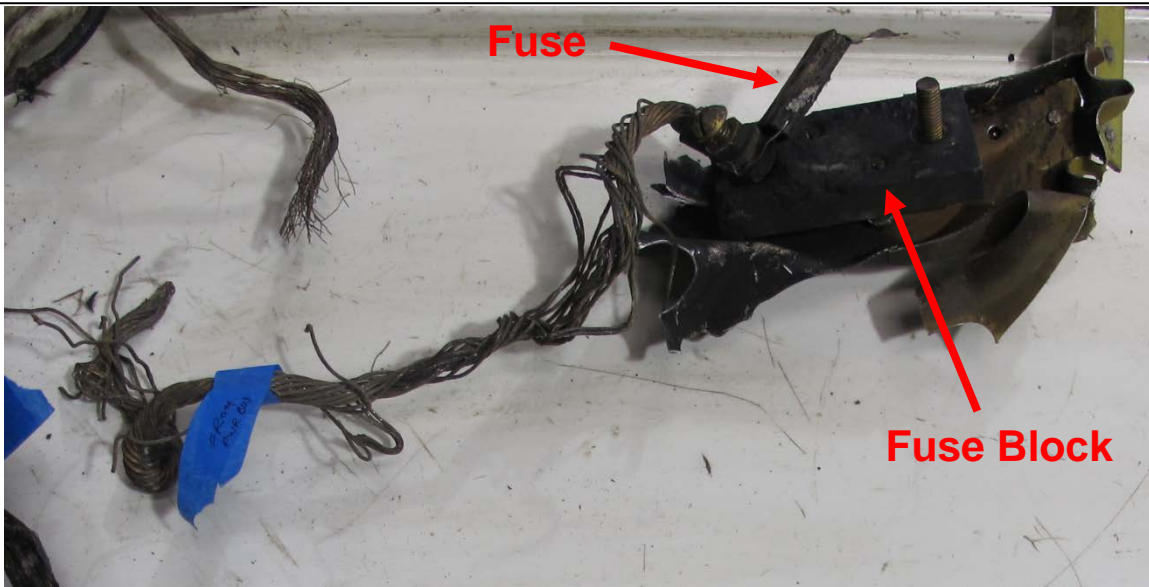
Figure 8 - STC fuse and fuse block installation as removed.

The installation also contained an 80 Amp fuse installed between the power bus and two EMS circuit breakers. The fuse and mounting block was located and removed from the wreckage. Only one wire, identified to be from the power bus to the fuse block, remained attached to the fuse. A multi-meter was used and the fuse was found on the open condition. The mounting block for the fuse showed signs of heat damaged around the area of one connection.

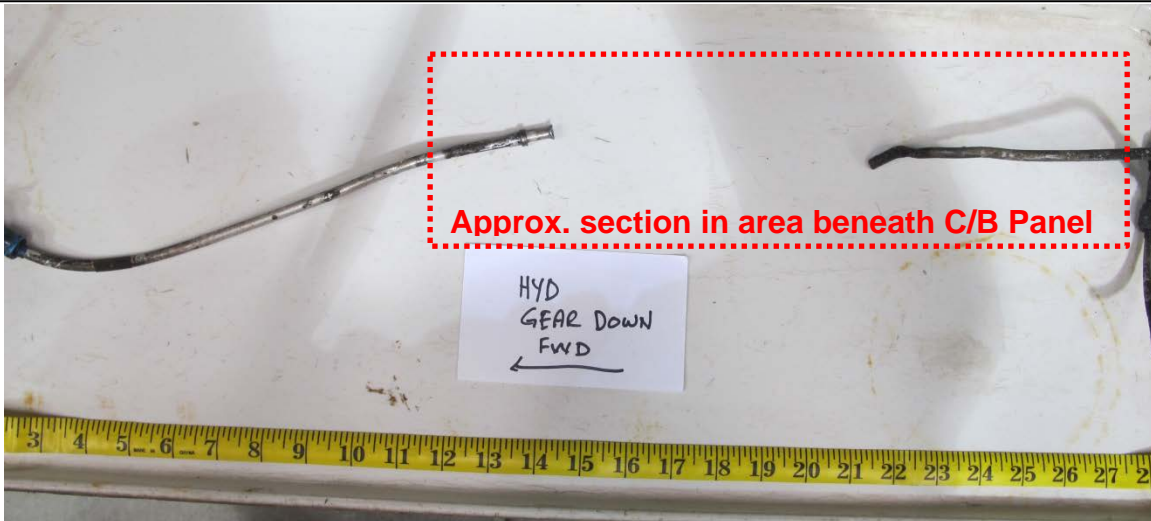
The line identified as "GEAR DOWN" was removed from the aft section of the fuselage wreckage. Approximately seven linear inches of tubing was recovered from the t-fitting towards the forward union beneath the floor circuit breaker panel. The total length of an undamaged tubing section is normally 19.7 linear inches. The end of the tubing which would normally connect to a union fitting beneath the circuit breaker panel was not present. The union fitting was also not recovered. The mating tube b-nut was also not present.

Figure 9 - Portions of hydraulic line "GEAR DOWN", with area beneath the circuit breaker panel highlighted.

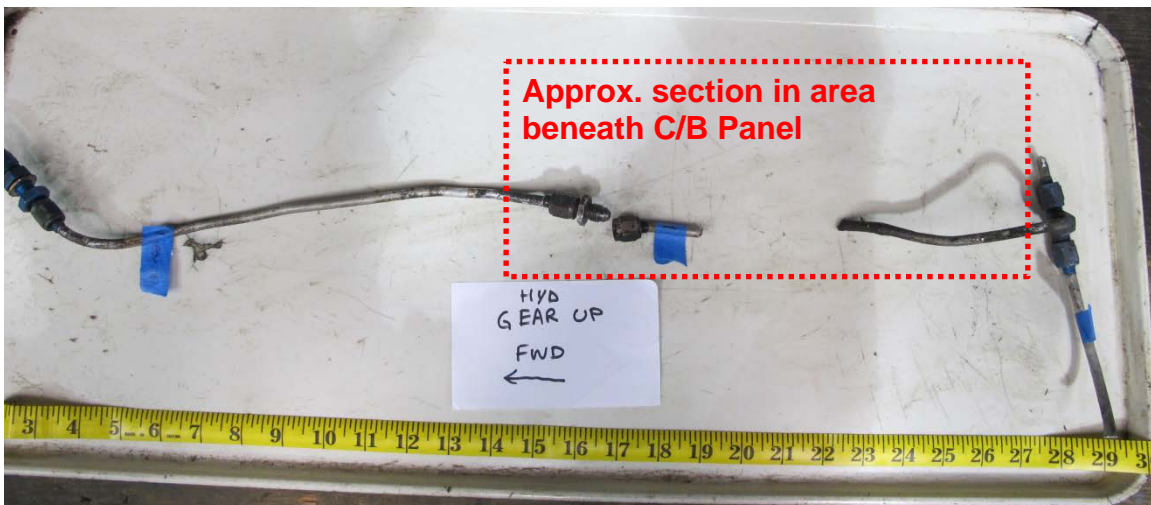
The line identified as "GEAR UP" was removed in two separate pieces from the forward section of fuselage wreckage and from the aft section of the fuselage wreckage. Approximately two linear inches of tubing were recovered from the union beneath the floor circuit breaker panel. Approximately six linear inches of tubing were recovered from the t-fitting towards the forward union beneath the floor circuit breaker panel. The total length of an undamaged tubing section is normally 18.5 linear inches.

Figure 10 - Portions of hydraulic line "GEAR UP", with area beneath the circuit breaker panel highlighted.

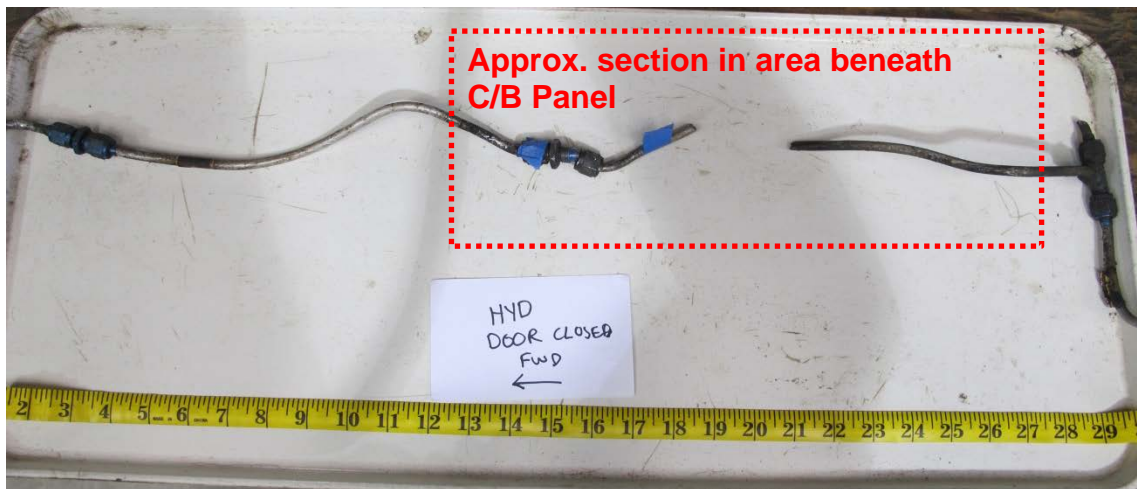
The line identified as "DOOR CLOSED" was removed in two separate pieces from the forward section of fuselage wreckage and from the aft section of the fuselage wreckage. Approximately three linear inches of tubing were recovered from the union beneath the floor circuit breaker panel. Approximately eight linear inches of tubing were recovered from the t-fitting t towards the forward union beneath the floor circuit breaker panel. The total length of an undamaged tubing section is normally 18.6 linear inches.

Figure 11 - Portions of hydraulic line "DOOR CLOSED", with area beneath the circuit breaker panel highlighted.

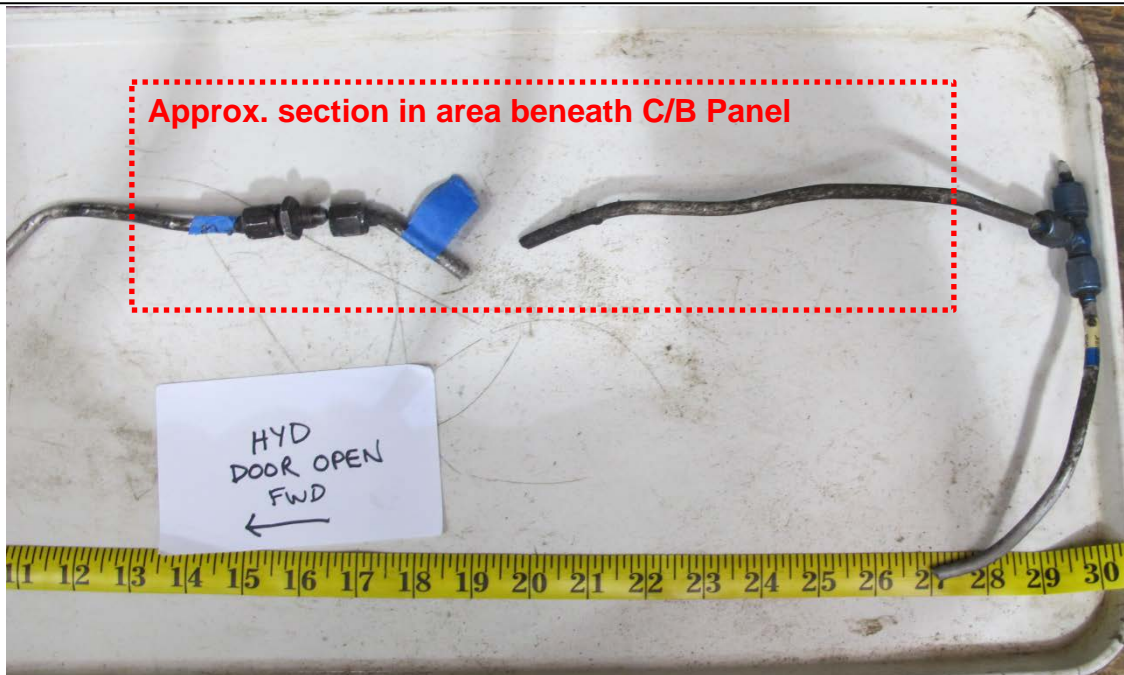
The line identified as "DOOR OPEN" was removed in two separate pieces from the forward section of fuselage wreckage and from the aft section of the fuselage wreckage. Approximately three linear inches of tubing were recovered from the union beneath the floor circuit breaker panel. Approximately ten linear inches of tubing were recovered from the t-fitting t towards the forward union beneath the floor circuit breaker panel. The total length of an undamaged tubing section is normally 20.0 linear inches.

Figure 12 - Portions of hydraulic line "DOOR OPEN", with area beneath the circuit breaker panel highlighted

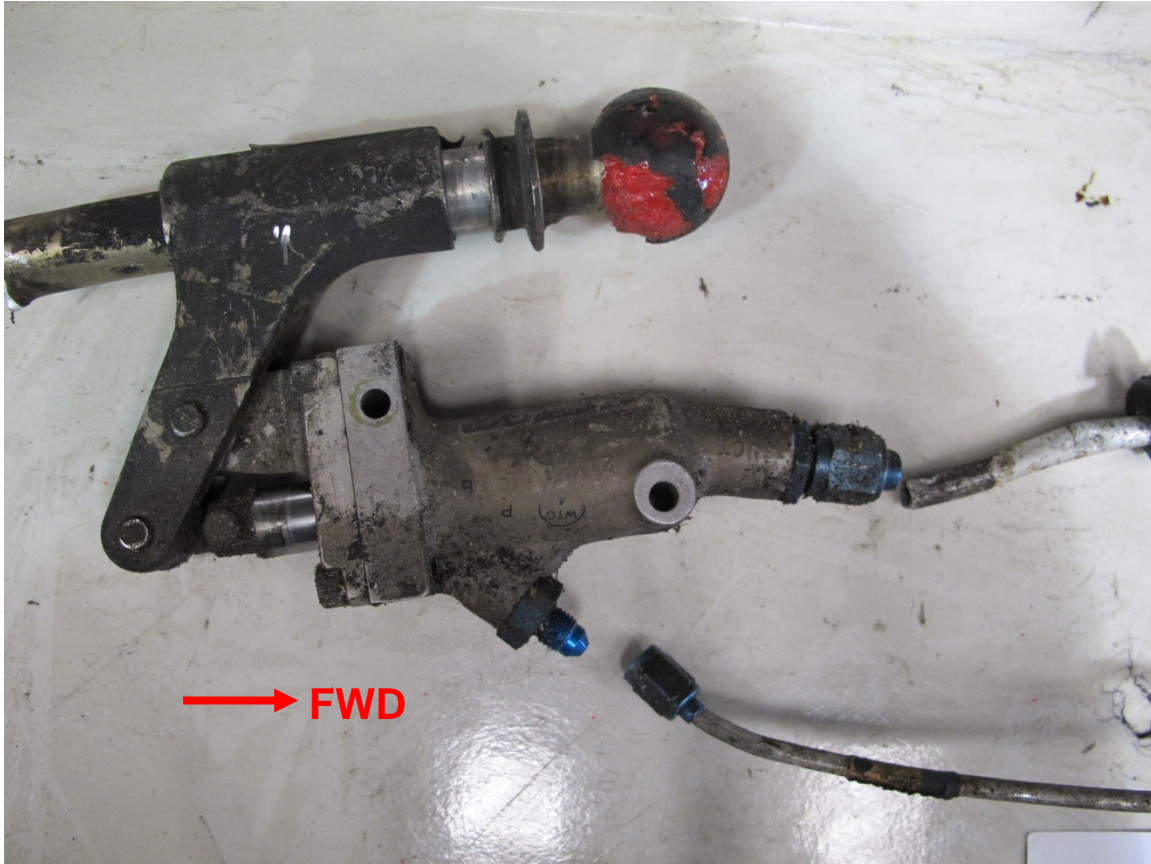
The hydraulic hand pump was identified in the wreckage and removed. The pump is located in the bay just forward of the floor circuit breaker panel. The pump showed signs of heat damage and the presence of soot. The red plastic knob was charred and cracked in numerous places. After removal the pump was actuated by hand and hydraulic fluid was present.

Figure 13 - Hydraulic hand pump as recovered.

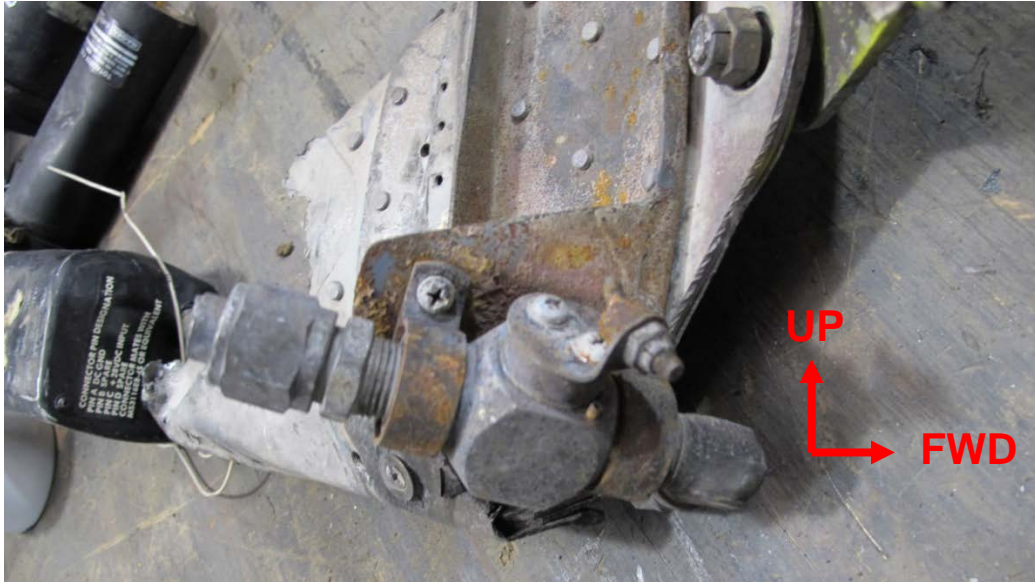
The left fuel shutoff valve (SOV) was found attached to a small portion of the forward spar, Figure 14. The left fuel pumps and the fuel cross-feed valve were attached to a piece of the left wing structure, Figure 15. The fuel tubing between the left hand fuel pump cross fitting and the fuel shutoff valve was not present except for the B-nut. A small portion of the fuel tubing that runs from the fuel SOV to the engine supply, including the 90° AN¹ fitting was present. The rubber position of the p-clamps used to mount the SOV was not present. The valve showed signs of heat damage. The valve was found in the OPEN position. The fuel shutoff valve is actuated via a cable-lever assembly located on the floor between the crew seats.

Figure 14 - Left hand Fuel SOV as recovered

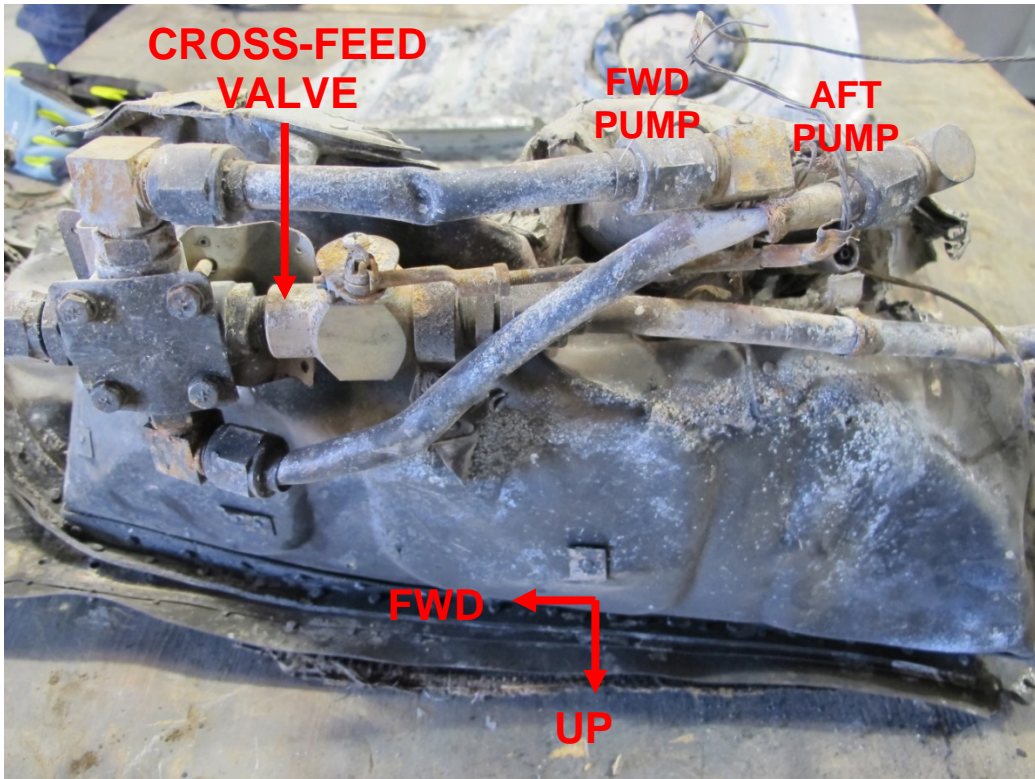
Figure 15 - Left hand side wing structure and forward and aft fuel pumps

A portion of the structure of the left wing was recovered which contained the two, forward and aft, fuel pumps and the fuel cross-feed valve. The fuel tubing from both fuel pumps to the cross fitting was present. The fuel line from the aft fuel pump showed signs of buckling approximately two to three inches from each end of the fuel line. The fuel line from the forward fuel pump showed signs of buckling at approximately mid length. Approximately twelve to fifteen inches of the fuel line which runs from the cross-feed valve to the heater supply line and right wing tank was present. Approximately five inches of the fuel line which runs from the right fuel pump cross fitting to the right fuel shut-off valve was present. In order to visually verify the position of the cross-feed valve, the fuel line was removed and the cross-feed valve was found in an intermediate position, Figure 16. The cross-feed valve is actuated via a cable-lever assembly located on the floor between the crew seats.

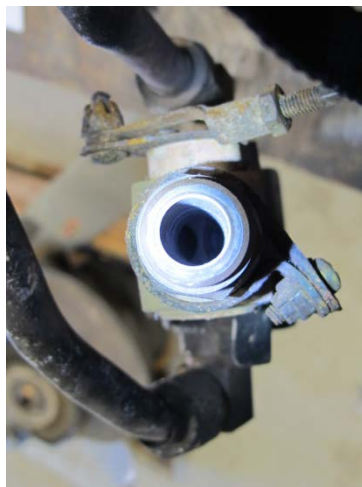
Figure 16 - Fuel cross-feed valve position

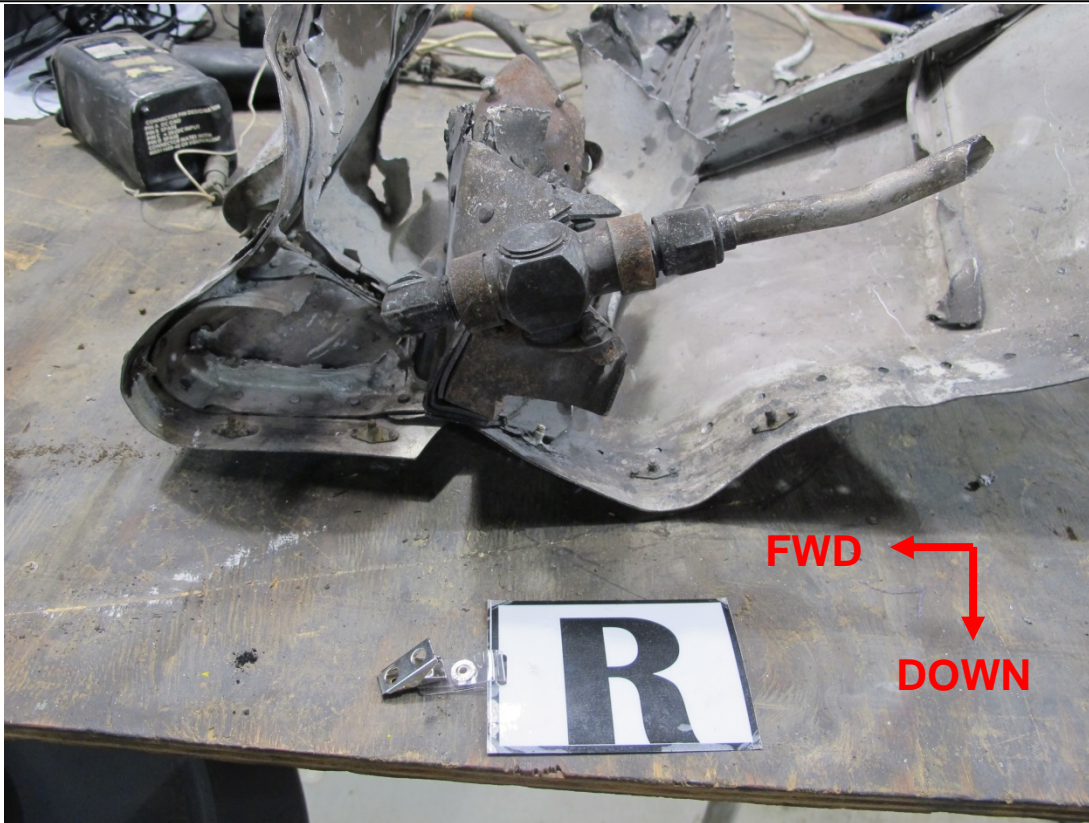
The right fuel shutoff valve was found attached to a small portion of the forward spar and forward wing skin, Figure 17. A small portion of the fuel tubing between then right hand fuel pump cross and the fuel shutoff valve was present. A small portion of the fuel tubing that runs from the fuel SOV to the engine supply, including the 90° AN fitting was present. The rubber position of the p-clamps used to mount the SOV was not present. The valve showed signs of heat damage. The valve was found in the CLOSED position. The fuel shutoff valve is actuated via a cable-lever assembly located on the floor between the crew seats.

Figure 17 - Right hand Fuel SOV as recovered

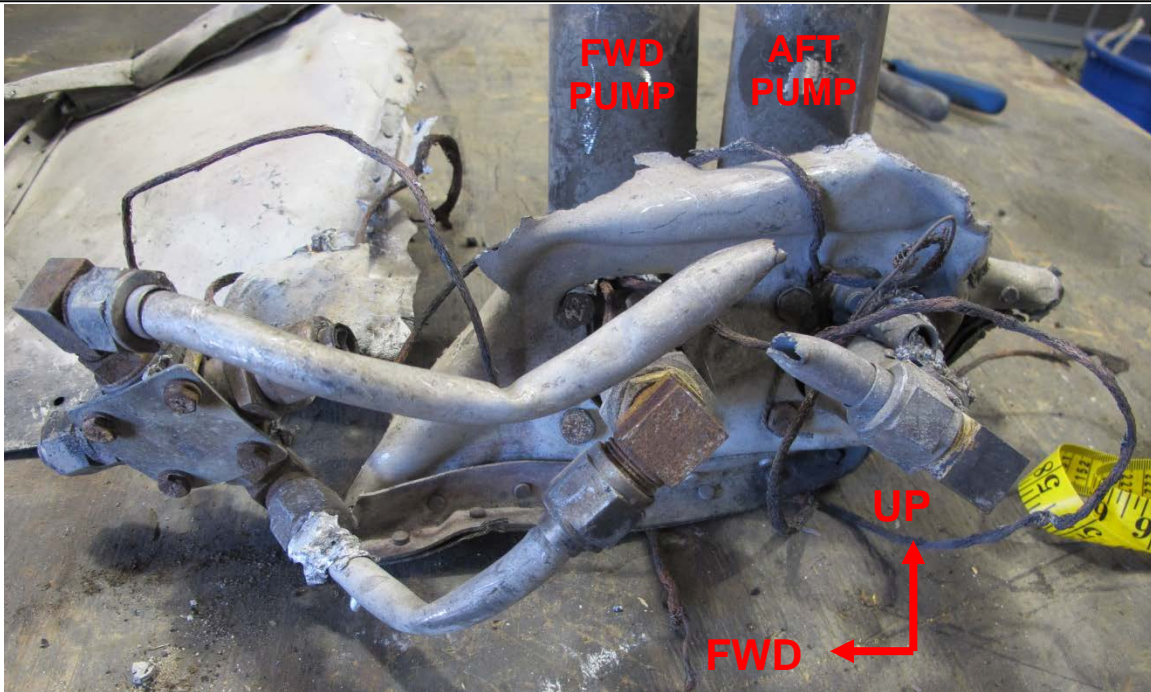
A portion of the structure of the right wing was recovered which contained the two, forward and aft, fuel pumps, Figure 18. The fuel tubing from both fuel pumps to the cross fitting was present. The fuel line from the aft fuel pump showed signs of buckling at approximately mid length. The fuel line from the aft fuel pump was also fractured approximately one to two inches from the fuel pump-check valve connection. The fuel line from the forward fuel pump showed signs of buckling at approximately mid length. The fuel line which would run from the cross to the fuel cross-feed valve and heater supply line was not present except for the b-nut attached to the cross fitting. The fuel line which would run from the cross to the right fuel shut-off valve was not present except for the b-nut attached to the cross fitting.

Figure 18 - Right hand side wing structure and forward and aft fuel pumps

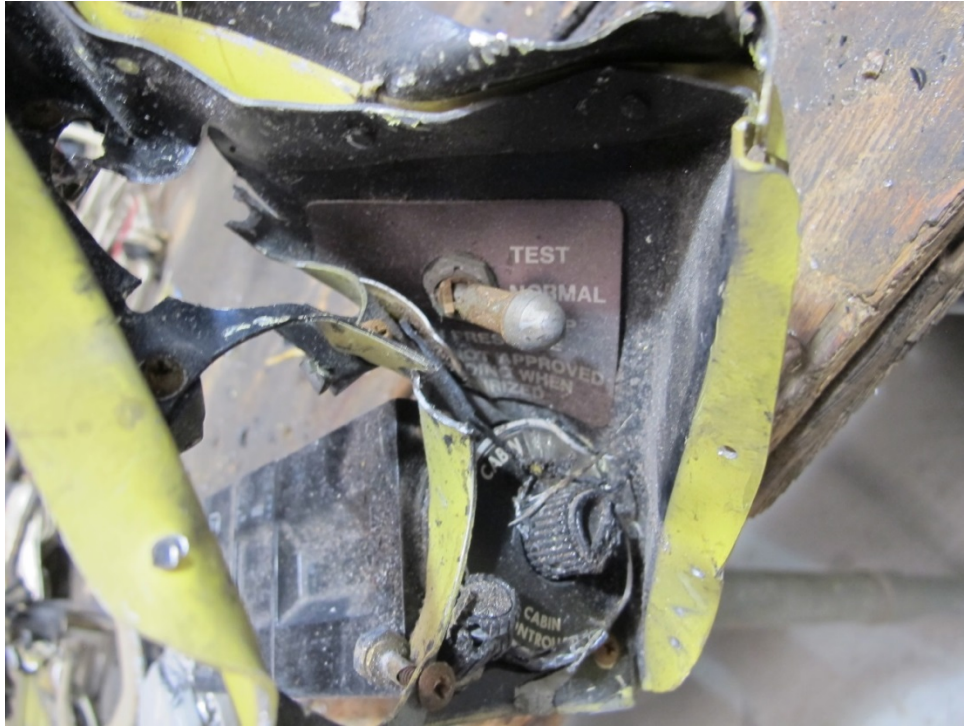
The cabin dump switch was located in the wreckage. The panel with the cabin dump switch exhibited signs of crush damage. The panel was separated from the cockpit wreckage and straightened in order to view the switch position, Figure 19. The cabin dump switch was bent towards the right (when looking forward) and the switch was pointed in a direction consistent with the “NORMAL” position. The rear portion of the switch, Figure 20, on the back side of the panel, was not present on the removed panel.

Figure 19 - Cabin Pressurization Panel-Front View

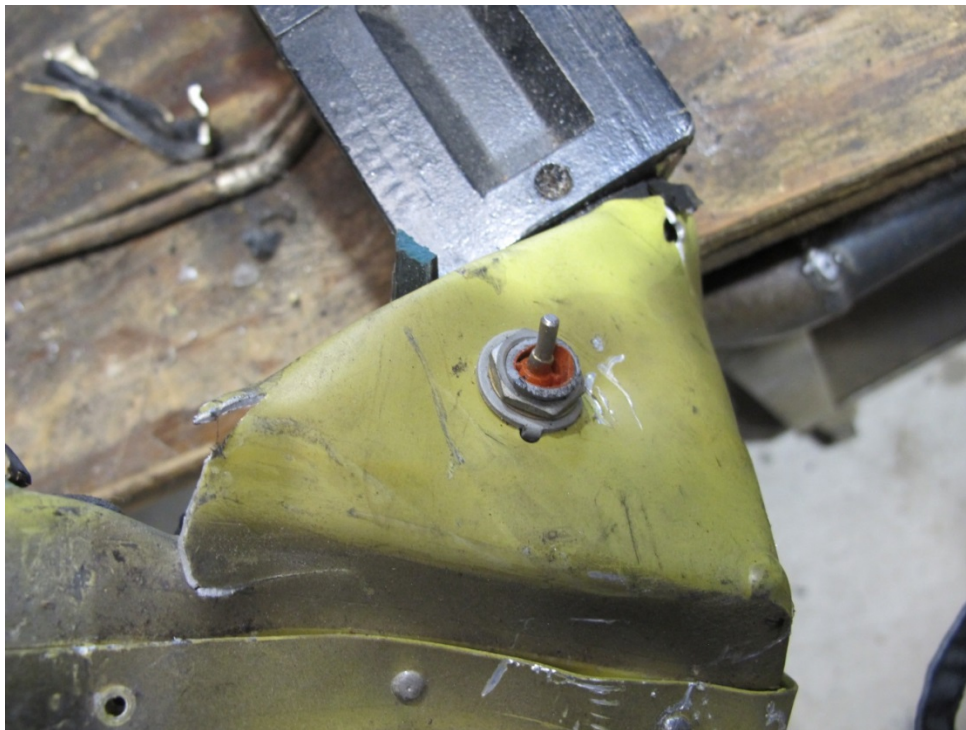
Figure 20 - Cabin Pressurization Panel-Rear View

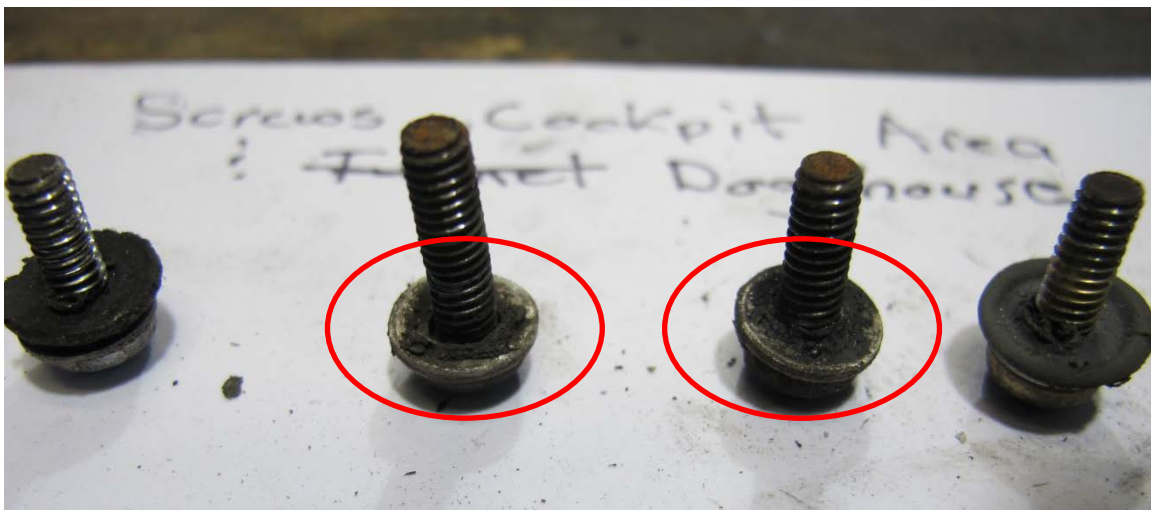
The floor boards in the cockpit area are part of the pressure floor. In order to attach the floor boards to the aircraft structure and maintain a pressure seal, each attach screw typically contains a flat washer and a rubber seal. Four screws were removed from a floor board on the right-hand side of the cockpit area to inspect the rubber seals around the screws. Two of the screws contained rubber seals and two did not.

Figure 21 - Floor board attach hardware, screws missing rubber seals circled.
