NATIONAL TRANSPORTATION SAFETY BOARD

SYSTEMS GROUP CHAIRMAN'S FACTUAL REPORT

CEN11IA234

Location: Akron-Canton Regional Airport, Canton, OH USA
Date: March 18, 2011
Time: 12:08 AM EDT
Aircraft: Express Jet, Embraer EMB 145 XR, N11187

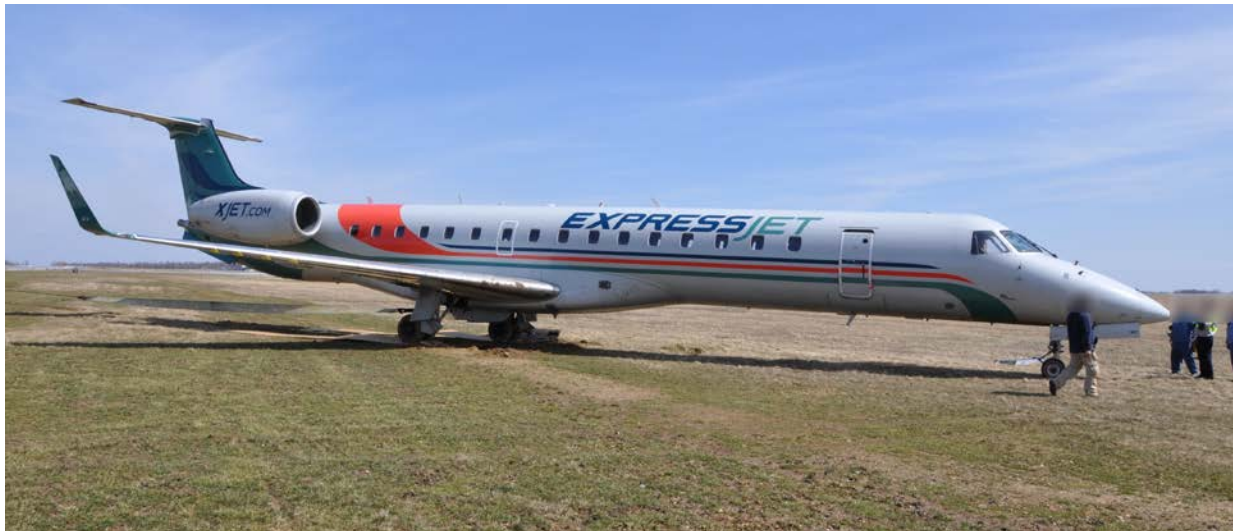
Figure 1: Aircraft Condition Following Runway Departure

The leading edges of the aircraft's wings were covered with splattered mud. The right wing exhibited more mud splatter than the left, and the inboard section of the right wing exhibited more mud splatter than the outboard section. The engine intakes and underside of the fuselage also exhibited mud splatter. The wheels and tires were caked in mud. The only visual damage to the aircraft was to the right wing outboard flap fairing. This fairing hit a runway sign during the runway departure and was removed by maintenance during aircraft recovery.

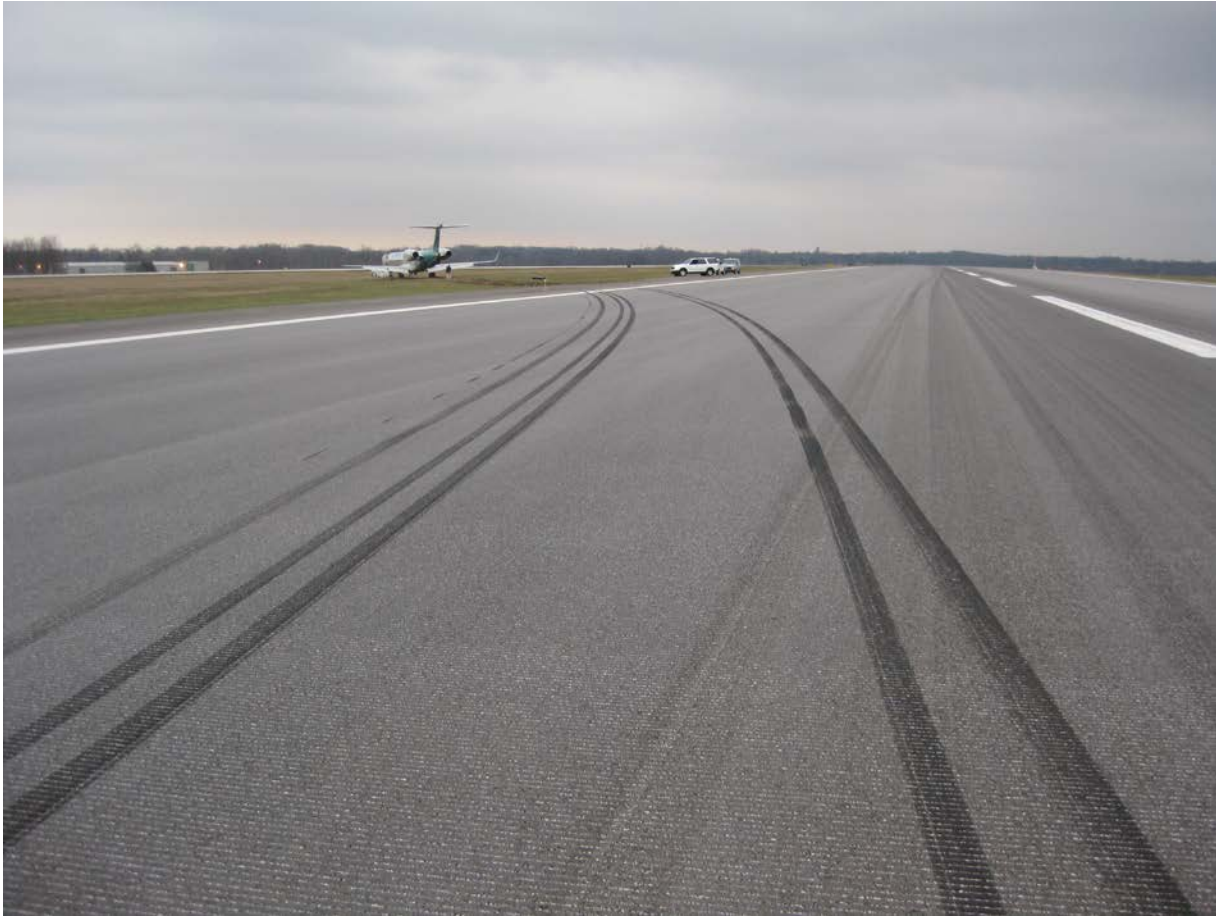
Figure 2: Runway Tire Marks

The runway was a grooved runway. The nose tires, the inboard left main tire, and both right main tires all deposited solid line witness marks on the runway. The outboard left main tire deposited an intermittent witness mark on the runway (see Figure 2). A distinct mark from the right nose wheel tire chine was visible along the track of the turn. The aircraft came to rest in the grass approximately 260 feet left of the runway center line. Significant coordinates were taken using a handheld GPS and are plotted in Figure 3.

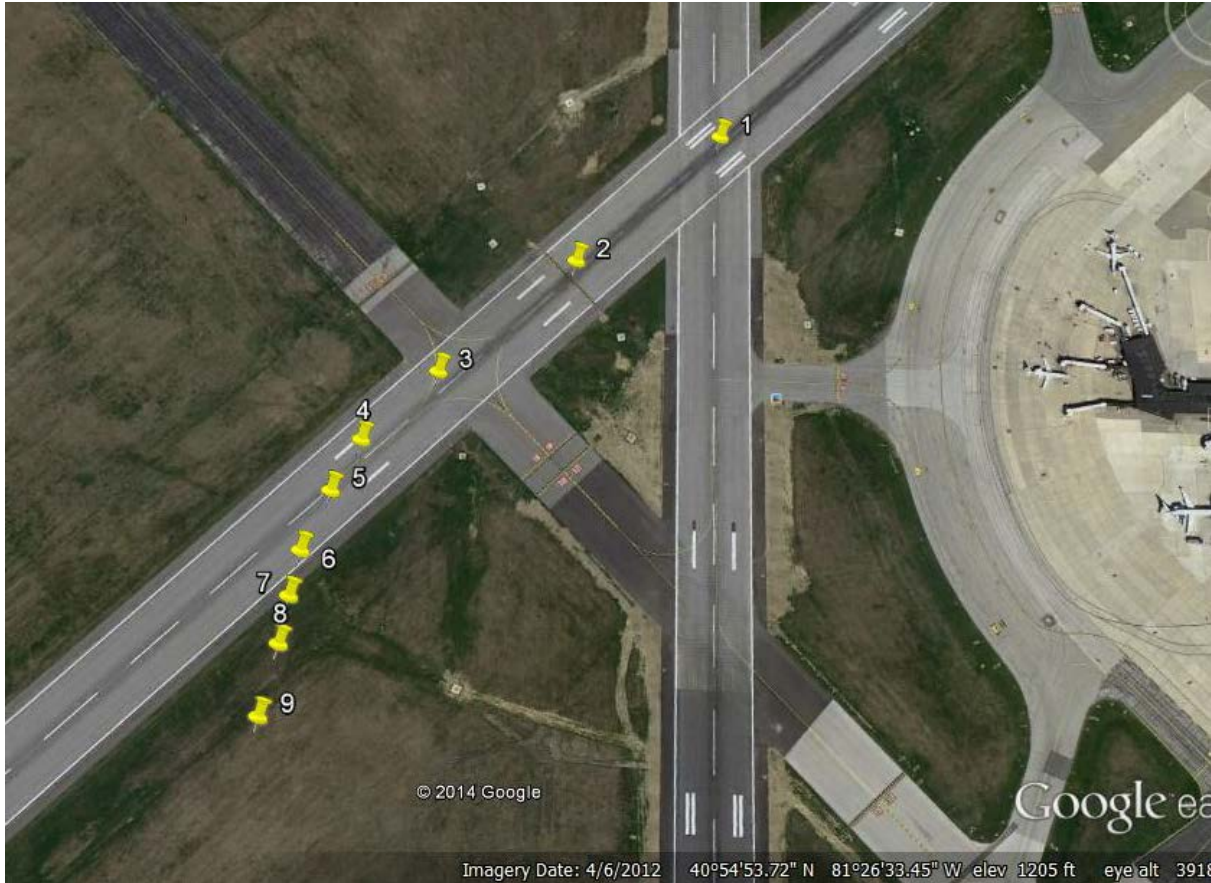
Figure 3: GPS Coordinates

1. First Visual Right Main Tire Mark: 40°54'59.36"N, 81°26'26.92"W
2. First Visual Left Main Tire Mark: 40°54'56.60"N, 81°26'30.96"W
3. First Visual Nose Tire Marks: 40°54'54.24"N, 81°26'34.66"W
4. Beginning of Turn To The Left (Coordinates from Right Main Tire Mark):
40°54'52.84"N, 81°26'36.66"W
5. Shortest Distance Between Nose and Left Main Tire Marks (Coordinates from Nose Tire
Marks): 40°54'51.81"N, 81°26'37.42"W
6. Runway Exit Marks (Coordinates from Left Main Tire Mark): 40°54'50.63"N,
81°26'38.15"W
7. Shortly After Runway Departure (Coordinates from Left Main Tire Ground Track):
40°54'49.75"N, 81°26'38.41"W
8. Approximately Halfway between Coordinates 7 and 9 (Coordinates from Left Main Tire
Ground Track): 40°54'48.84"N, 81°26'38.63"W
9. Final Aircraft Position (Coordinates from end of Nose Wheel Ground Track):
40°54'47.48"N, 81°26'39.07"W

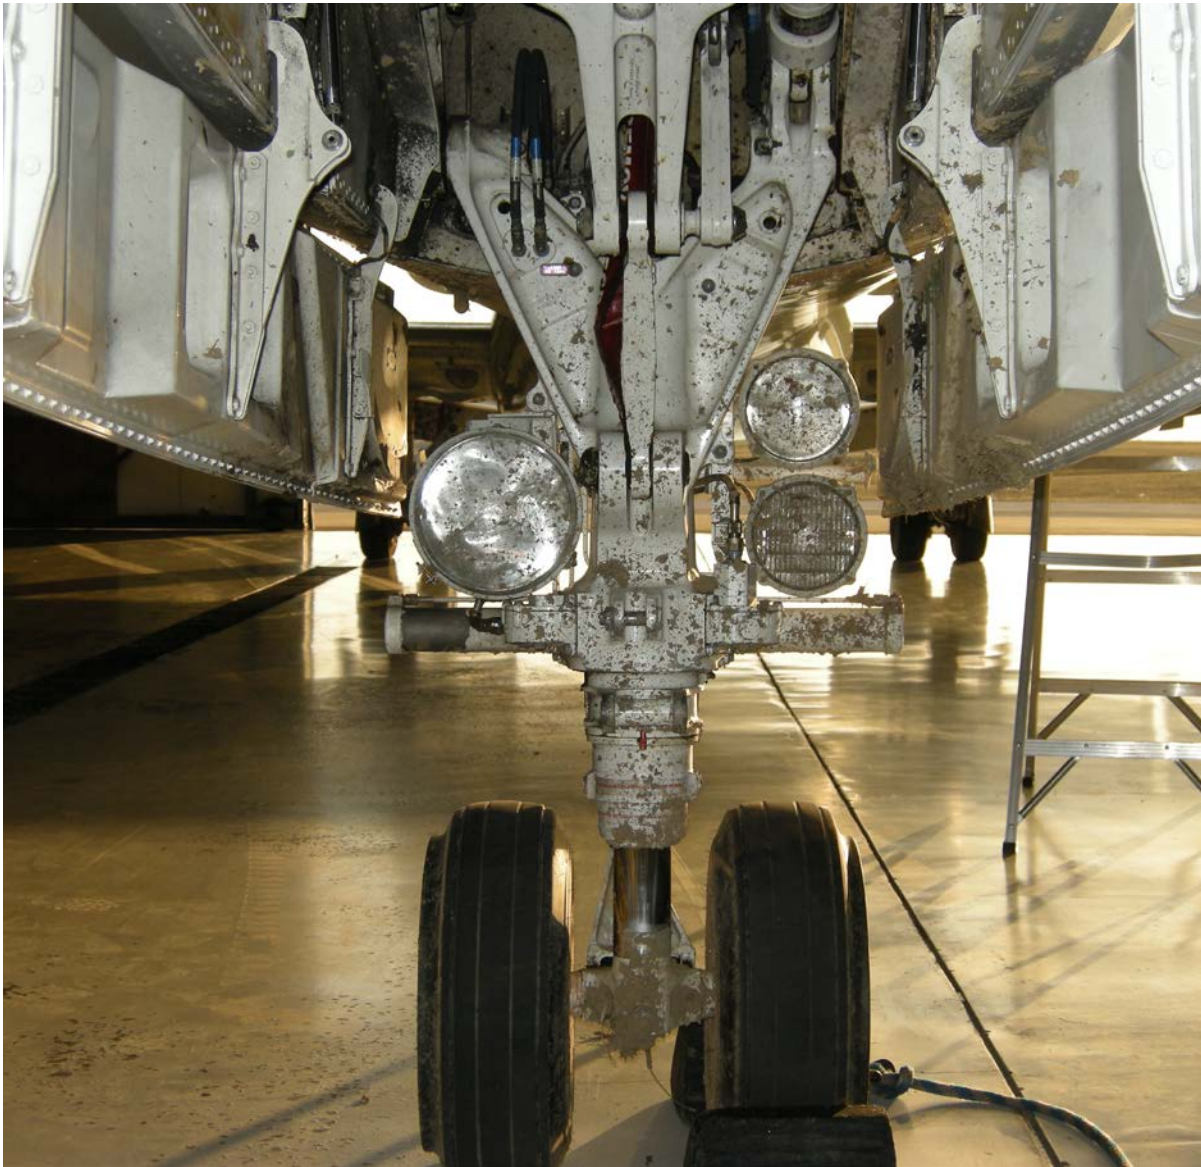
Figure 5: Nose Landing Gear

A visual inspection of the NWS system, nose landing gear assembly, and nose tires was performed (see Figure 5). Inspection revealed that the electrical connector connected to the 7 degree position sensor was ¼ turn loose. Following the functional test the nose wheels were moved back and forth using the tiller and then the rudder pedals while shaking this connection by hand. The system functioned normally during this test.

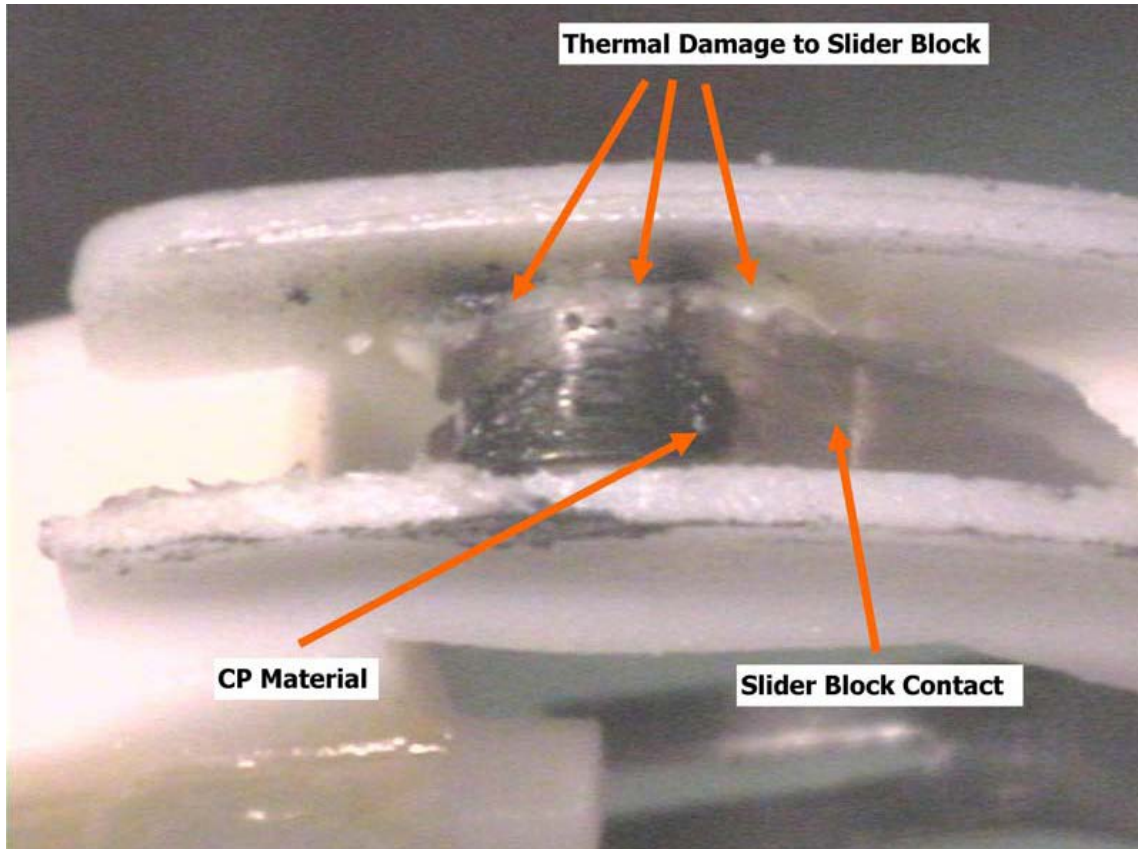
Figure 6: Slider Block and Contact

Output Smoothness – FAIL

According to BI Technologies Corporation documentation, the output smoothness is a measurement of any variation in electrical output not present in the input. Smoothness includes the effects of resistance variation, resolution, and other nonlinearities in the output. The smoothness in the clockwise direction was measured utilizing the smoothness bench test stand and no anomalies were noted. The test was performed in the counterclockwise direction and multiple spikes exceeding the tolerance of 0.05% in excess of the input voltage were observed. Based on the failure of the smoothness test, the resistance between the common tag and the coil were measured utilizing a digital ohm-meter. Rotation of the potentiometer shaft by hand resulted in multiple “open” resistance points.

The rear cover was removed and thermal damage was noted to the plastic slider block area adjacent to the coil contact (see Figure 6). The coil slider pin appeared correctly installed within the plastic slider block. The slider plate and contact were removed and examined utilizing a microscope. Fragments of black material, consistent with thermally damaged conductive plastic were noted to both the contact surface and the adjacent slider block sleeve. Yellowing and thermal damage was also noted to the slider block guide plates.

The rear case slip ring and associate slider block and contacts were removed and appeared undamaged. Examination of the coil revealed an indentation in the conductive plastic in an area approximately 5mm from the counterclockwise tap point. The damage to the conductive plastic appeared consistent with thermal exposure.
