----- SYSTEMS GROUP CHAIRMAN'S FACTUAL REPORT -----

Location: Koehn Dry Lake, California
Date: October 31, 2014
Time: 1007 Pacific daylight time (PDT)
Vehicle: Scaled Composites LLC M339 – “SpaceShipTwo”
Registration: N339SS

3. SUMMARY

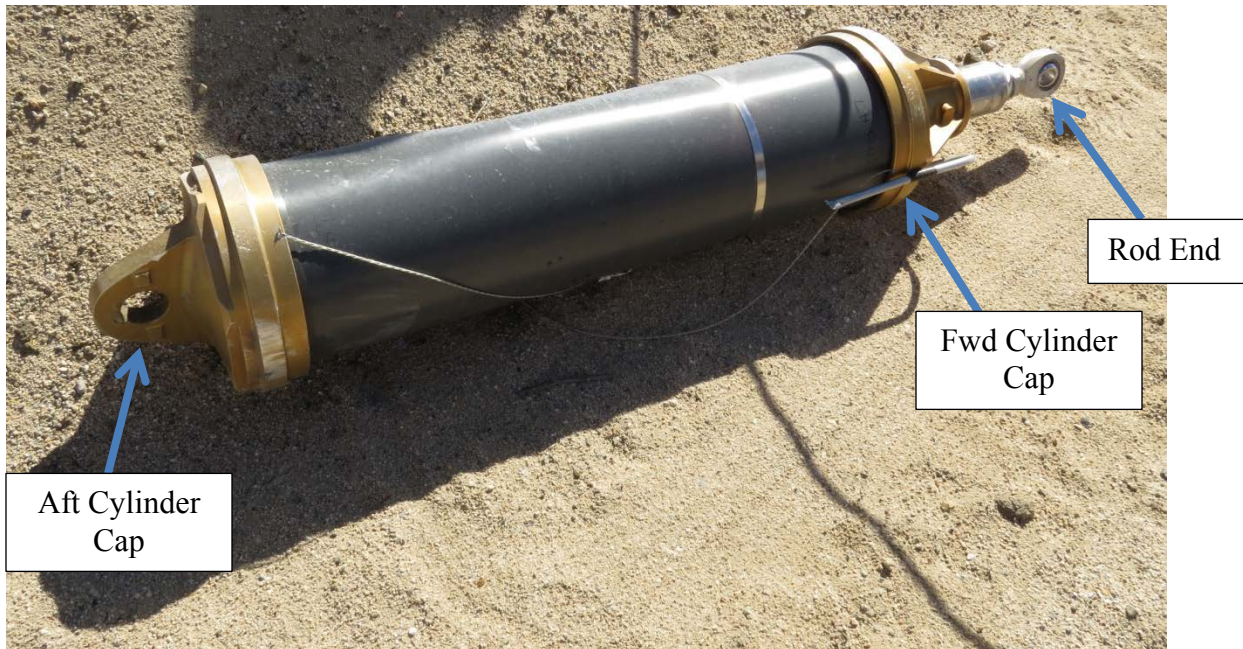
Figure 14 - LH feather actuator as found

The actuator was placed on a service cart and an external visual inspection was performed. Figure 14 shows the left hand feather actuator as found by the vehicle recovery group.

The aft cylinder cap had multiple areas of scratches and debris embedded in the surface, consistent with impact damage. There were no threads exposed on the cap or cylinder.

The spherical bearing and retention snap ring were not present on the aft cylinder cap. The snap ring groove was in good condition, with loose debris in the snap ring groove and around the bearing race. The sides of the aft cylinder cap attach fitting (where the actuator interfaces with the aft vehicle structure) had symmetrical marks, consistent with impact.

There are two safety wire runs normally attached from the aft cylinder cap to the forward cylinder cap. One of the safety wire runs was still connected between the two caps, however the wire was loose and exhibited signs that the wire was “pulled” and was starting to unravel. The other safety wire run was not connected to the aft actuator cap, with damage consistent with the safety wire being pulled out from its attachment point.

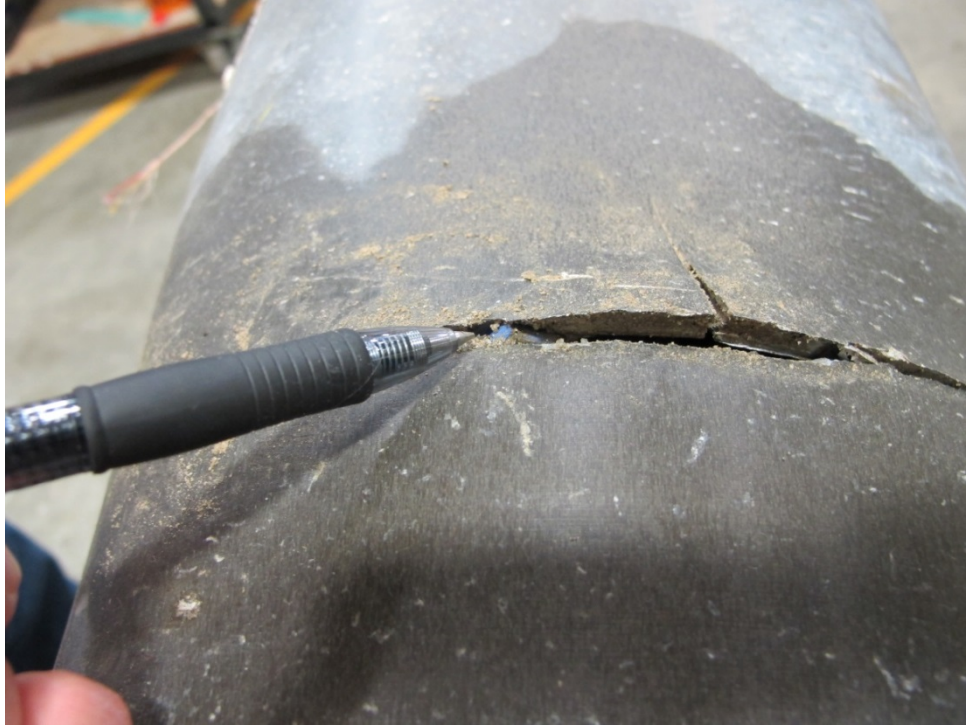
Figure 15 - LH feather actuator cylinder breach with seal exposed

The cylinder was found breached approximately 7 inches from the edge of the aft cylinder cap. The breach was approximately 6 inches along the circumference of the cylinder wall. A piece of blue seal could be seen embedded in the breached area, Figure 15. Yellow marks along the cylinder could be seen in two places. The yellow coloring was consistent with the plastic cases used for housing the sensors of the breach detection system for the rocket motor.

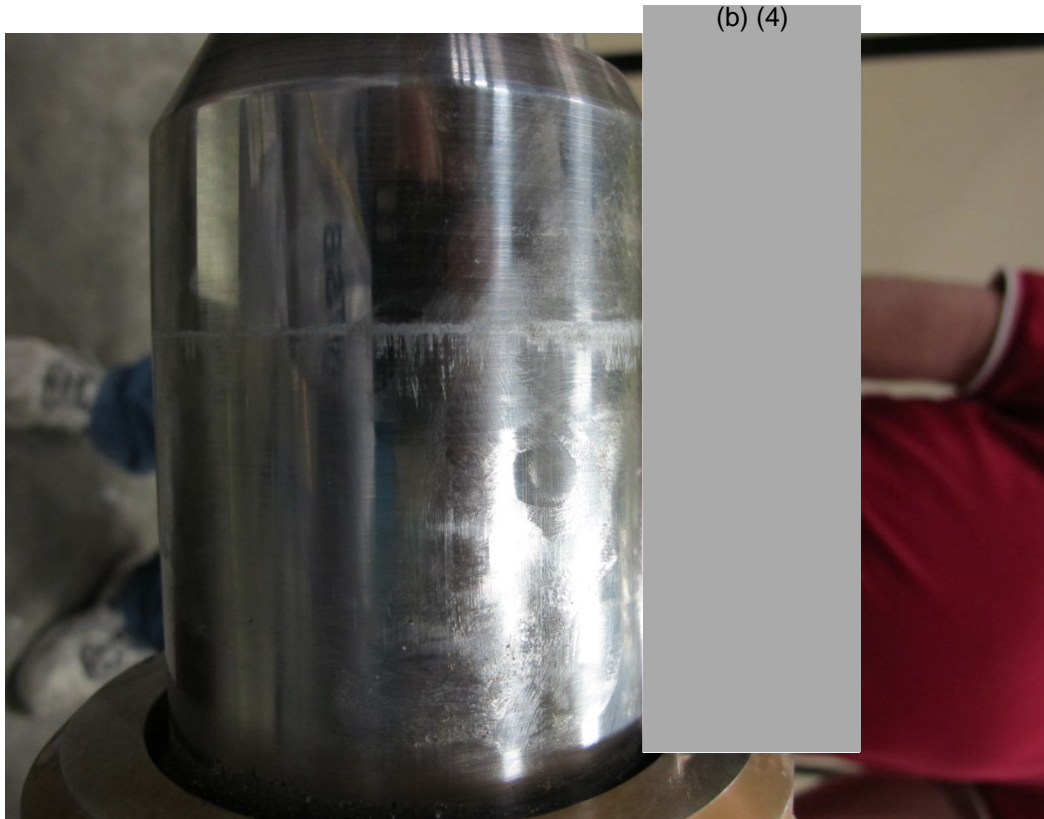
Figure 16 - Exposed end of the LH feather actuator shaft

The piston shaft was extended approximately $3 \frac{7}{8}$ " from the forward cylinder cap, Figure 16. A circumferential score was present approximately $1 \frac{1}{4}$ " from the end of the shaft, as measured from the beveled end. Debris, consistent with sand, was present at the scraper, which was mounted in the forward cylinder cap. The scraper did not show signs of exterior damage.

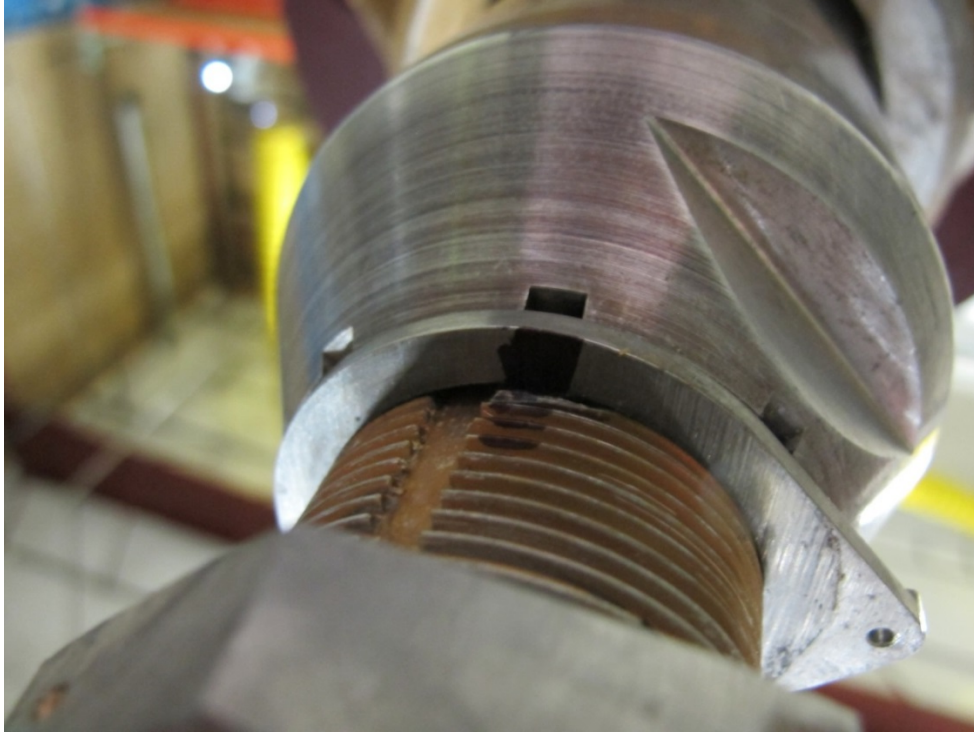
Figure 17 – Displacement of the reluctor key (black mark) with LH rod end groove

The rod end jam nut safety wire was present, intact but loose. The spiral groove slip retractor key was displaced from the rod end groove in the rod end by approximately 5-10°. The jam nut was removed and it was determined that the rod end was rotated from its original position by approximately 5-10° and the keys from the retractors (in two places) were embedded in the threads of the rod end, Figure 17. The rod end was removed with normal removal forces applied.

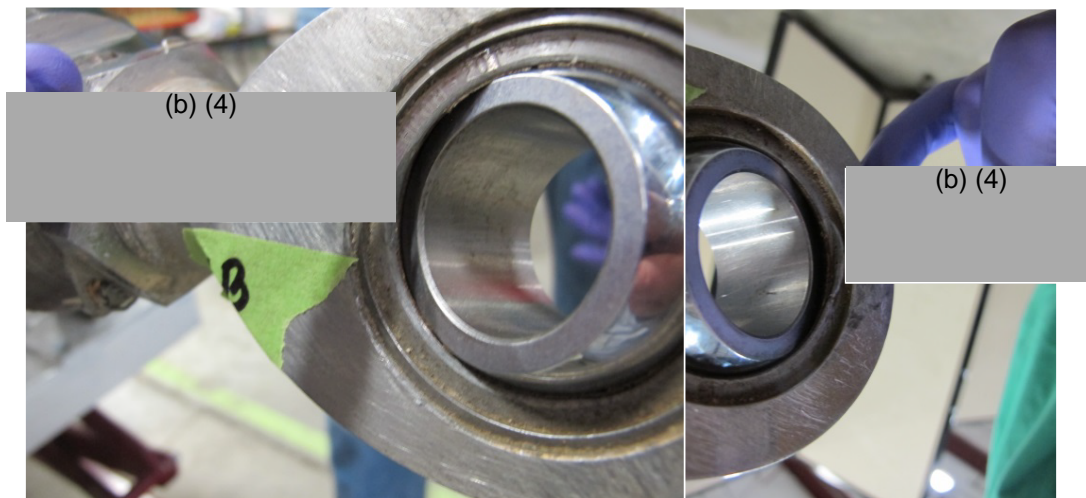
Figure 18 - Impact marks on the outer race of the LH actuator rod end bearing

The rod end had surface scrapes on both sides of the main face. The spherical bearing was present and the snap ring to secure the bearing was also present. Impact marks in the outer bearing race were consistent with the attach pin striking the outer race due to over rotation of the pin assembly, Figure 18.

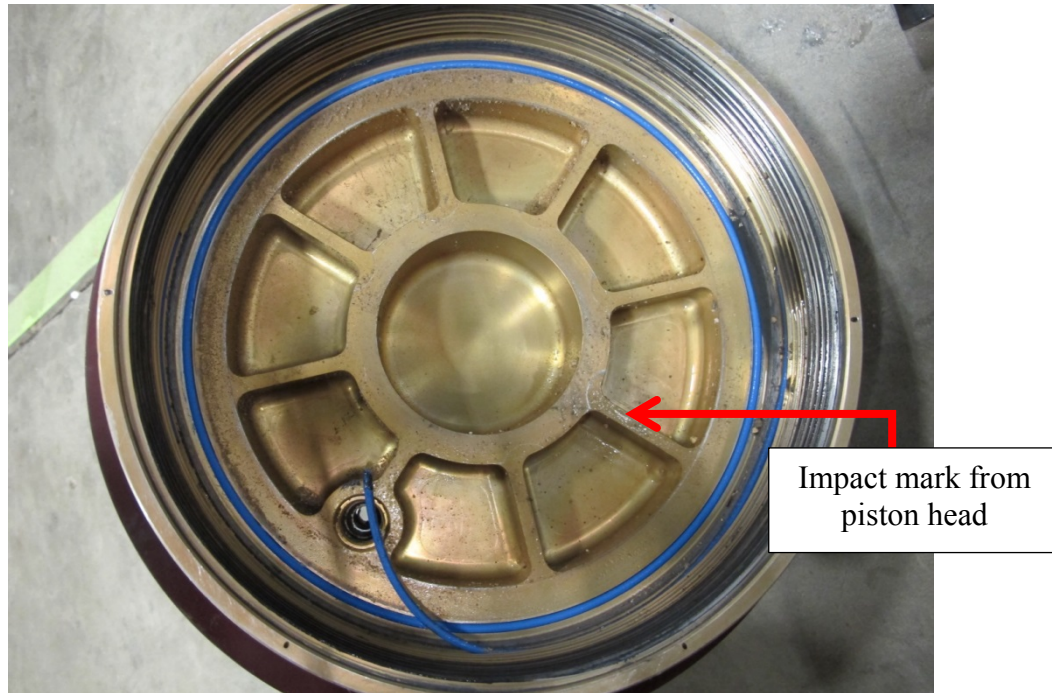
Figure 19 - Interior of aft cylinder cap with seal and impact marks from piston head

The aft cylinder cap was difficult to remove and required greater than normal torque. During the cap removal one of the cylinder seals was damaged. Four pieces of the seal were recovered. The second cap seal was intact and exhibited no signs of cuts or dry areas. The cap was removed and the interior of the cylinder between the piston head and

cap. Debris lined the cylinder walls and was consistent with the soil at the recovery location. No scoring or wear marks could be seen on the cylinder walls. Fluid, consistent with (b) (4) lubricant was present. On the interior of the aft cap, markings consistent with contact of the piston head were present, Figure 19. Based on discussions with Scaled engineering, during normal operations the piston head should not contact the aft cylinder cap.

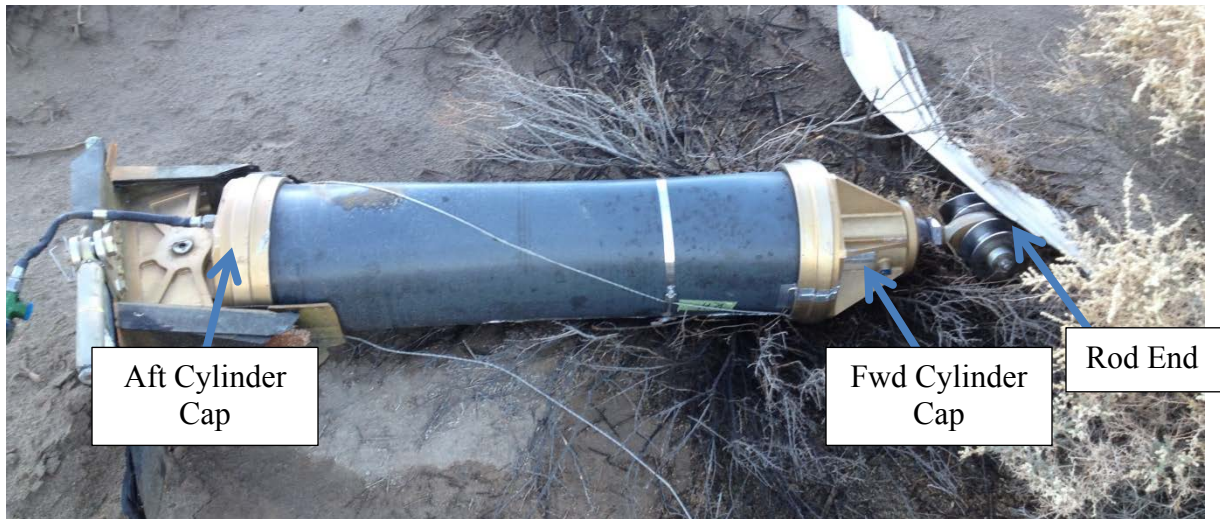
Figure 20 - The RH feather actuator as found

The actuator was placed on a service cart and an external visual inspection was performed. Overall the actuator appeared to have a slight bow along its length. Figure 20 shows the right hand feather actuator as found.

The aft cylinder cap had multiple areas of scratches and debris embedded in the surface, consistent with impact damage. There were no threads exposed on the cap or cylinder.

The sides of the aft cylinder cap attach fitting (where the actuator interfaces with the aft vehicle structure) had symmetrical impact marks consistent with the mounting bracket. During the condition inspection, the aft cylinder cap sustained minor damage during reinstallation at the interface with the aft structural fitting and was repaired. The area of the repair was noted.

The bearing retention snap ring was not present and the spherical bearing was present on the aft cylinder cap. The snap ring groove was in good condition, with loose debris in the snap ring groove and around the bearing race. The ball bearing was loose inside the bearing race.

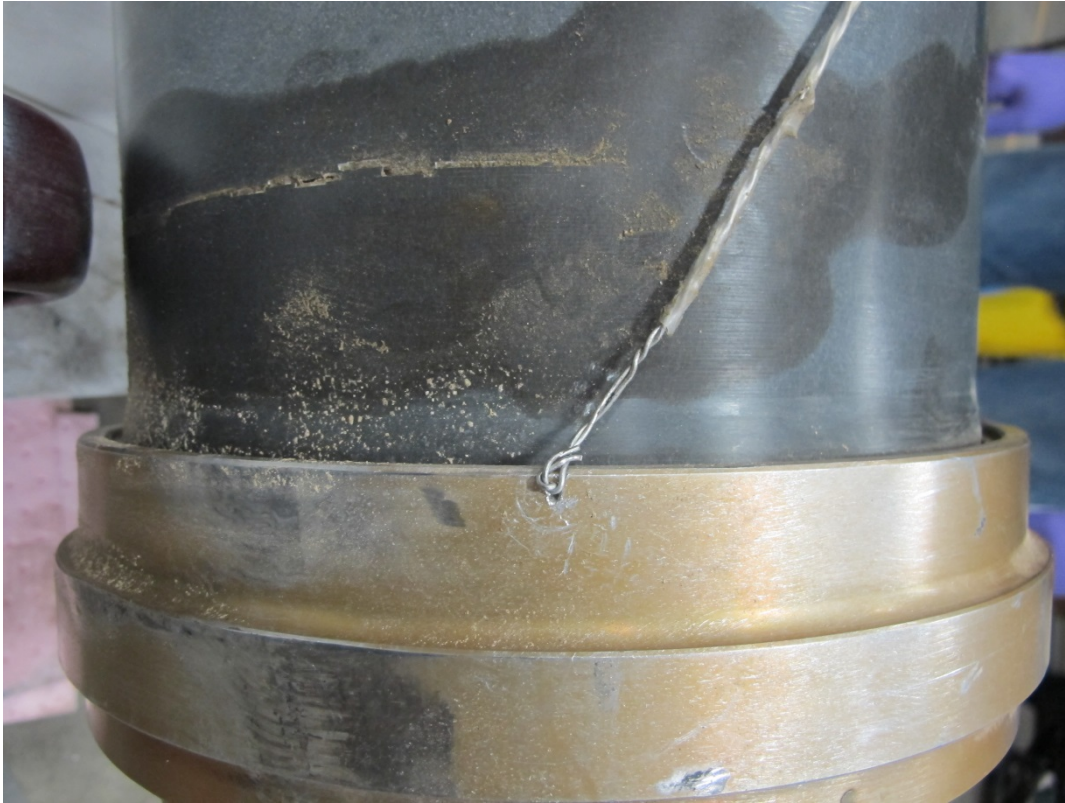
Figure 21 - The RH feather actuator breach

The cylinder was breached approximately 2 inches from the edge of the aft cylinder cap, see Figure 21. The breach was approximately 5 inches long along the circumference of the cylinder wall. The presence of lubrication fluid seeping from the inside of the cylinder to the outside could be seen.

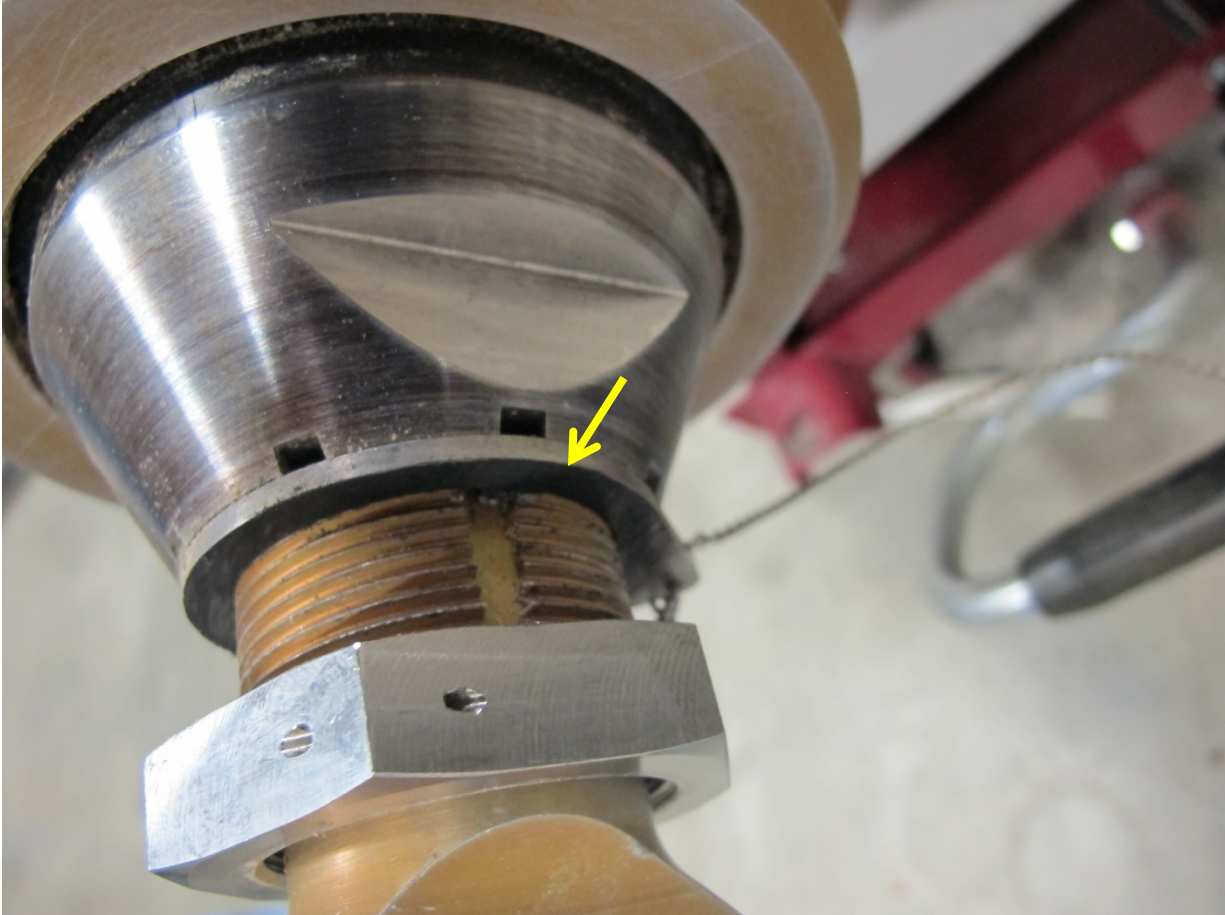
Figure 23 - Displacement of the reluctor key(yellow arrow) with RH rod end groove

The rod end jam nut safety wire was present, intact but loose. The spiral groove slip retractor key was displaced from the rod end groove in the rod end by approximately 2° . The jam nut was removed and it was determined that the rod end was rotated from its original position by approximately 2° and the keys from the reluctors (in two places) were embedded in the threads of the rod end, Figure 23. The rod end was removed with normal removal forces applied. It was noted that the shaft was rotated approximately 90° off nominal position.

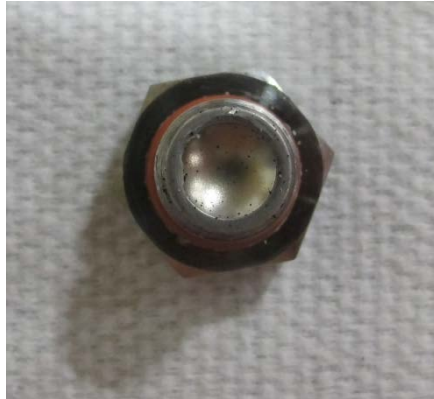
Figure 25 - Burst disc from RH regulator

The port labelled “4” on the cross had a (b) (4) burst disc installed. The O-ring was present and in good condition with no visible cuts or damage. The frangible face of the burst disc was intact, Figure 25.

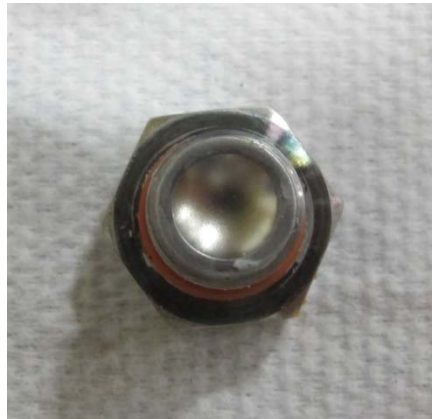
Figure 27 - Burst disc from LH regulator

The port labelled “4” on the cross had a (b) (4) burst disc installed. The O-ring was present and in good condition with no visible cuts or damage. The frangible face of the burst disc was intact, Figure 27.

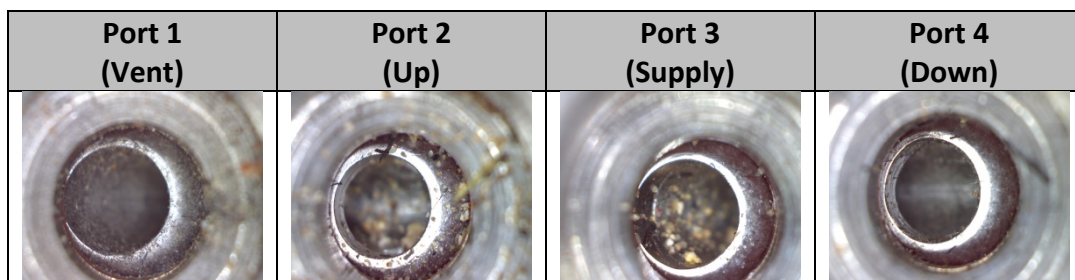
Figure 29 - Images showing position of valve ball for each port in the RH feather valve

Figure 29 contains images of the four ports showing the position and debris in each port as found during the examination.

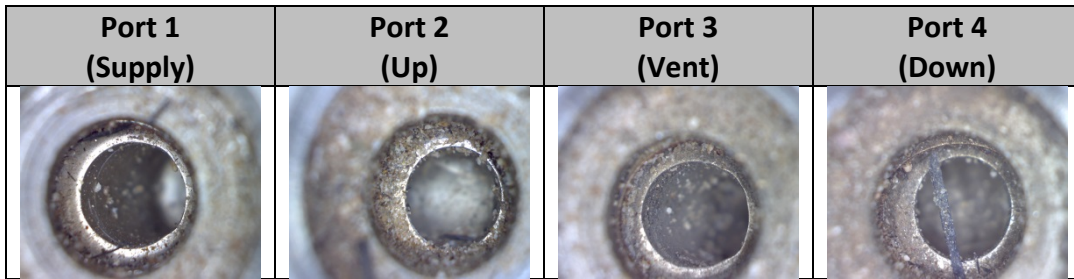
Figure 31 - Images showing position of valve ball for each port in the LH feather valve

Figure 31 contains images of the four ports showing the position and debris in each port as found during the examination.

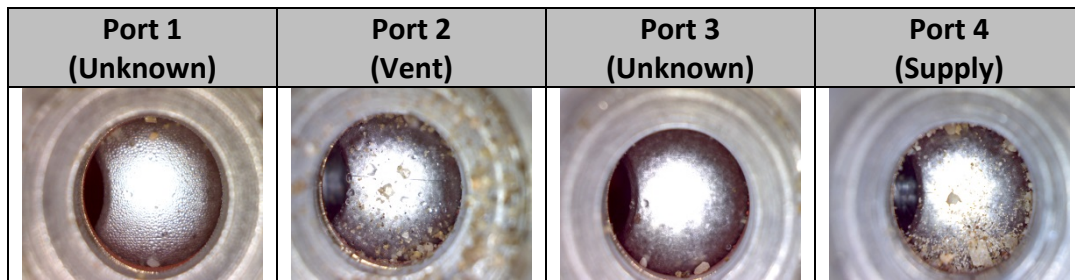
Figure 33 - Images showing position of valve ball for each port in the feather lock valve

Figure 33 contains images of the four ports showing the position and debris in each port as found during the examination.

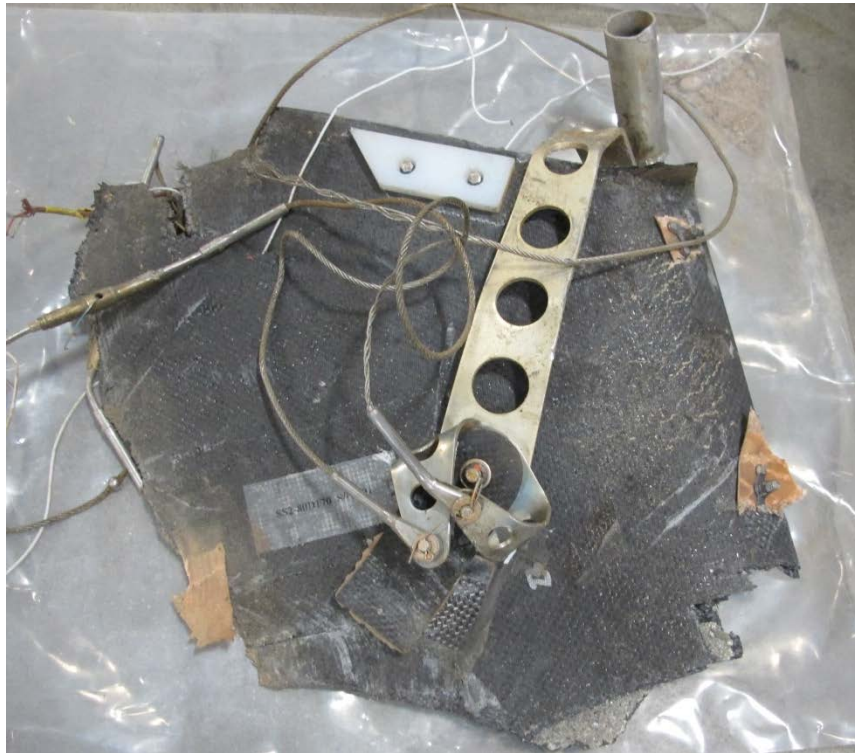
Figure 36 - LH feather unlock handle

The LH feather lock handle was found attached to a portion of the center pedestal structure, Figure 36. The handle was bent in an outboard direction at the structure. The handle was found in the lock position. The control cables that connect with the feather lock valve were also attached to the handle.
