NATIONAL TRANSPORTATION SAFETY BOARD

Factual Report of Systems Group Chairman

A. ACCIDENT: ERA15LA140
Location: Marco Island, FL
Date: March 1, 2015, 16:15 EST
Aircraft: Bombardier CL-600-2A12, N600NP¹

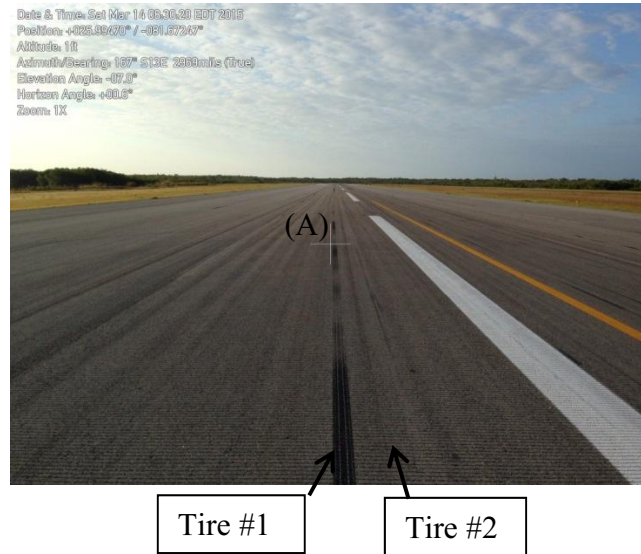
The Marco Island runway path of the airplane could be followed as damage to the off-runway surface and on-runway black rubber transfer marks from the resting position of the airplane to the area of landing. Following the black marks toward the arrival end of the runway, the tire markings merged into the overall black area of the runway which had been created by the landings of many airplanes. Photographs of the discernable tire paths closest to the arrival end of the runway revealed that the left two tires differed from the right two tires. The examination revealed black rubber transfers from three of the four tires, with little transfer from the #2 tire. (See Figure 1)

Figure 1. Rubber tire transfer marks on runway in direction of travel. Two individual rain grooves in the #1 tire transfer are visible at the bottom edge of the photo. The arrow denotes the path of the #2 tire and lack of black braking rubber transfer to the runway. The point (A) is detailed in Figure 2.

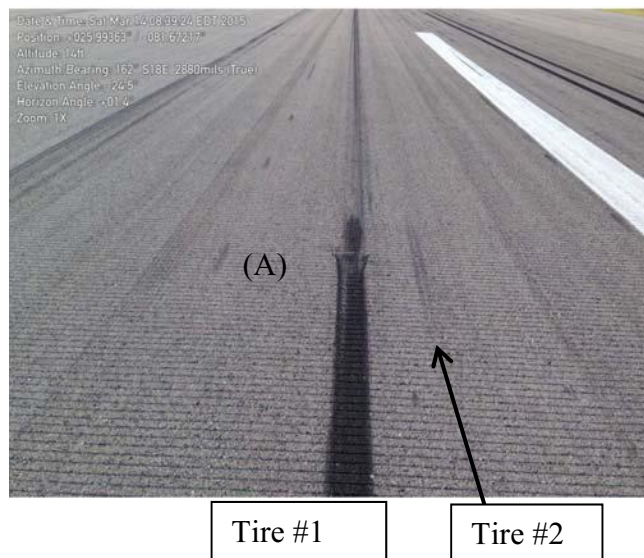
In the direction of travel, the #1 tire tread runway markings initially showed the drainage grooves in the tread, then a solid black width of the tire where the worn area was deeper than the grooves, followed by the end of the continuous tire mark where the tire shoulders moved apart, followed by flail marks (alternating dark/light) consistent with the deflated tire on the pavement. (See Figure 2)

Figure 2. View depicting the changes in rubber transfer marks from the #1 and #2 tires. The (A) corresponds with Figure 1. The mark in the #2 track is consistent with the airplane weight supported by tire #1 shifting to tire #2. At the bottom of

the photo the #1 tire rain grooves visible in Figure 1 no longer exist. The tire examination showed that the rain grooves remained in all but the flat spot of the tread where the cross-shaped blow out existed.

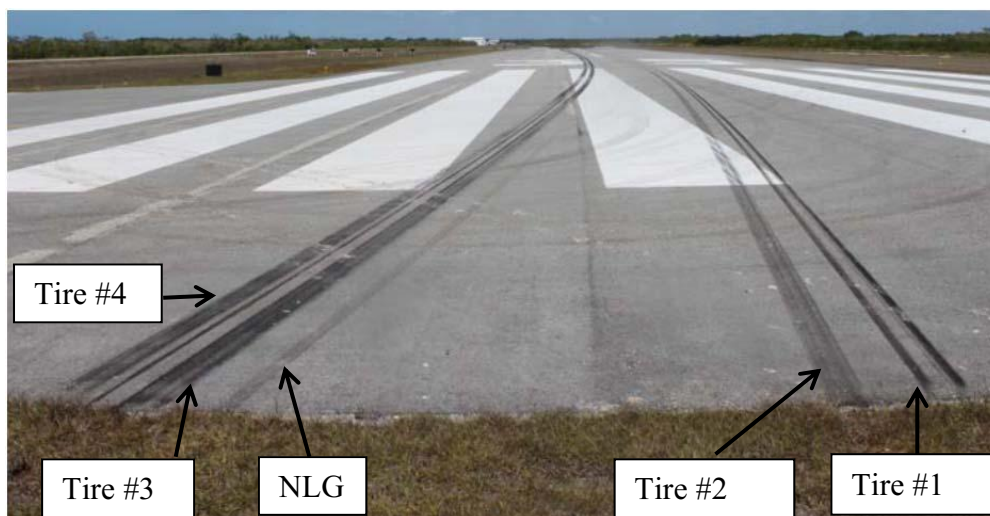
Tire #2 was the only tire which remained inflated and the rubber transfer from it at the departure end of the runway continued to be lighter than the marks made by the other tires. (See Figure 3) Tires #1 and #4 tire shoulder rubber transfers appeared as dark parallel lines on the runway, without rubber transfer from the centers of the treads, consistent with a lack of pressure. The Captain stated that “I applied full right rudder in an attempt to keep the airplane on solid ground.” Bombardier noted that the rubber transfer left by the nose landing gear tires indicated that the steering system was operational because the nose landing gear is designed to freely caster when inoperative, and that castering would not leave a rubber skid mark.

Figure 3. Marks made by all main landing gear tires at departure end of runway. Since this view is backward along the path, the marks are for Tire #4 at the left and Tire #1 at the right. Inboard of the #3 tire transfer was a rubber transfer that was consistent with the nose landing gear (NLG). Photograph provided by the IIC.

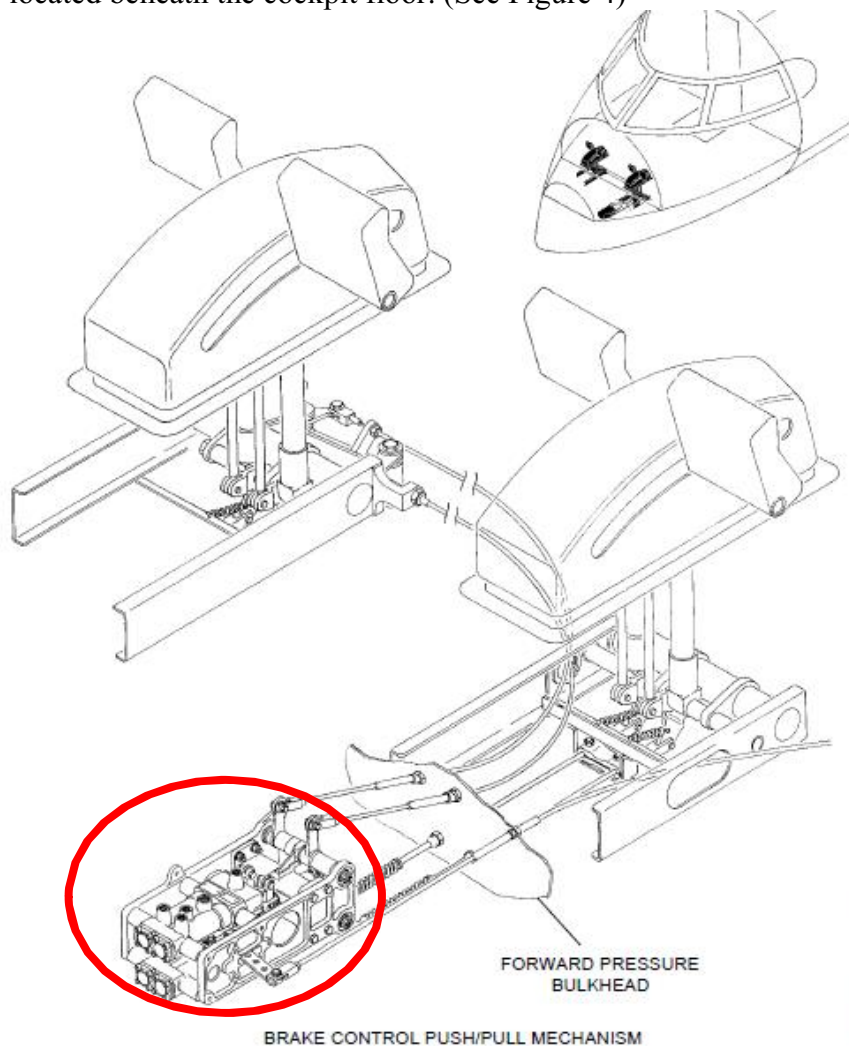
Figure 4. Airplane Maintenance Manual illustration shows location of the brake control components in the nose of the airplane. The broken spring was on one of the two brake control valves in the circle. Specifically, Bombardier noted that the broken spring was on the upper outboard brake control valve, controlling the inboard left (#2) brake. The #3 hydraulic system supplies the left and right inboard brakes and the #2 hydraulic system supplies the outboard brakes.

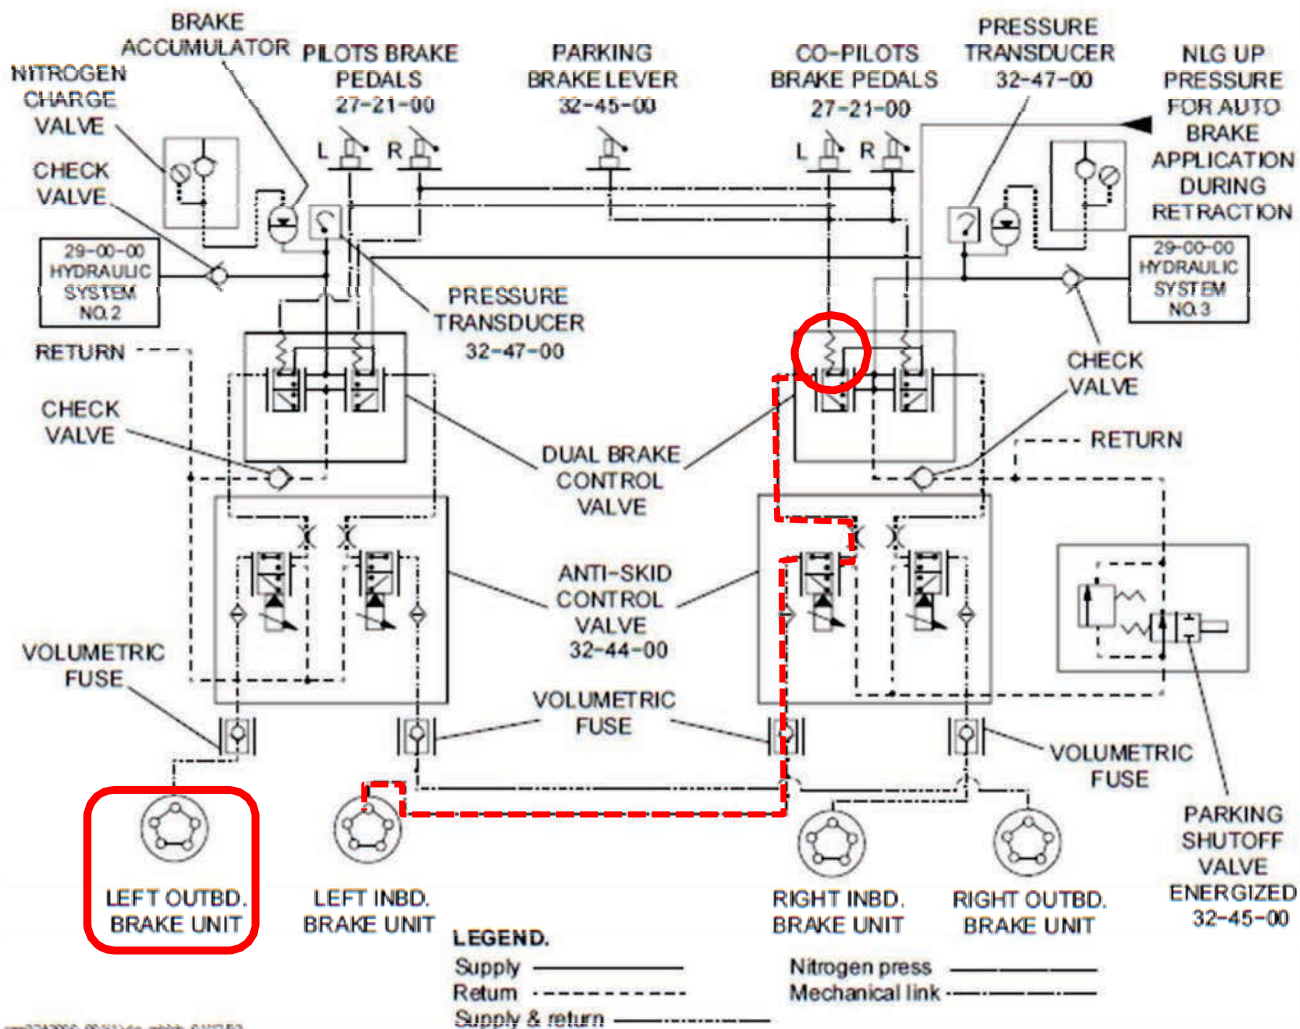
Figure 5. Airplane Maintenance Manual functional schematic of the braking system. The spring found broken is circled. The route from the dual brake control valve to the left inboard brake unit is a dashed line. Separately, the square in the lower left was the location of the broken plastic anti-skid coupling.

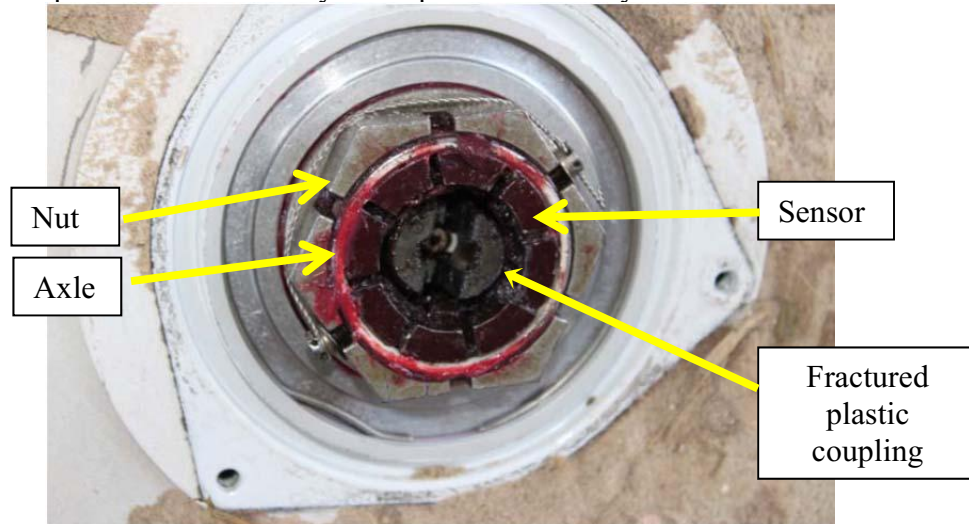
The on-site testing found that the #3 and #4 wheel anti-skid systems functioned, as did the #2 WSS when installed into the #3 position. A fracture in the #1 anti-skid WSS plastic coupling was visible when the hubcap was removed by the IIC in Florida. The fracture was confirmed by the Systems Group Chairman at the NTSB Laboratory and submitted for examination of the fracture details, which are the subject of an attached report. (See Figures 8 and 8A) The #3 WSS was installed in the #1 position and the #1 system operated normally.

Figure 8. The #1 wheelspeed sensor (WSS) in axle, prior to removal, with visible break in plastic coupling. Photo provided by IIC.

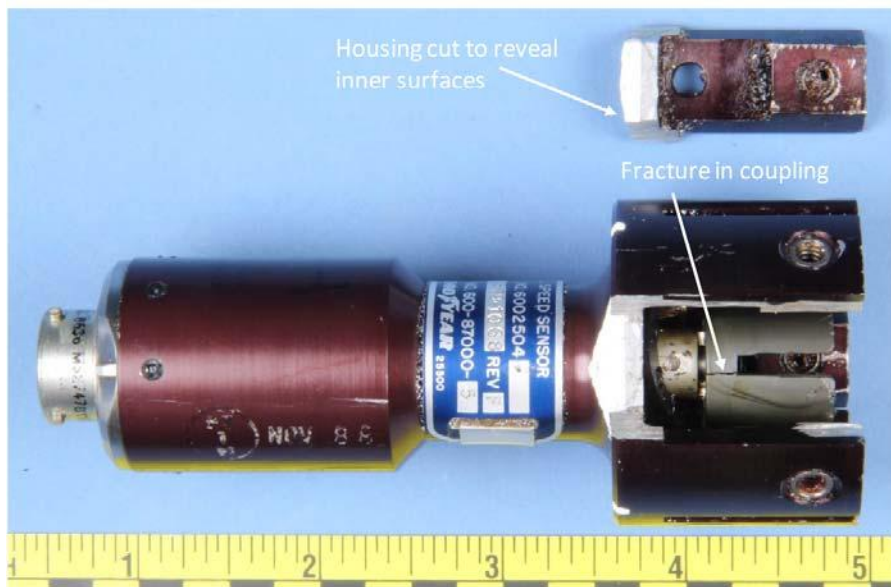
Figure 8A. Wheel speed sensor at NTSB Materials Laboratory after being cut by Systems Group Chairman, showing fracture in coupling.

Small spiral-nails which had secured the plastic had backed out, allowing the coupler to rotate independently of the shaft. To remove the plastic coupling required cutting the end of the sensor. The plastic part was submitted to the NTSB Materials Laboratory for examination of the fracture and the body of the sensor was sent to the manufacturer for testing of the electrical portion with oversight delegated to the FAA. The #1 wheel speed sensor functioned after the manufacturer created a temporary adapter to take the place of the plastic coupling.

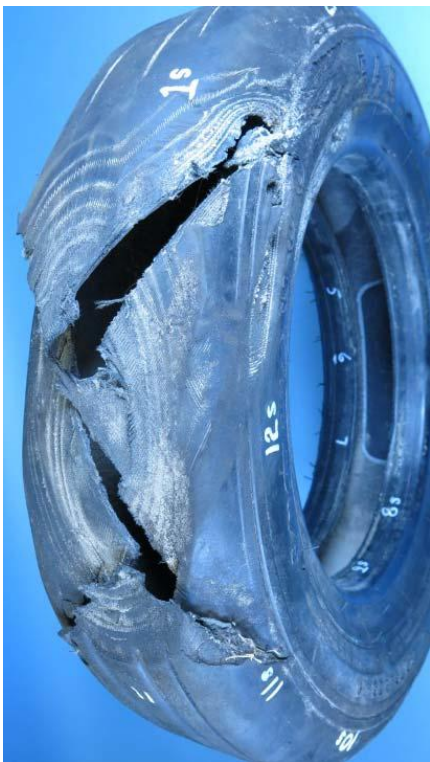
The #1 (outboard left) main landing gear tire strongly resembled the Michelin example with a flat spot through the tread and casing of the tire which had an X-shaped tear through the plies at the center which had not been ground away. (Figures 11 through 13) The tear was consistent with rupture of the inner bladder by release of pressure. Detailed examination of the #1 tire revealed no evidence of operation at low pressure, pre-existing damage, or of manufacturing defects. The tire also had a tear/cut to a hole at the edge of the flat-spotted area.

Figure 12. Oblique view of flat spot on Tire #1, showing serialized shoulder. Note numbering added for

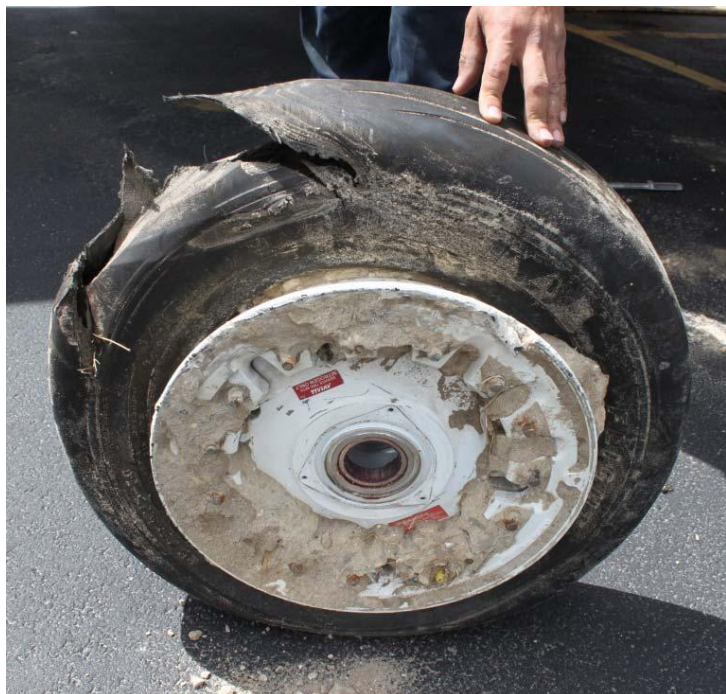
Figure 13. #1 tire on wheel, as recovered. Photo provided by Investigator in Charge.

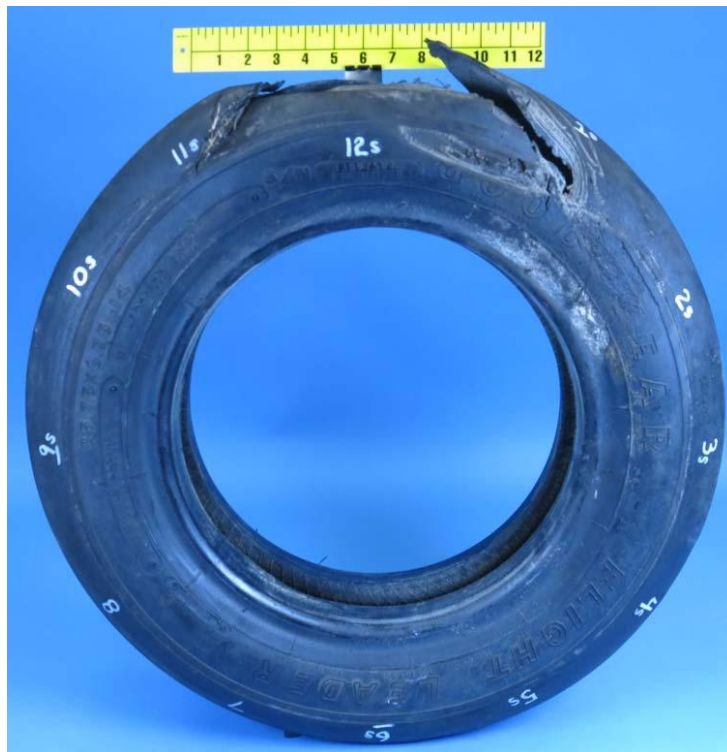
The X-patterned tear through the flat area was used as the 12 o'clock orientation to mark the tire sidewalls and tread. The orientations include a lower-case "s" on the sidewall marked with the serial number. For example, "12s" was marked on the serialized sidewall at the center of the flat spot and "12" was marked on the non-serialized sidewall. As mounted on the airplane, the serialized sidewall had been oriented outboard and to the left, away from the airplane so that the serialized numbers would contact the ground in order as the airplane rolled forward. (1s, then 2s, then 3s, etc.) (See Figures 12, 14, and 15)

Figure 14. Tire with markings and scale in inches at NTSB laboratory.

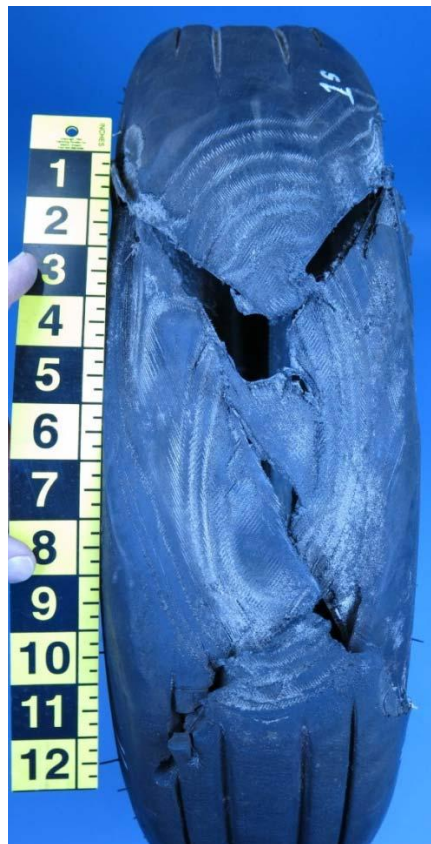
Over a length of 11.5 inches, from 11 o’clock to 1 o’clock, the tread was worn through in the flat spot, exposing the inner liner. The serialized sidewall folded under the tread and the sidewall had chafed through near the marking 1s, extending to the mark 2s. (See Figure 15) Minor sidewall folding flexure marks were found limited to the portion of the sidewalls centered on the X-shaped damage, from about 3 to 8 o’clock. Grass was found caught in the sidewall tears at the markings 1 and 1s.

Figure 15. Direct photo of flat spot centered on tread. The 1 o’clock orientation is at top.

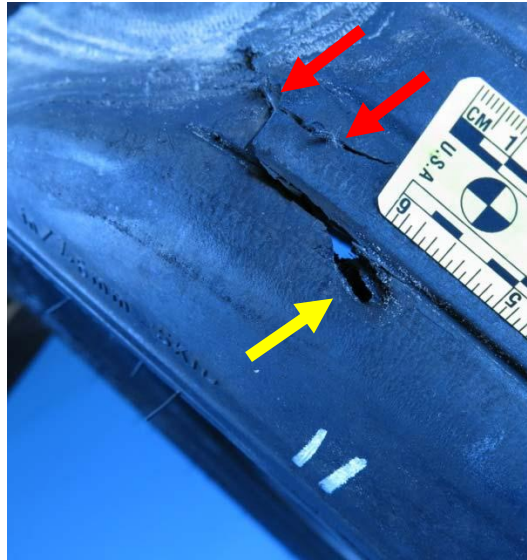
A sharp-edged circular hole of about slightly more than quarter-inch diameter was found at the end of the X-shape nearest near the 11 o'clock marking. The wheel flange was subsequently found to have about the same lateral distance from center, straightness of cut/tear toward X-shaped damage, parallel nature of the cut/tear with the wheel flange, and approximate diameter of the hole. (See Figures 16 and 17)

Figure 16. Hole in tread. (See yellow arrow from left) Material displaced outward is above the hole. (See red arrows from right) As installed, the tire would roll toward the camera.

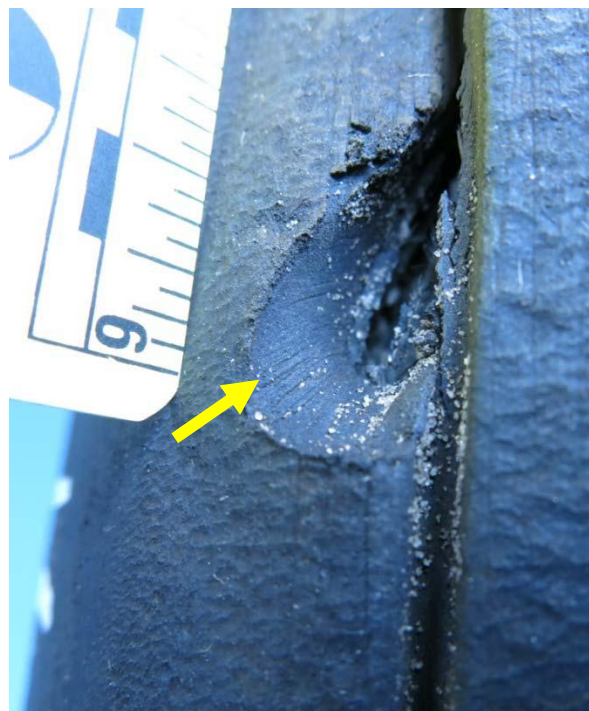
Figure 17. Detail of hole, showing striations. (arrow)

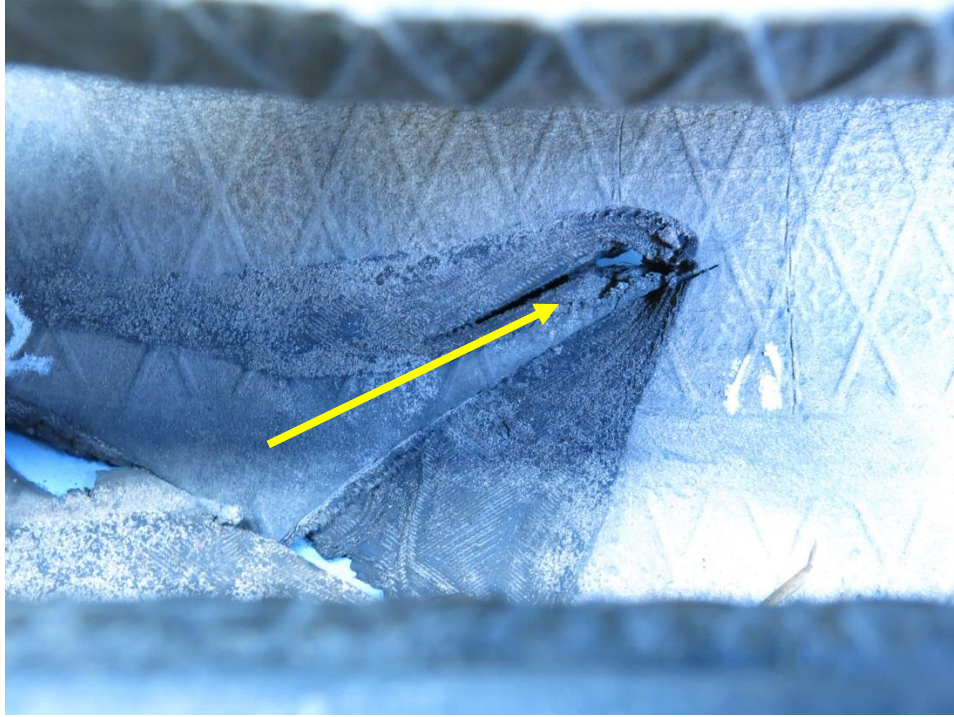
The circular portion of rubber was missing at this location aligned on the interior of the tire with a missing conical portion of material. At the center, the plies were displaced inward and covered by a tongue of bladder material. The interior of the tire had a straight tear or cut from the hole to the end of the X-shaped tear. (See Figures 18 and 19)

Figure 18. Interior of tire at hole, showing conical loss of plies radiating out from the hole and straightness of cut/tear toward X-shaped damage. The tongue of liner material overlays the missing material from the lower left, and inward ply damage is visible at the tip of the tongue. (The yellow arrow is oriented on tongue from base toward tip and points at the inward ply damage.)

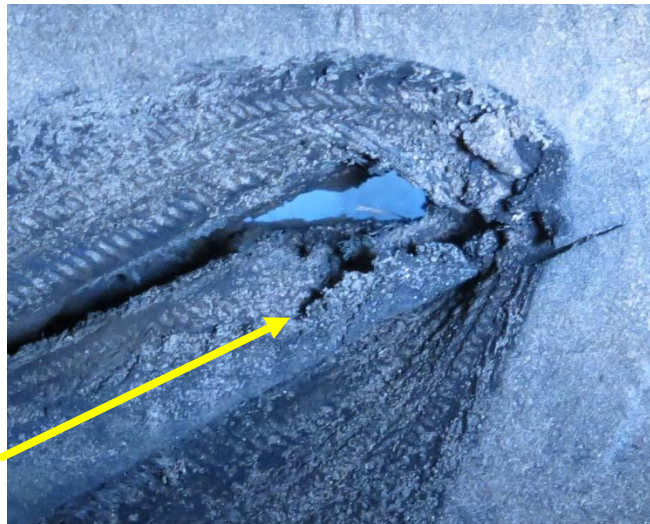
Figure 19. Detail of damage at tip of tongue in Figure 7. Note inward tear of flap at tip of arrow on tongue.

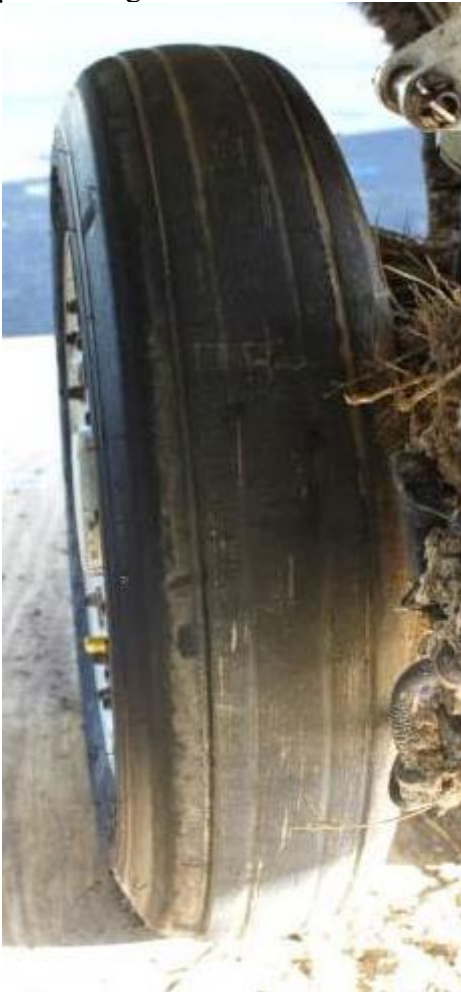
The #2 tire was found within inflation pressure limits and had tread remaining.¹⁷ It had cuts and other damage consistent with operation off of the paved runway surface and did not have the flat spots through the tread found in the other three tires.

Figure 20. The tread of the #2 main landing gear tire. (Image brightness increased for visibility)

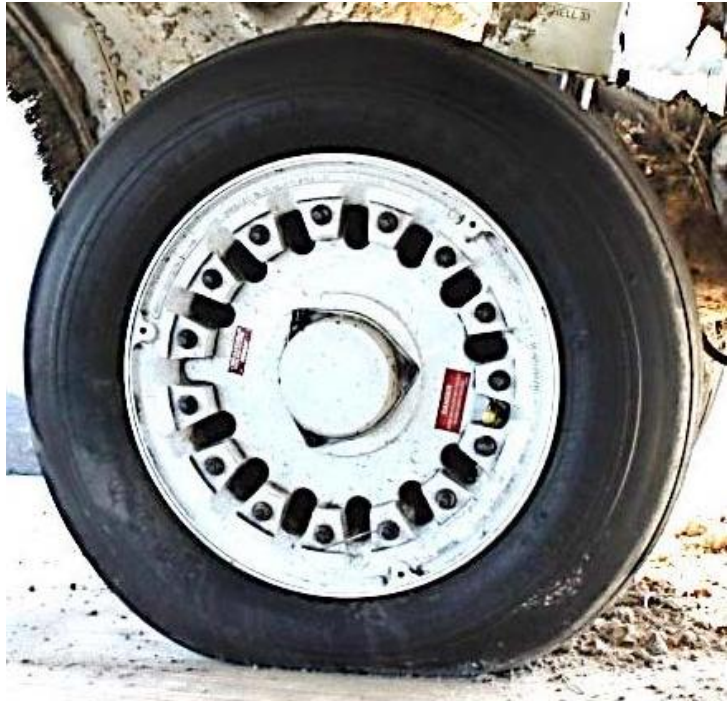
Figure 21. Sidewall of the #2 main landing gear tire. (Image brightness increased for visibility)

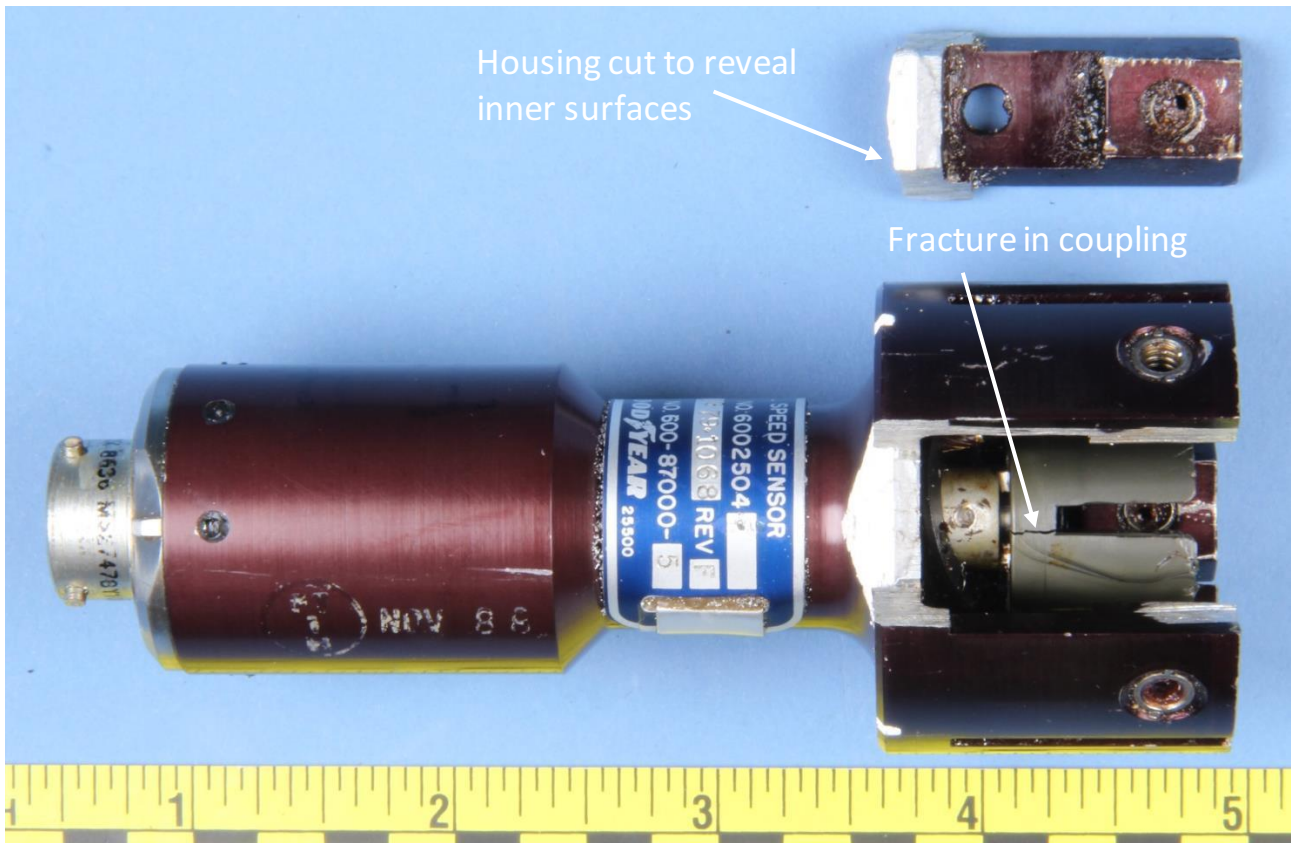
Figure 1 Side view of the wheel speed transmitter. A portion of the housing was removed to reveal the coupling. A fracture in the coupling is identified.

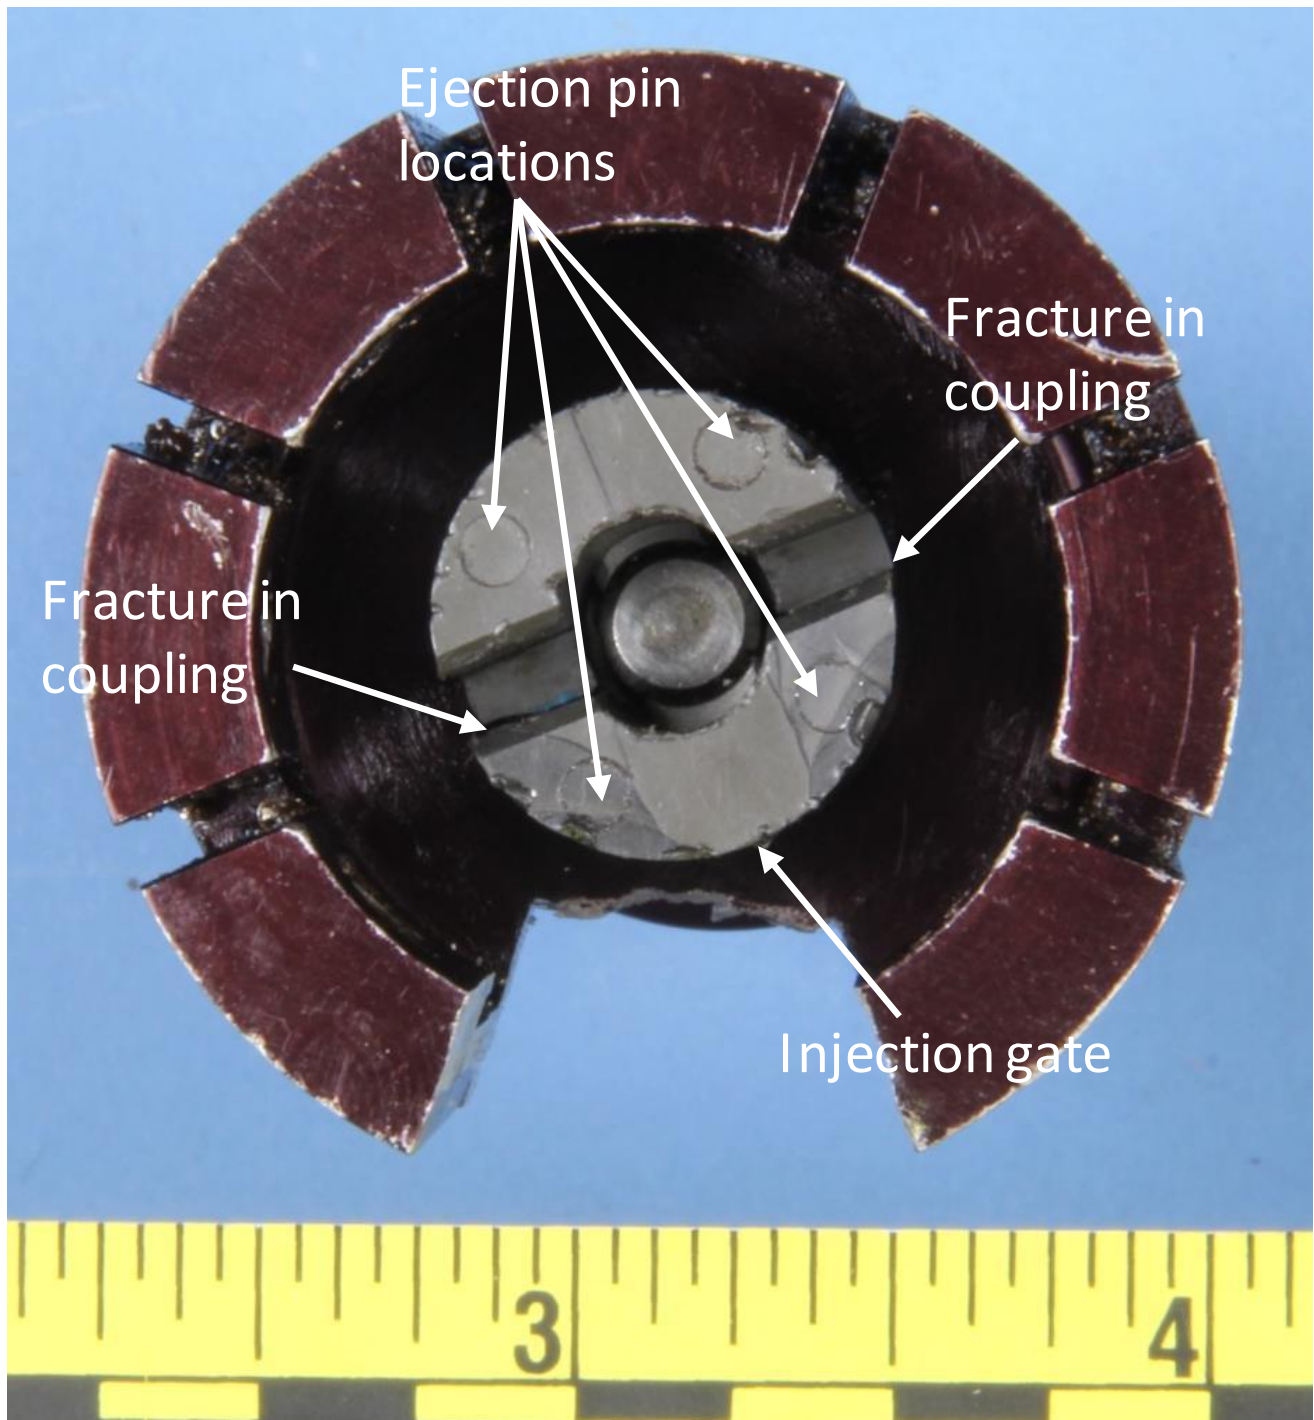
Figure 2 Top view of the wheel speed transmitter showing the fractured coupling in place. The fractures are identified as well as the location of the injection molding gate and the ejection pin locations.

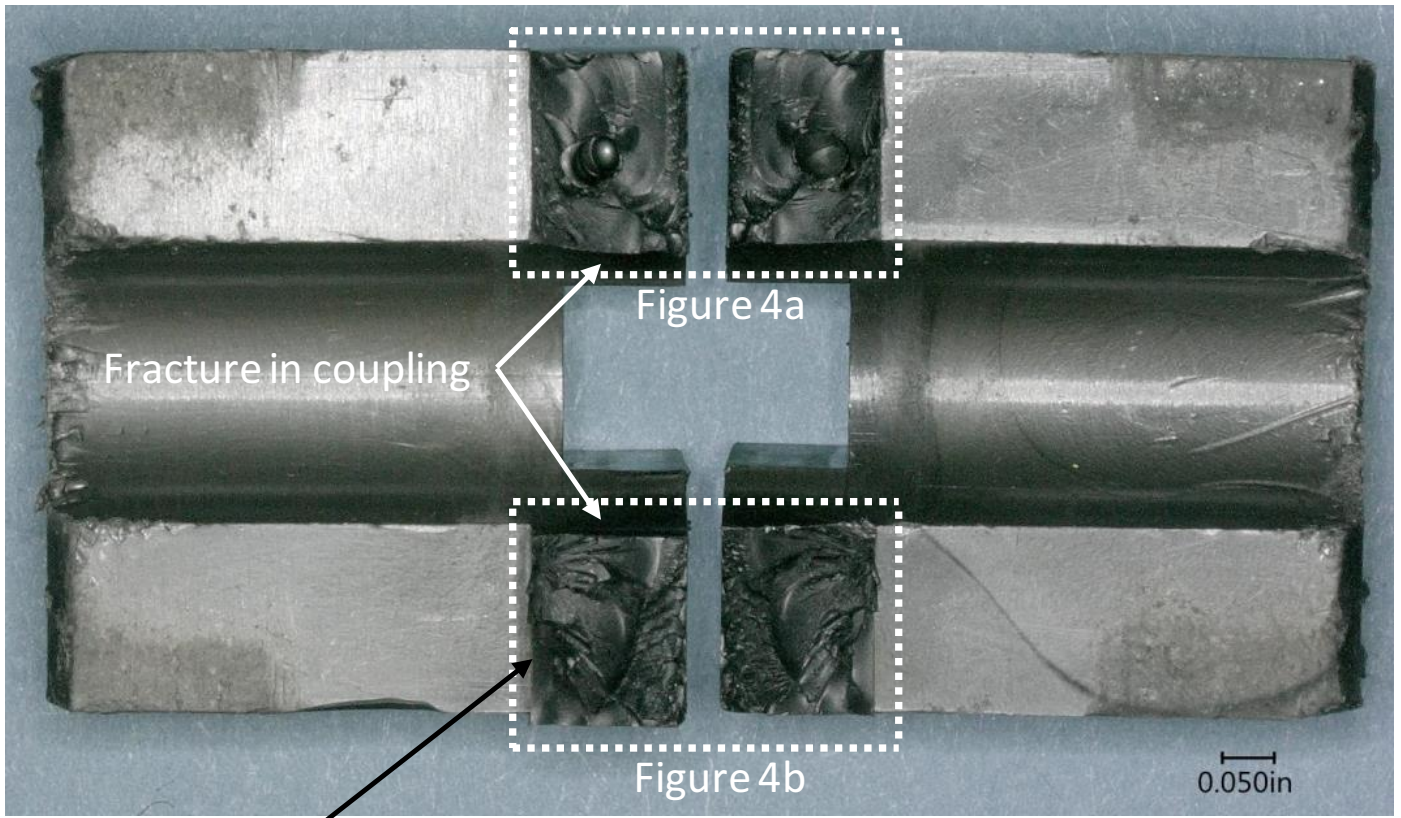
Figure 3 Image showing the two halves of the fractured coupling. Closer views of the fractures surfaces are depicted in Figure 4.

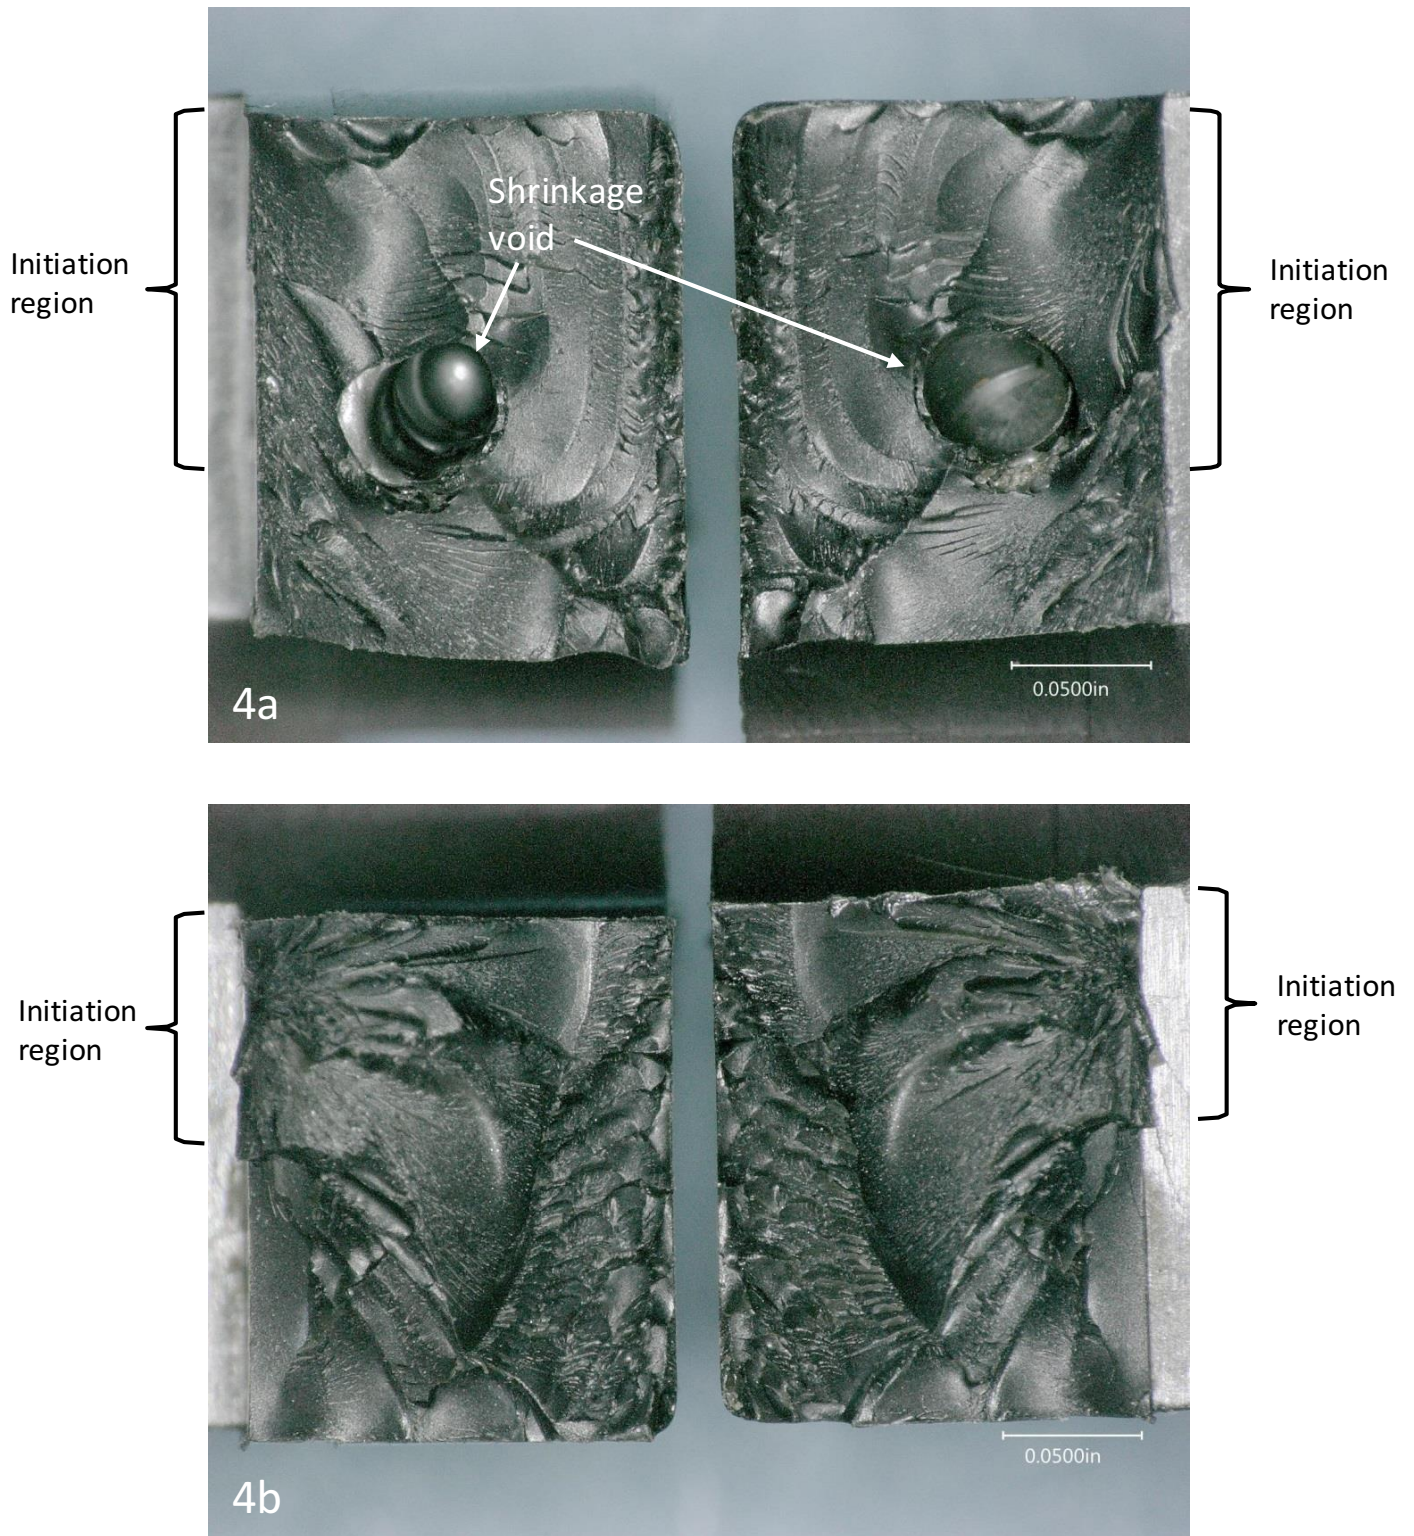
Figure 4 Closer views of the fracture surfaces on the coupling in Figure 3.

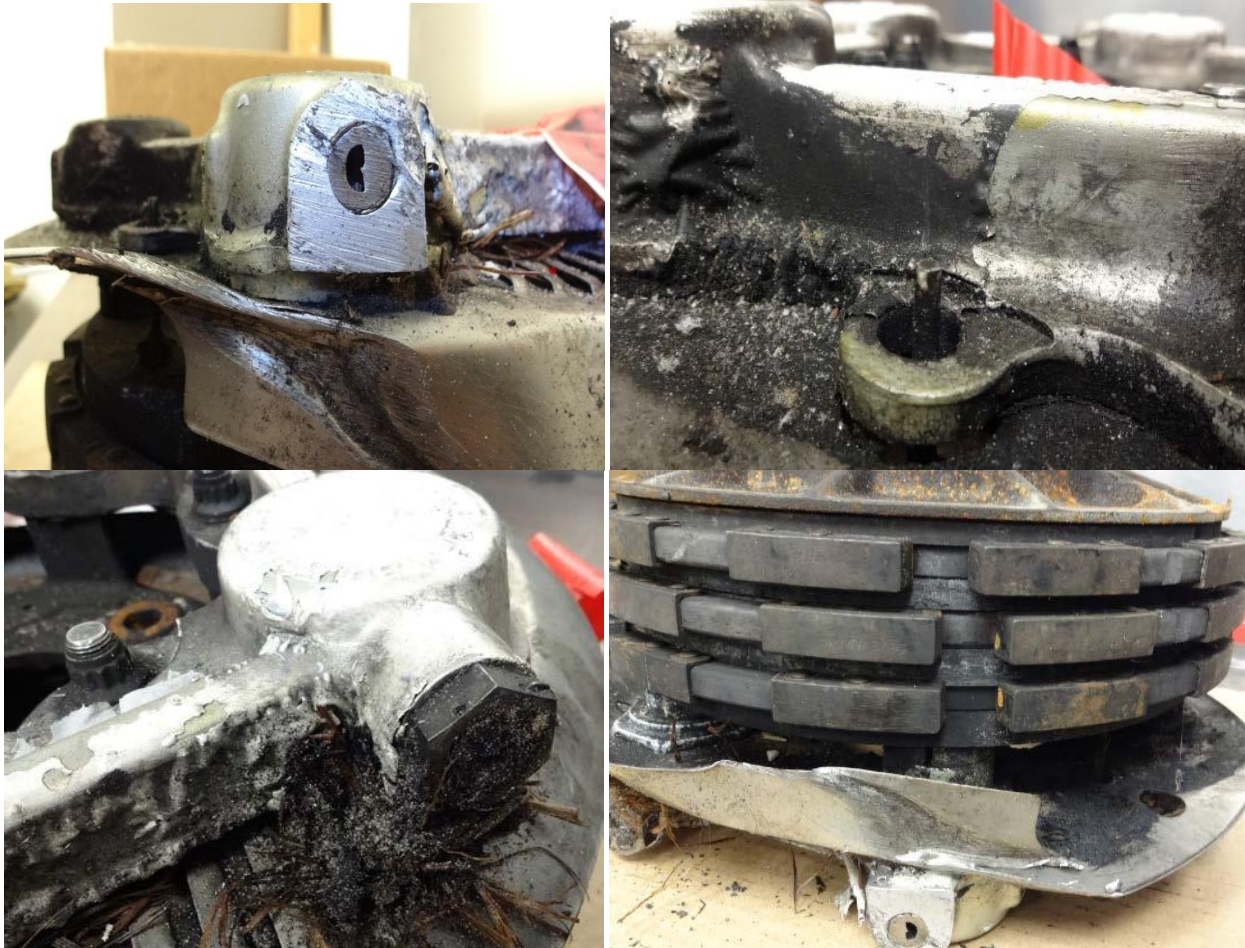
A visual inspection of the brake assembly took place. Serial Number MAY82-814 had considerable damage to the water shield and at one port of the housing. The housing was damaged enough to not allow the brake to be pressurized to validate function.

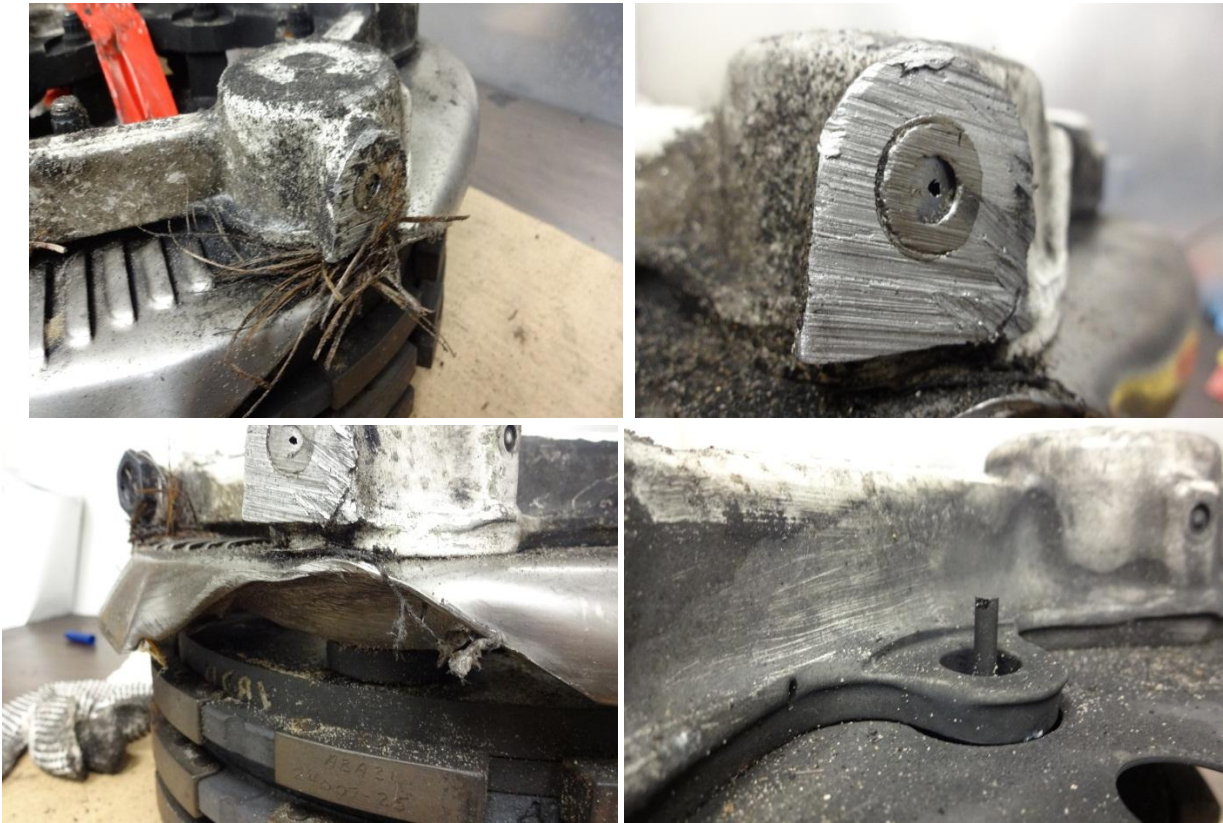
A similar visual inspection of brake #4 took place. Serial Number OCT81-84 showed similar damage to that of brake #3. Again, there was considerable damage to the water shield and at one housing port location. The housing was damaged enough to not allow the brake to be pressurized.

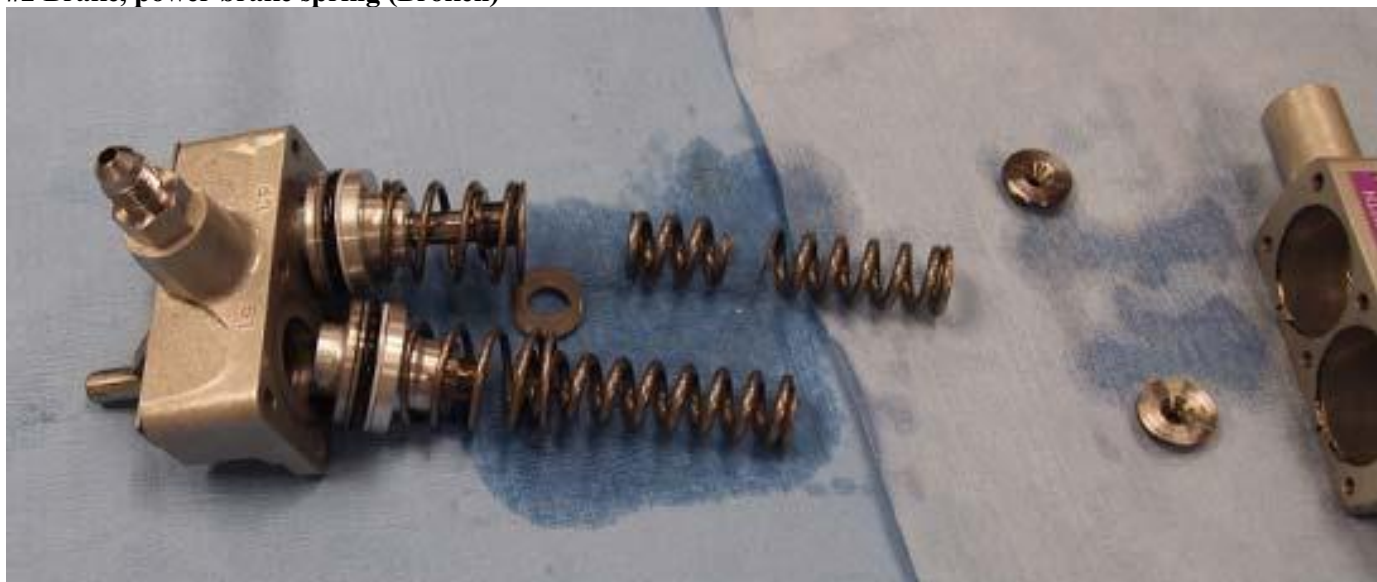
#2 Brake, power brake spring (Broken)

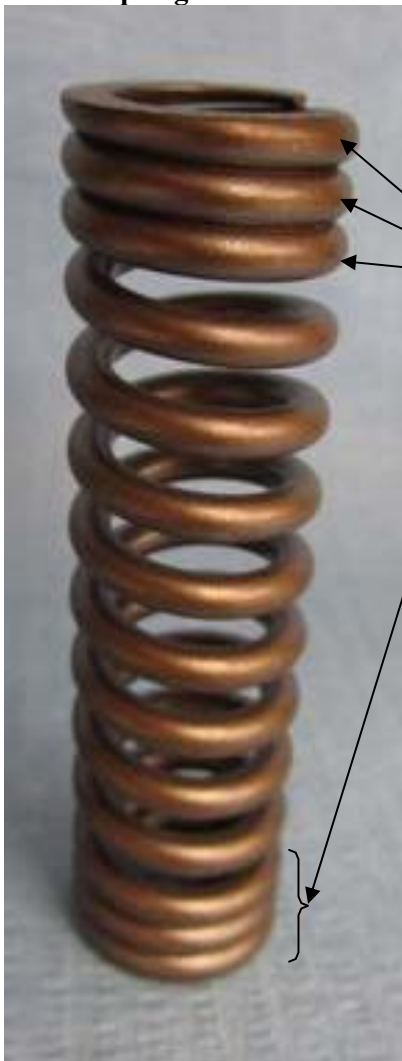
#4 New Spring

The P/N of the “new” spring design (with additional dead coils) is the same P/N as the broken spring discovered in the investigation unit.

Design change to incorporate three (3) dead coils on each end of the spring.
