TP 185E  
Issue 4/2006

# AVIATION SAFETY LETTER

## Post-Accident Survivability—Direct-to-Airframe Helmet Cord Connections

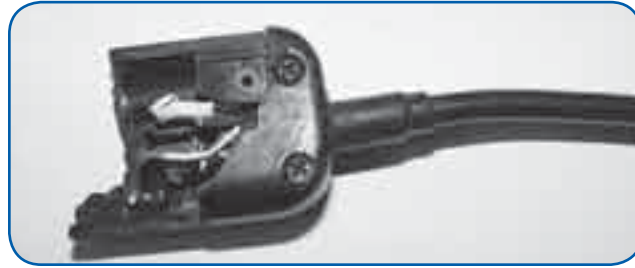
On December 7, 2005, an MBB-BO105 helicopter was operating near Marystown, N.L. The helicopter was observed flying along the shoreline, at low altitude, in snow, and in darkening conditions. The helicopter struck the water about 1 000 ft from shore, and sank to the bottom of Mortier Bay. The pilot and passenger escaped from the helicopter; however, they later perished in the frigid water. The TSB investigation into this accident (A05A0155) is ongoing. After the accident, an examination of the pilot's aviation helmet found that the end fitting of the communication cord was fractured at the point where it attaches to the helicopter (see Figure 1).

*Figure 1. Fractured cord end fitting*

The communication cords for front-seat occupants connect to receptacles located on the overhead center console. When the helicopter was recovered, the metal pins from the end fitting were still inside the receptacle. Metal remnants from the connection show that the cord was being pulled sideways, towards the pilot's door, when the fracture occurred. A downward pull is required to release the connection. A break test of a similar fitting required a 70-lb pull before the cord failed. After ditching or water impact, the occupants of a capsized helicopter are prone to disorientation. Therefore, unimpeded egress through any available exit is vital to survival. An attached communication cord that will not release cleanly may impede this egress.

Other operators may have aircraft with similar direct-to-airframe connections, and may be unaware that these can impede egress in an emergency. Therefore, Transport Canada may wish to advise the aviation community that these connection types may impede egress, and that an intermediate cord can help to mitigate this hazard.

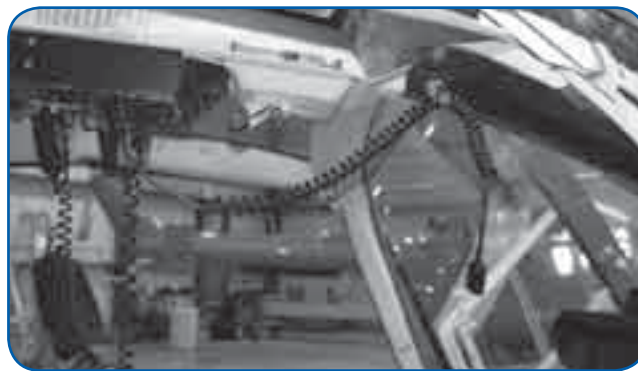
In the past, similar BO-105 helicopters have been fitted with an intermediate “pig-tail” communication cord for helmet connections. Instead of plugging the helmet cord into the helicopter's receptacle, the helmet cord is instead plugged into this intermediate cord (see Figure 2).

The helmet connection plug can release cleanly from the intermediate “pig-tail” cord receptacle as it is pulled in the direction of travel during egress. Over a period of years, the use of the intermediate helmet cords at this operator declined, perhaps because pilots were not aware that the cords ensure separation in an emergency. However, since this accident, the operator has indicated that the use of intermediate “pig-tail” cords for helmet connections will now be re-instituted where necessary.

*Figure 2. Intermediate helmet “pig tail” connection cords*
