TWA Flight 800 Missile Impact Analysis

by
Richard Bott
Survivability Division
Systems Engineering Department

DECEMBER 1997

NAWCWPNS TM 8126

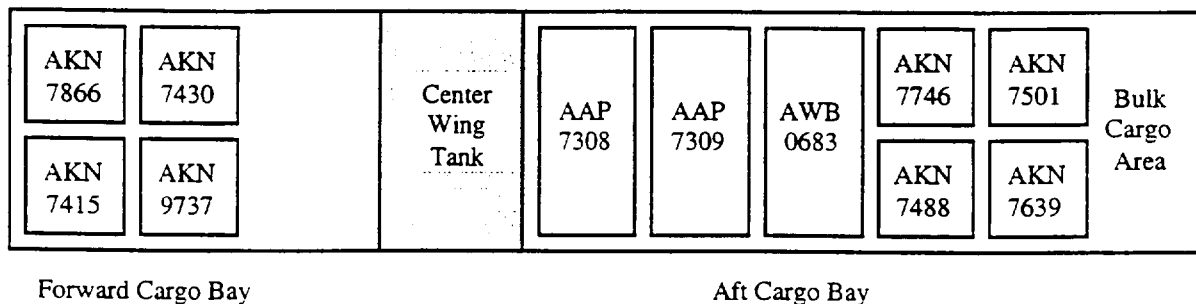
FIGURE 1. Cargo Container Locations on TWA Flight 800.

Four baggage containers were located in the forward cargo compartment of TWA Flight 800. A diagram of all container locations is shown in Figure 1. The two containers on the left side of the aircraft, AKN7415 and AKN9737, were recovered in the red debris field and were not severely damaged. Both containers have virtually all sides intact, and the damage is consistent with water impact.

The two containers on the right side of the forward cargo hold, AKN7866 and AKN7430, were recovered in the yellow debris field. These containers are more severely damaged, but the majority have been recovered and reconstructed. The damage also appears to be attributable to water impact.

Seven baggage containers were in the aft cargo hold of TWA Flight 800. All containers were severely damaged and similar in appearance to each other. The nature and similarity of the damage to all aft containers are consistent with water impact. The only exception is a single baggage container, AWB0683, constructed of fiberglass reinforced plastic rather than aluminum, that shattered. This failure mode is typical of its more brittle construction and still consistent with water impact.

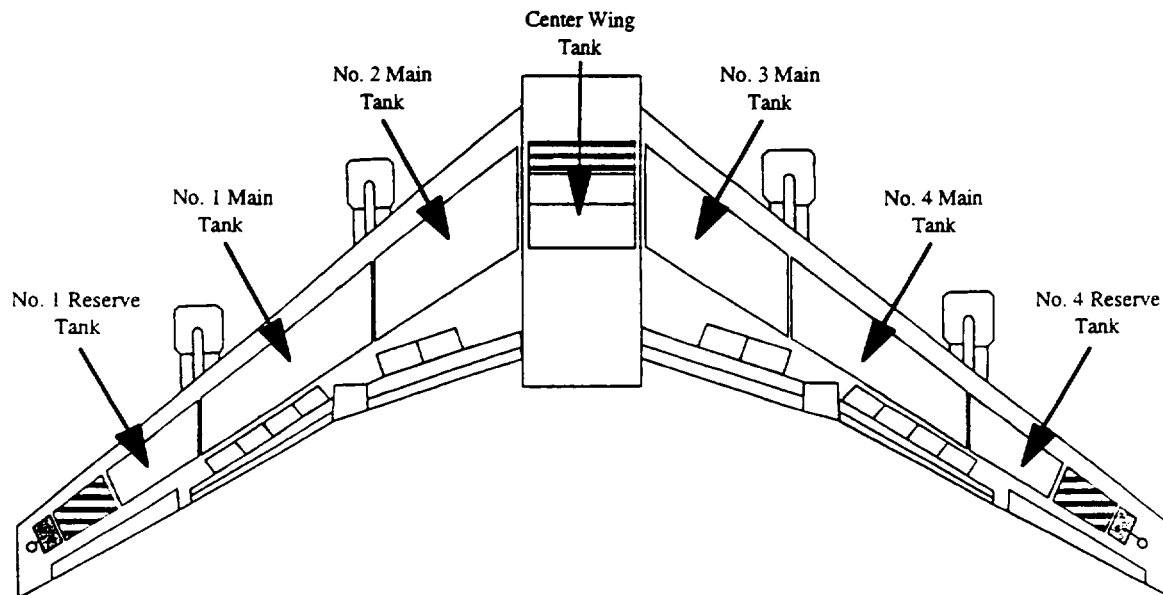
FIGURE 2. Boeing 747-100 Fuel Tank Arrangement.

The thickest part of the wing fuel tanks are at the fuselage where the number 2 and number 3 main tanks butt up against the center wing tank. A schematic of the 747 wing fuel

tanks is shown in Figure 2. The kinetic energy of the missile body and the explosive energy of the detonating warhead would create a significant hydrodynamic ram event that could cause severe damage to one or more of the following structures even though the possibility exists that warhead fragmentation damage would not occur:

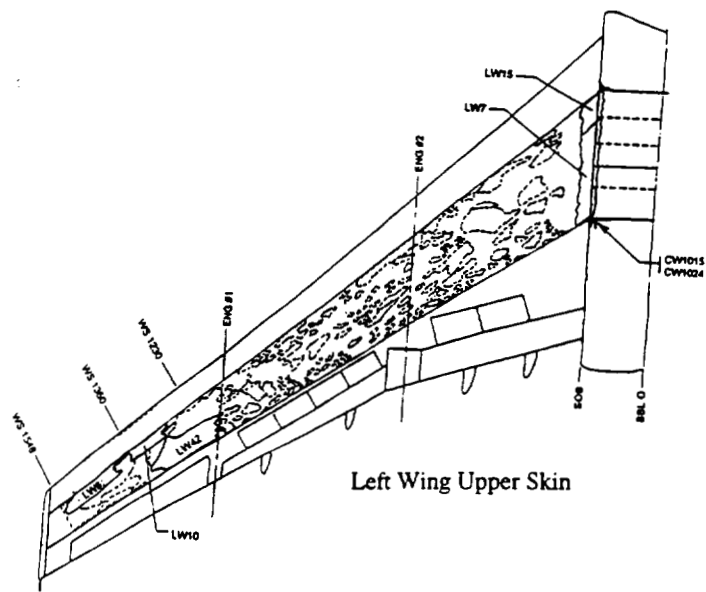
Left Wing Upper Skin

Detailed examinations of the TWA Flight 800 wing fuel tanks were conducted. The left upper wing skin, the left side-of-body rib, and the left leading-edge spar exhibit different and more severe damage from their right wing counterparts. Figures 3, 4, and 5 show comparisons of the damage to the upper wing skins, side-of-body ribs, and inboard leading-edge spars, respectively. Close inspections of the wreckage in these areas revealed no evidence of penetrations by foreign objects and no high-velocity fragment damage consistent with a missile impact. NTSB and FBI documentation support these findings (References 3 and 4).

Some unexplained damage characteristics on these structures have puzzled investigators, for example, the severe shattering of the left wing upper skin. While the damage mechanisms involved may not be completely understood, the recovery and reconstruction of TWA Flight 800 is the most comprehensive undertaking of its type ever made. This wing damage may be typical for severe water impacts but has gone unnoticed in previous mishaps due to the lack of recovery and reconstruction of debris. Further, the left and right wings of TWA Flight 800 impacted the water in different attitudes, as evidenced by the damage to the engines, which may explain the disparity in damage between the two structures. These damage characteristics are not deemed characteristic of a missile impact, but without validating test data this conclusion cannot be made with 100% certainty.

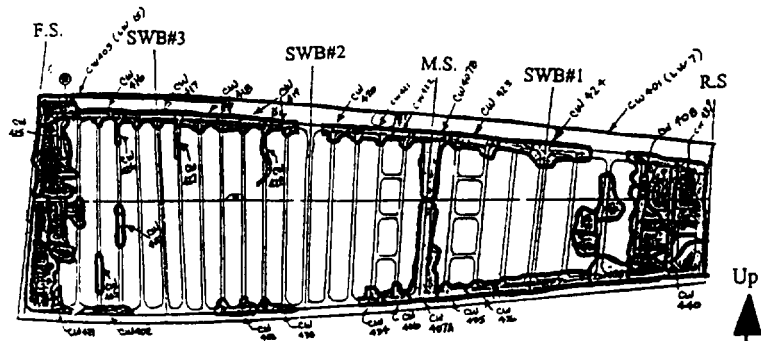
Left Side-of-Body Rib

Note: Numerous small pieces cannot be placed.
