National Transportation Safety Board
Washington, D.C. 20594

Tank Car Performance Factual Report

Carrier: CSX Transportation
Train No.: M 30381 06
Location: Mount Carbon, West Virginia
Date/Time: February 16, 2015, 1:15 p.m. EST
NTSB No.: DCA15FR005

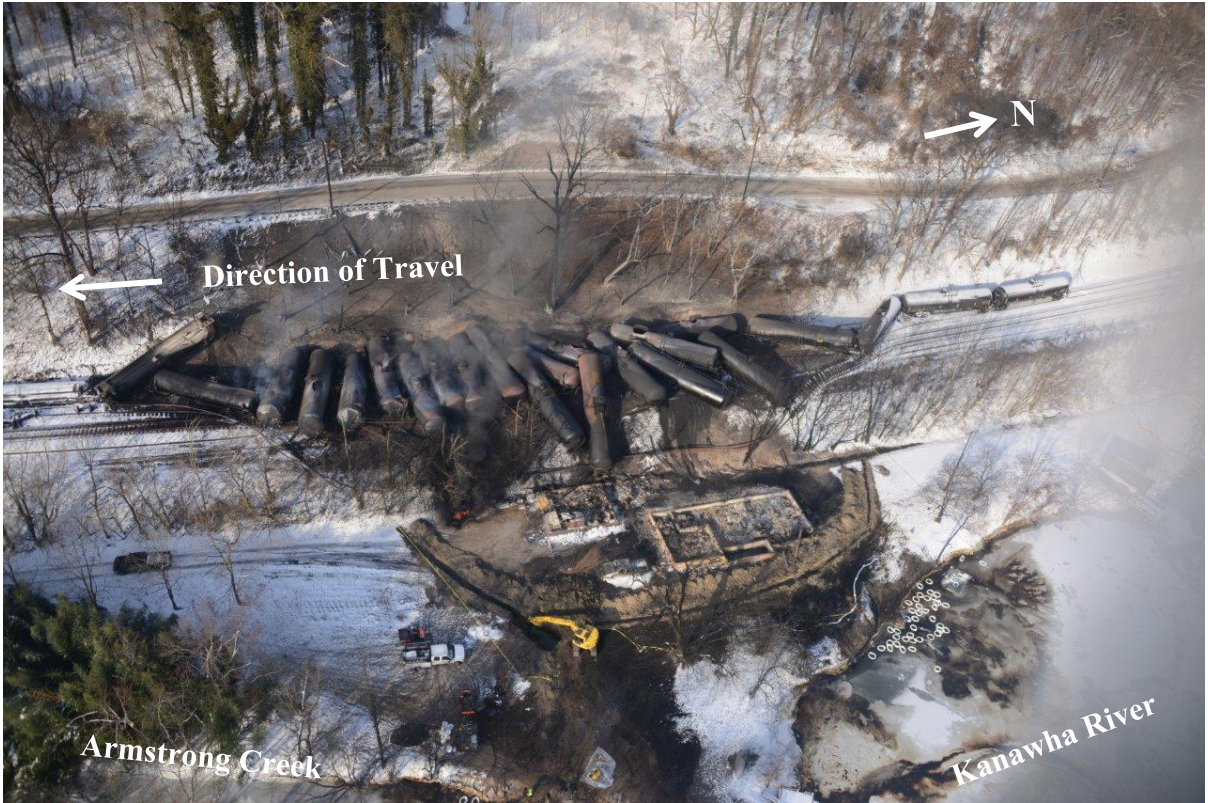
Figure 1: Aerial view of the derailment scene, February 18, 2015.¹

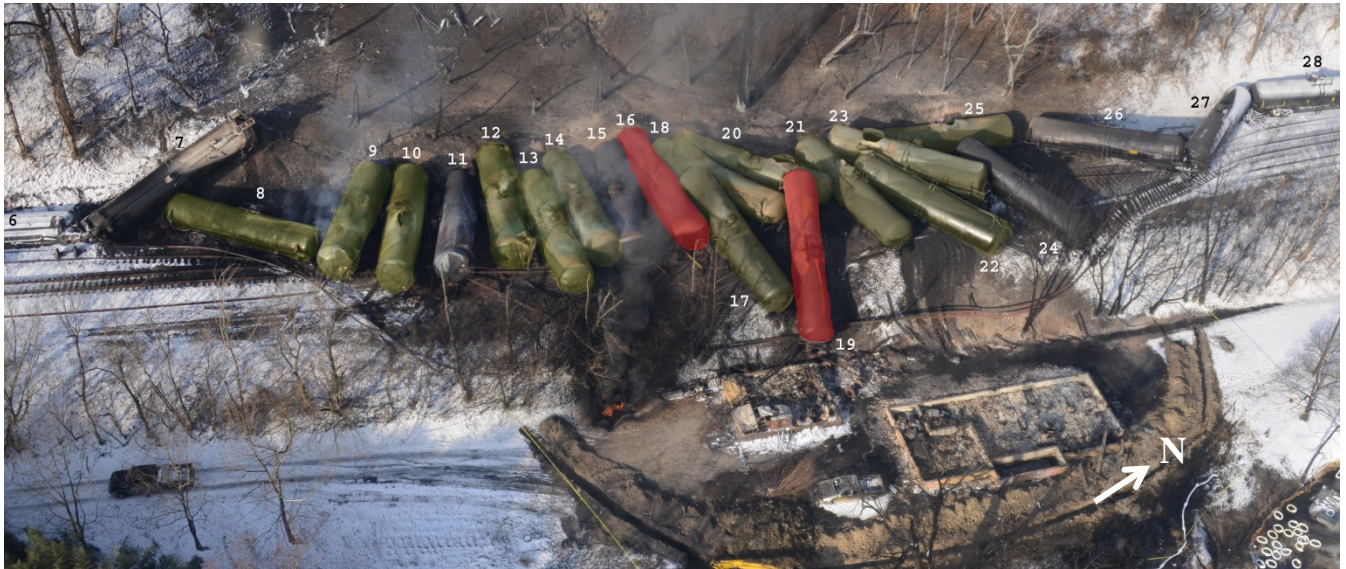
indication of the size and geometry of the pool fire that engulfed the derailed tank cars between lines 8 and 25 of the consist (see Figure 3).

Figure 3 provides a labeled aerial photograph of the derailment scene indicating the line positions of each derailed car in the consist. In this figure, two (2) cars that released crude oil lading from puncture damage are highlighted in red, while 13 cars that sustained thermal tears in their tank shells are highlighted in green. Four (4) that are not highlighted in the figure released product from valves and fittings. For one car (number 24), the mechanism of release could not be determined.

Figure 3: Tank car locations. Punctured cars are highlighted in red, cars with thermal tears are highlighted in green. (Courtesy Federal Railroad Administration, February 18, 2015)

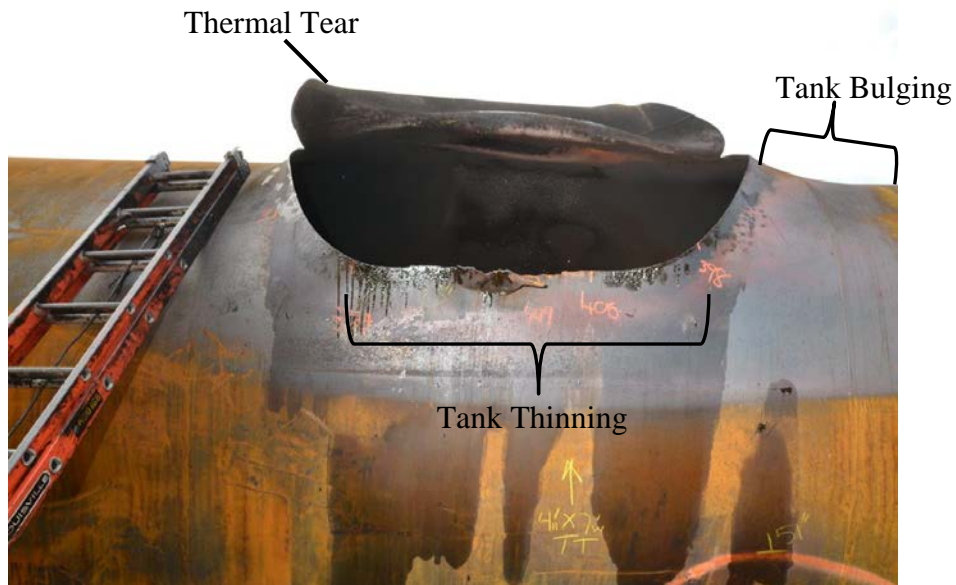
Investigators found consistent evidence of shell material thinning and bulging from overpressure in the vicinity of the thermal tears in the vapor space of tank cars that experienced thermal tears. Larger thermal tears (line numbers 9, 10, 12, 18, 20, 21, 23, and 25) were characterized as longitudinally-oriented breaches in the vapor space of the tank shell with flaps of steel peeled outward from the tank (see Figures 4 and 5). Smaller thermal tears (line numbers 8, 13, 14, 17, and 22) appeared as a longitudinal split in the shell material with little evidence of energetic release (see Figure 6).

Figure 4: Tank car CBTX 741946 thermal shell tear surrounded by bulging and thinning shell.

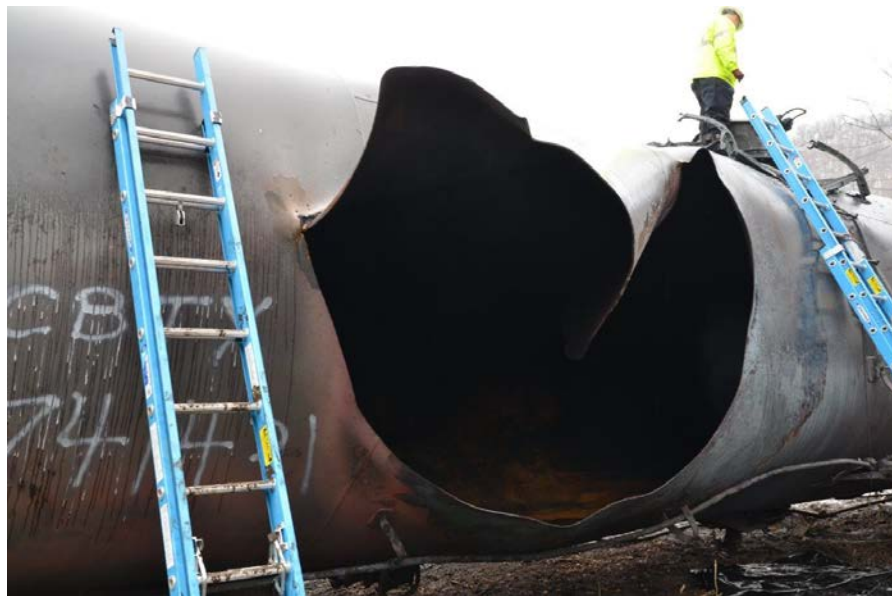
Figure 5: Tank car CBTX 741431 thermal shell tear.

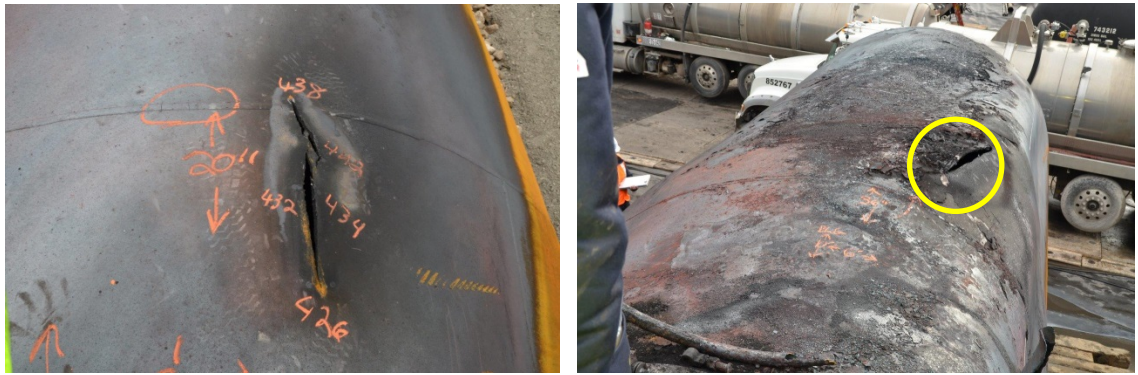
Figure 6: Examples of small thermal tears CBTX 741944 (left) and CBTX 742035 (right).

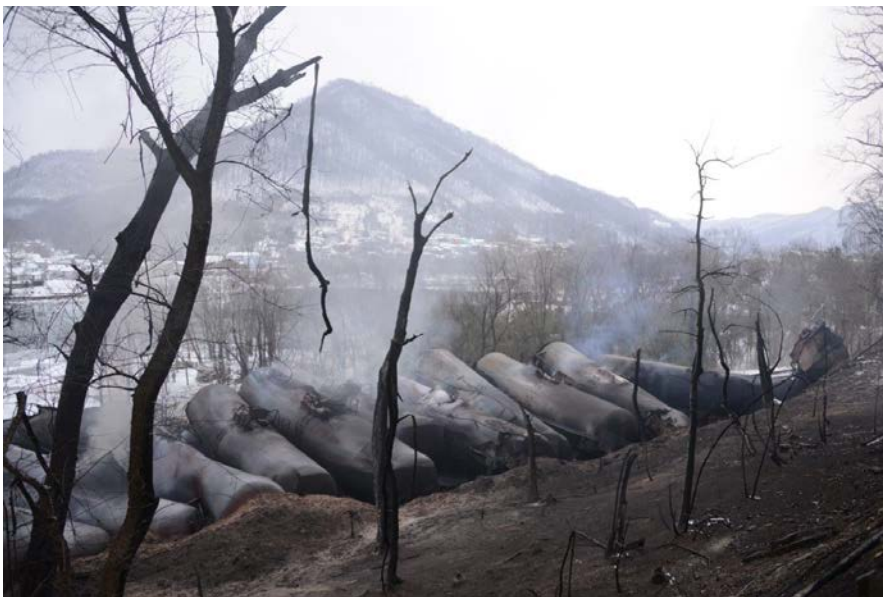
Figure 7: Derailment scene viewed from Highway 61 looking east, February 18, 2015 (Courtesy Federal Railroad Administration).

The residual pool fire was allowed to burn itself out, and continued to smolder until Saturday, February 21, 2015 (see Figure 7). Crude oil remaining in the tank cars was transloaded to tank trucks. Once the risk of fire or explosion had been eliminated, the evacuation order for Boomer was lifted at 9:00 p.m. on February 19, and the evacuation order for Adena Village/Mount Carbon was lifted at 10:43 a.m. on February 20.

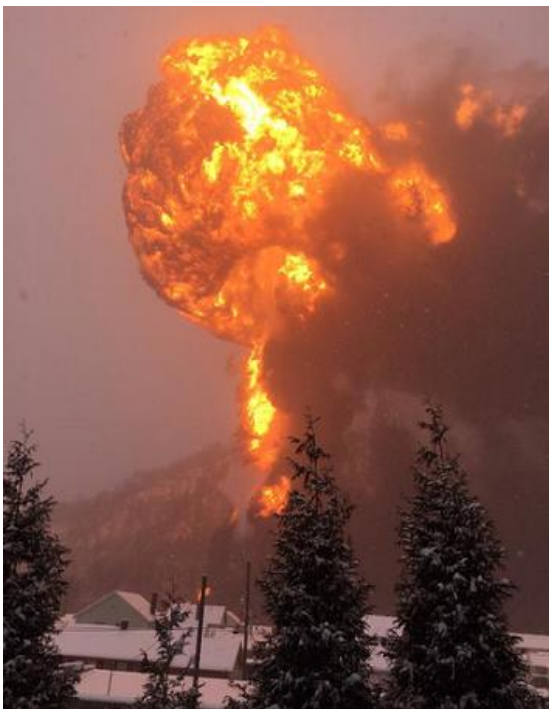
Emergency responders reported that the first thermal failure with energetic fireball eruption occurred about 25 minutes after the accident. By about 65 minutes after the accident, at least four thermal failures with fireball eruptions had occurred (see Figure 8). The 13th and last thermal failure occurred more than ten hours after the accident.

Figure 8. Fireball eruption from the Mount Carbon, West Virginia derailment scene, February 16, 2015. (Photo courtesy WWVA News Radio, Wheeling, West Virginia.)
