TECHNICAL RECONSTRUCTION ATTACHMENT
ATTACHMENT 1: SCENE DIAGRAM AND DATA ANALYSIS

HWY15FH010

**NATIONAL TRANSPORTATION SAFETY BOARD
OFFICE OF HIGHWAY SAFETY
WASHINGTON, D.C.**

TECHNICAL RECONSTRUCTION ATTACHMENT

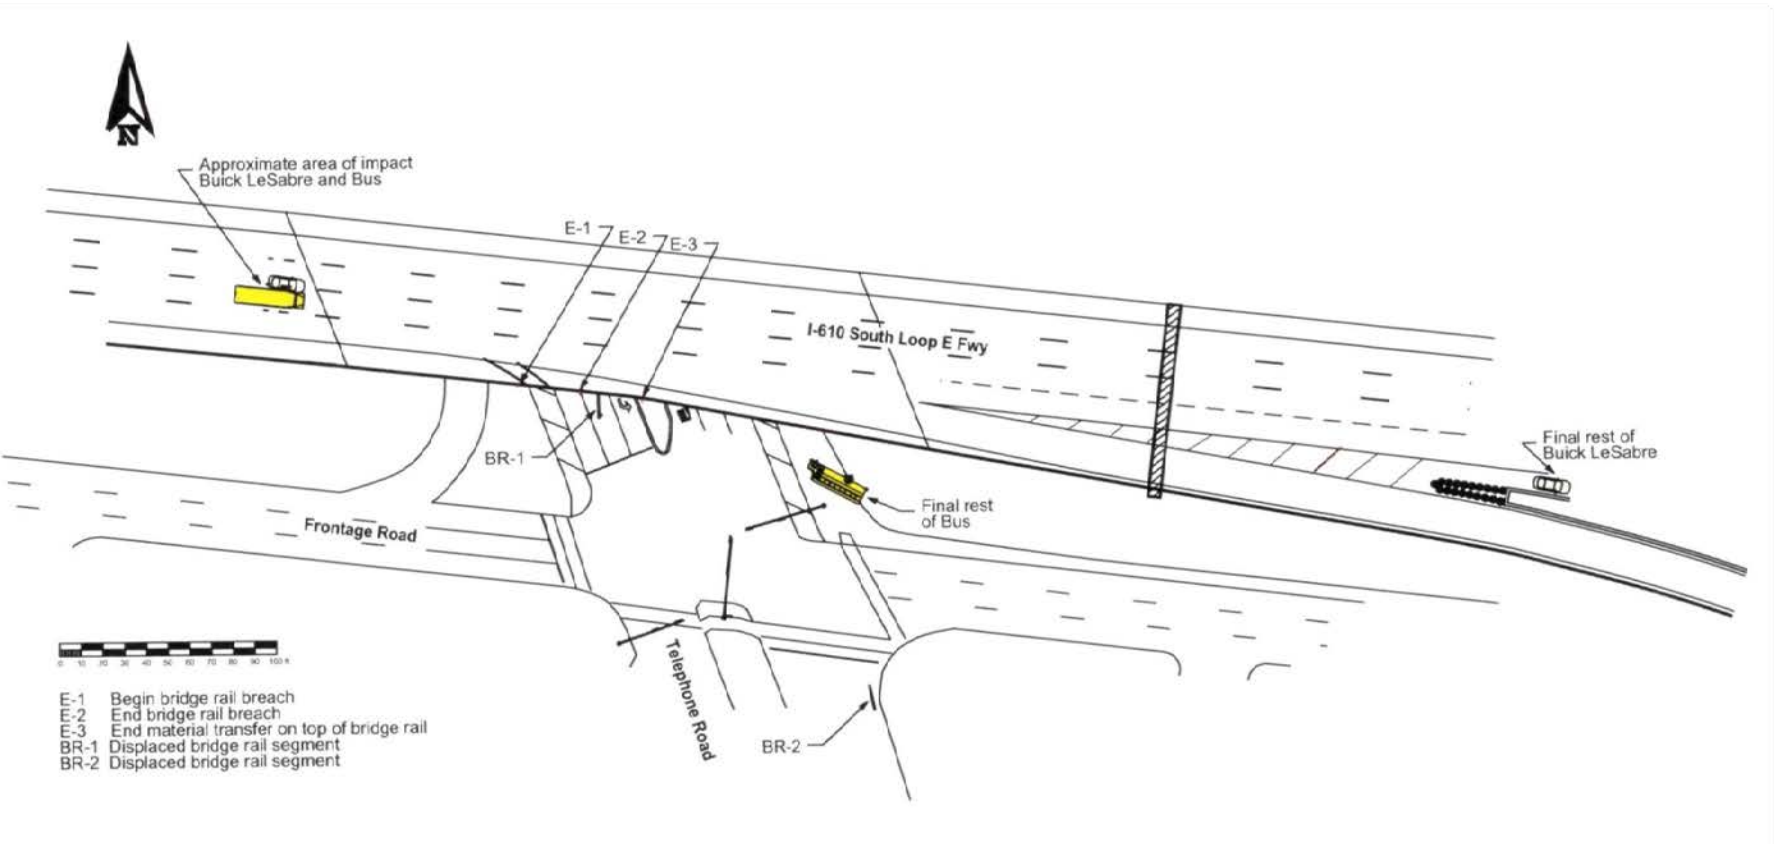
During their investigation, HPD documented the highway area with a Leica 3D scanner and provided the point cloud data to NTSB investigators. The area documented included the breached section of the bridge rail, the position of rest for the bus and portions of both roadways adjacent those features. Using a combination of the scan data, scene photographs and highway build plans, a post-collision diagram was created. The approximate area of impact was derived from video images recorded from a system on board the school bus. The completed diagram is depicted in figure 1.

Figure 1 : Scene diagram depicting the positions of rest for both vehicles and the approximate area of impact.

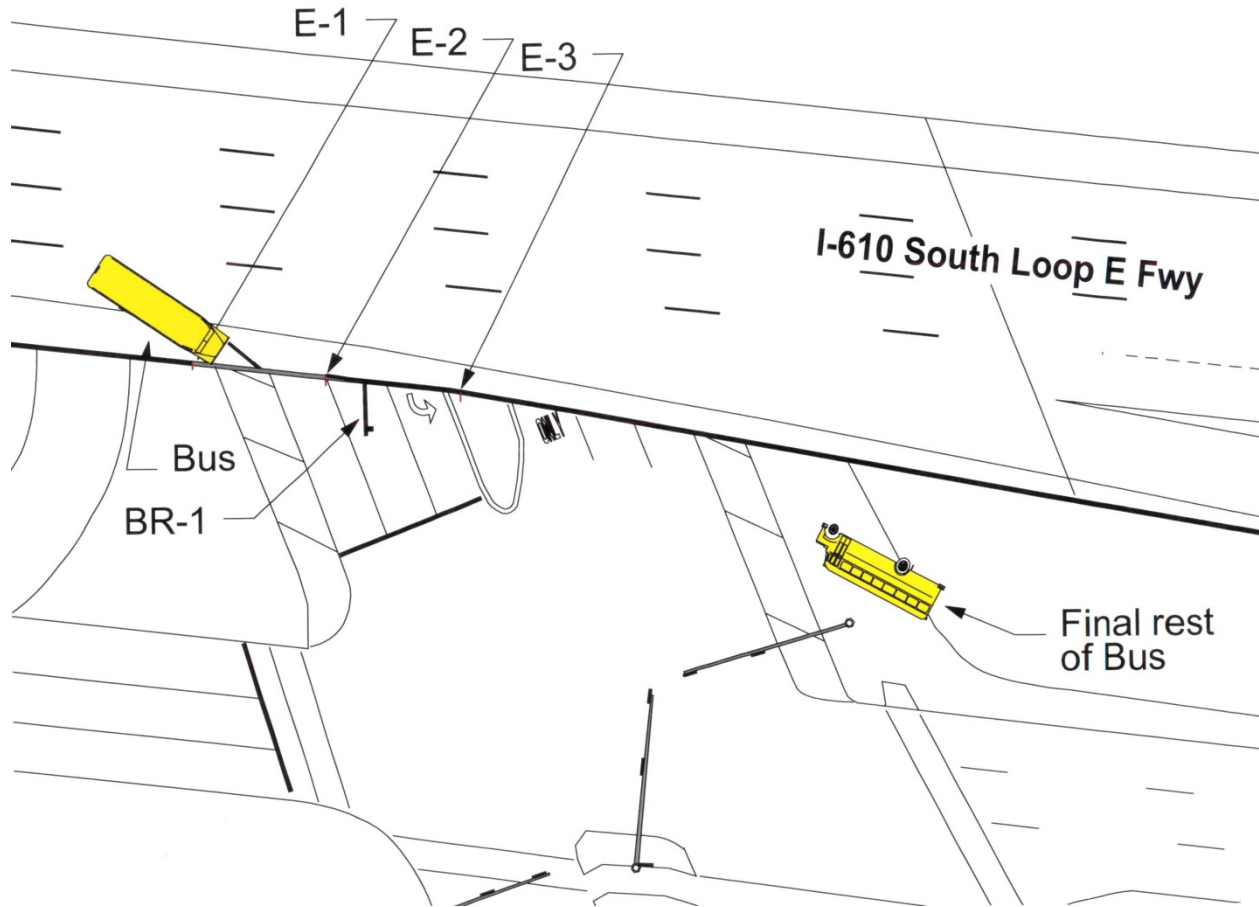
Figure 2 is an enlarged portion of the diagram depicting the area where the bus breached the bridge rail relative to its position of final rest. The position of the bus as it impacted the bridge was based on the documentation of roadway evidence (tire friction marks).

Figure 2: Enlarged portion of diagram depicting the section of bridge rail that was breached and the position of final rest for the bus.

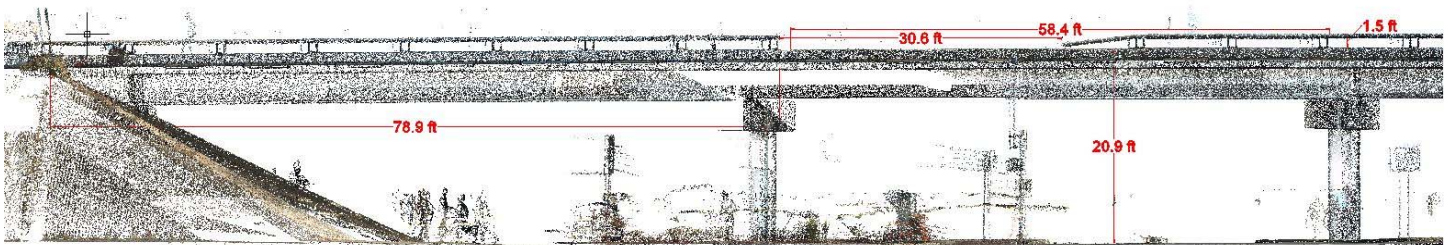
Photographs depicted evidence of black material transfer on the parapet wall beginning about 1.5 feet past the western end of the rail breach. Material transfer (interspersed with gouging to the concrete) continued toward the eastern end of the rail breach. Additional black material transfer then continued an additional 29 feet along the top of the intact rail east of the breach. Where the intact rail resumed at the eastern end of the breach, the first seven feet of rail was observed to be angled (bent) downward toward the top of the wall.

The vertical height from the top of the parapet wall to the roadway below the bridge (Telephone Road) measured 20.9 feet. The vertical height from the top of the bridge rail to the same roadway surface measured 22.4 feet. The position of rest for the bus was approximately 96 feet east-southeast of the east end of the rail breach.

Figure 3 is a screen capture of the scan point cloud depicting the bridge segment that included the rail area breached by the bus. Dimensions depicted in the image include the opening created by the missing bridge rail, the length of material transfer evidence along the parapet wall and intact rail and the vertical height of the parapet wall relative to the roadway beneath the bridge and the bridge rail relative to the wall.

Figure 3: Image of scan point cloud depicting area of bridge rail breached by the bus.
