**TECHNICAL RECONSTRUCTION GROUP CHAIRMAN'S
FACTUAL REPORT**

**Bridge Collapse
Mount Vernon, WA; 05/23/2013**

HWY-13-MH-012

**NATIONAL TRANSPORTATION SAFETY BOARD
OFFICE OF HIGHWAY SAFETY
WASHINGTON, D.C. 20594**

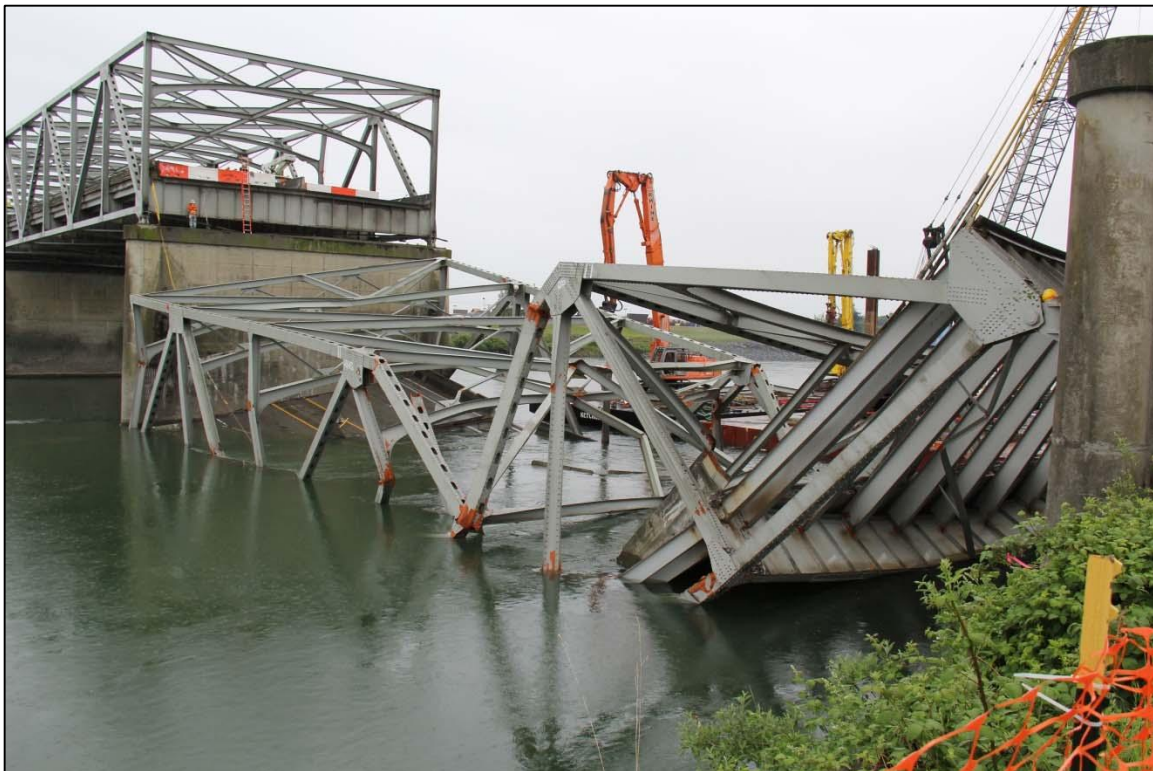
Span number 8 had collapsed and separated completely from its supporting piers. The bridge deck and truss superstructure were fractured with portions becoming partially submerged in the river following the collapse (see figure 3). Other investigative group reports should be consulted for additional details regarding the collapsed span.

Figure 3: East side of collapsed span 8 as viewed from northern river embankment.

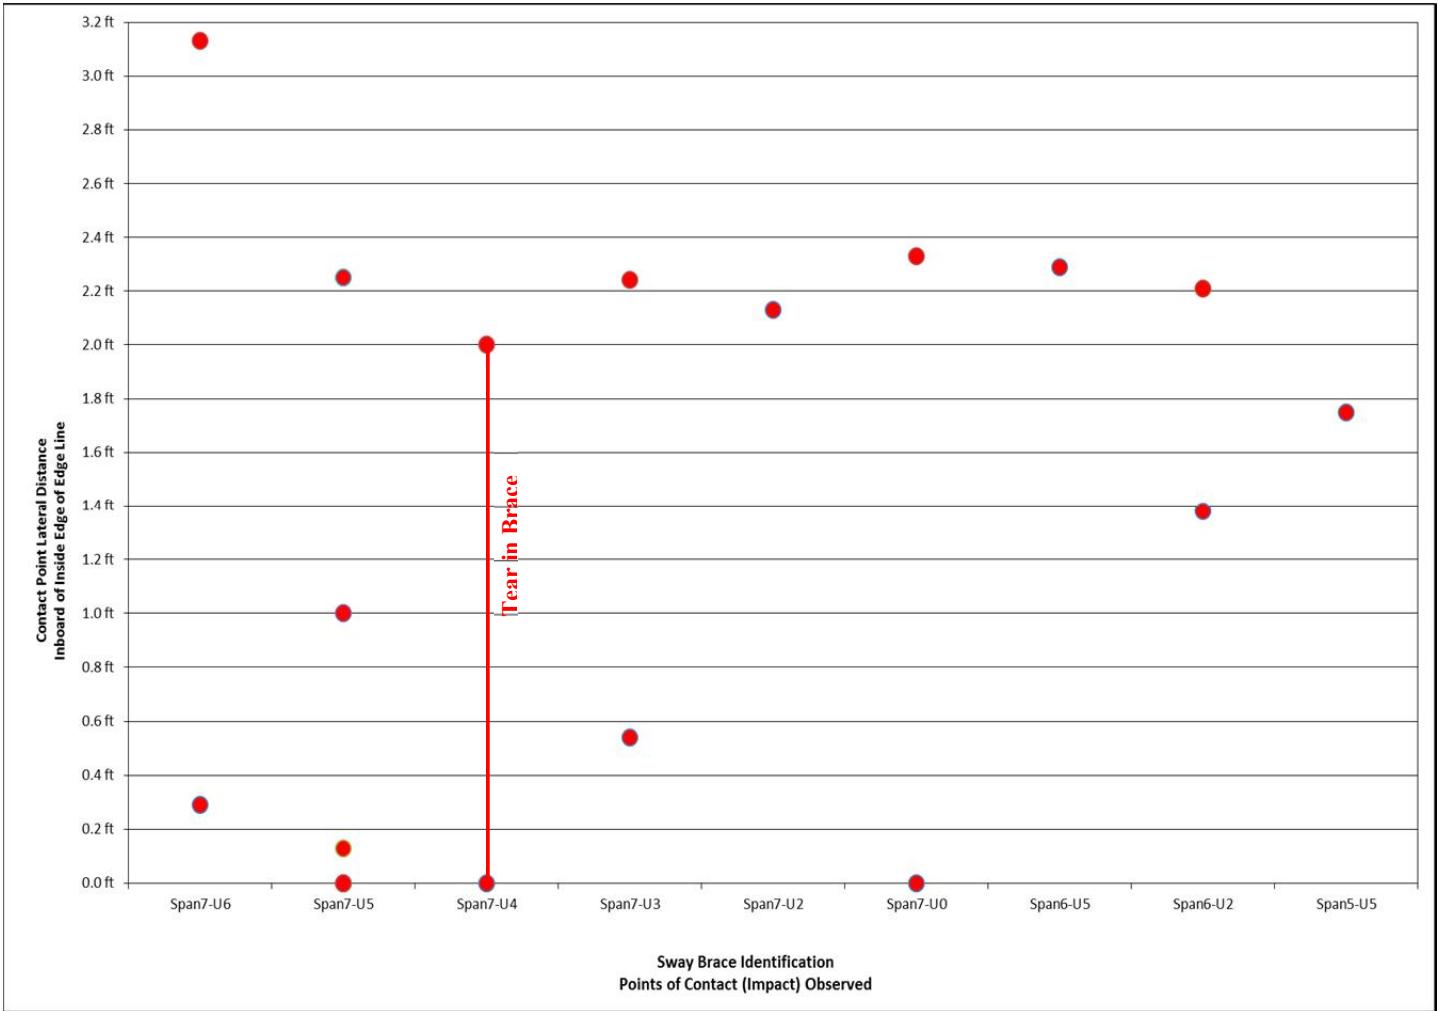
Evidence of contact resulting in observable damage to each sway brace was also documented across both the south- and northbound roadways. In addition to documenting the vertical height at which the contact evidence appears, the distance of the contact damage relative to the curb side fog line was also noted³. Figure 5 provides a graphical representation of the contact damage position relative to the fog line. Evidence of contact that appeared recent was observed on five of the seven sway braces on span 7. Contact damage that appeared aged was observed to one brace on span 7 (U0), two braces on span 6 and one brace on span 5. Appendix A provides additional detail regarding the documentation of the observed contact damage above the southbound roadway (heading of accident truck).

Figure 6: Contact evidence position relative to curb side fog line.

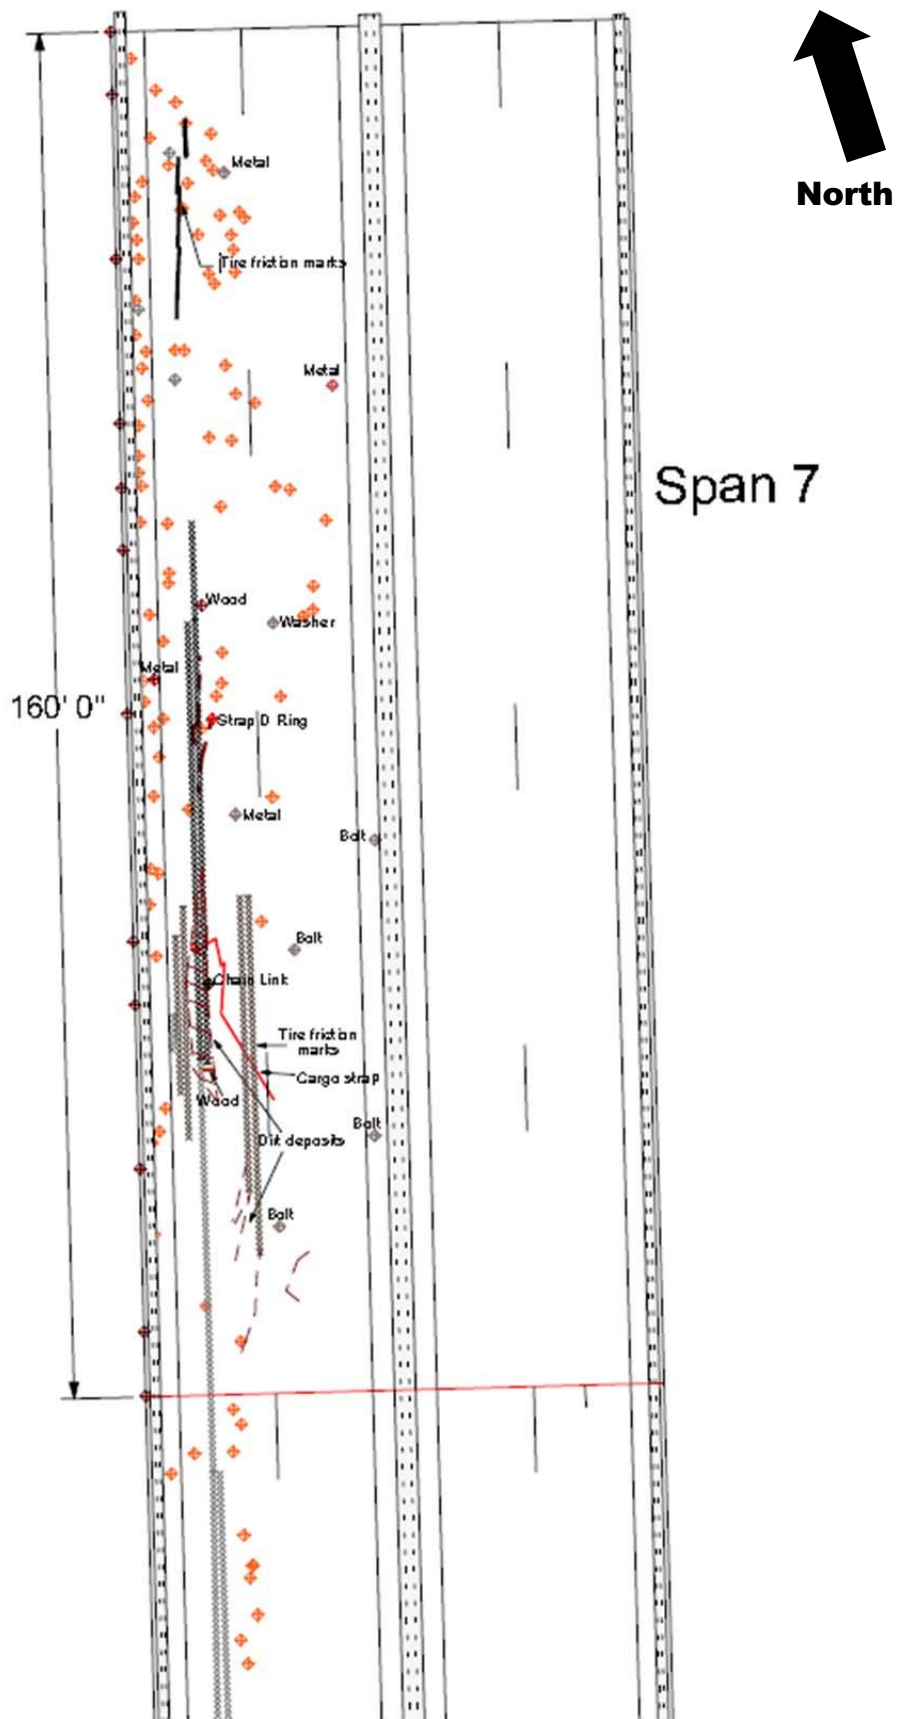
Several large steel hex nuts with portions of sheered threaded fasteners were located within the southbound roadway atop span 7. Additional debris included a wide scattering of orange-colored paint chips that extended from the northern end of span 7 approximately 194 feet to the south or about one-fifth the overall distance onto span 6. Identical paint chips were also found on the Kenworth combination.

Figure 9: Diagram depicting data captured by Washington State Patrol atop span 7 and a portion of span 6 (numerous orange points represent scattering of paint chips).

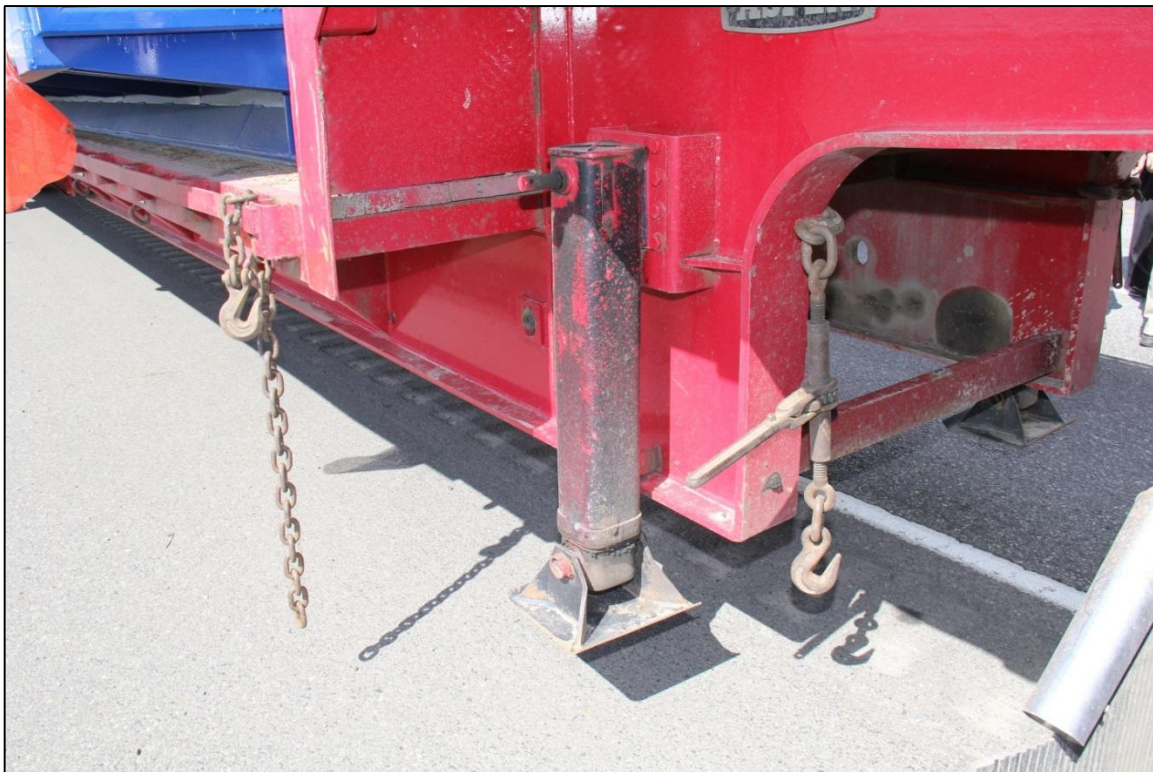
Examination of the load and securement devices revealed that the two synthetic straps and one chain assembly had separated from the cargo during the event. The chain assembly at the right forward corner was found separated from the load binder and hanging from the trailer side rail (see figure 10). The forward cargo strap was unfastened and hanging from the left side forward corner. The casing shed exhibited evidence of a strap having been transversely positioned through the casing shed at the rear. As previously noted, a cargo strap was found in the roadway atop span 7 of the bridge. The trailer deck and load securement chains exhibited evidence of substantial scuffing and blue colored paint transfer.

Figure 11: Broken securement chain at forward right corner of casing shed.

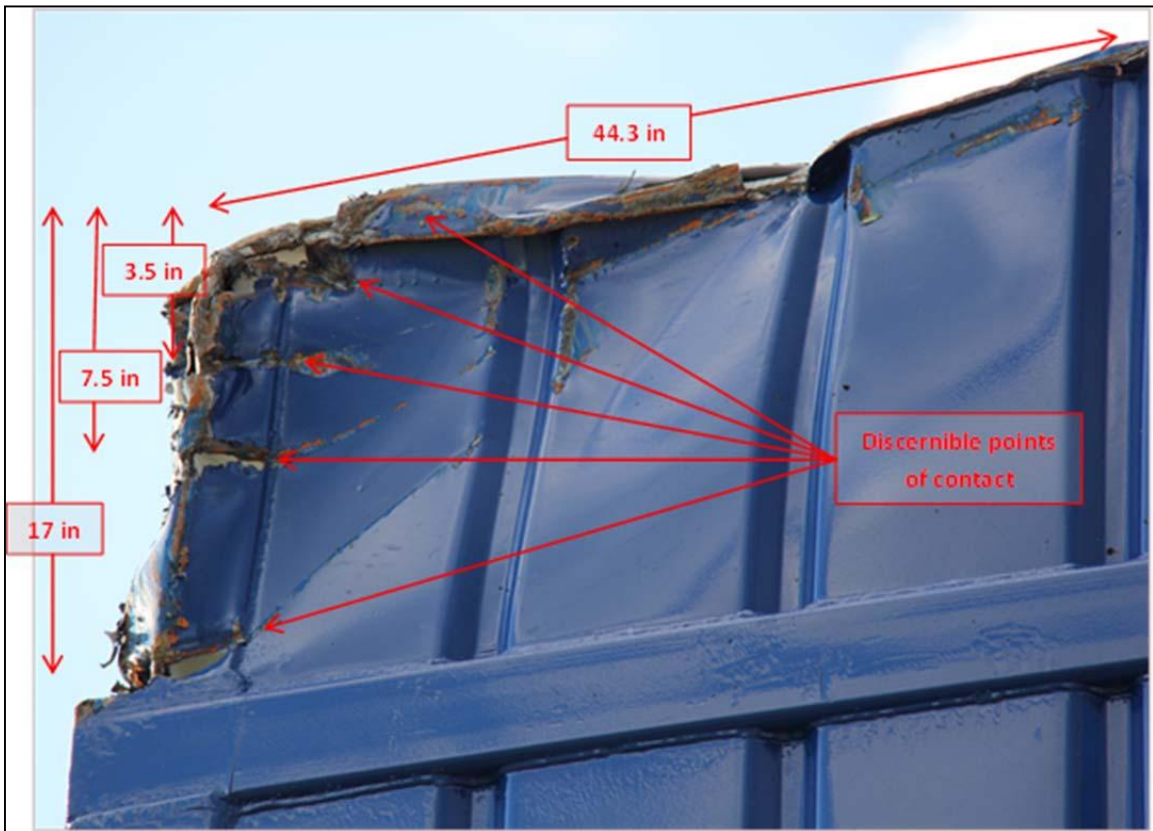
Direct damage sustained by the casing shed as a result of contact with the bridge structure was confined to the forward upper right side corner (relative to truck orientation). The forward wall of the shed was skewed rearward at the top making the shed out of square. The right upper side panel at the roof line exhibited additional minor deformation and

The damaged area at the upper right corner of the casing shed exhibited evidence of multiple points of contact. Distinct areas of contact were located at the roof line, 3½ inches, 7½ inches and 17 inches below the roof line. The individual areas of damage also exhibited an angular or arched pattern. The overall area of damage extended laterally inboard approximately 44 inches from the right side of the shed.

Figure 13: Contact damage at upper right corner of casing shed.

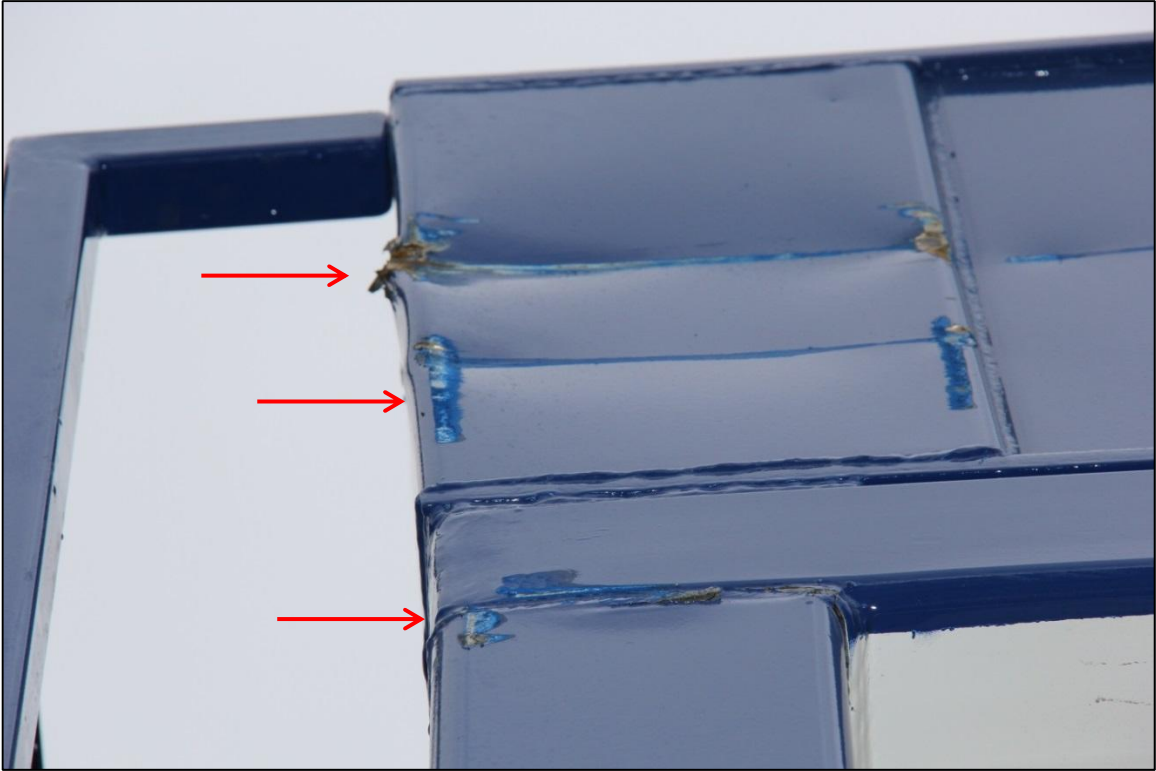
The casing shed also exhibited scrape marks along a portion of the left side upper sidewall. These marks consisted of gouging to the painted surface with some indentation and tearing of the steel at the forward left corner. At the forward end, the contact damage terminated at multiple points with three individual areas being discernible. The areas of damage were longitudinally oriented and extended rearward along the face of the upper sidewall at an apparent uniform spacing. The marks also exhibited a change in vertical height as they progressed longitudinally.

At the forward termination points for this sidewall damage, the upper scrape was approximately 7½ inches downward from the shed roof (15.3 feet above road) and had a maximum contact width of contact of 2.5 inches. The middle area of damage and second longest scrape terminated approximately 12 inches downward from shed roof (14.9 feet above road) and had a maximum contact width of 4 inches. The lower area of contact, which appeared as paint scuffing, was about 22 inches downward from shed roof (14.08 feet above road) and exhibited a width of 1 inch.

Figure 14: Forward termination of damage at forward left side of casing shed.

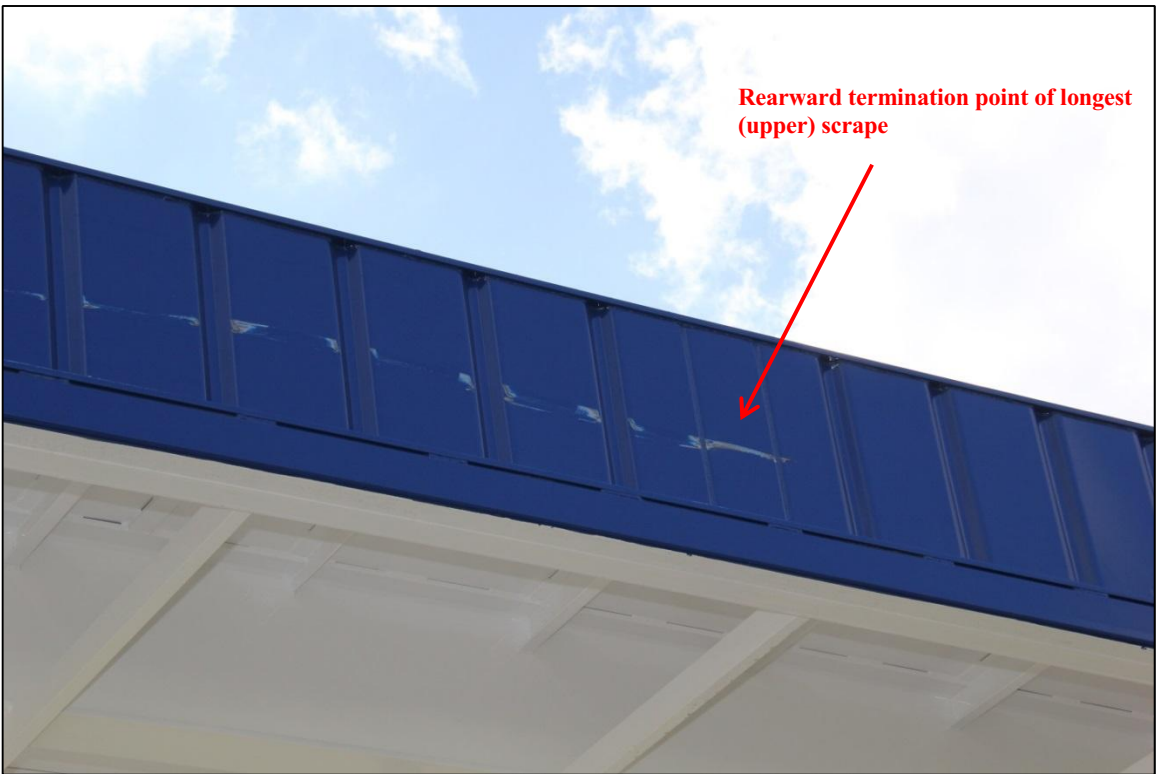
Onset of the longer scrape appeared as a single point toward mid-section of casing shed, about 15 feet aft of shed front. Onset of second scrape appeared further forward approximately 3.2 feet aft of the shed front. The rearward termination points of the scrapes appeared as narrow points but the contact area appeared to widen as the marks progressed forward.

Figure 15: Rearward termination point of longest damage on left side of casing shed.

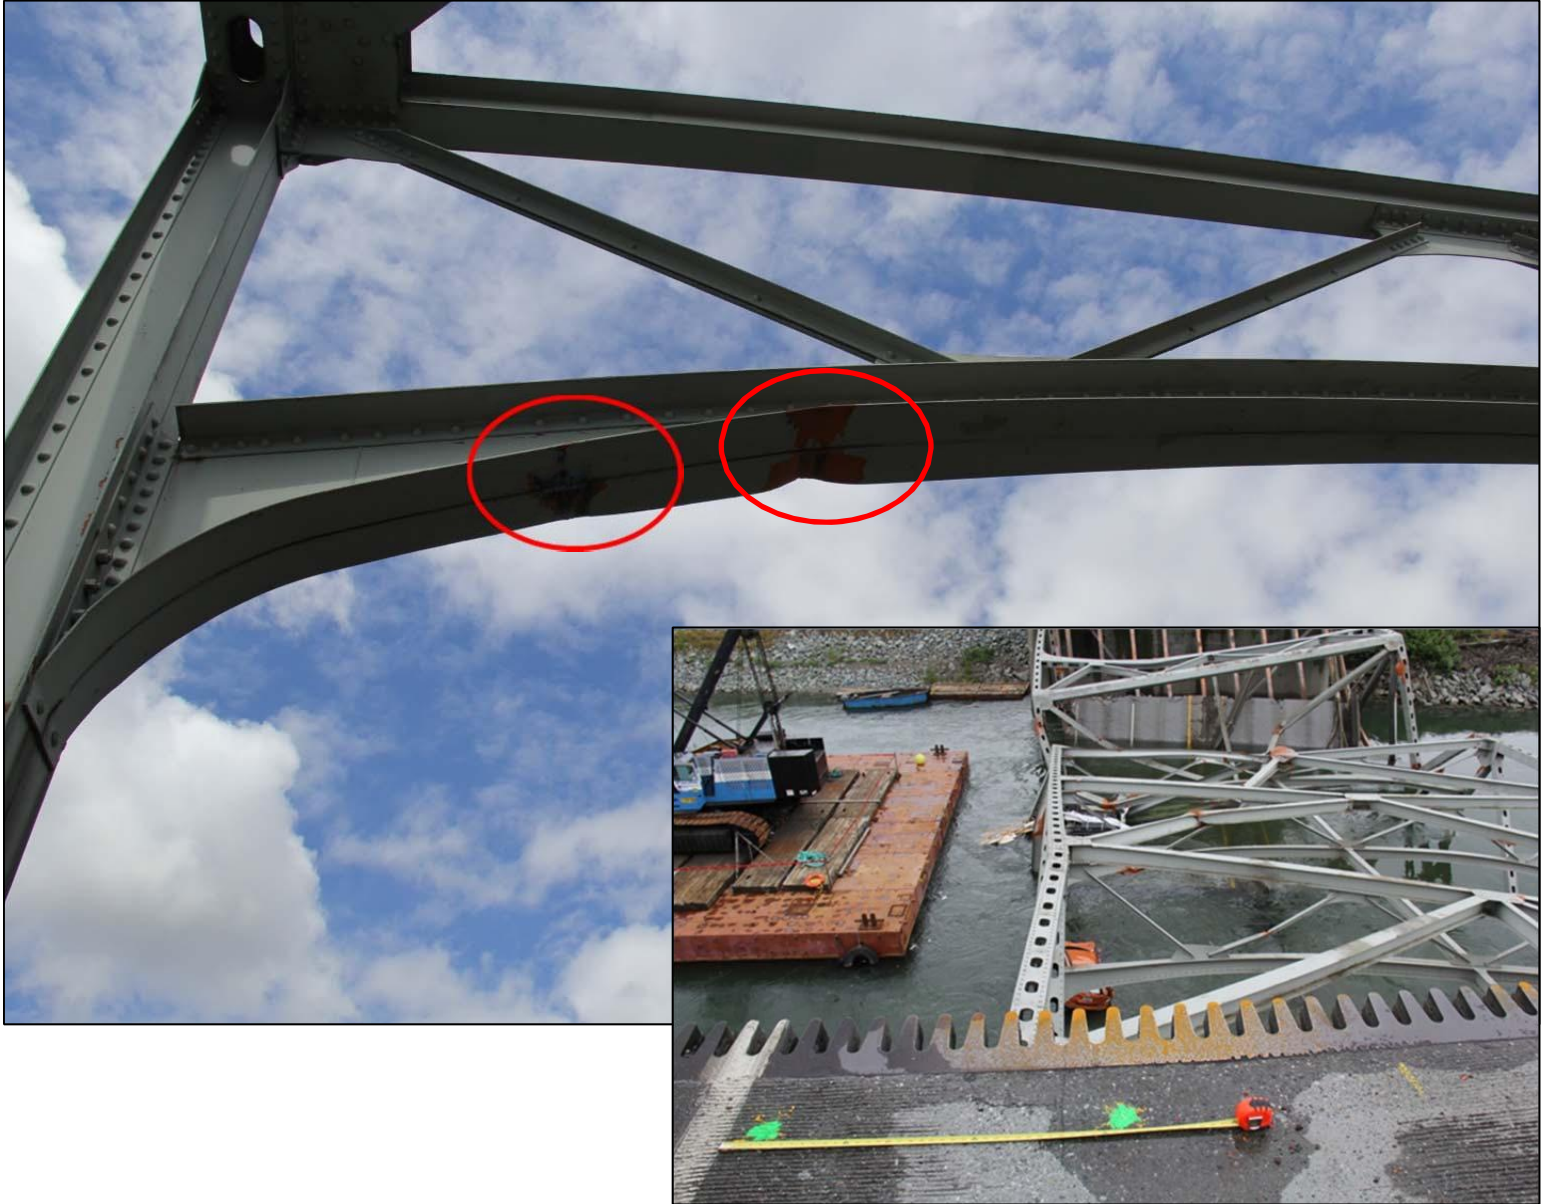
Span 7 – U6

Point 1	Point 2
Distance inboard of edge line	0.29 ft	3.13 ft
Vertical height	15.95 ft	16.63 ft
Measurement from inside edge of striping

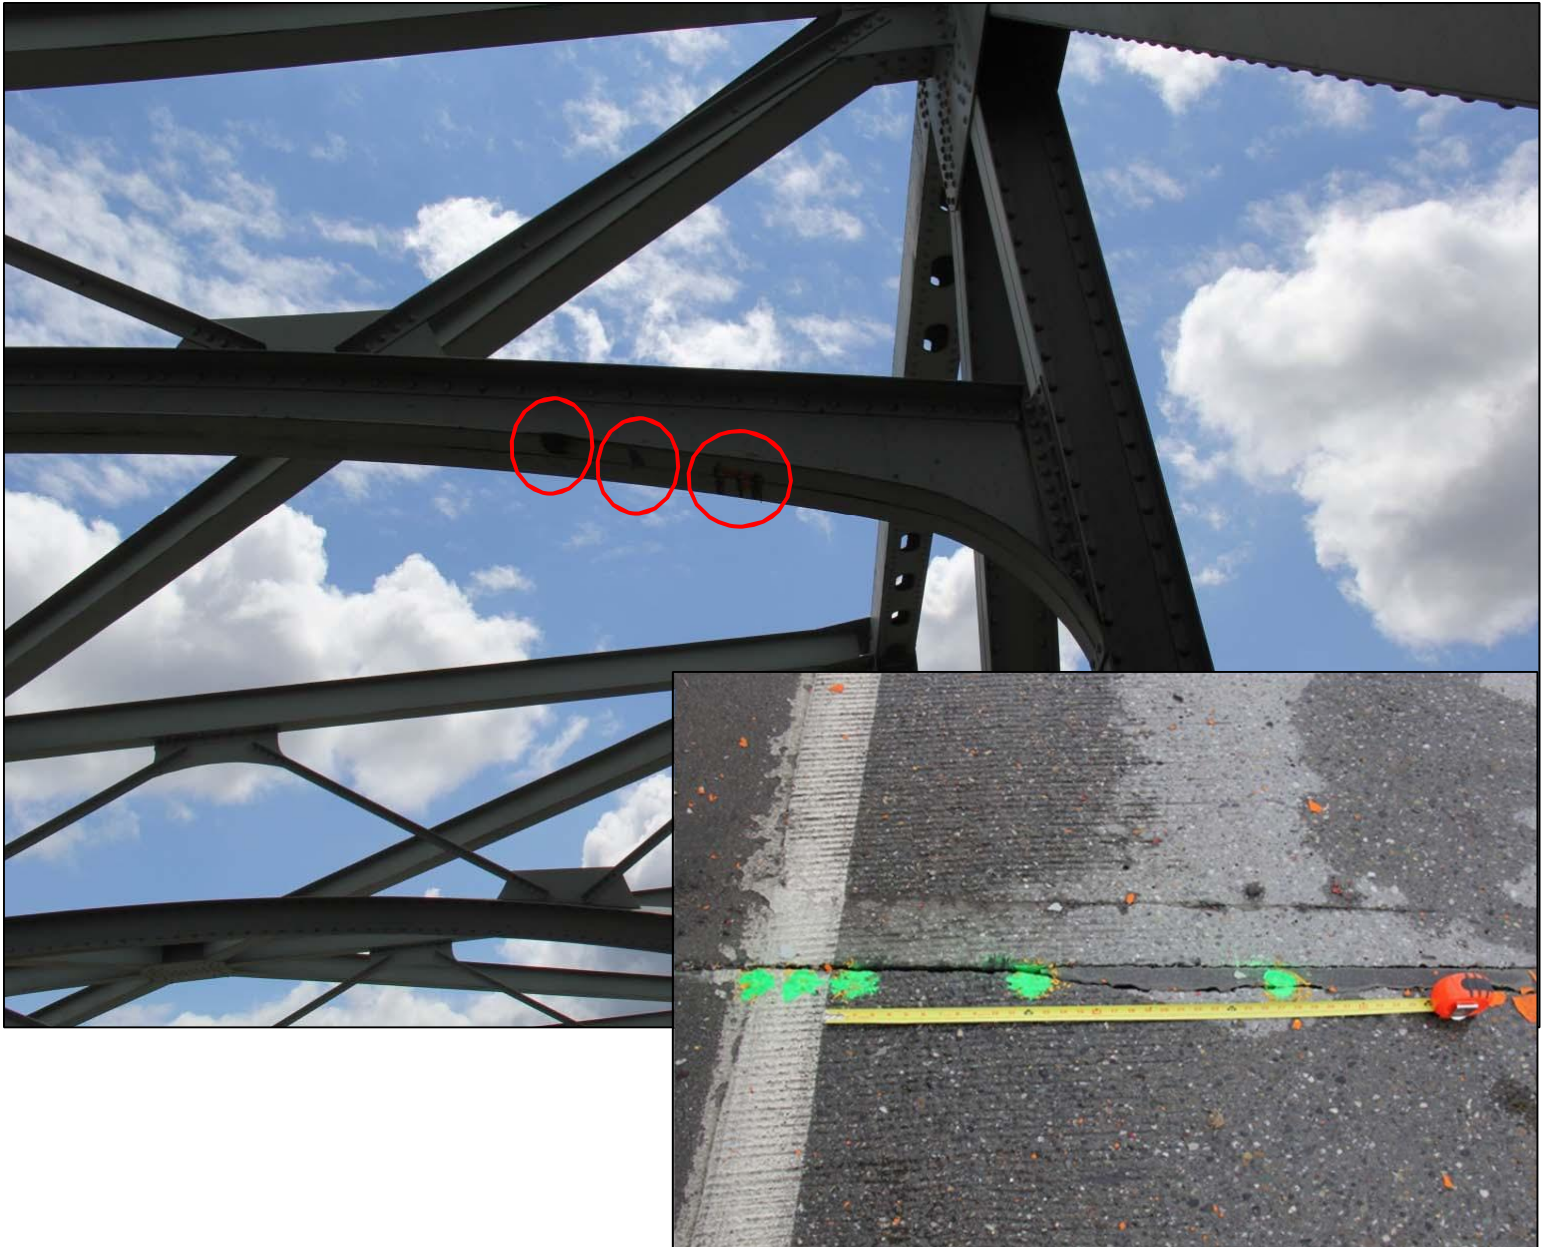
Span7 – U5

Point 1	Point 2	Point 3	Point 4	Point 5
Distance inboard of edge line	0.00 ft (-0.37 ft)	0.00 ft (-.17 ft)	0.13 ft	1.00 ft	2.25 ft
Vertical height	15.69 ft	15.75 ft	15.82 ft	16.13 ft	16.40 ft
	Measurement from inside edge of striping

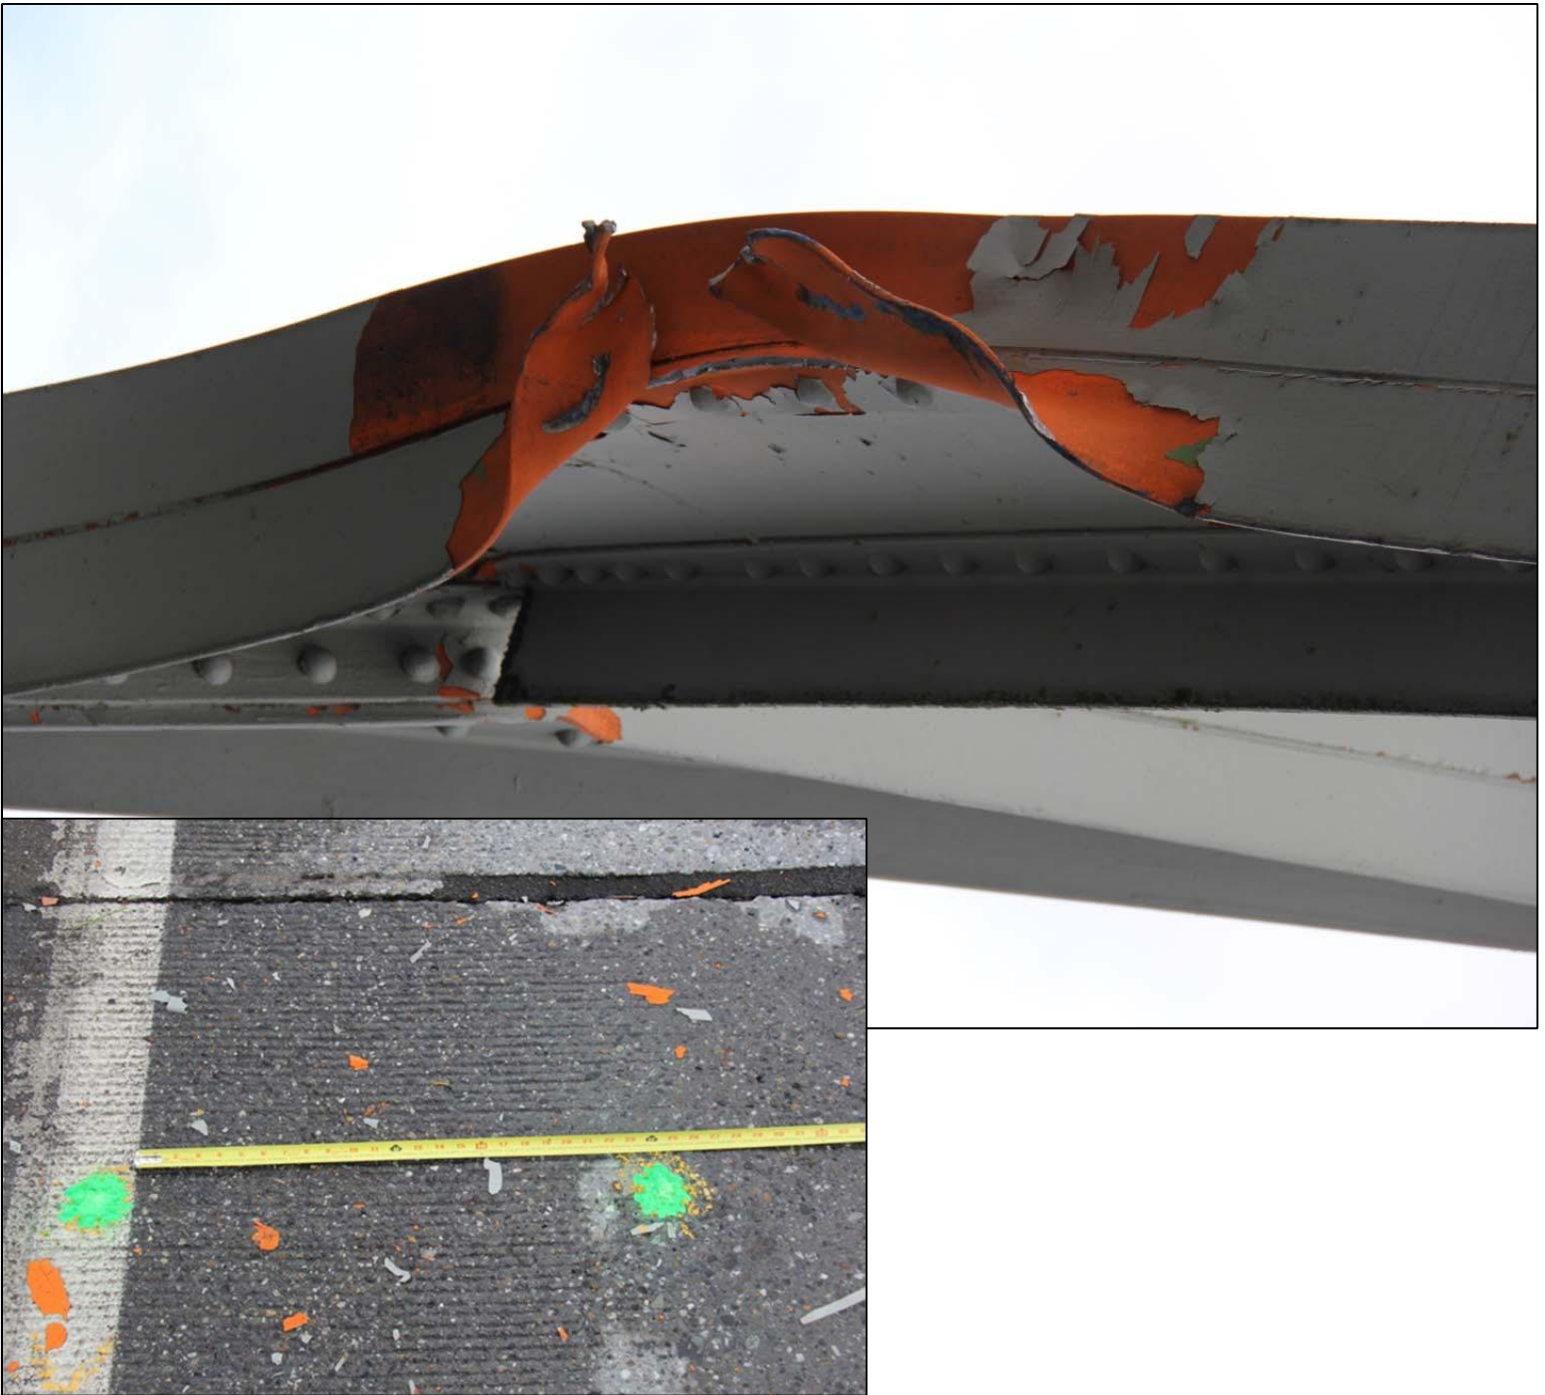
Span 7 – U4

Point 1	Point 2
Distance inboard of edge line	0.00 ft (-.16 ft)	2.00 ft
Vertical height	15.24 ft	16.16 ft
Measurement from inside edge of striping. Measured points define approximate edges of significant deformation.

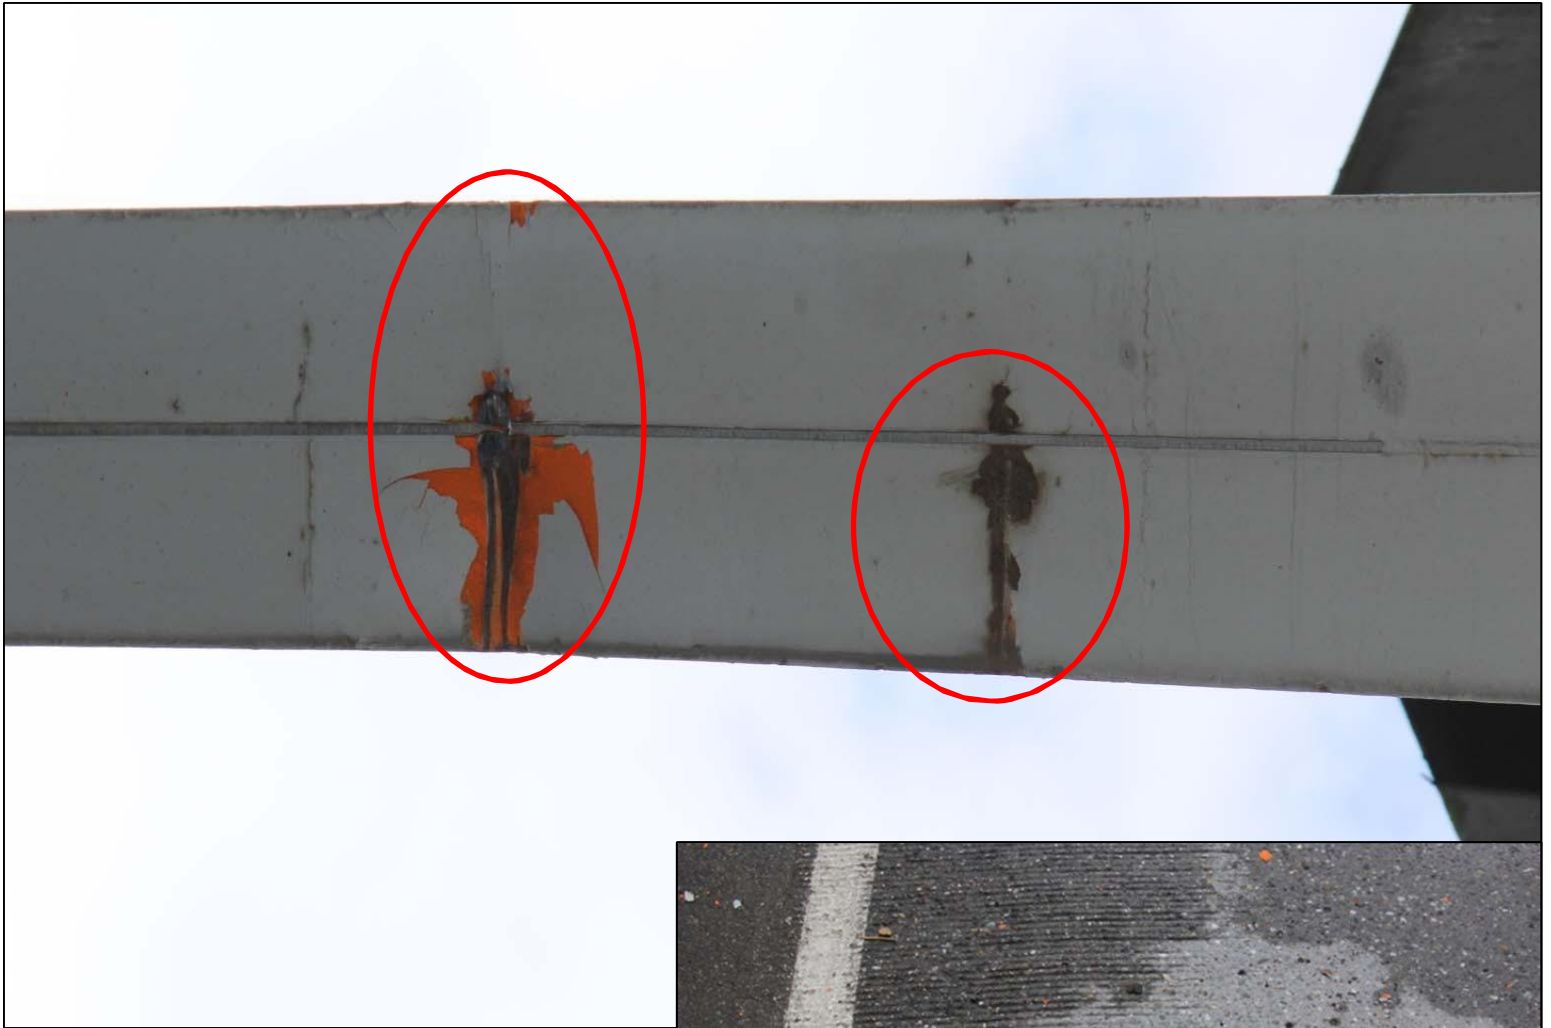
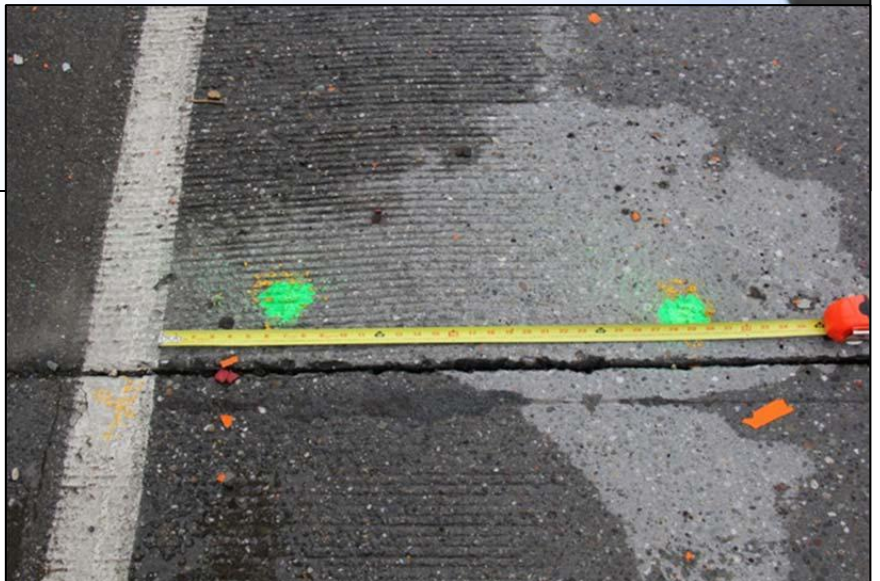
Span 7 – U3

Point 1	Point 2
Distance inboard of edge line	0.54 ft	2.42 ft
Vertical height	15.98 ft	16.43 ft
Measurement from inside edge of striping

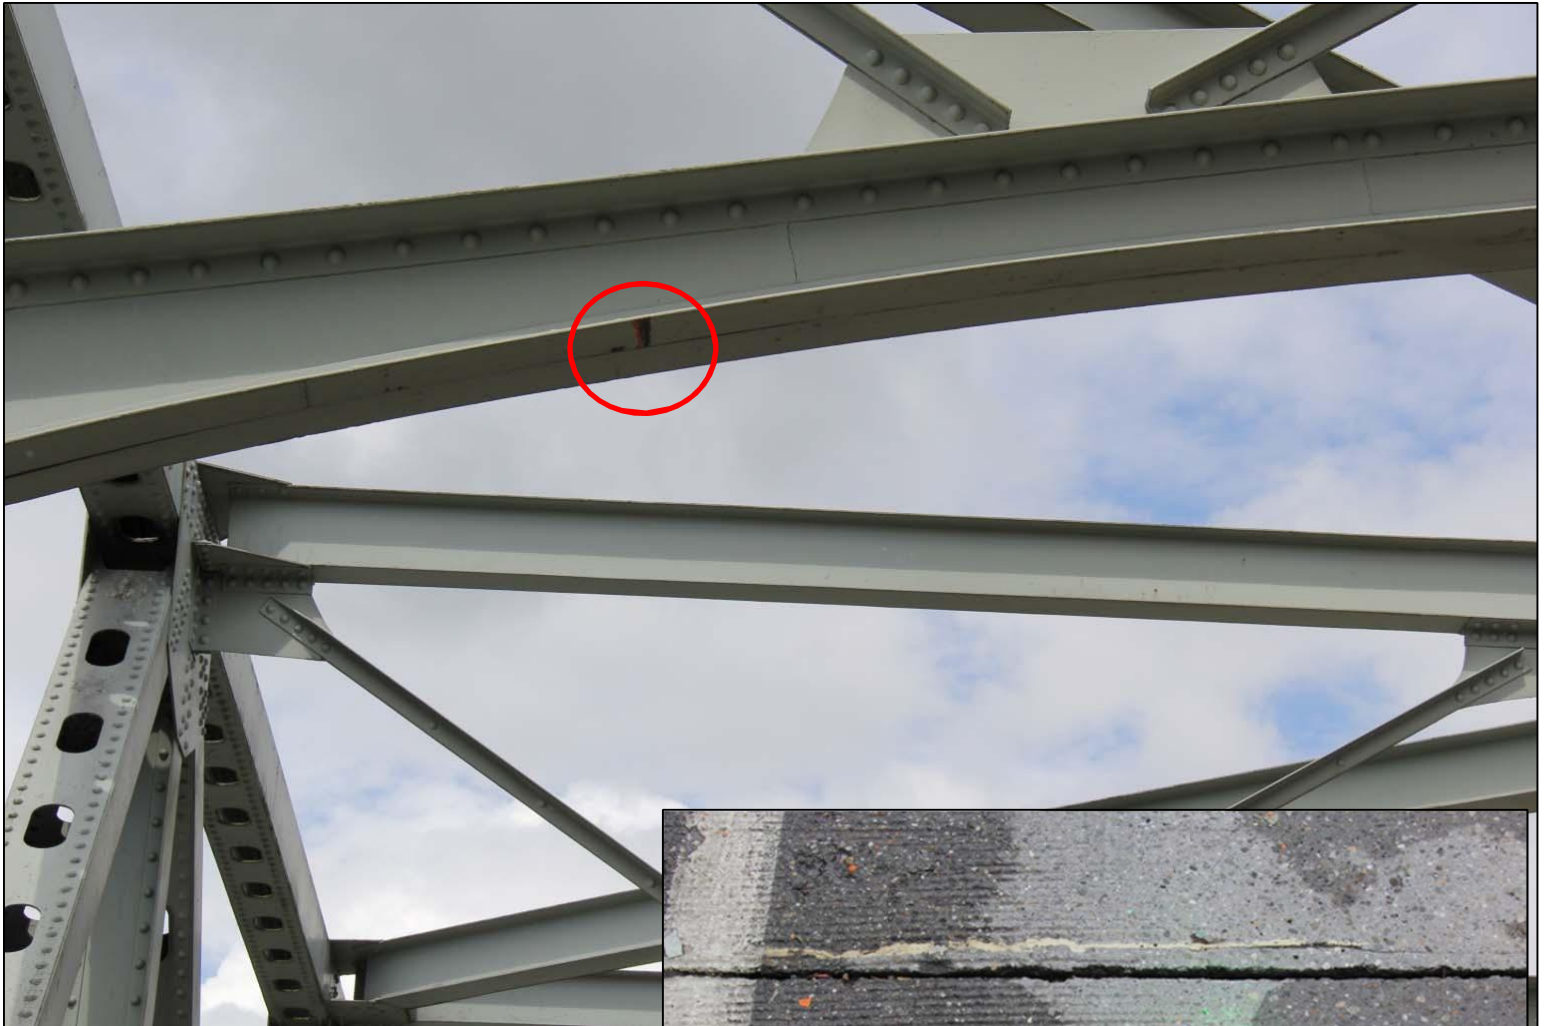
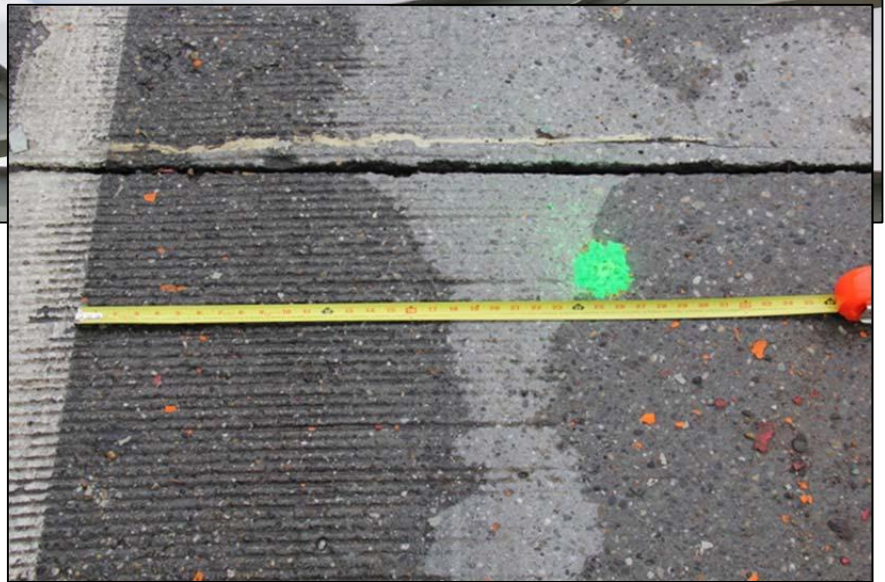
Span 7 – U2

Point 1	
Distance inboard of edge line	2.13 ft	
Vertical height	16.40 ft

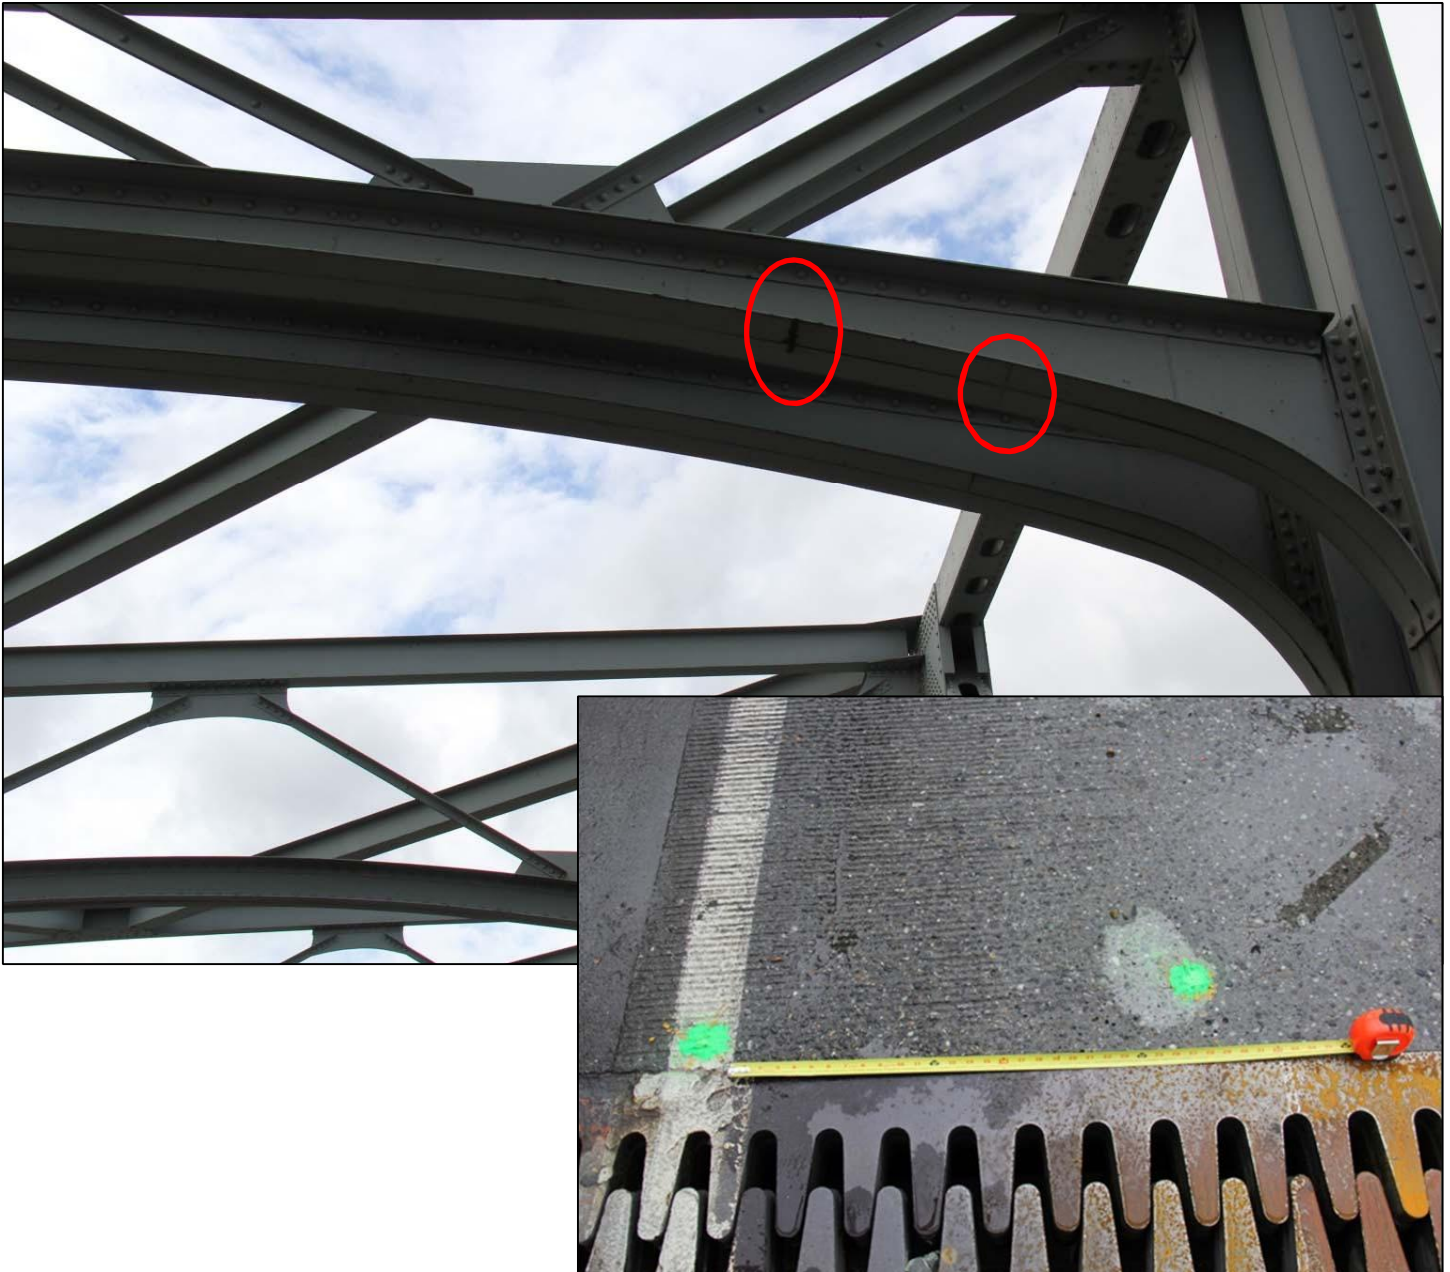
Span 7 – U0

Point 1	Point 2
Distance inboard of edge line	0.00 ft (-0.17 ft)	2.33 ft
Vertical height	15.65 ft	16.36 ft
	Damage appears aged	Damage appears aged
	Measurement from inside edge of striping

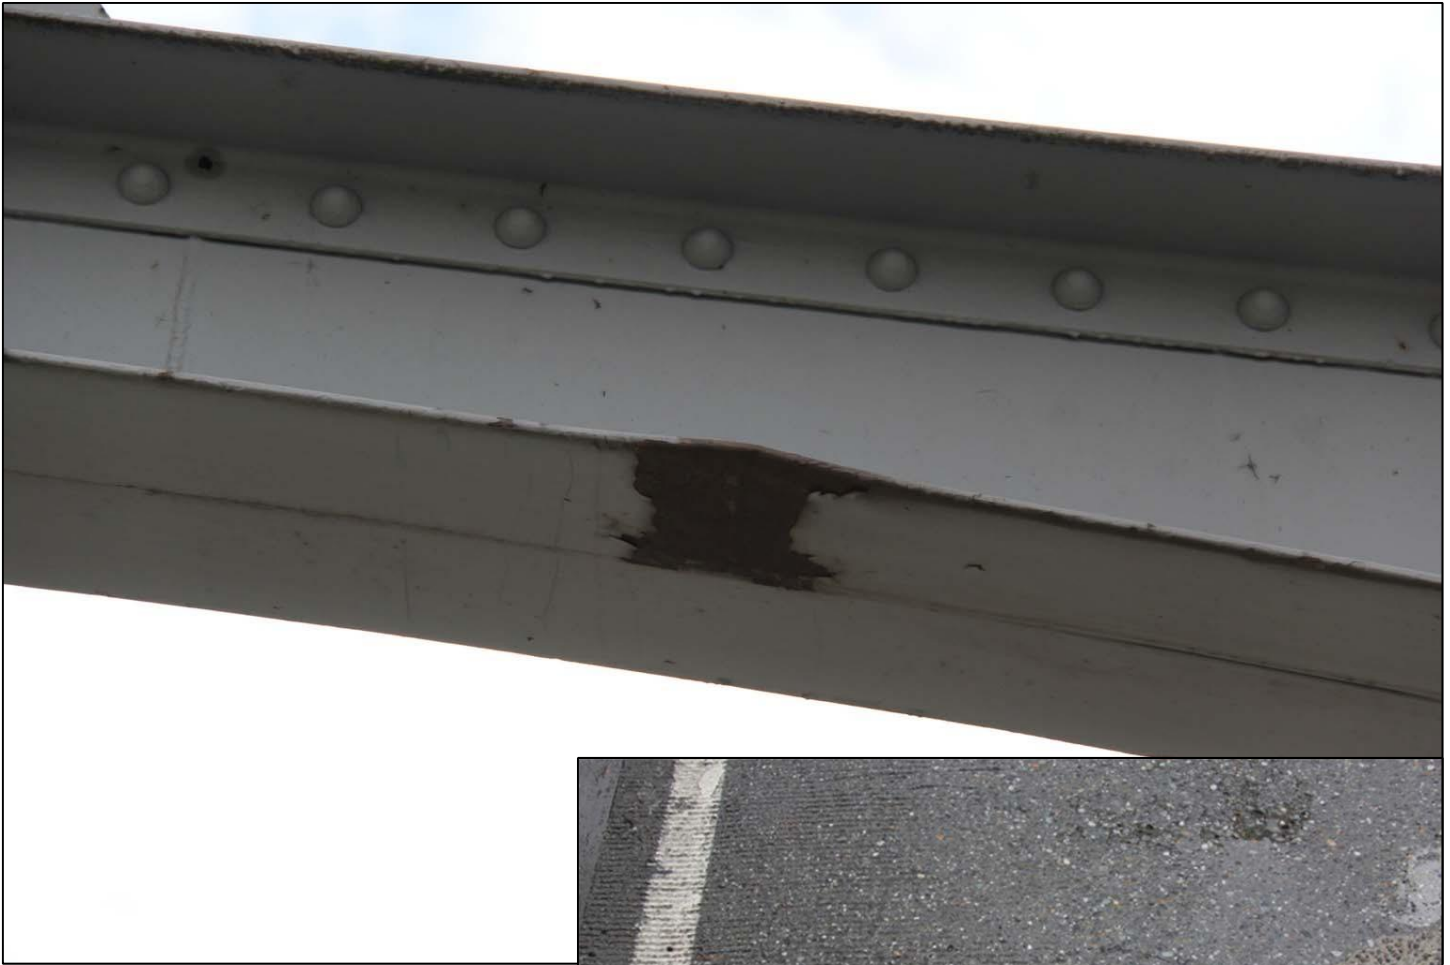
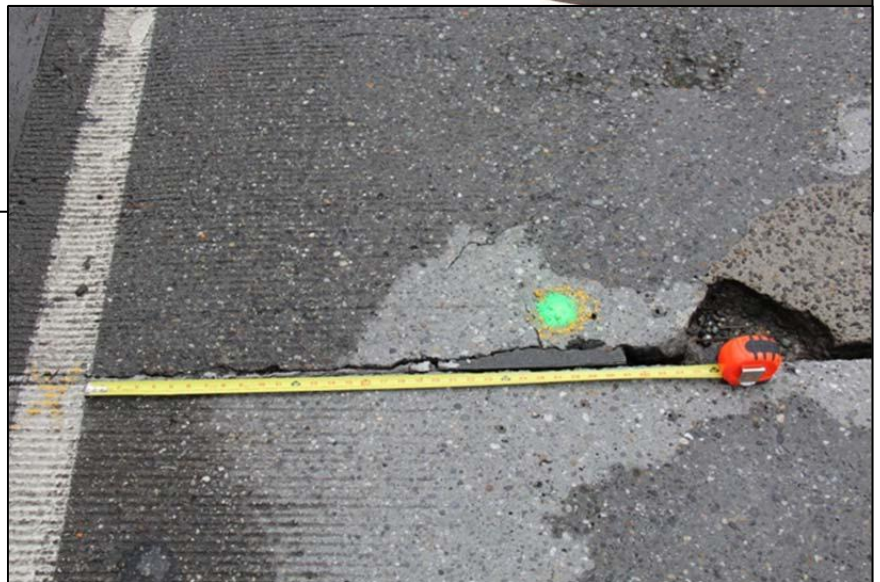
Span 6 – U5

Point 1	
Distance inboard of edge line	2.29 ft	
Vertical height	16.33 ft	
	Damage appears aged
