**TECHNICAL RECONSTRUCTION GROUP CHAIRMAN'S
FACTUAL REPORT**

**Bridge Collapse
Mount Vernon, WA; 05/23/2013**

HWY-13-MH-012

**NATIONAL TRANSPORTATION SAFETY BOARD
OFFICE OF HIGHWAY SAFETY
WASHINGTON, D.C. 20594**

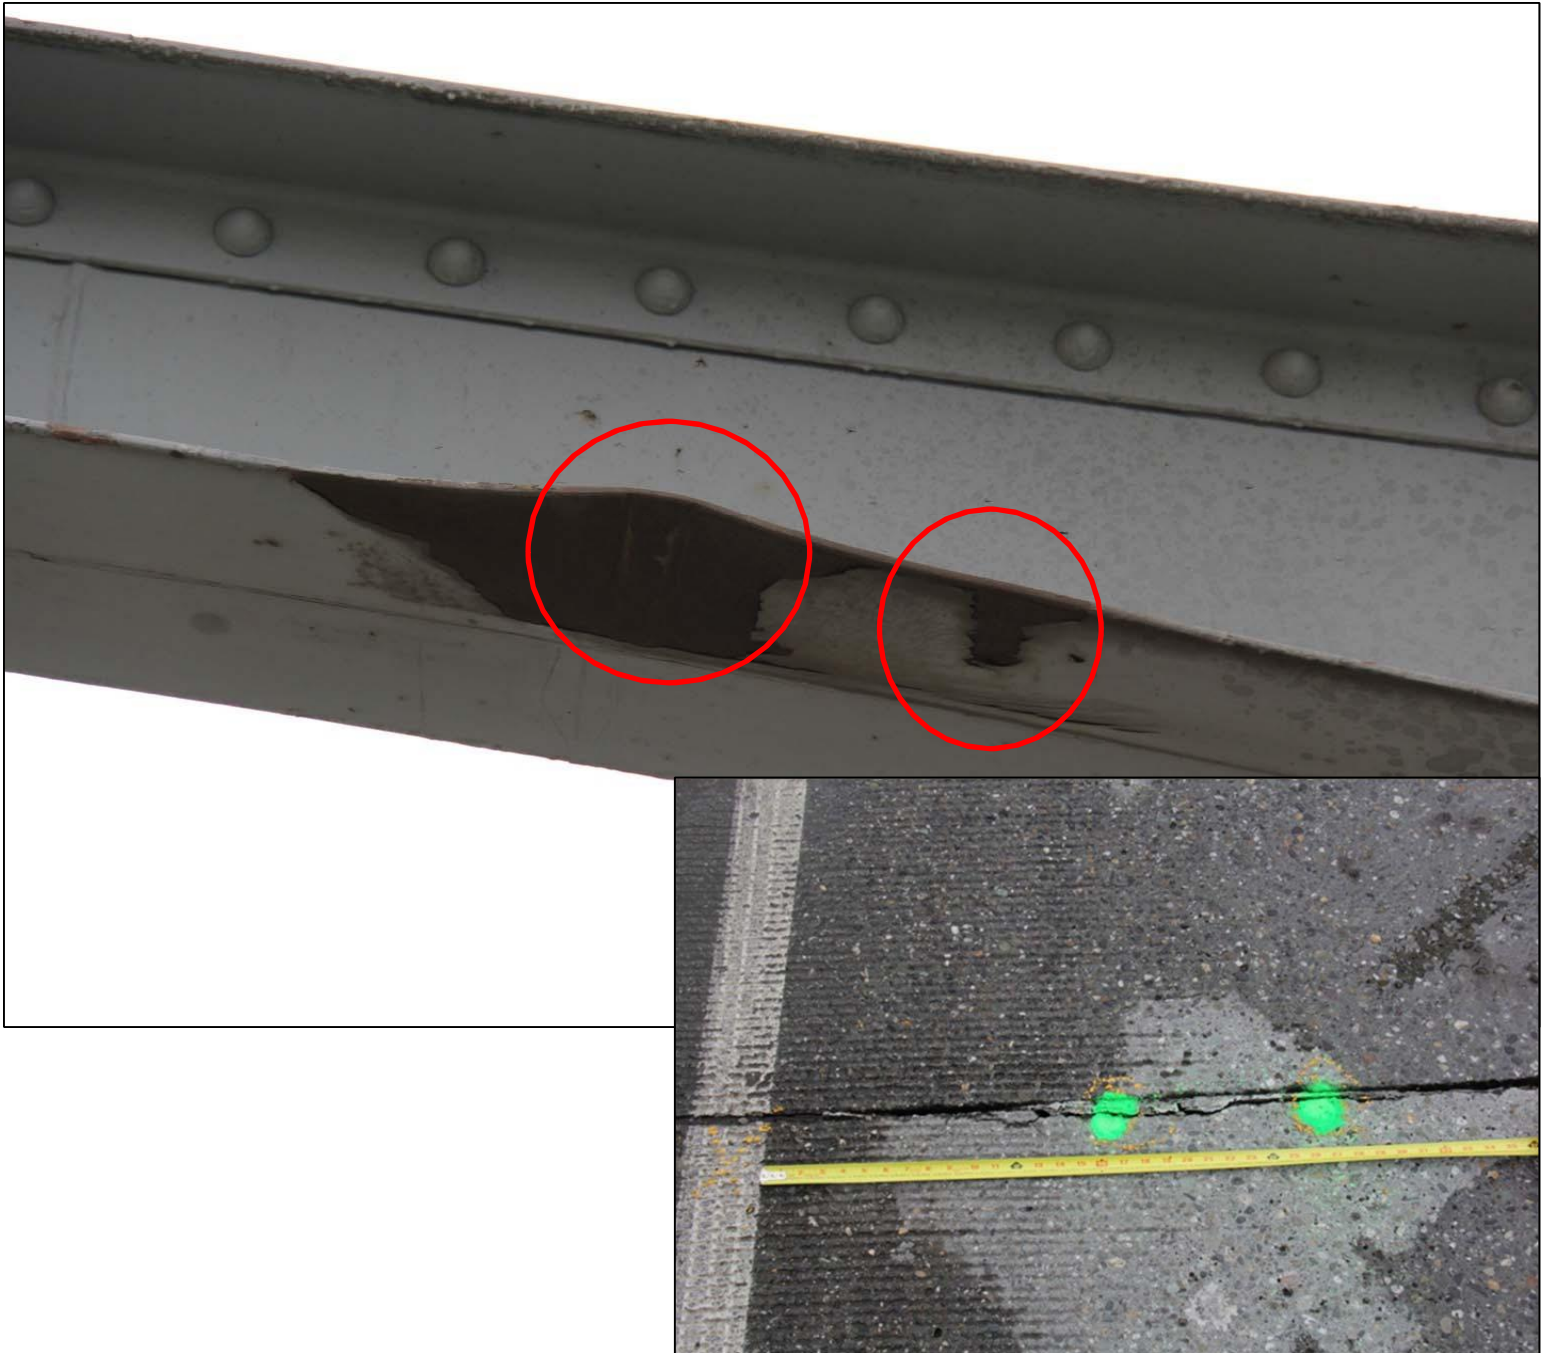
Span 6 – U2

Point 1	Point 2
Distance inboard of edge line	1.38 ft	2.21 ft
Vertical height	16.17 ft	16.37 ft
	Damage appears aged	Damage appears aged
	Measurement from inside edge of striping

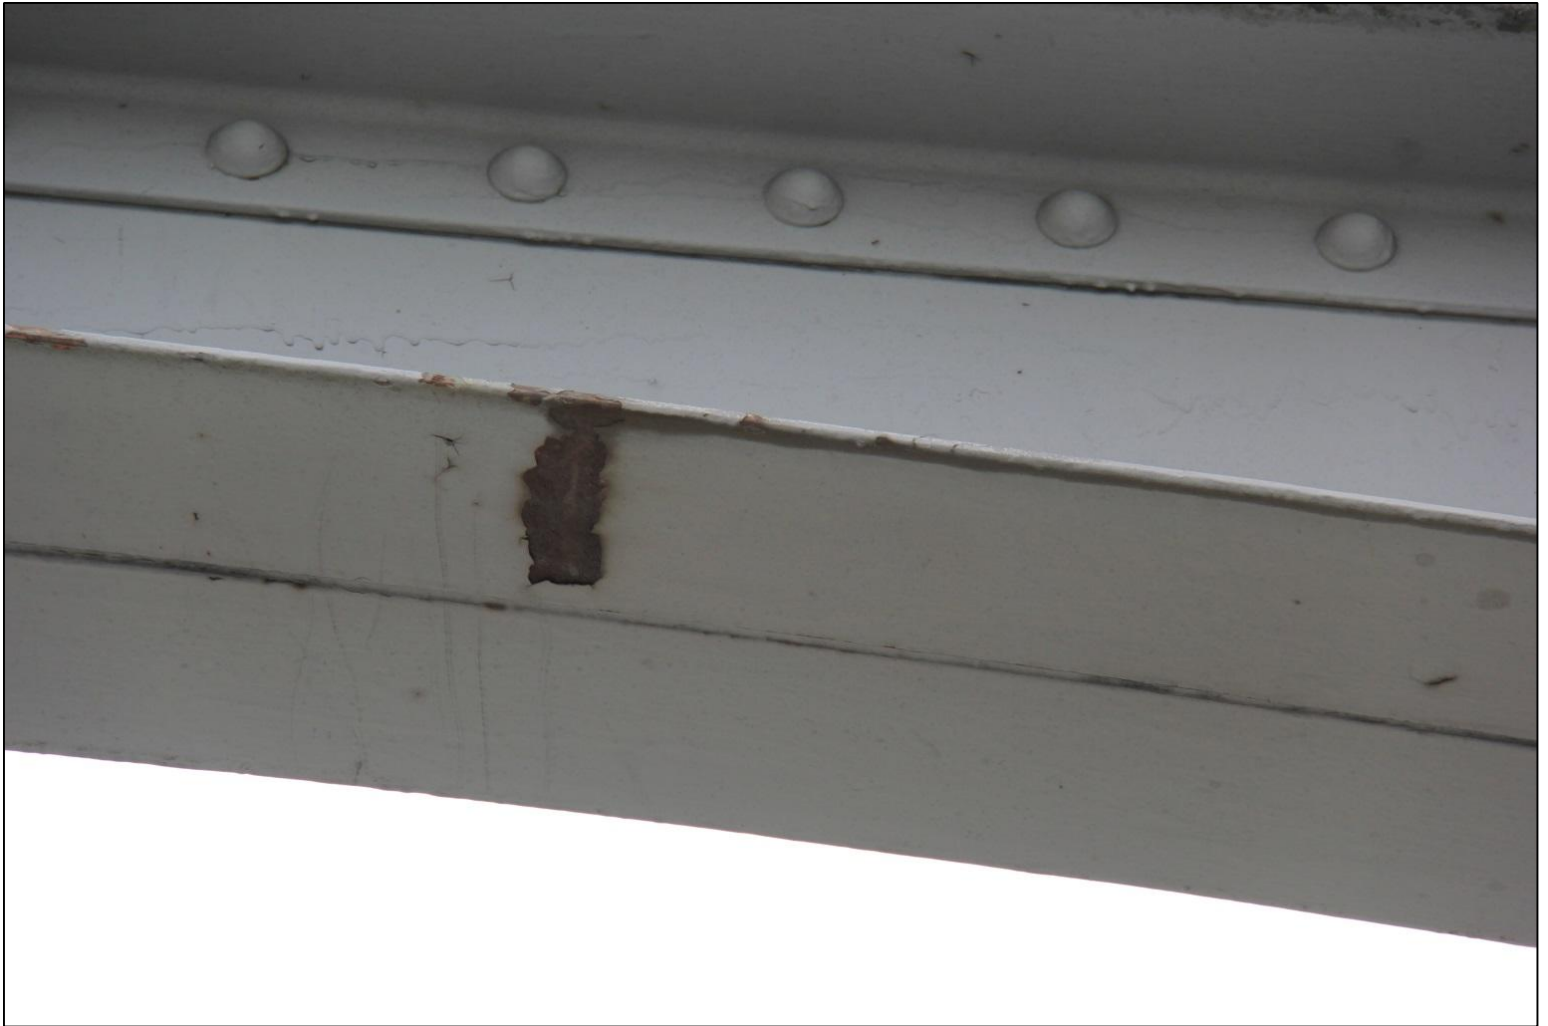
Span 5 –U5

Point 1	
Distance inboard of edge line	1.75 ft	
Vertical height	16.34 ft	
	Damage appears aged
