**TECHNICAL RECONSTRUCTION GROUP CHAIRMAN'S
FACTUAL REPORT**

HWY16FH018

Location: US-Alt 27, milepost 29, near Williston, Levy County, Florida

Vehicle #1: 2015 Tesla Model S 70D

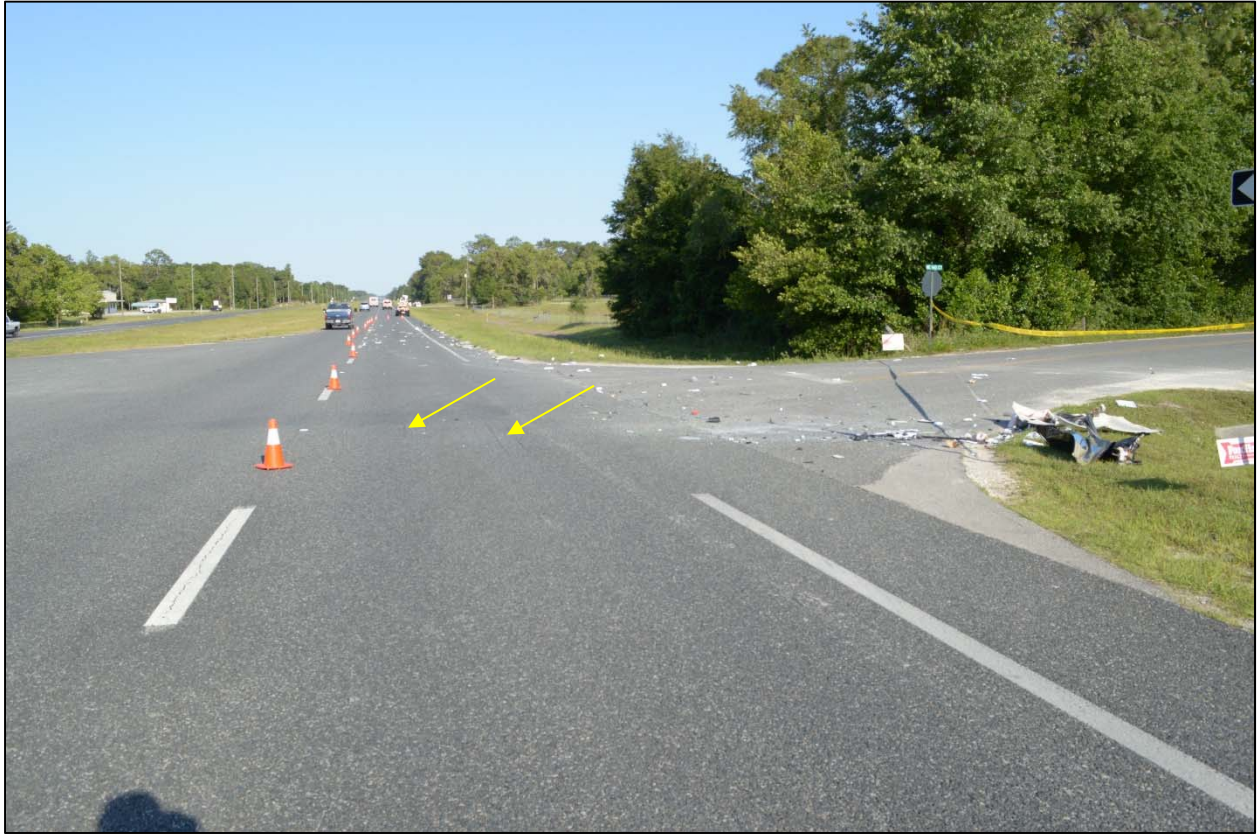
The collision occurred when the Tesla, traveling eastbound on US-27A, struck the right side of the semitrailer as the combination vehicle made a left turn from westbound US-27A onto (southbound) NE 140th Court. The Tesla passed beneath the semitrailer and continued eastward after the collision. While roadway evidence was no longer visible upon the arrival of NTSB investigators, the area was photographed and documented by investigators with the Florida Highway Patrol (FHP). FHP investigators identified the area of impact as within the confines of the intersection formed by the right through lane of eastbound US-27A and the southbound lane of NE 140th Court. Documentation provided by FHP depicted a single linear tire friction mark in the eastbound right lane of US-27A in this area. The length of the mark was documented as about 11.5 feet in length. Examination of FHP photographs appear to depict the presence of a second parallel linear tire mark, although this second mark appears very faint. The marks were constrained within, and parallel to the right eastbound travel lane. The characteristics of the marks appeared consistent with vertical loading or over deflection of vehicle tires without indication of sliding. The separation between the marks appeared consistent with the wheel track of a passenger vehicle. The tire mark documented by FHP investigators would have been consistent with location of the passenger side tires of the Tesla at impact. The photographs also depicted debris from the Tesla at the southwest corner of the intersection and trailing eastward from the area of impact. The debris located at the southwest corner of the intersection appeared to consist of the Tesla's interior and exterior roof panels. Figure 1 is a FHP photographs depicting the two faint tire friction marks and vehicle debris observed near the area of impact.

Figure 1: Florida Highway Patrol photograph facing eastward on US-27A at the intersection with NE 140th Court. Two parallel tire friction marks are referenced by the yellow arrows. Additional Tesla debris is located at the southwest corner of the intersection (right side of photograph).

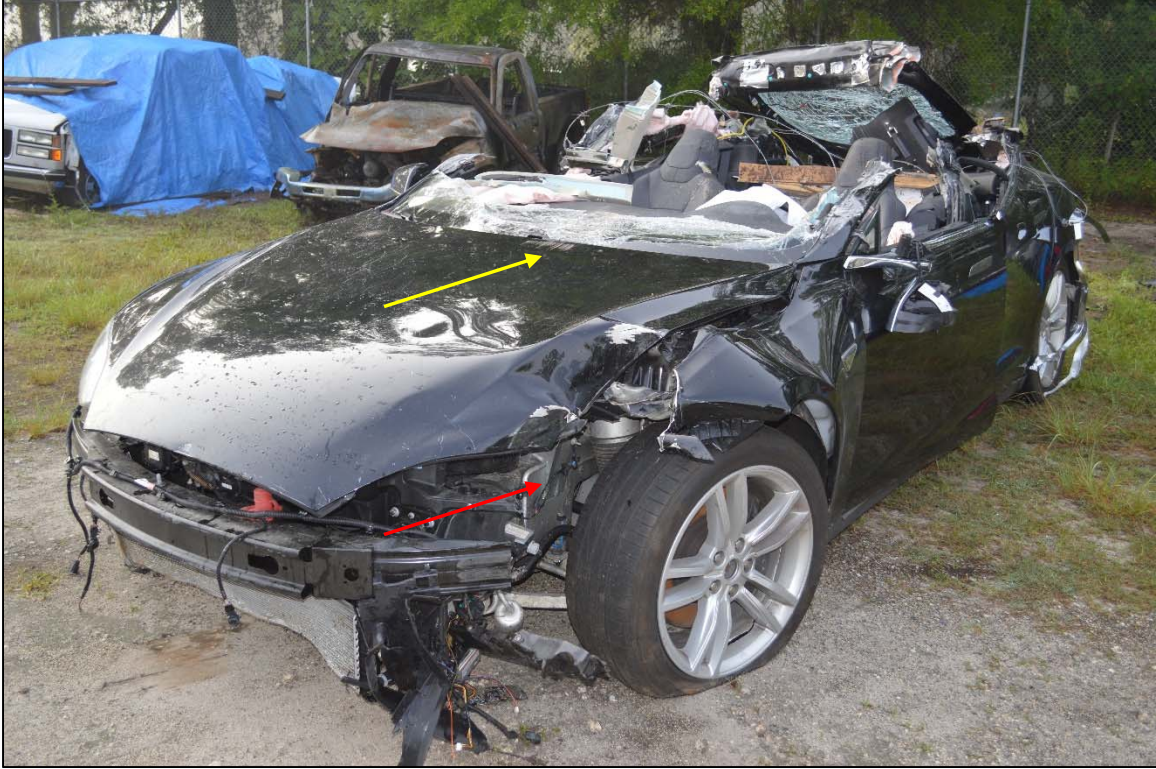
The vehicle was identified as a 2015 Tesla Model S 70D, four-door sedan. The vehicle was scanned from four stations. Damage to the vehicle included the complete separation of the roof panel, which exhibited fore to aft compression similar to an accordion. The combination rear window frame and trunk lid (lift back) was observed to be inverted and folded over the rear of the vehicle. Impact damage was also observed at the left front of the vehicle forward of, and in line with the left front wheel.

The forward facing surface of the A-pillars exhibited evidence of impact (disfigurement and material damage) just below where the A-pillar had separated. Measurements acquired from the 3D scan of the vehicle (in a static position), placed the evidence of contact at a vertical height of 3.17 feet.⁴ Additional evidence of impact consisted of scrapes to the trailing edge of the hood about 44.8 inches aft of the leading edge or just forward of the windshield. The area comprising the scrapes extended laterally about 5.2 inches toward the driver's side of the vehicle and were centered about five inches from the longitudinal centerline of the vehicle. The static height of the trailing end of the hood measured approximately 3 feet. The width of the scrapes was consistent with the length of the trailer's center side marker lamp that had been mounted below the side rail on the semitrailer.

Impact damage to the left front exhibited an arced pattern with rearward displacement of the vehicle's left front fender and other structures. The damage was characteristic of an impact into a pole and was centered about 12.4 inches inboard of the left side, in line with the front wheel. The left (driver's) side wheelbase measured about four inches shorter than the right side. The vertical height of the leading edge of the hood measured approximately 2 feet.

Figure 4: Florida Highway Patrol post-collision photograph depicting collision damage to Tesla. The yellow arrow indicates upper surface damage to the hood, while the red arrow indicates the pole impact damage. The rear window frame and trunk deck combination has been returned to the upright position.

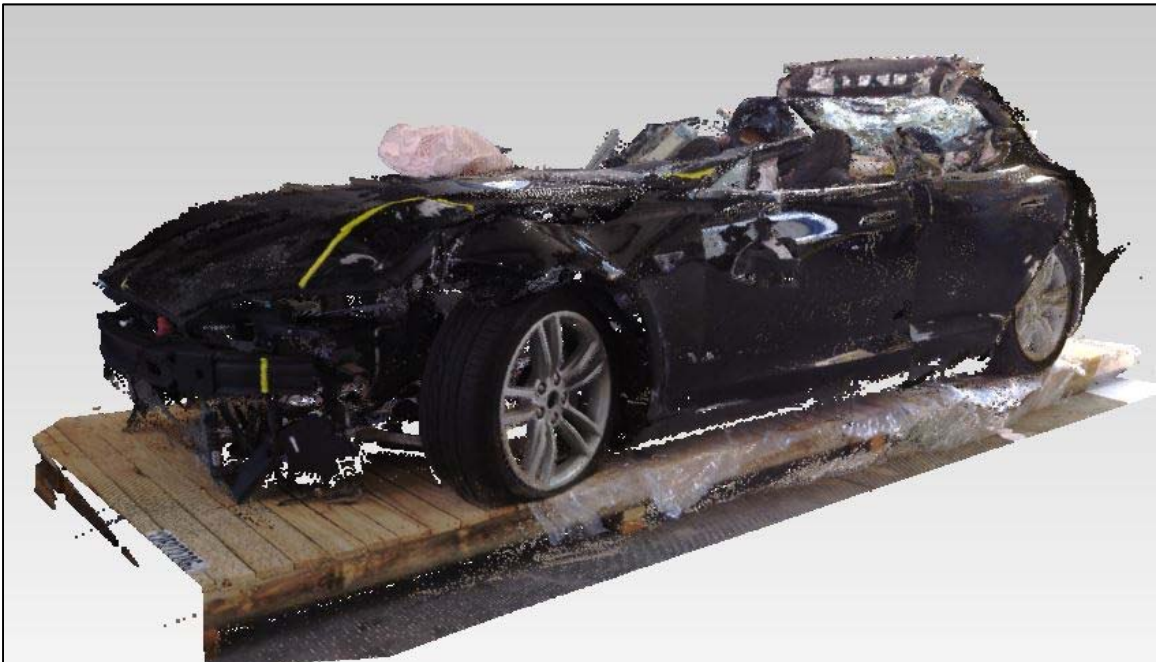
Figure 5: Image depicting linked 3D scans of the Tesla. The yellow tape visible in the image was applied by other investigators to outline areas of damage.

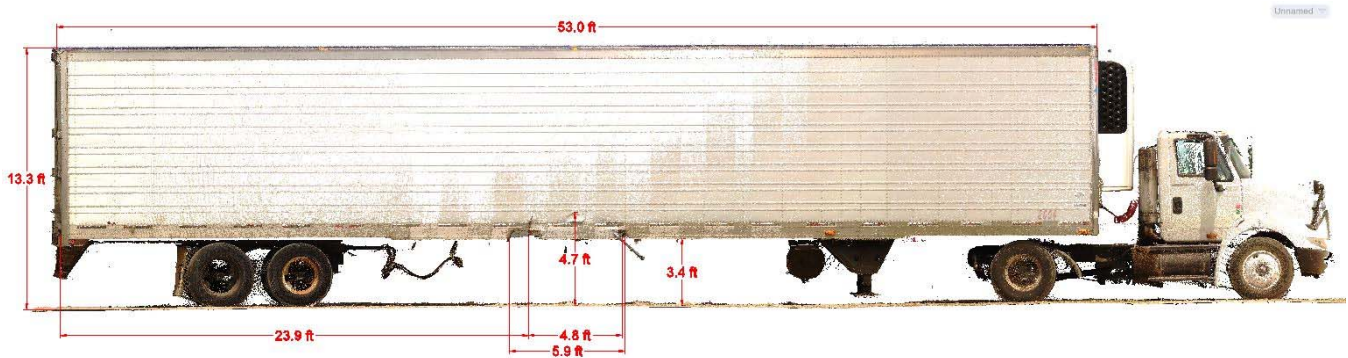
As measured in a static position, the vertical clearance below the trailer was approximately 3.42 feet. This measurement is approximately 1.29 feet lower than the published maximum

vertical height of the Tesla.⁶ The overall vertical height of the trailer measured approximately 13.3 feet, resulting in a sidewall surface area of just under 525 square feet.

Figure 4: Screen capture image depicting certain dimensional measurements for the semitrailer acquired from the 3D scan point cloud. The truck tractor depicted in the image is not the involved Freightliner.

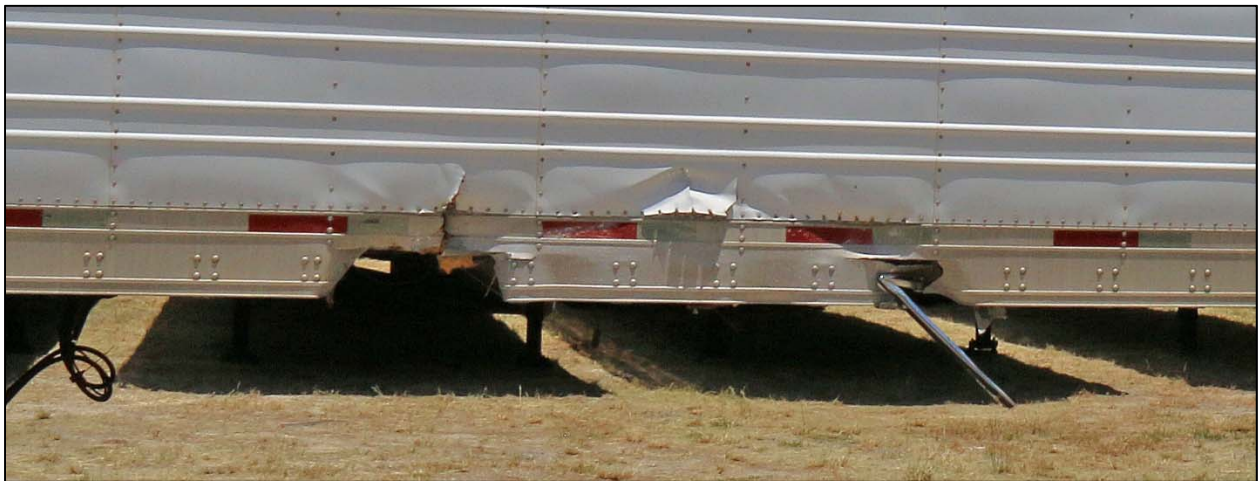
Collision evidence consisted of impact damage to the lower sidewall rails on both sides of the trailer and the undercarriage between the opposing damaged rails. Damage to the passenger (right) side exhibited inward intrusion, while damage on the driver (left) side exhibited an outward deformation. The damage on both sides exhibited two distinct areas of contact. The undercarriage damage consisted of a displaced transverse floor support rail between the damage areas on the two sides.

Damage on the right side exhibited two distinct areas of contact where the trailer's lower sidewall rail was torn and displaced inward. The sidewall between these two contact areas was superficially damaged and exhibited an arced impression that extended vertically above the sidewall rail damage. The rear most area of contact was centered approximately 23.91 feet (23 feet, 11 inches) forward of the end of the trailer. The forward most area of contact was centered about 28.58 feet (28 feet, 7 inches) forward of the trailer end. A segment of windshield trim from the Tesla was observed entangled within the damage of the forward most area of contact. The distance between the two areas of contact measured 4.66 feet (4 feet, 8 inches) from the approximate centers. Overall, the areas of contact comprised a longitudinal distance of 5.91 feet (5 feet, 11 inches).⁵ The lateral distance between the Tesla's A-pillars measured approximately 5.25 feet (5 feet, 4 inches) at the widest point.

Figure 5: Photograph depicting impact damage to the right side of the semitrailer. A segment of front windshield trim from the Tesla is entrapped in the forward most area of damage.

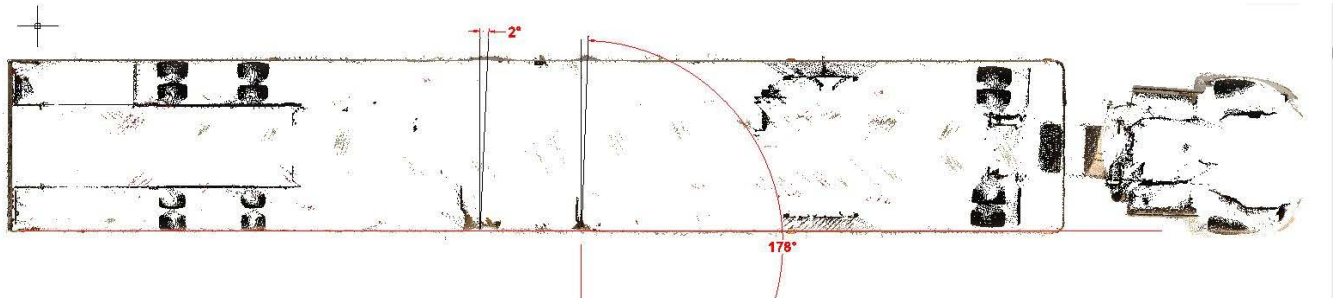
Damage to the left (driver) side of the semitrailer exhibited an outward displacement of the lower sidewall rail, but to a lesser extent than the right side. The left side areas of damage were similarly separated as observed on the right side, but were slightly forward. Figure 8 depicts a slice of the 3D point cloud at the level of the damage.

Figure 6: 3D point cloud slice depicting trailer damage at the lower sidewall.

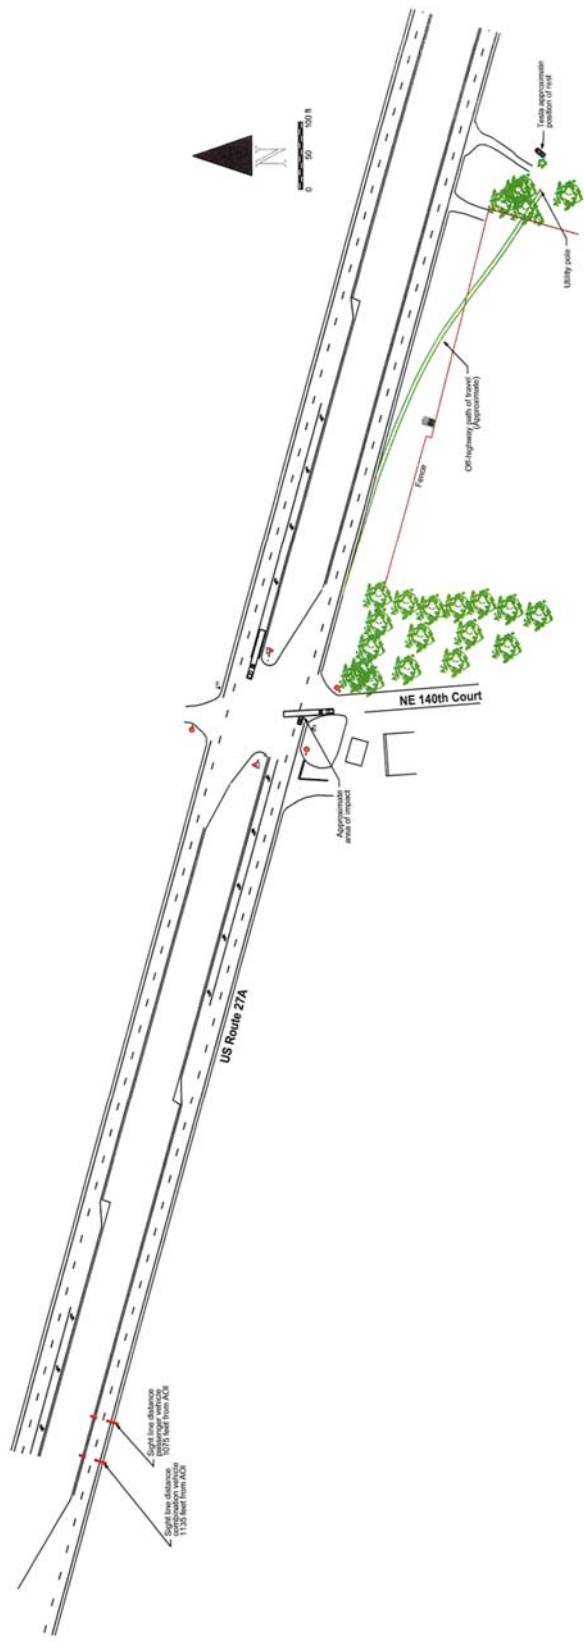
While the highway exhibited a heading that was straight, the line of sight available to opposing drivers operating near the intersection was affected by the highway crest vertical curve west of the intersection. Using the highway plan and profile data provided by FDOT, sight line distance for the left turning combination vehicle was calculated. Based on a truck driver average eye height of 7.6 feet and a distant target height of 3.5 feet, the sight line distance was calculated at 1,135 feet as measured from the area of impact.⁹ The calculated sight lines exceed the minimum AASHTO recommendations.

Similar sight line calculations were made for the eastbound Tesla driver, although the driver eye height was decreased to 3.5 feet as recommended for passenger vehicles in the AASHTO reference. The sight line distance for the eastbound passenger vehicle was calculated to be approximately 1,075 feet from the area of impact. The slight decrease in the calculated distance of the eastbound passenger vehicle is due to the difference in driver eye heights. However, the taller truck would represent a larger target.

Figure 8: Crash site diagram depicting sight line distances as measured from the area of impact.
