**ACCIDENT RECONSTRUCTION GROUP
FORENSIC DOCUMENTATION
CHAIRMAN'S FACTUAL REPORT**

**Fatal Grade Crossing Accident
Midland, TX; 11/15/2012**

**HWY-13-MH-003
(23 Pages)**

**NATIONAL TRANSPORTATION SAFETY BOARD
OFFICE OF HIGHWAY SAFETY
WASHINGTON, D.C. 20594**

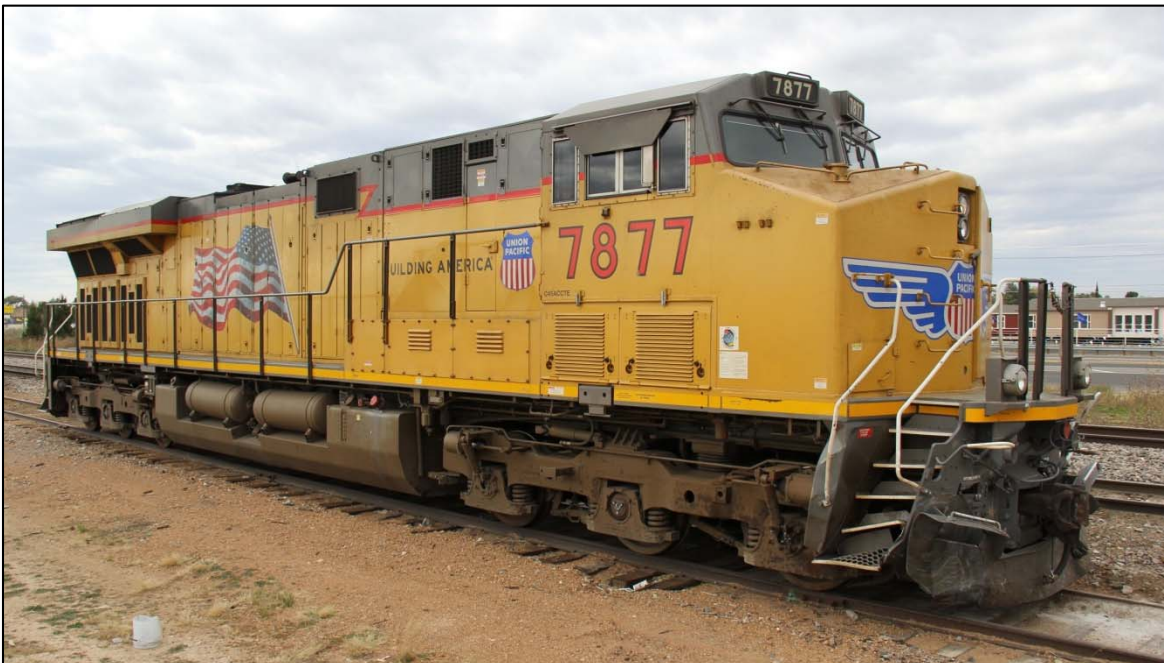
Figure 1: Photograph of subject locomotive taken during follow up examination

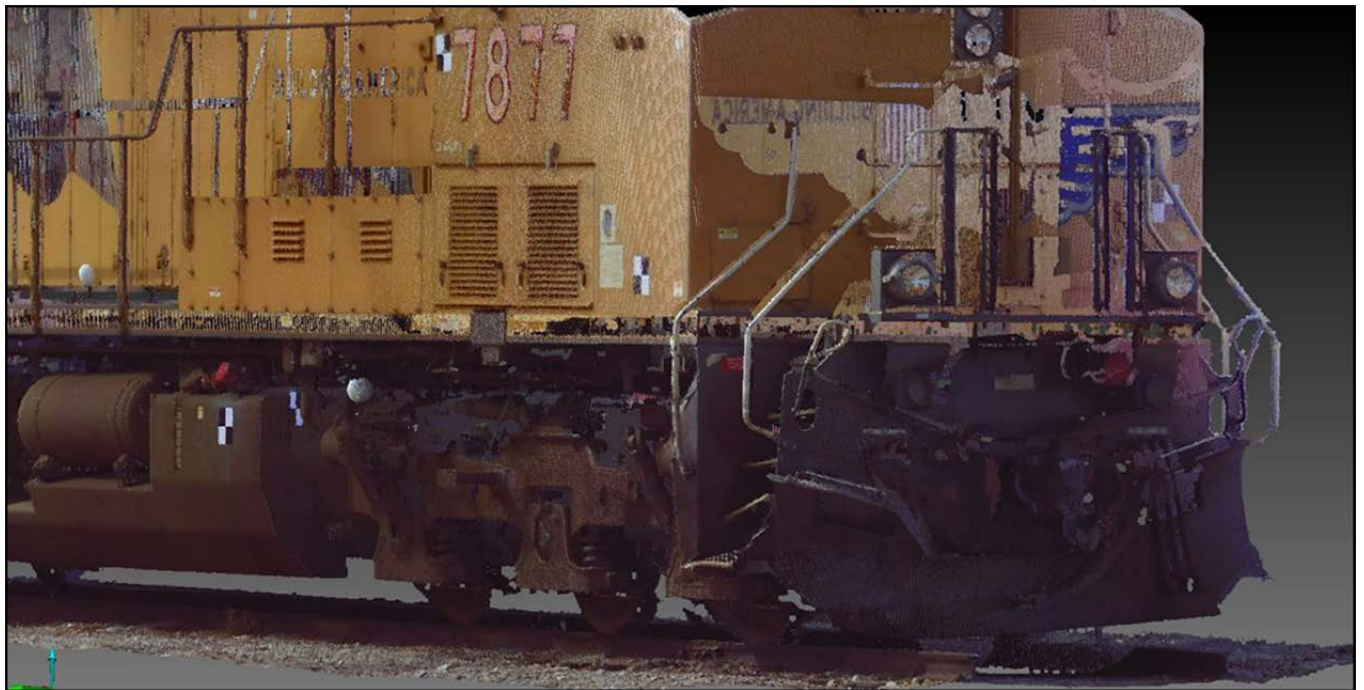
Impact to the locomotive occurred at the right front with evidence of direct contact extending inboard a maximum distance of 37 inches. The majority of material transfer and structural deformation was confined to within about 30 inches from the outboard edge of the locomotive's front-mounted plow. The plow was positioned forward of the locomotive end plate³ and extended across most of the lateral width of the locomotive's front end. While the end plate was a vertical structure (that extended downward from the side step landing to within a few inches of the rail), the plow exhibited an aftward taper from the locomotive's centerline. Outboard of the coupler the plow extended vertically to a maximum height of approximately 43 inches above the rails and exhibited an increasing curved surface such that the top edge arcs further forward than the bottom. At a minimum, the back side of the plow on the undamaged side was about five inches forward of the end plate.

The plow, end plate, side steps and side step mounting plate on the right side all exhibited rearward displacement. The displacement ranged from approximately one foot at the bottom edge of the side step mounting plate, to 1.2 feet at the end plate to 1.6 feet at the plow. The top edge of the plow was displaced downward approximately seven inches at the outboard edge. Some tearing of the approximately $\frac{5}{16}$ -inch thick steel near the lower corners of a cutout in the plow was observed within the area that made contact with the semitrailer wheel. Figure 3 depicts a screen capture of linked three-dimensional scans of the damaged area on the locomotive. Figures 4 and 5 are photographs that depict elements of the impact damage.

Figure 3: Depiction of linked 3D scans with focus on frontal impact area.

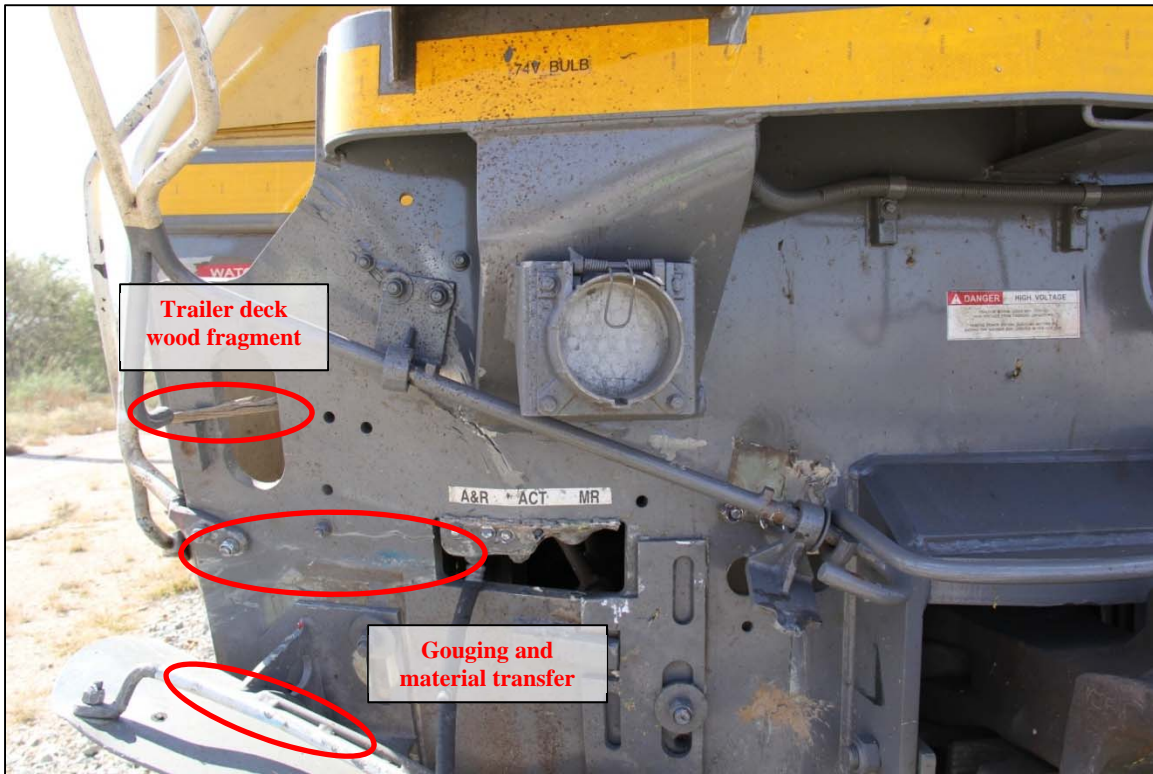
Evidence of material transfer at the right front of the locomotive exhibited black, red and blue coloring. The color and location of the material transfer was consistent with the tire and decorative banner material that had been in place on the trailer. The plow also exhibited scrapes and gouges to the paint and steel structure that included an arced pattern consistent with the rim and tire from the semitrailer. The arced pattern was most pronounced within an area about 21 inches inboard of the plow edge and 19 inches above the rail. Blue colored material transfer was observed on the hand rail at the top of the plow as well as further aftward on the end plate. The end plate also exhibited surface gouging and additional material transfer (blue and red color) that extended inboard from the right edge at a vertical height of 43 to 44½ inches. Red and blue material transfer was also observed on protruding fasteners and hardware and both side step hand rails on the right side of the locomotive. A wood fragment consistent with the semitrailer's deck surface was located within an end plate cutout just inboard of the right edge and about 46 inches above the rail.

Figure 4: Photograph of impact damage to subject locomotive exhibiting semitrailer override of plow.

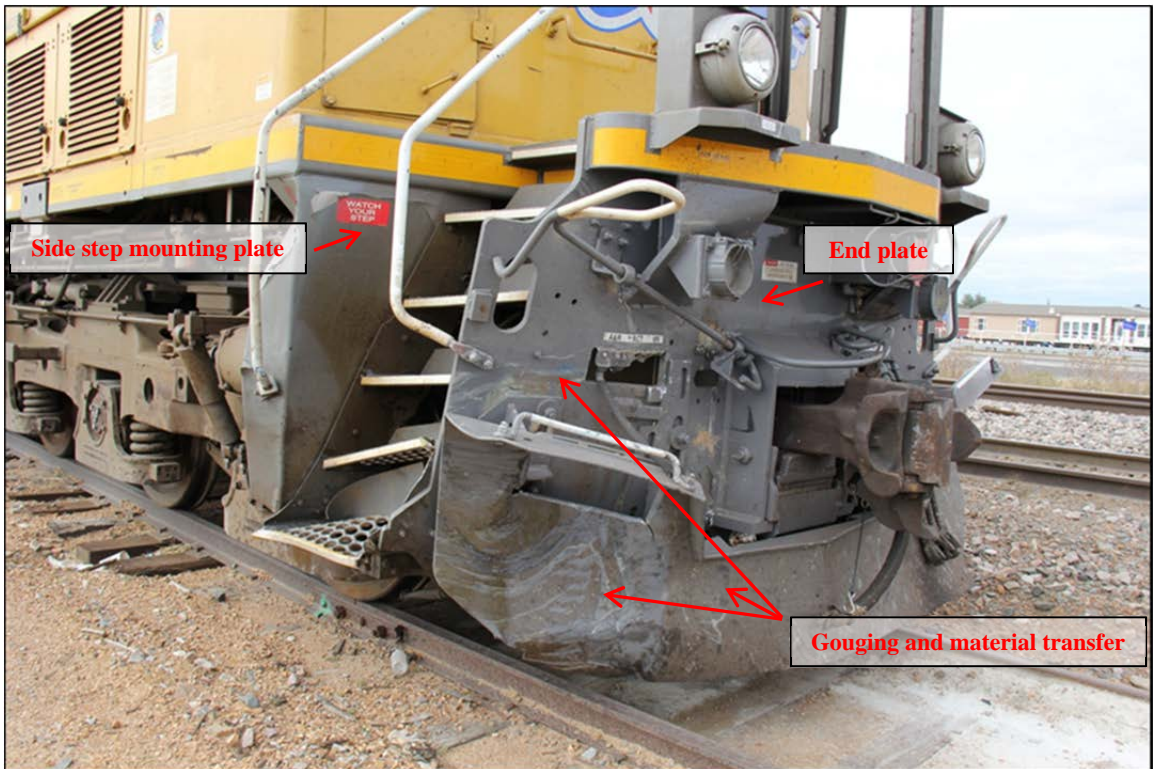
Figure 5: Photograph of subject locomotive depicting impact damage and subsequent component deformation.

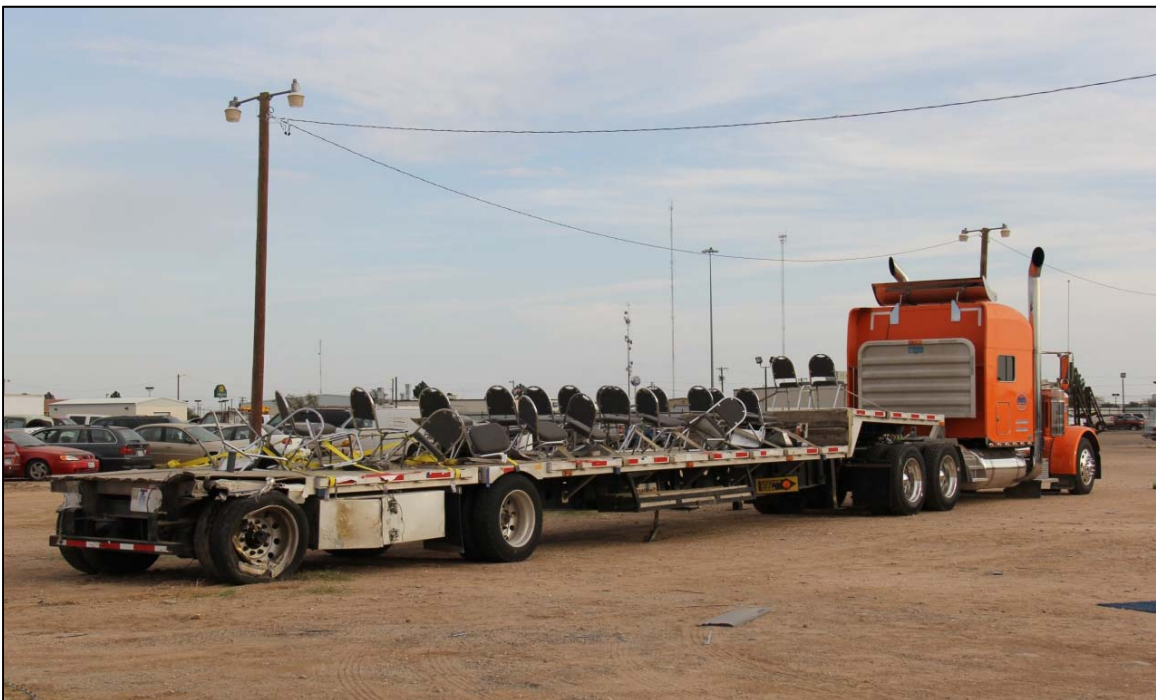
Figure 6: Subject combination vehicle as viewed forward from the impact area.

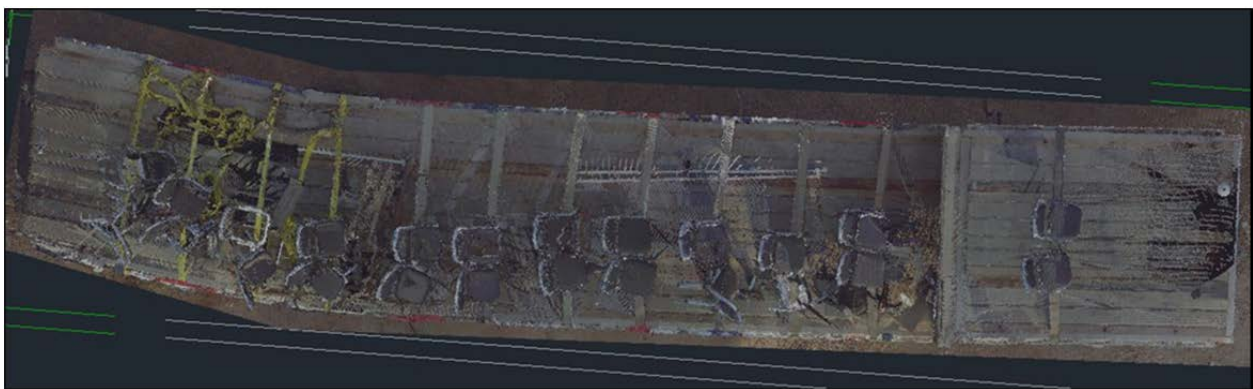
As a result of the impact the aft end of the trailer was displaced laterally toward the driver's (left) side resulting in a skew of the trailer deck measuring approximately 1.9 to 2.0 feet at the aft end (see Figure 9). Onset of the lateral displacement was observed approximately 10.9 feet forward of the tail end of the trailer⁴ or just behind the leading trailer axle. At this location a two-inch wide gap was observed at the right side rail while there was a corresponding compression of the left side rail. Additional side rail separation was observed on both sides of the trailer approximately three feet further forward, just forward of the leading axle. The trailer deck was buckled and fractured between these locations.

Despite the lateral displacement of the trailer deck and associated lateral offset of the trailing axle, the axle wheelbase on both sides were essentially unaltered measuring 10.11 and 10.08 feet on the right and left sides respectively (nominal wheelbase is 10.08 feet).

Figure 9: Depiction of linked scans illustrating post-collision skew of trailer.

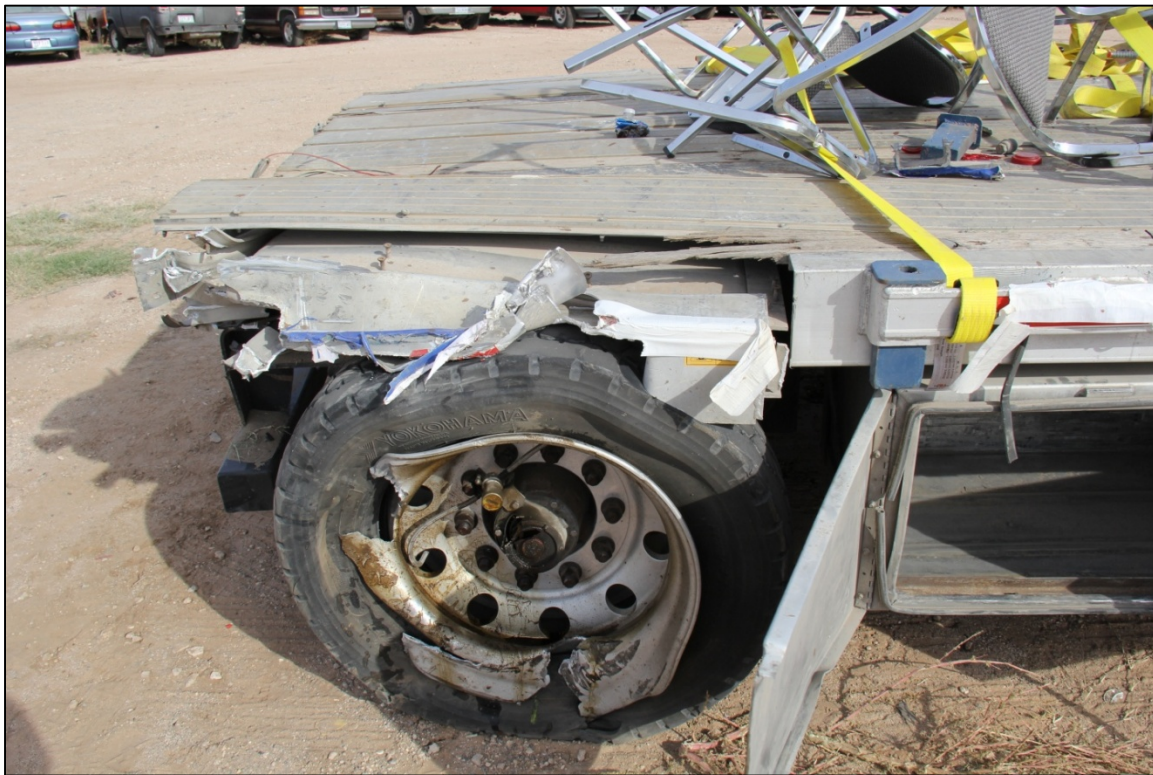
Contact damage about the area of the locomotive impact was observed at the passenger side rear of the trailer. Damage was observed to the rearmost wheel assembly⁵, side rail, deck and end plate⁶. The deck sidewall exhibited evidence of direct contact that extended from the aft end of the trailer forward for a distance of approximately 32 inches (2.69 feet). Induced damage adjacent the area of contact included additional tearing of the side rail and extended another 3.5 inches forward of the contact area. Other than the bowing of the semitrailer and related structural disfigurement, induced damage adjacent the area of contact extended forward from the aft end of the trailer approximately 46 inches. In addition to the contact damage exhibited at the side rail and deck, the trailing axle outer wheel rim and tire sustained contact damage. The rim was deformed and torn. The outer tire was punctured, deflated and entrapped by deformation of the side rail. The end plate, which also comprised approximately 10 inches of the aft end of the side rail, had been torn from its securement hardware and displaced from the vehicle. Adjacent the area of direct contact, aluminum sections of the deck were buckled upward while wooden sections were fractured and splintered. Vertical height of the trailer deck was measured at 39 to 40 inches when coupled to the truck tractor. Figure 10 depicts the damage about the area of direct contact. Figure 11 depicts linked scans with certain dimensional measurements.

Figure 10: Photograph of area of contact to subject semitrailer.

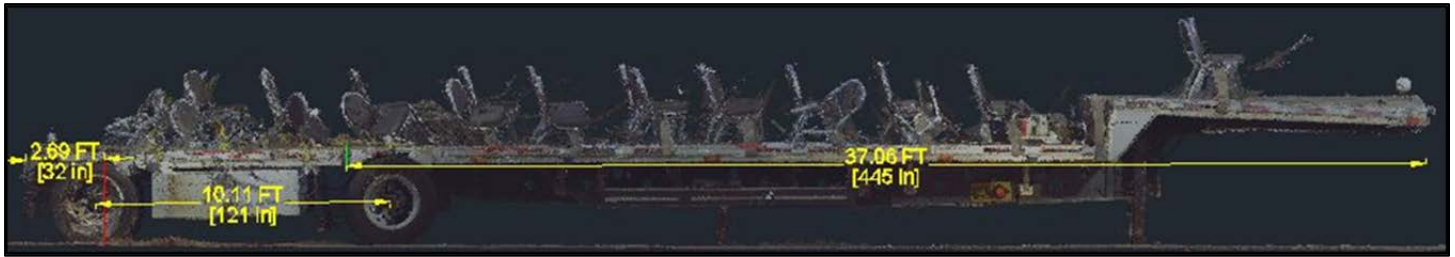
Figure 11: Depiction of linked 3D scans with dimensional measurements.

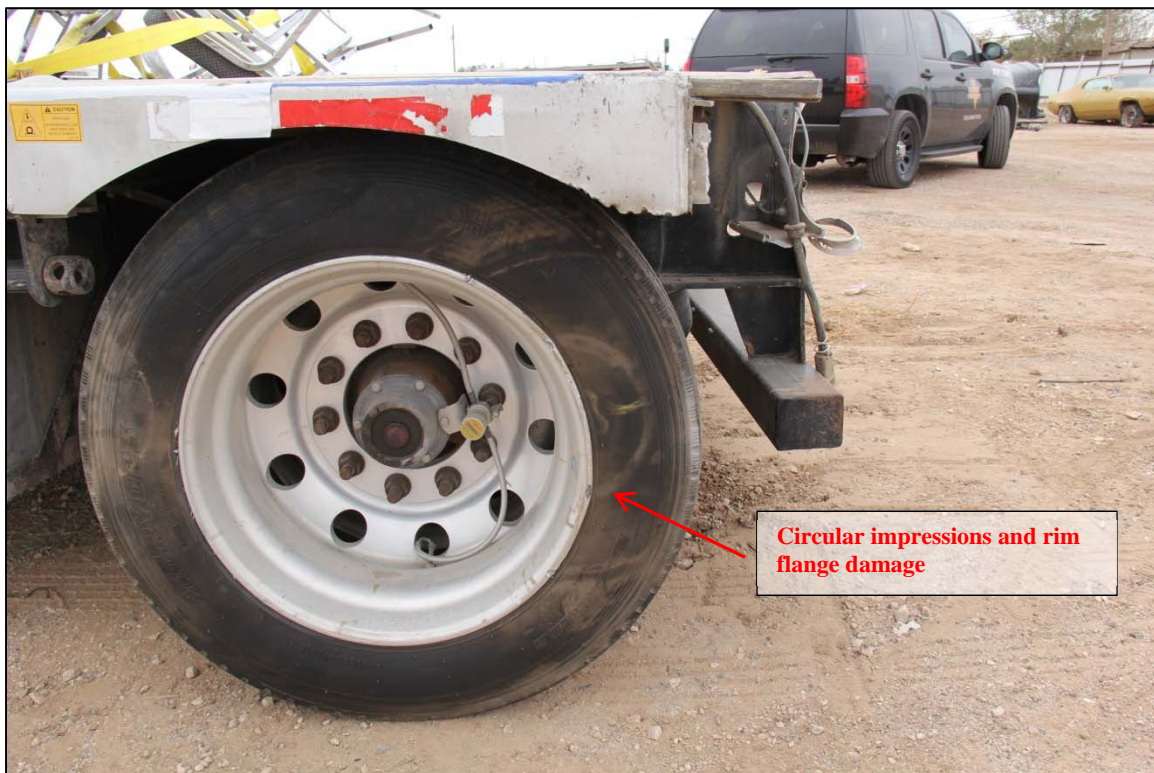
Evidence of subsequent contact that resulted in minor damage was observed at the trailing axle on the left (driver's) side. Concentric circular impressions were visible on the tire sidewall and rim flange. The rim flange exhibited minor indentations in conjunction with the tire sidewall impressions. The impressions were consistent with the impact to the rear wheel of the Midland County Sheriff Department patrol vehicle that was also struck by the trailer. Figure 12 below depicts the outer wheel assembly on left side trailing axle.

Figure 12: Photograph of left side trailing axle tire and rim contact evidence.

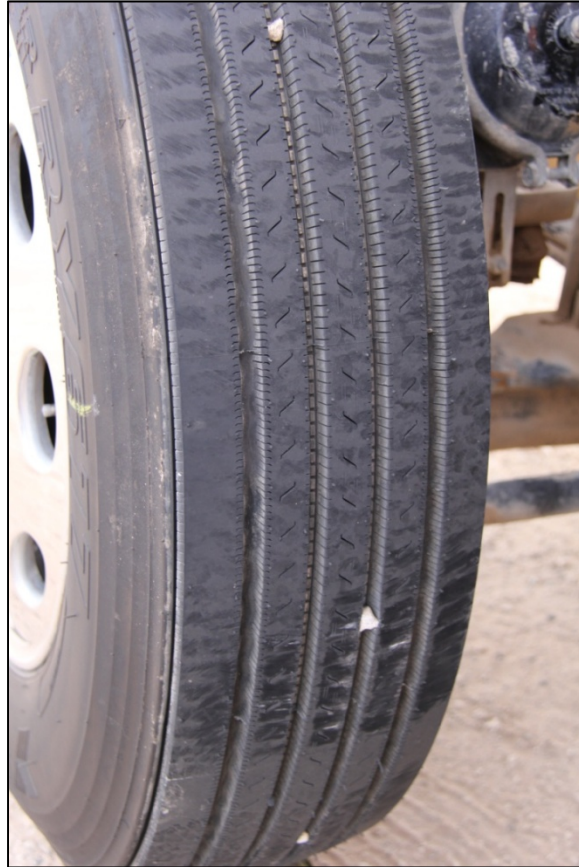
While the truck tractor exhibited no collision damage, lateral scuff marks were observed about the circumference of tread area on both steer axle tires and are depicted in Figure 13.

Figure 13: Photograph depicting scuff marks to steer axle tires (right side tire illustrated).

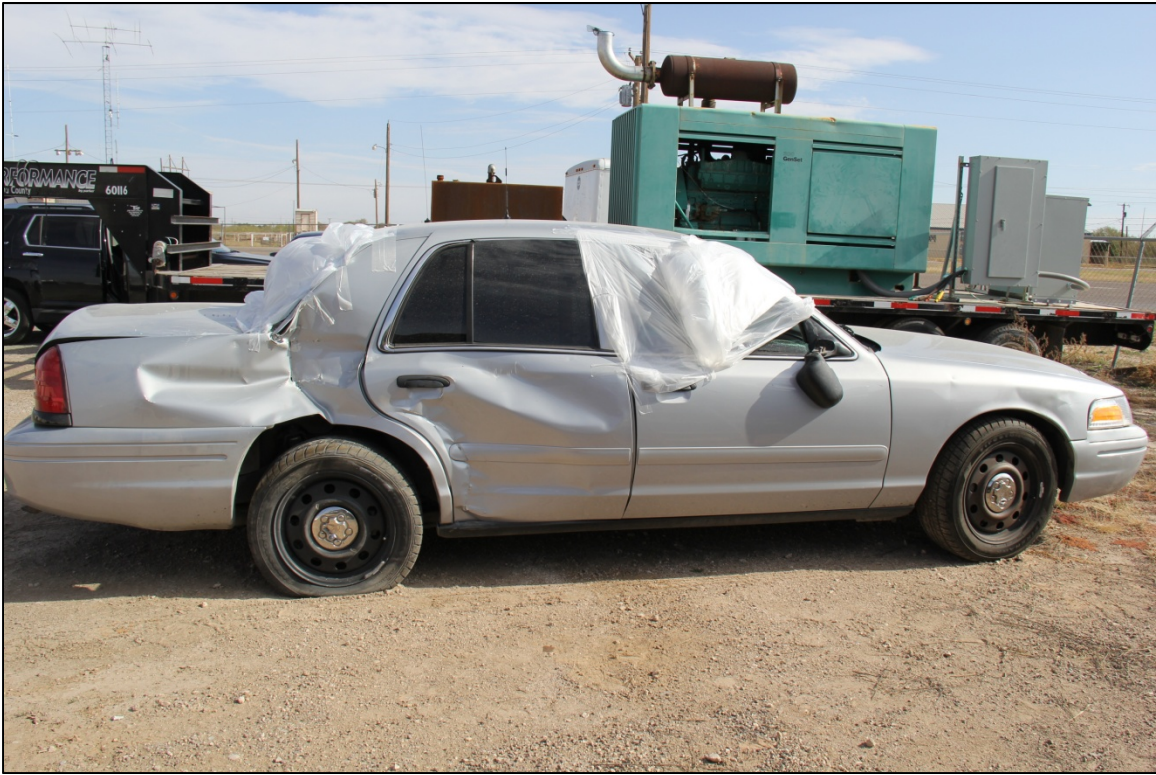
The vehicle exhibited evidence of impact damage to the passenger (right) side with the more significant area of damage about the rear fender and wheel. The area of damage included the fender, rear passenger door, wheel and tire and rear window. Direct contact, which was consistent with contact from the trailing end of the trailer's left side rail, initiated approximately six inches aft of the rear axle and within a vertical height of 35 to 41 inches (adjusting for tire deflation). Induced damage extended within an area between approximately 28 inches aft of the axle and the rear passenger door opening at the C-pillar. The lower portion of the C-pillar and lower right corner of the rear window frame were distorted and the rear window fractured and displaced from the frame. The interior body panel at the C-pillar exhibited some intrusion into the occupant compartment such that the rear seat back was slightly compressed. About midway along the passenger rear door, just below the window sill, a group of vertical scrape marks superimposed an indentation in the sheet metal. The vertical height of this damage was consistent with the side rail height of the semitrailer.

Additional contact damage was observed at lower trailing edge of the rear passenger side door. This area of contact was characterized by an arced indentation and paint gouging of the door sheet metal that extended approximately 21 inches forward of the rear axle. A reverse impression of the arced indentation was likewise observed on portions of the tire sidewall, wheel rim flange and hub cap. At points of contact the rim flange and hub cap exhibited minor deformation. The circular indentations were indicative of contact from the left side trailing outboard wheel assembly on the trailer.

Characteristics of the damage and the pre-collision position of the vehicle indicate that as the semitrailer rotated following the locomotive impact it struck the rear of the Ford inducing it into a clockwise rotation until the passenger side front made contact with the trailer. Impact induced rotation and lateral movement of the Ford is also depicted in video footage viewed by investigators.

Figure 14: Photograph depicting Midland County Sheriff patrol vehicle damage.

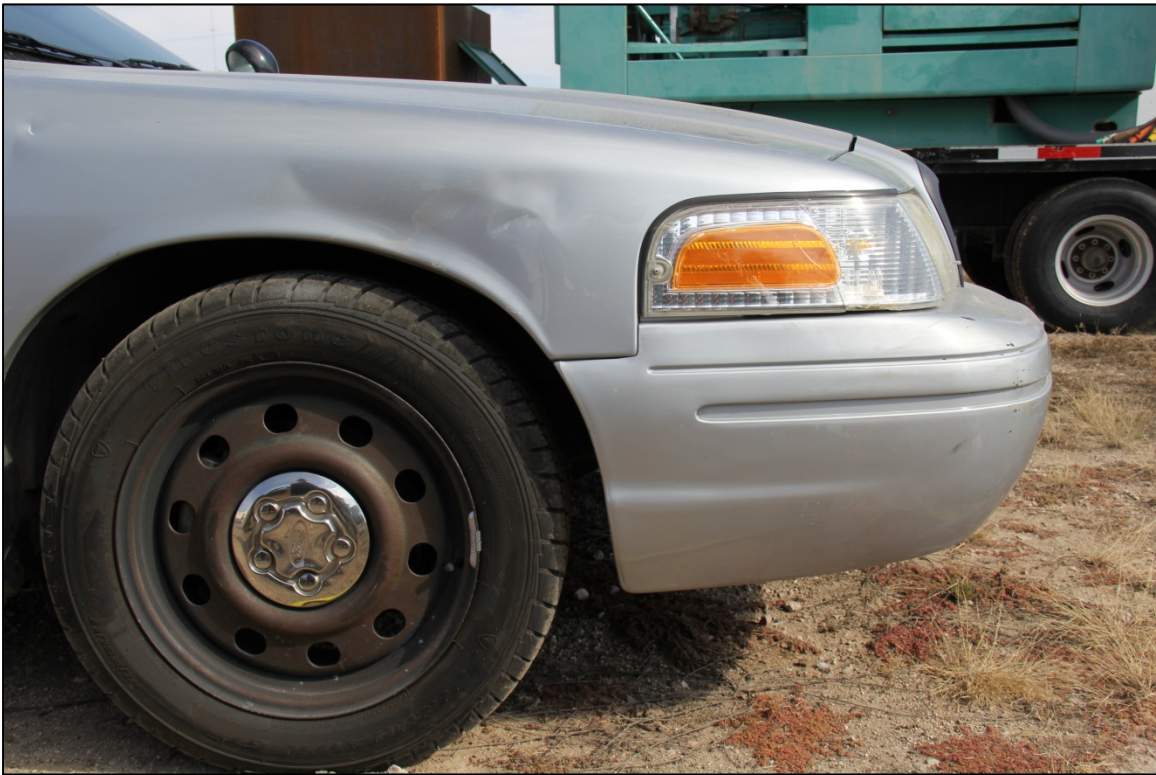
The second area of contact was observed about the right front fender, side marker lamp housing and outboard corner of the bumper cover. Minor indentations, black colored material transfer and paint scuffing were located on the fender beginning about 3-4 inches forward of the axle, but at a vertical height less than 31 inches. The tire sidewall exhibited scuffing. Further forward, arced scuff marks were observed across the side marker lamp/reflector housing and corner of the bumper cover. Measurements taken forward from the rear axle placed this damage at slightly more than 120 inches forward of the rear contact damage. Additional damage exhibited on the Ford included the fracturing of the front passenger side window.

Figure 15: Photograph depicting damage to passenger side front of sheriff patrol vehicle.

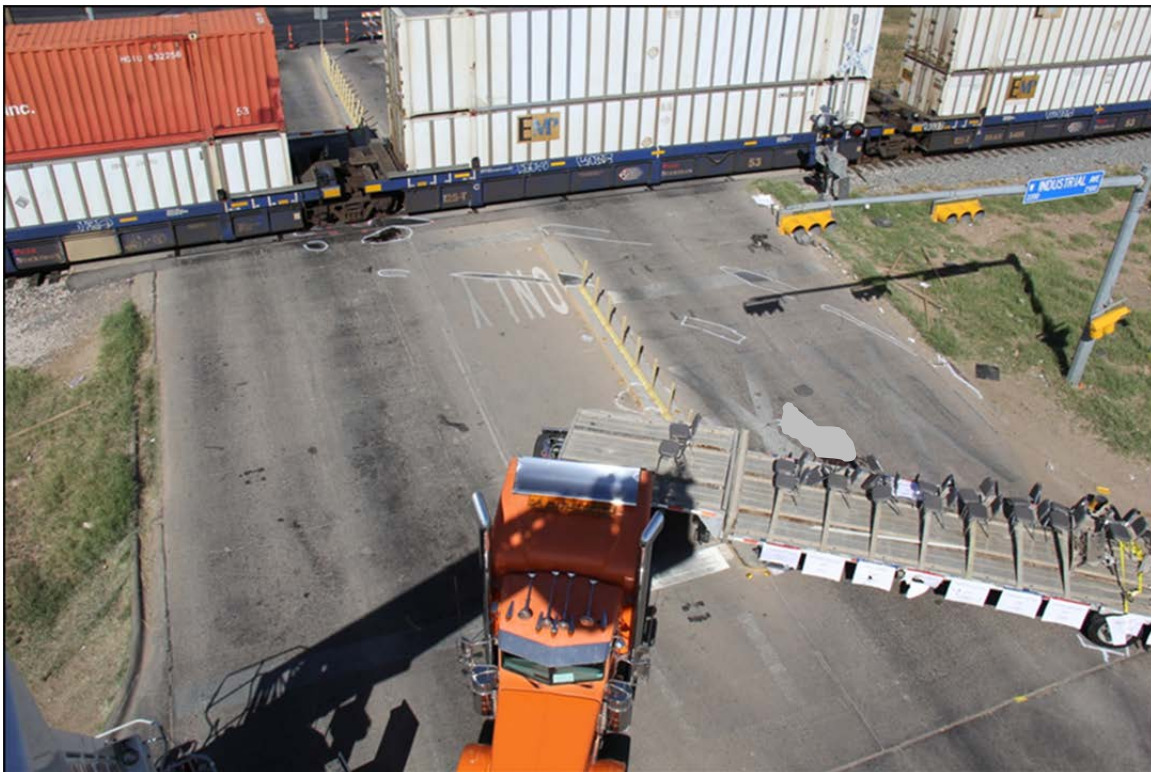
Figure 16: Photograph depicting overhead view of commercial vehicle in its post-collision position of rest. Roadway evidence was outlined by law enforcement personnel. (Note – Light gray color area on opposite side of trailer was inserted to obscure a large deposit of biological material on the road surface.)

In its position of final rest, the truck tractor exhibited a clockwise rotation of about 28° relative to its original direction of travel. The front of the tractor occupied the left through lane of southbound S. Garfield Street while the drive axles occupied the southbound left turn lane. The front of the truck tractor was approximately 68 feet south of the southern rail. The semitrailer was angled at about 90° relative to the tractor and at rest was straddling the raised median and occupied both through lanes of northbound S. Garfield Street. At final rest the trailer exhibited a clockwise rotation of about 122° relative to its original direction of travel. As the aft end of the trailer progressed through its post-impact rotation the arc radius increased from about 47 to 53 feet and covered an average distance of approximately 105 feet. The tractor's fifth wheel coupler exhibited a lateral movement of approximately 10.6 feet during the collision.

The onset of roadway evidence consisted of tire friction marks created by the passenger (right) and driver (left) side dual tires on the trailing axle of the semitrailer. The marks initiated about one foot south of the southern rail and 14.9 and 22.3 feet east of the western curb line for the right and left side tires respectively. From the onset of these marks, additional intermittent tire friction marks exhibiting an arced path of travel continued in southeasterly direction. The final mark created by the trailing axle was observed atop the east side curb approximately 37.6 feet south of the southern rail. The trailing axle wheels then traveled atop the roadside soil and returned to the paved road surface. At final rest the right side wheels were about 2.6 feet into the roadway.

Approximately 10.6 feet further south from the trailing axle tire marks and 6.4 feet further east, pavement scuff marks from the right side leading tires were observed. The road surface scuffing transitioned to intermittent black friction marks that surmounted the raised median about 18.2 feet south of the southern rail.

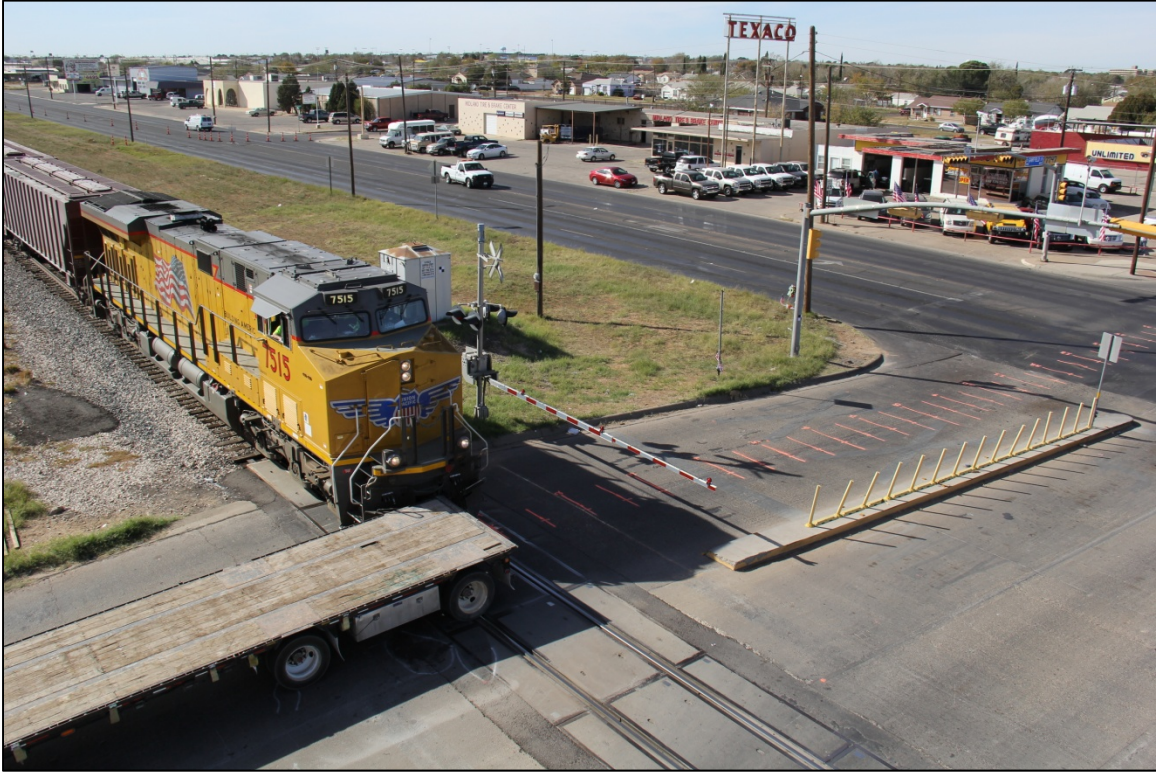
At impact, approximately 48 inches of the aft end of the semitrailer overlapped the locomotive right-of-way. Figure 20 is a photograph depicting the relative positions of the train and Peterbilt combination at impact using an exemplar semitrailer and locomotive.

Figure 20: Photograph depicting relative position of locomotive and semitrailer at impact (using exemplar equipment).
