**TECHNICAL RECONSTRUCTION GROUP CHAIRMAN'S  
FACTUAL REPORT**

**Chattanooga, TN**

**HWY15MH009**

**NATIONAL TRANSPORTATION SAFETY BOARD  
OFFICE OF HIGHWAY SAFETY  
WASHINGTON, D.C.**

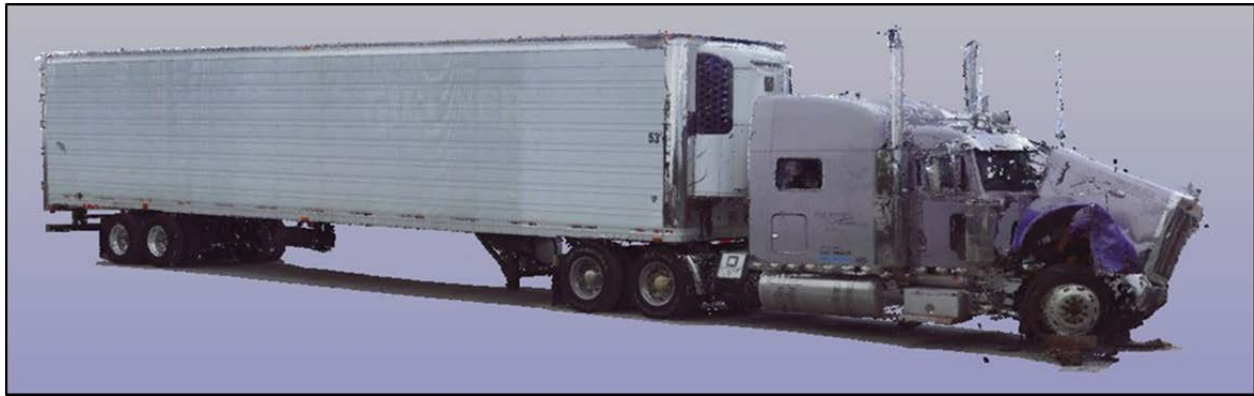
Figure 2: Colorized image of linked 3D scans depicting the right side of the Peterbilt combination.

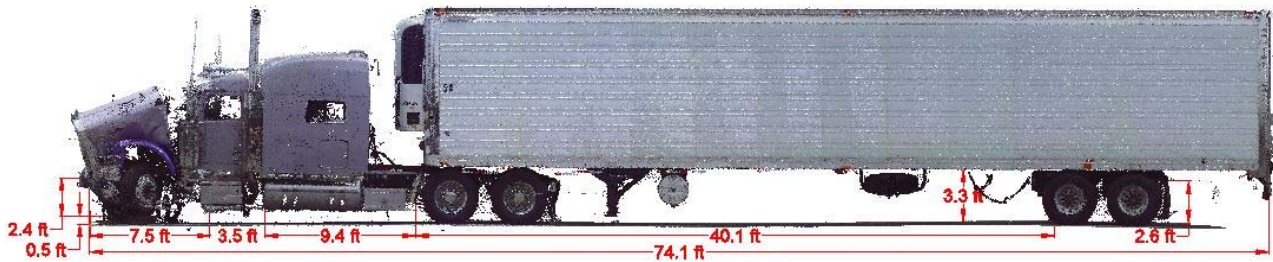
damage that encompassed the entire width of the vehicle. The scan data did not depict any offset in the alignment of the tractor frame and body aft of the engine compartment. The front bumper outboard of the frame rail on the left (driver's) side was displaced rearward as were both front fenders. The hood was canted leftward toward the driver's side. Evidence of contact damage at the front of the vehicle extended vertically about 6.2–6.5 feet to about the top of the grill and hood. The overall length of the vehicle was measured at 74.1 feet.

Figure 3: Point cloud image of the Peterbilt combination depicting certain dimensions. Note that the vertical measurement at the vehicle front accommodates the wheels being elevated on six-inch wood blocks.

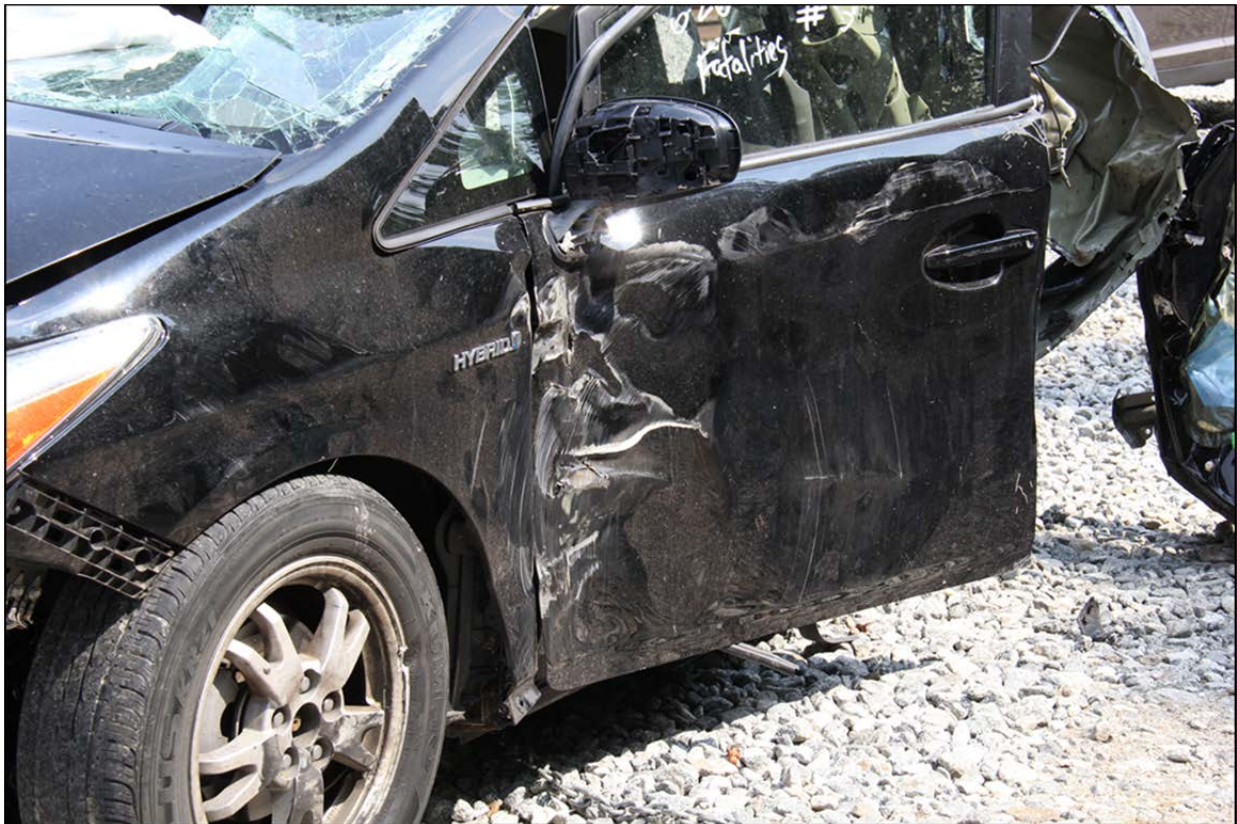
On the left side of the vehicle, evidence of contact damage was observed to the left front wheel, front fender, driver's door and a portion of left rear door. Indentations and arced scrapes resulting in paint removal and scuffing were observed at the trailing edge of the left front fender and extended rearward to cover most of the driver's door. The diameter of the opposing arcs measured about 2.6–2.8 feet (~31–34 inches).

Figure 4: Photograph depicting arced scrapes and associated indentation contact damage to the driver's door on the Toyota Prius.

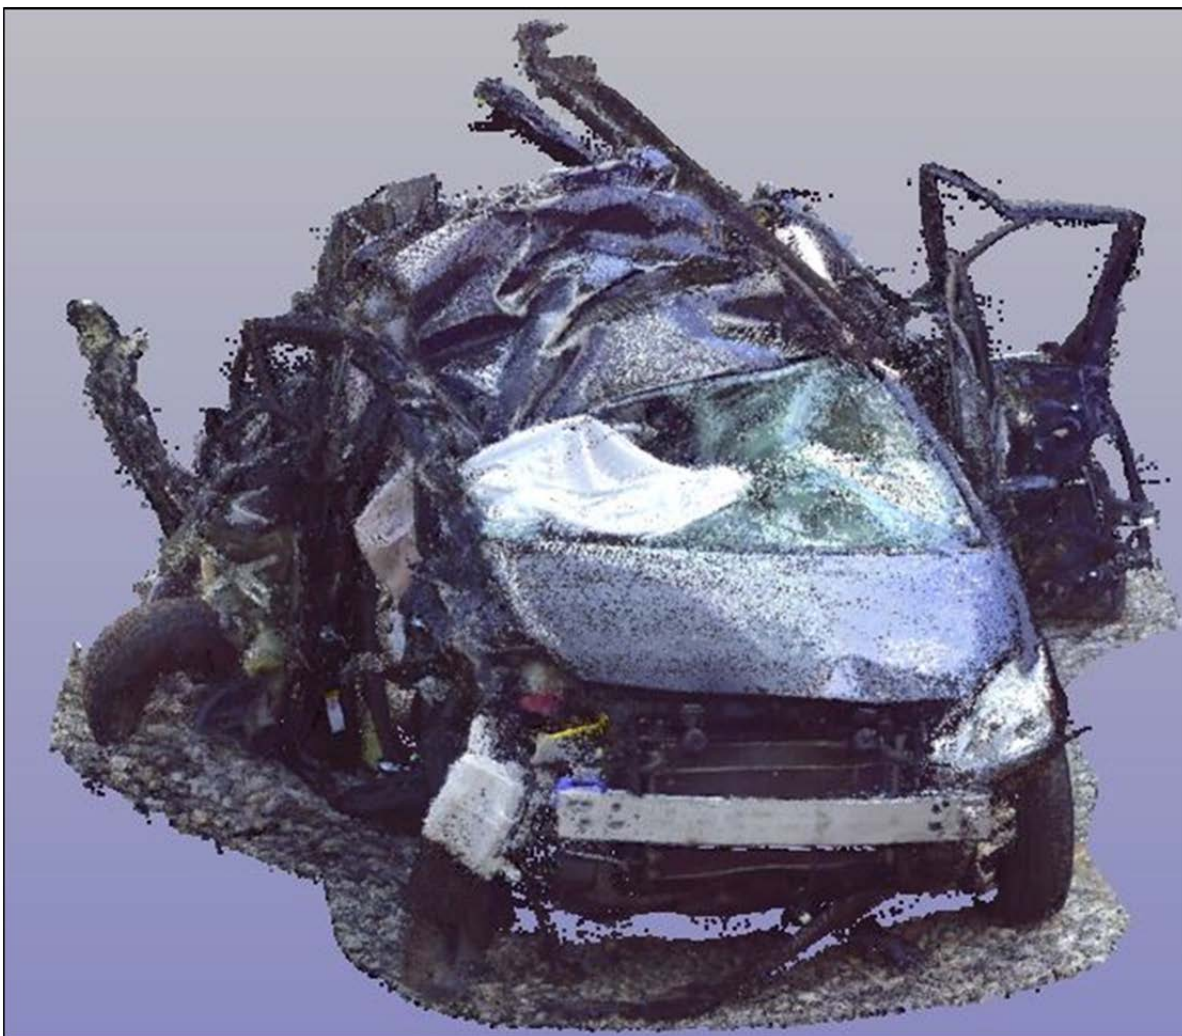
The vehicle also exhibited contact damage to the right side, right front fender and left side. The right front fender exhibited multi-directional displacement that included rearward,

laterally inward and vertically downward. The static vertical height at the top of the front fender ranged from approximately 2.7 to 3.1 feet (post-collision). The right front wheel also exhibited impact damage, as did the front passenger side door.

Figure 5: Colorized image of linked 3D scans depicting the front and forward right side of the Prius.

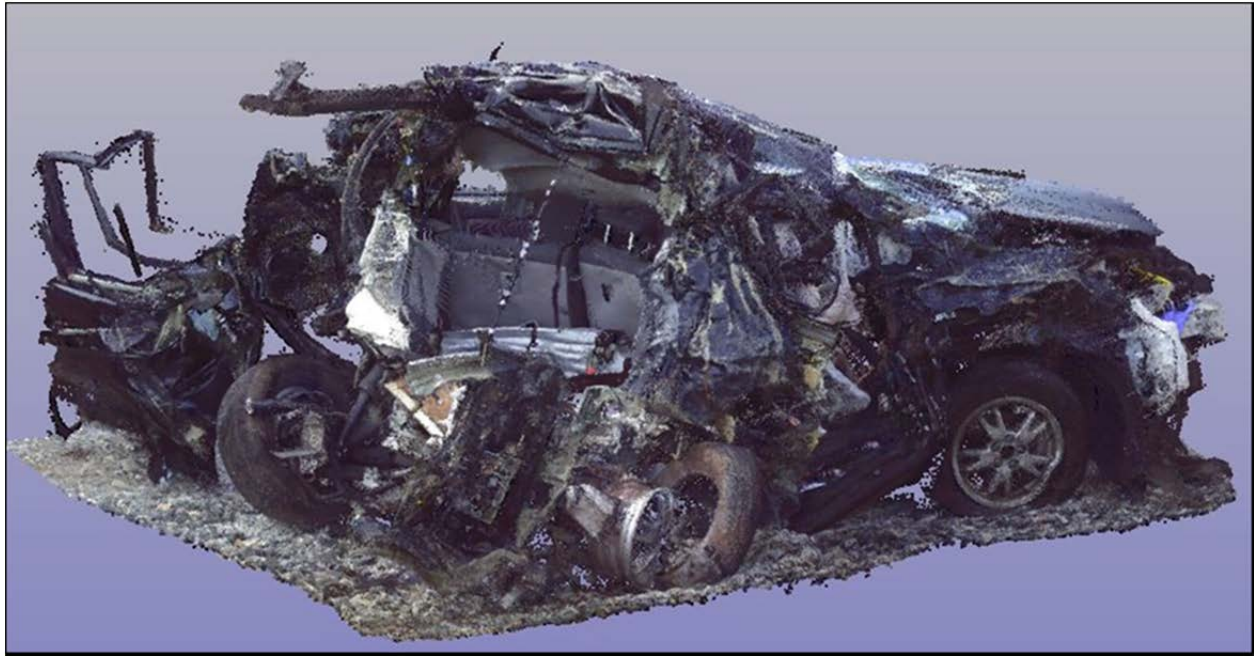
The Prius was identified as a four-door sedan that exhibited substantial damage and evidence of multiple impacts. The most significant damage was to the rear of the vehicle, which included substantial occupant compartment intrusion and override of the floor pan. The vehicle exhibited a rightward (passenger side direction) bowing as well as downward buckling of rocker panel on the passenger side. The average overall length of the vehicle was reduced by approximately 6.4 feet (76 inches) and wheelbase measurements on the right and left sides were also reduced by about 3.1 and 0.7 feet (37 and 8 inches) respectively.

Figure 6: Colorized image of linked 3D scans depicting the rear and right side of the Prius. The front passenger side door was removed at the crash site by emergency response personnel.

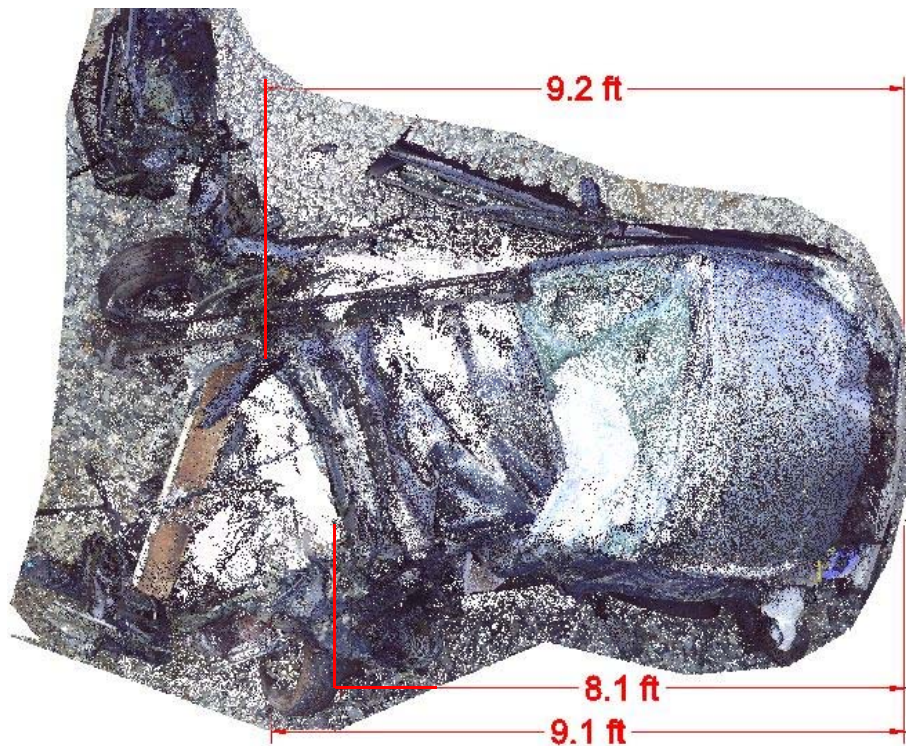
Figure 7: Point cloud image of the Prius depicting certain dimensions.

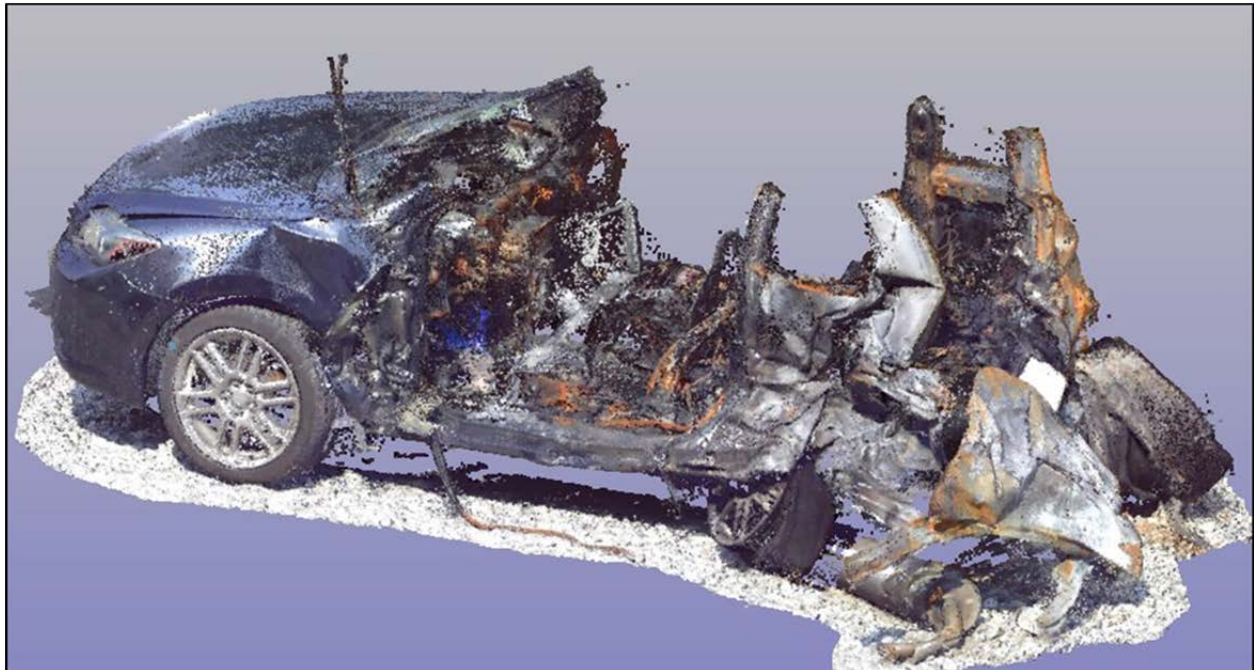
The Scion was identified as a two-door, hatchback sedan. The vehicle interior had been totally consumed by a post-impact fire. There was substantial rear impact damage that reduced the average overall vehicle length by about 2.5 feet. The rear impact damage was skewed toward the left. Although at the time the vehicle was documented the roof and all occupant compartment doors had been removed, CPD scene photographs depict that the doors were closed and intact after the vehicle came to rest. The police photos also depict evidence of an impact at the driver's door.

Figure 8: Colorized image of linked 3D scans depicting the left side of the Scion.

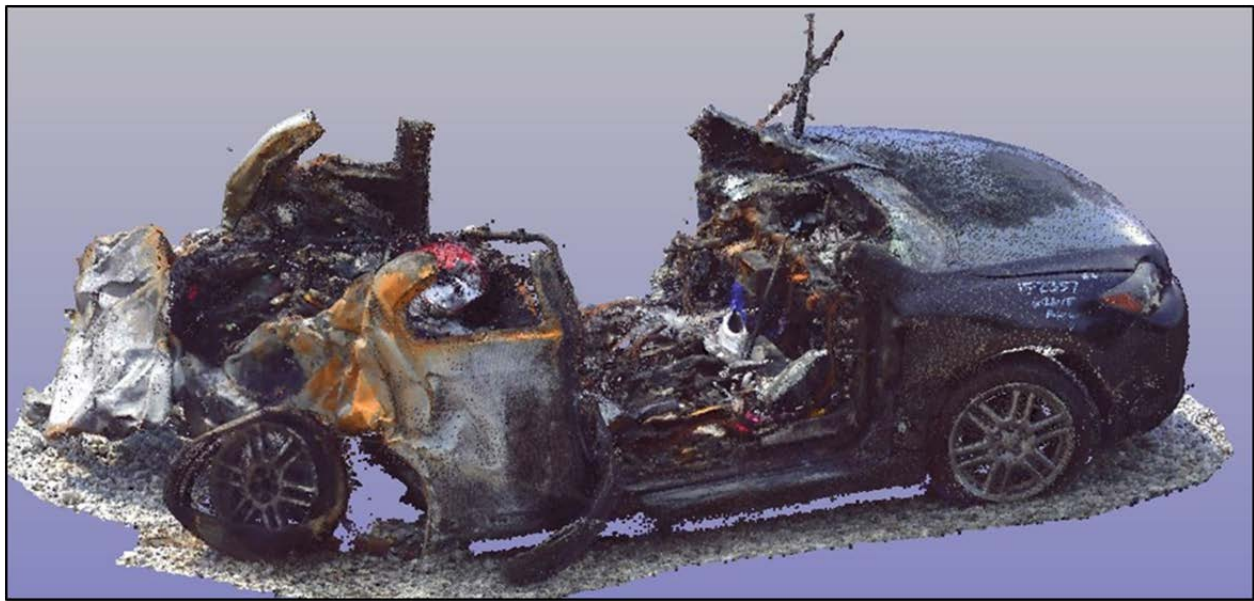
Figure 9: Colorized image of linked 3D scans depicting the right side of the Scion.

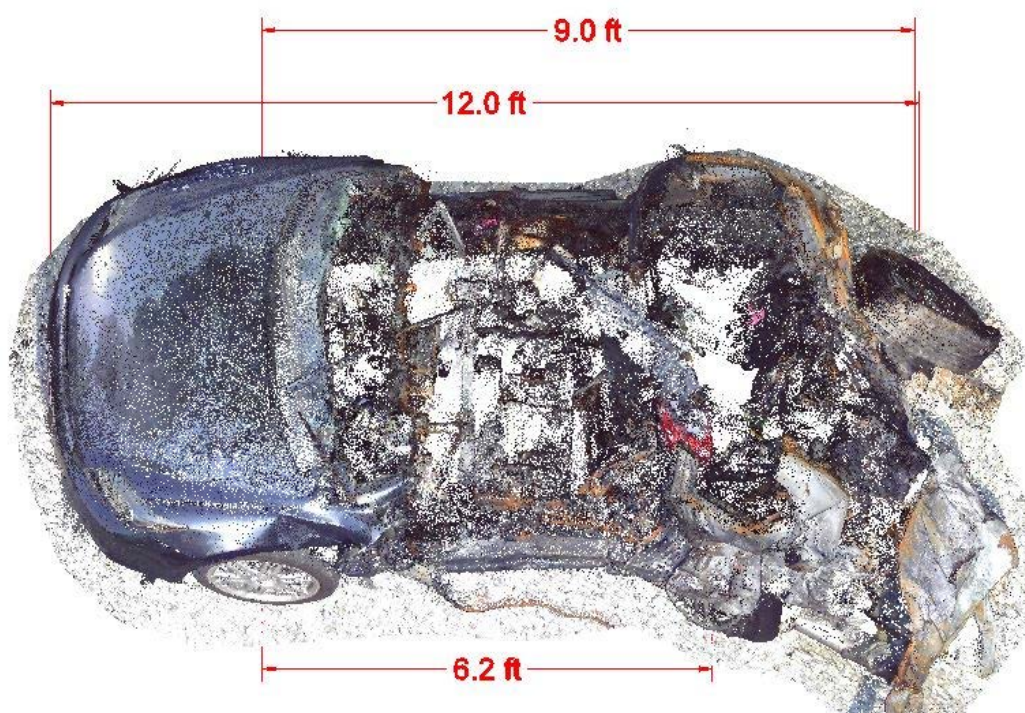
Figure 10: Overhead point cloud image of the Scion depicting certain dimensions.

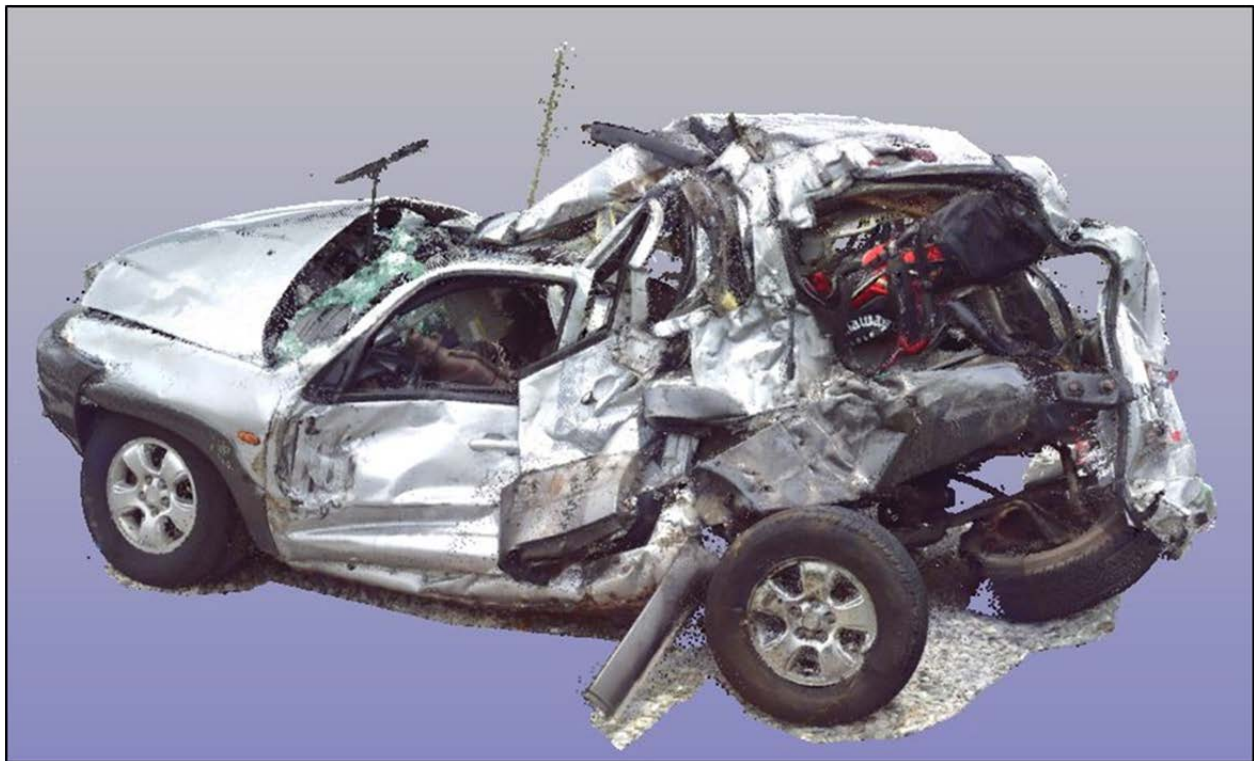
The vehicle exhibited evidence of multiple impacts that resulted in substantial occupant compartment intrusion. Impact evidence and body deformation were observed at the left rear and side, and extended forward to include the driver's door. Additional impact evidence and substantial deformation was observed at the right rear and along the right side of the vehicle. Lateral intrusion on both sides of the vehicle resulted in an overall reduction in the maximum vehicle width of about 3 feet, as measured post-collision.<sup>2</sup> The average overall length of the vehicle was reduced by about 3.8 feet on the driver's side. The face of the front bumper also exhibited evidence of lateral scrapes and was in contact with the median barrier following the collision. Material transfer, which appeared to be paint, tire residue and concrete were observed within several areas of damage. The appearance of red paint was observed within some damage on the right side, while black color material (characteristic of tires) was observed on the left side.

Figure 11: Colorized image of linked 3D scans depicting the rear and left side of the Mazda.

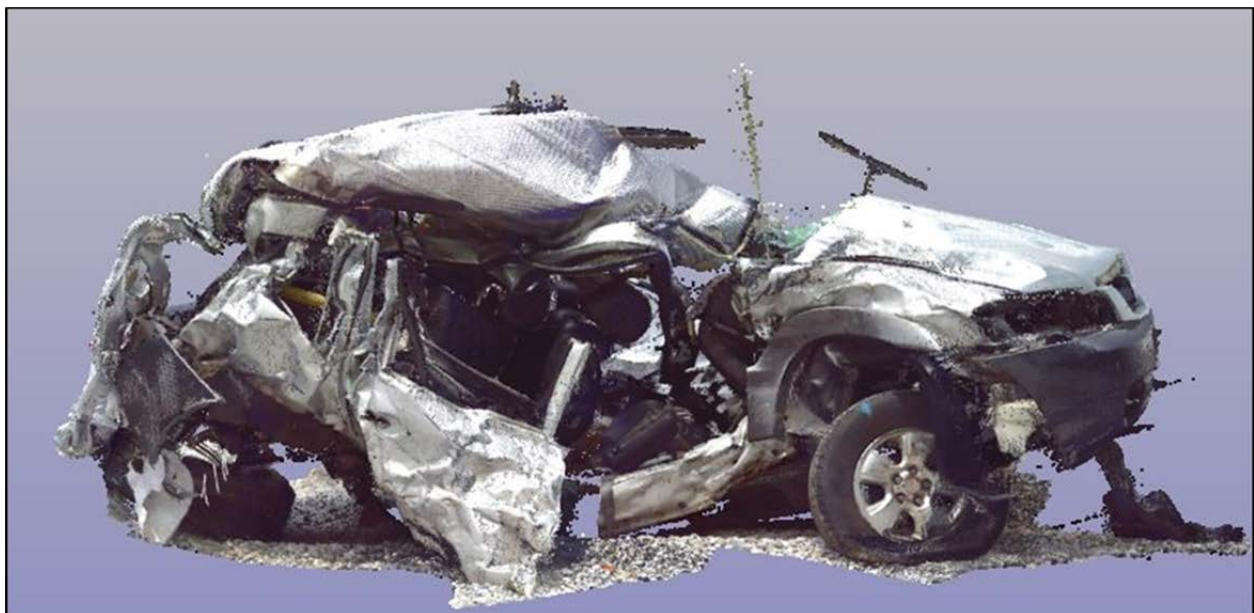
Figure 12: Colorized image of linked 3D scans depicting the front and right side of the Mazda.

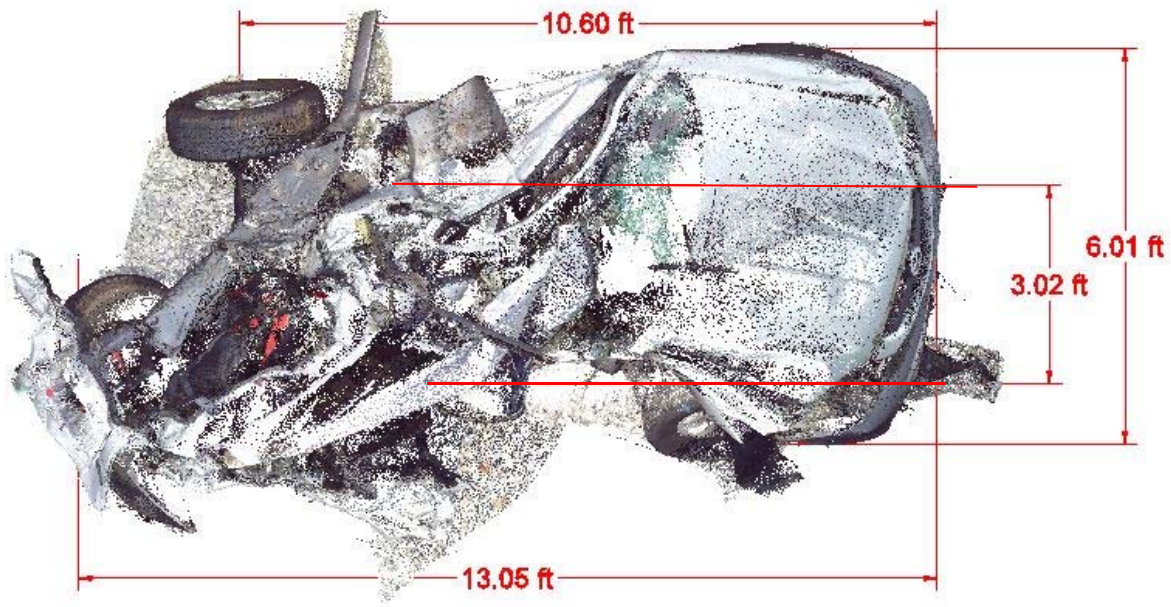
Figure 13: Overhead point cloud image of the Mazda depicting certain dimensions.

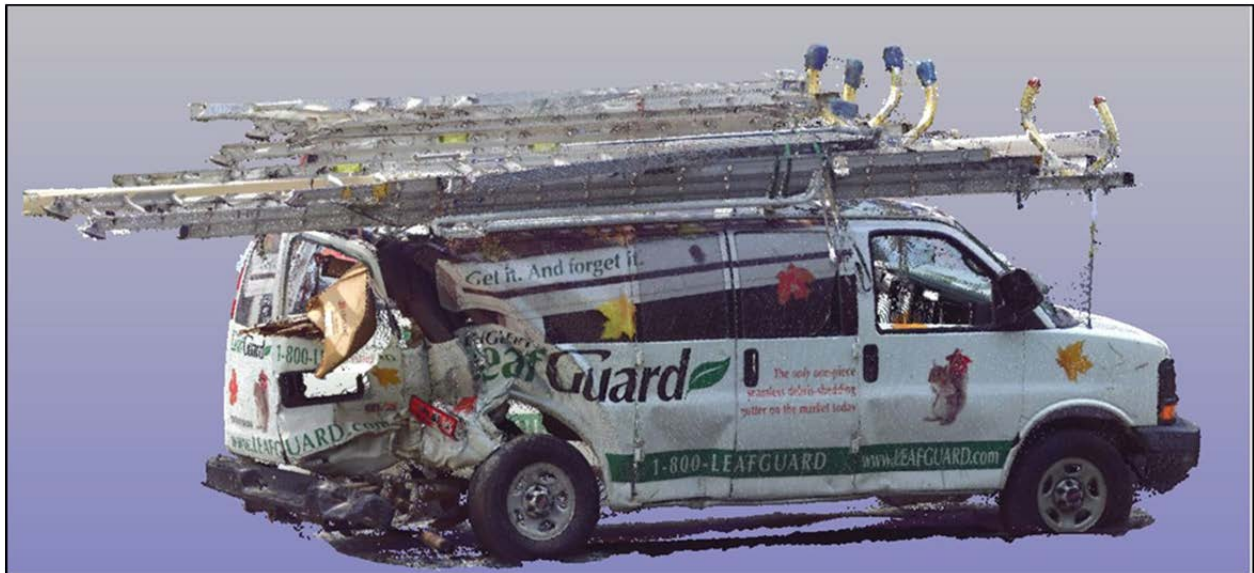
The van sustained an impact at the right rear of the vehicle. The impact resulted in damage to the right rear cargo door and quarter panel. The area of direct contact at the rear of the vehicle was concentrated at a vertical height of about 2.5 to 2.7 feet and extended inboard about 1.2 feet (14 inches) from the right side. The impact damage was outboard of the right frame rail. The majority of induced damage extended forward about 2.5 feet.

Forward of the right rear wheel, the aft side cargo area door exhibited an indentation. Horizontal scraping to the paint and an indentation at the trailing end of the passenger door were also observed. An unidentified cylindrical piece of black plastic was found embedded in the composite wheel well trim just behind the right front tire. The door indentations exhibited a static vertical height of about 1.1 to 1.2 feet (13 to 14 inches), while the scrape marks and damage to the right front wheel well trim were measured at a height of about 1.8 feet (21.5 inches). Minor horizontal scrapes were also observed to the right corner of the front bumper. White powdery material consistent with concrete was found embedded in the bumper scrapes.

Impact damage was also observed to the rear bumper on the right side, outboard of the frame rail. The top portion of the bumper was compressed downward with the area of contact exhibiting vertical scuffing and possible black material transfer. The approximate static vertical height of the bumper contact was about 1.3 feet.

Figure 14: Colorized image of linked 3D scans depicting the right side of the GMC van.

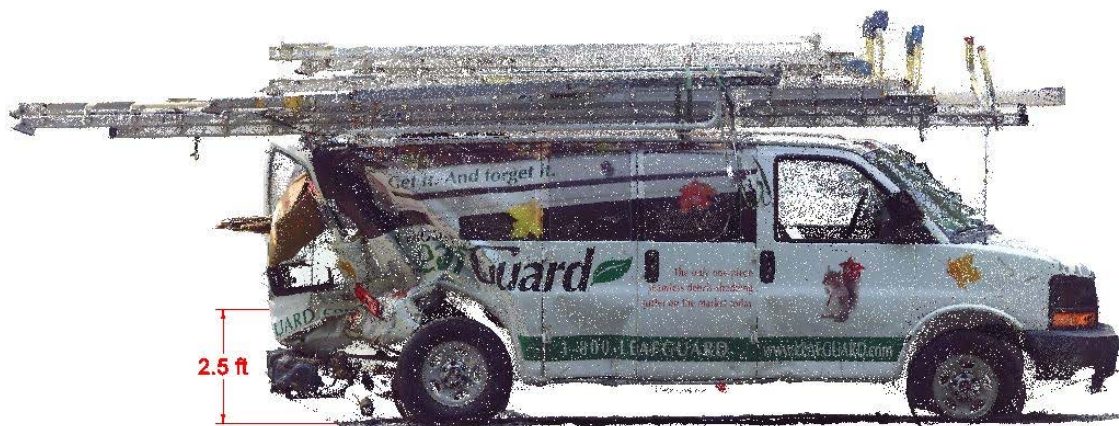
Figure 15: Point cloud image of the GMC van depicting certain dimensions.

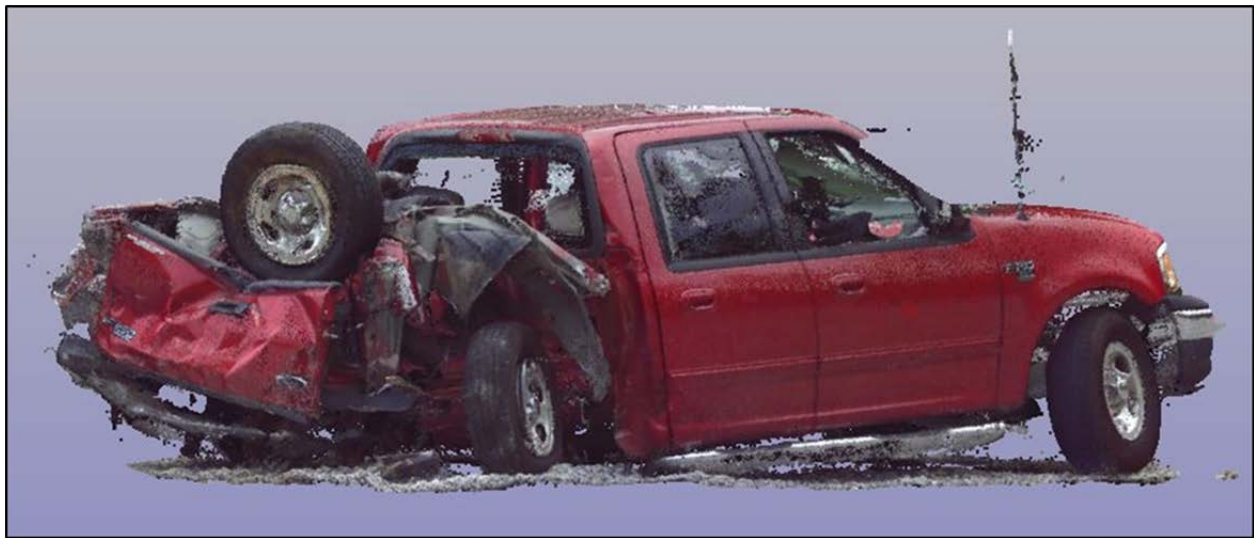
The Ford was identified as XLT Supercrew model and exhibited evidence of multiple impacts. The vehicle sustained a substantial impact at the right rear that forced the aft corner of the rear quarter panel and cargo bed forward and to the left. The right rear wheel was likewise forced forward into the back wall of the cab.

Figure 16: Colorized image of linked 3D scans depicting the rear and right side of the Ford F-150.

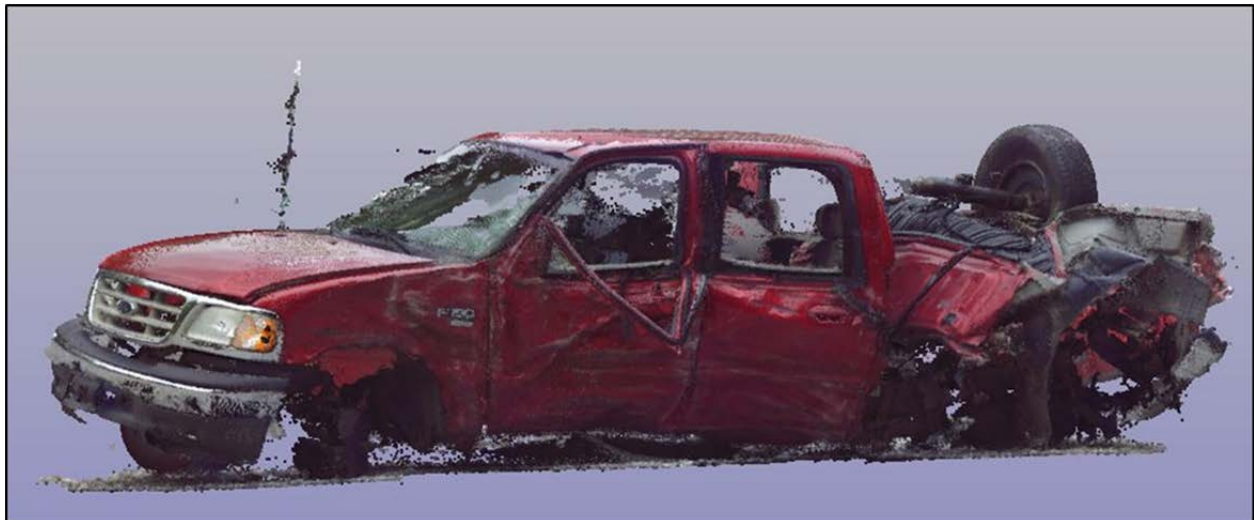
The entire left side of the vehicle exhibited contact damage and deformation consistent with a sideswipe type impact. The damage began at the trailing edge of the front bumper and continued rearward along the entire length of the vehicle. The left front wheel and hub were displaced from the axle spindle. Both cab doors were displaced inward toward the occupant compartment as well as rearward. The forward wall of the bed (left front) was also displaced rearward and overlapped the deformation that resulted from the impact at the right rear.

Figure 17: Colorized image of linked 3D scans depicting the front and left side of the Ford F-150.

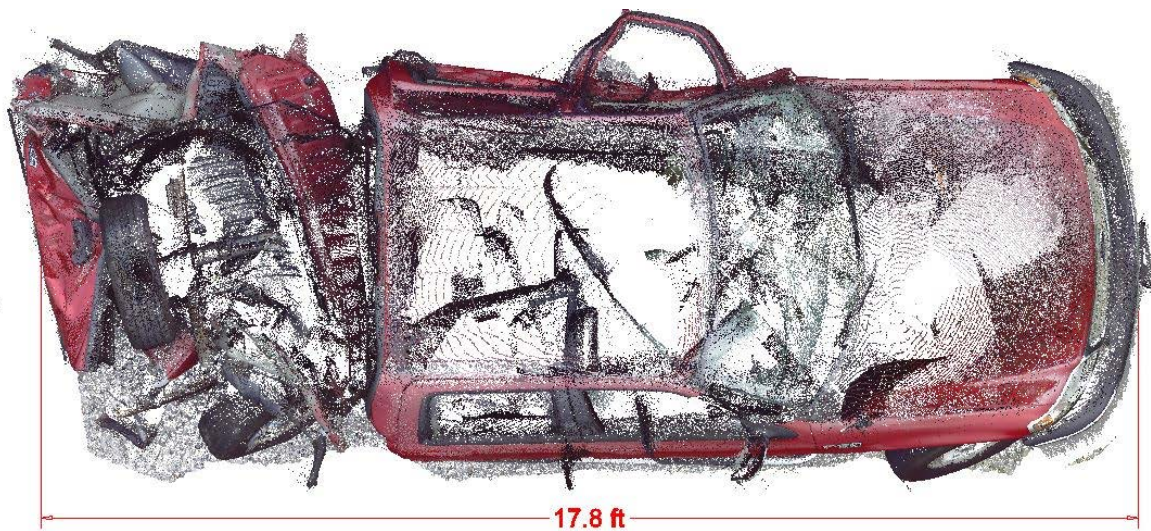
Figure 18: Overhead point cloud image of the Ford F-150 depicting certain dimensions.

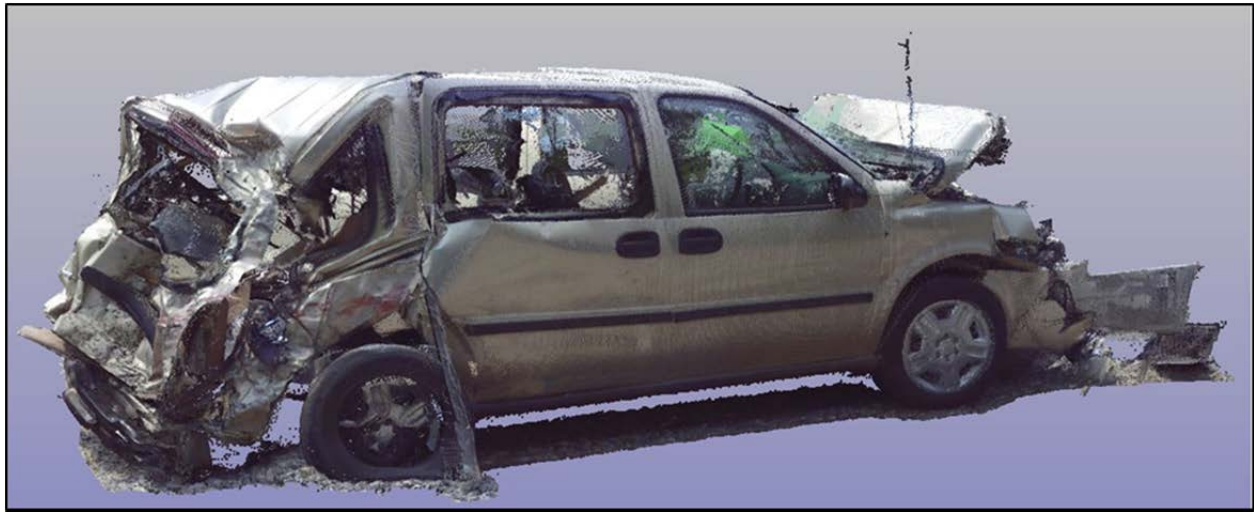
The Uplander is a minivan that sustained impacts at both the front and rear of the vehicle. Impact damage at the rear was concentrated toward the right side, but extended across the entire width of the vehicle. While the rightward end of the bumper exhibited some damage, most of the intrusion damage was above the bumper. The apparent transfer of red and black colored material was observed within the damage, primarily toward the right side of the vehicle.

Figure 19: Colorized image of linked 3D scans depicting the rear and right side of the Chevrolet Uplander.

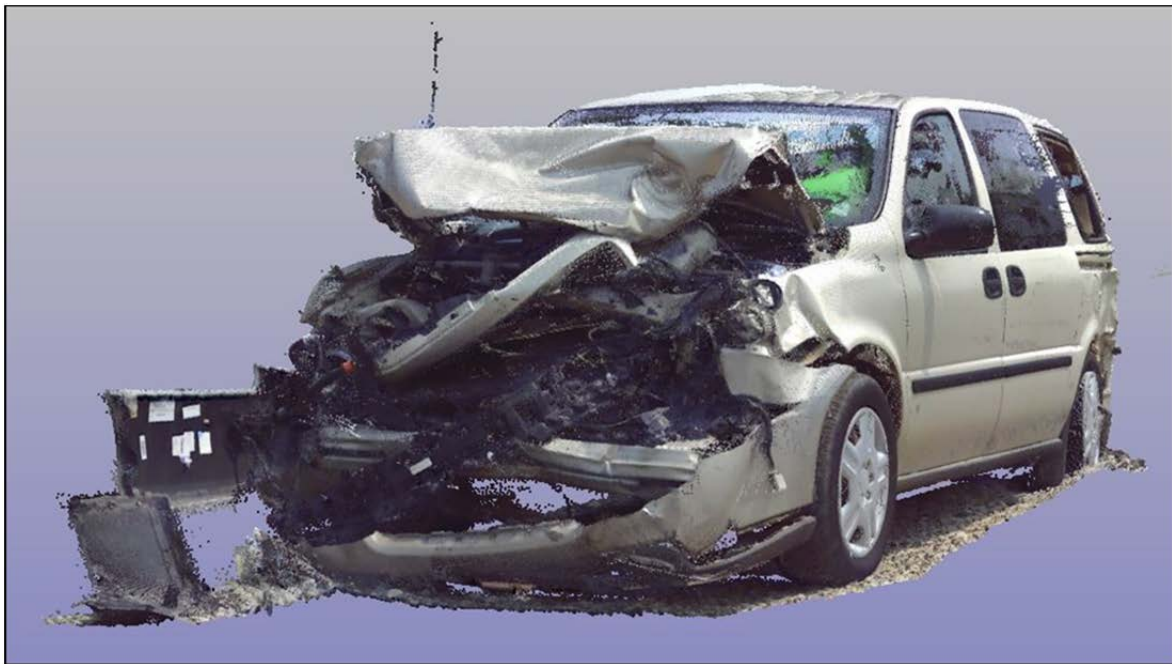
Frontal impact damage extended across the entire width of the vehicle, although there was a more substantial rearward displacement of the front end structure on the left side. The front bumper bar exhibited a rearward bend just left of longitudinal vehicle centerline. More extensively the top of the bumper bar and longitudinal frame rails exhibited evidence of having been overridden. The radiator and upper radiator support were also displaced rearward.

The rear bumper cover and energy absorbing foam from the rear of the Cadillac were found entangled within the frontal damage. The cover had overridden the Chevrolet's bumper and become entrapped beneath the upper radiator support.

Figure 20: Colorized image of linked 3D scans depicting the front and left side of the Chevrolet Uplander.

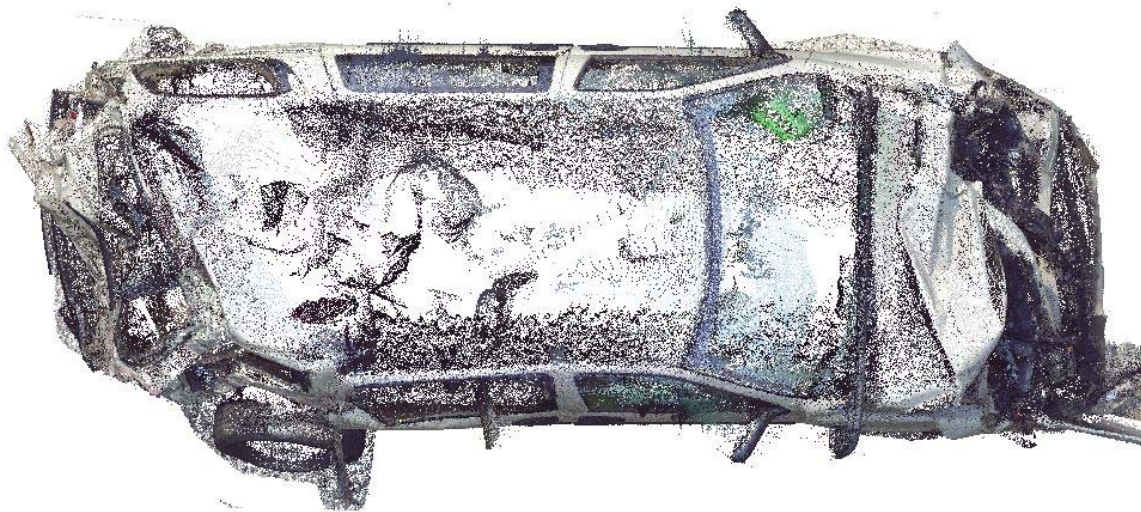
Figure 21: Overhead point cloud image of the Chevrolet Uplander.

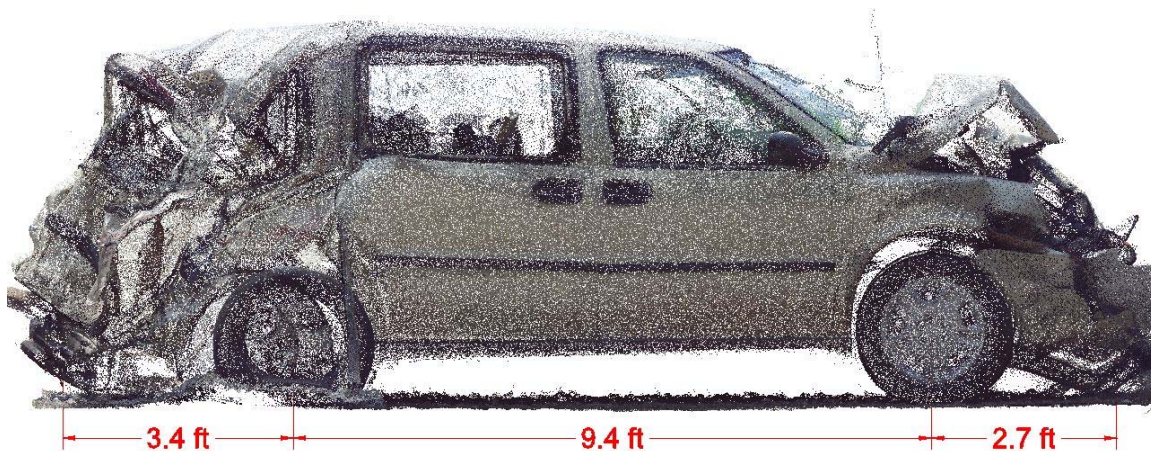
Figure 22: Point cloud image of the Chevrolet Uplander depicting certain dimensions.

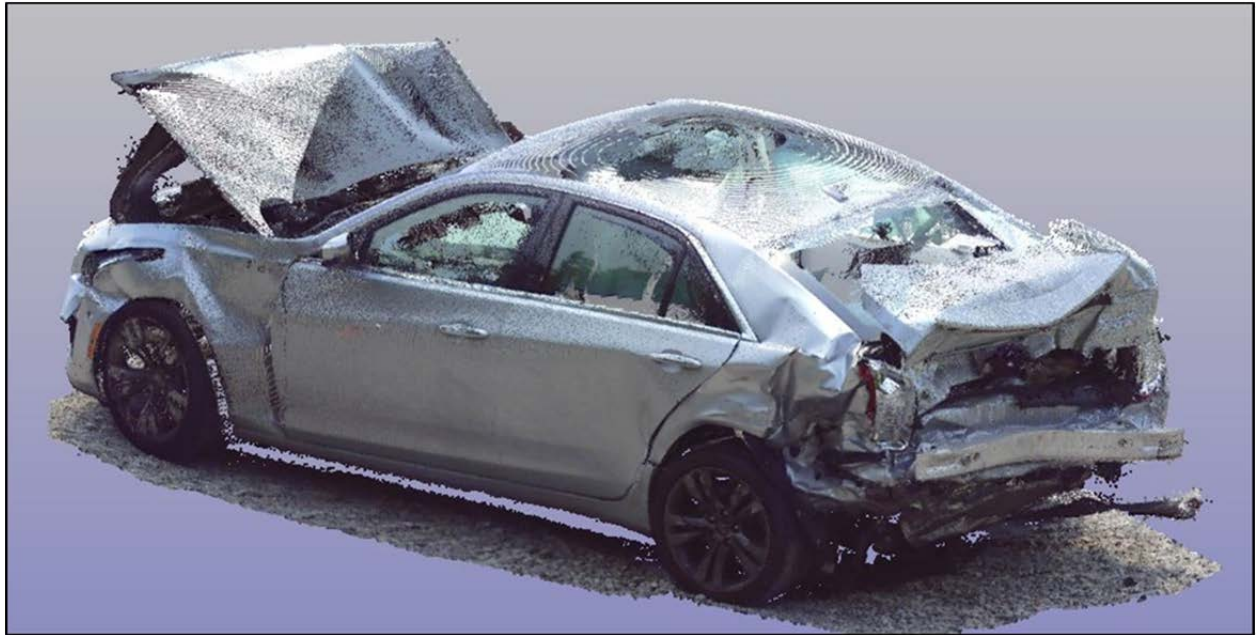
The Cadillac, a four-door sedan CTS model, exhibited evidence of multiple impacts at both the front and rear of the vehicle. The more significant contact damage at the rear encompassed the entire width of the vehicle, although there was greater forward displacement of the left quarter panel. The left rear quarter panel was displaced about 9.6 inches further forward than the right side. While at rest, the left side of the rear bumper also exhibited a greater vertical displacement as compared with right side. The damaged area exhibited evidence of having been under ridden by the striking vehicle. The rear bumper cover was missing and found entangled in the Uplander's frontal damage.

Figure 23: Colorized image of linked 3D scans depicting the rear and left side of the Cadillac.

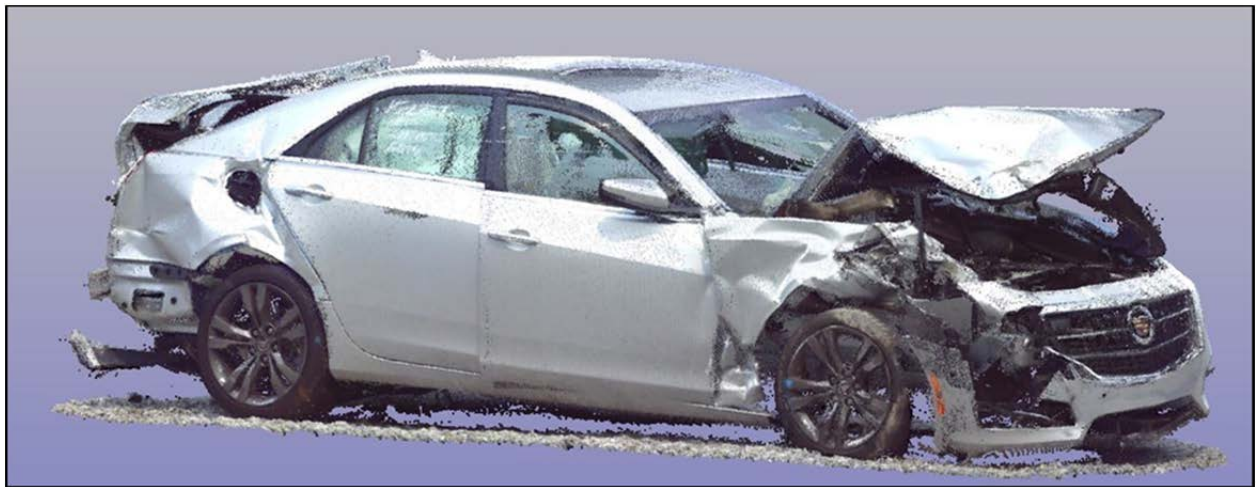
The right rear quarter panel exhibited horizontal scrapes that extended forward from the tail lamp toward the wheel well. Additional contact damage was observed around the fuel port that resulted in the quarter panel just aft of the rear door being indented and the fuel port door being removed.

The left front fender exhibited contact damage that encompassed, and then extended rearward of, the headlamp/side marker lamp assembly. The left front (driver's) door exhibited vertical scrapes to the paint below the door handle that covered the mid-section of the door. Horizontal scrapes were observed on the left rear door in addition to an indentation to the door just forward of the rear wheel well.

Figure 24: Colorized image of linked 3D scans depicting the front and right side of the Cadillac.

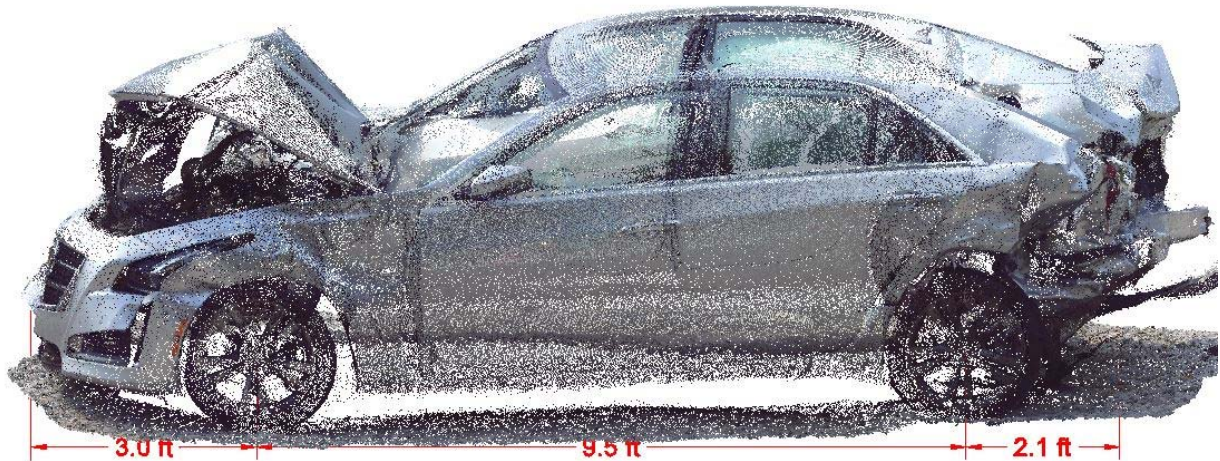
Figure 25: Point cloud image of the Cadillac depicting certain dimensions.

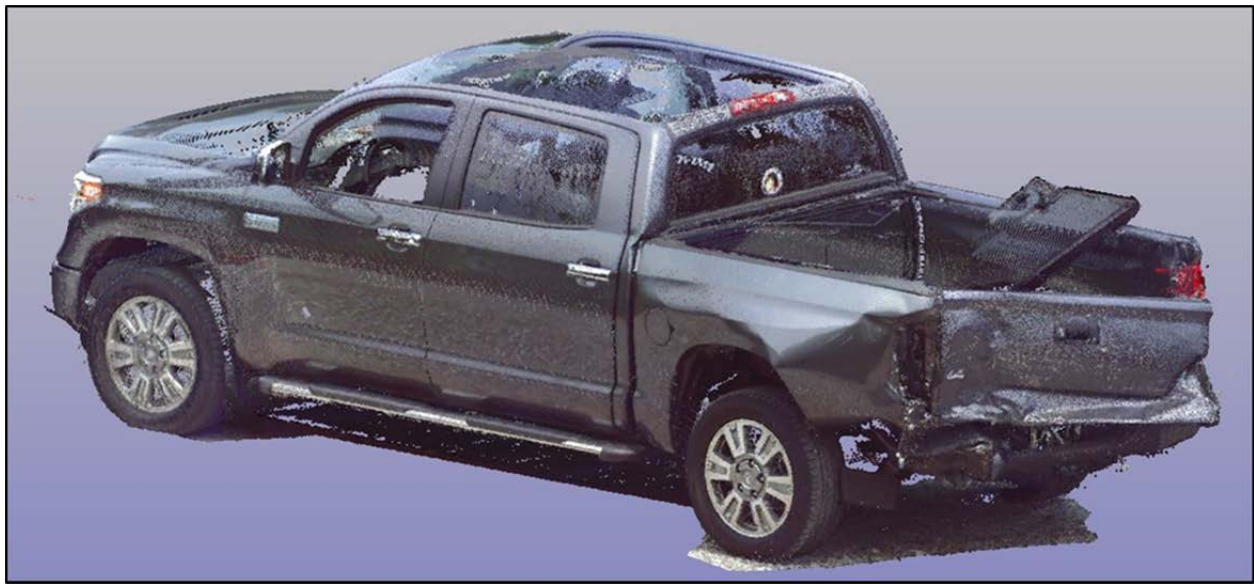
The final vehicle involved in the collision sequence was a Toyota four-door model pickup truck. The vehicle exhibited evidence of a longitudinal impact at the left rear. The rear bumper on the left side was displaced forward as was the aft portion of the rear quarter panel. The primary area of contact extended inboard about 12 to 13 inches from the left side and exhibited evidence of having been under ridden by the impacting vehicle. Additional damage to the lower edge of the tail gate was observed between 14 and 24 inches inboard of the left side.

Figure 26: Colorized image of linked 3D scans depicting the rear and left side of the Toyota Tundra.
