**TECHNICAL RECONSTRUCTION GROUP CHAIRMAN'S  
FACTUAL REPORT**

**Chattanooga, TN**

**HWY15MH009**

**NATIONAL TRANSPORTATION SAFETY BOARD  
OFFICE OF HIGHWAY SAFETY  
WASHINGTON, D.C.**

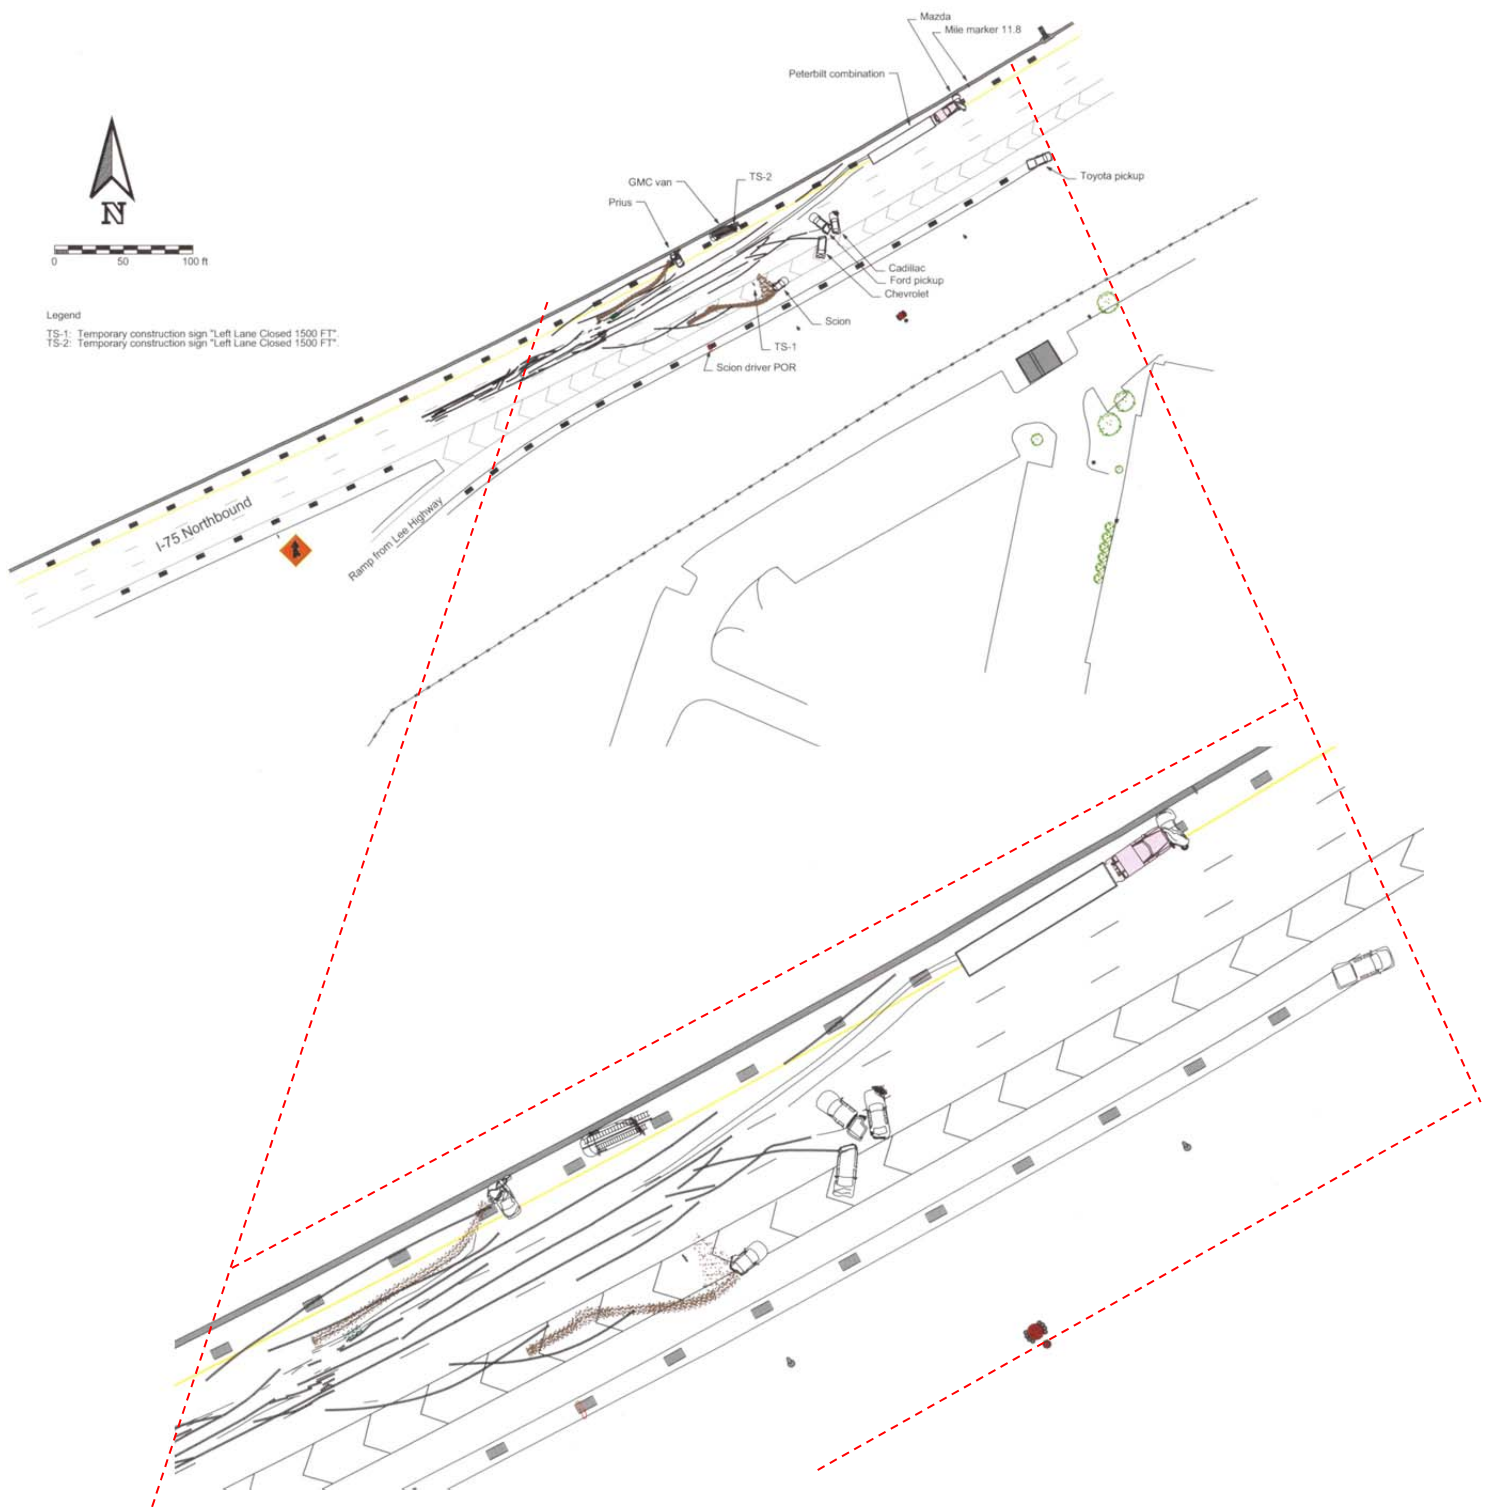
Figure 27: Illustration of the post-collision crash scene with an enlargement of area encompassing the vehicle positions of rest. Data was derived from CPD total station mapping and NTSB 3D scans.

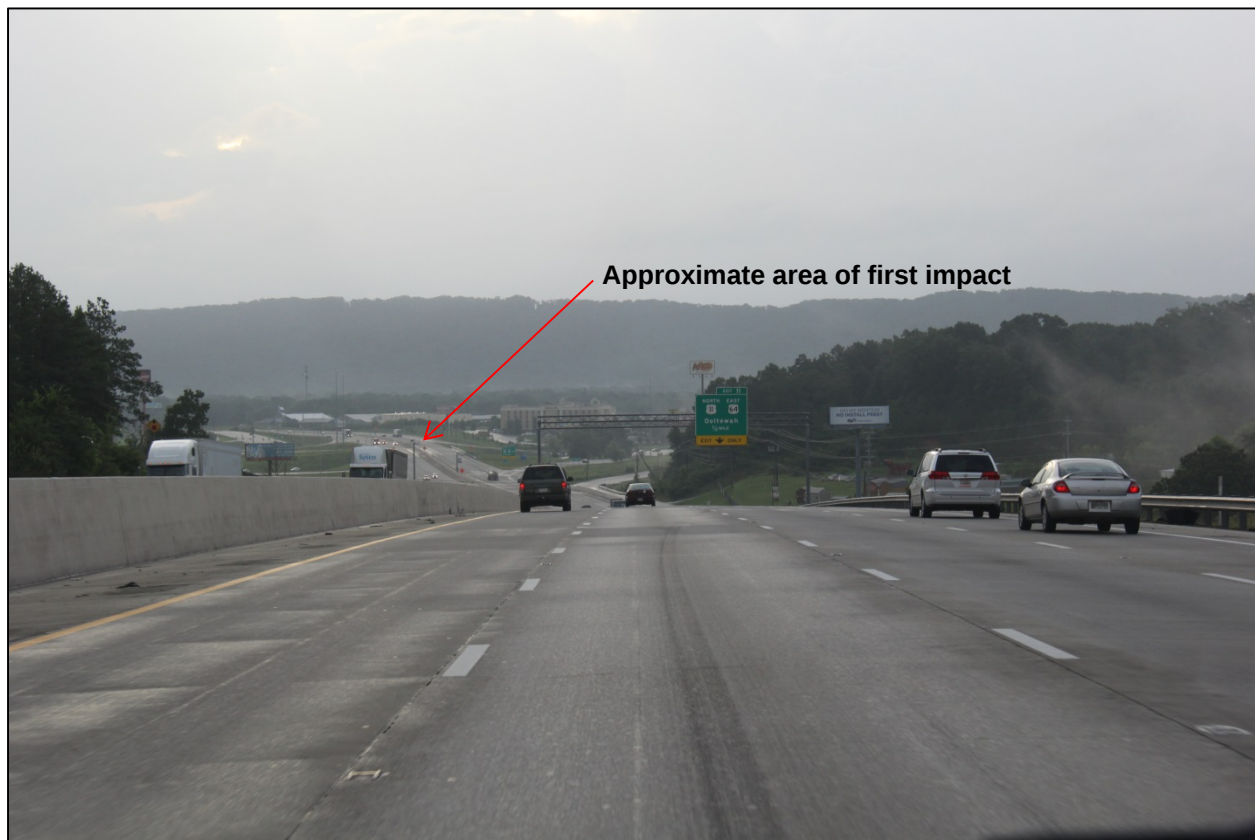
Figure 28: Photograph depicting the approximate minimum driver line of sight as viewed from the center lane of northbound I-75 looking north toward the collision area.
