**NATIONAL TRANSPORTATION SAFETY BOARD  
OFFICE OF HIGHWAY SAFETY  
WASHINGTON, D.C.**

**TECHNICAL RECONSTRUCTION GROUP CHAIRMAN'S  
FACTUAL REPORT**

Location: 300 block of Talley Road, Chattanooga, Hamilton County, Tennessee  
Vehicle #1: 2008 Thomas Built School Bus  
Operator #1: Durham School Services LP of Warrenville, IL  
Date: November 21, 2016  
Time: Approximately 03:20 p.m. Eastern Standard Time (EST)  
NTSB #: **HWY17MH009**

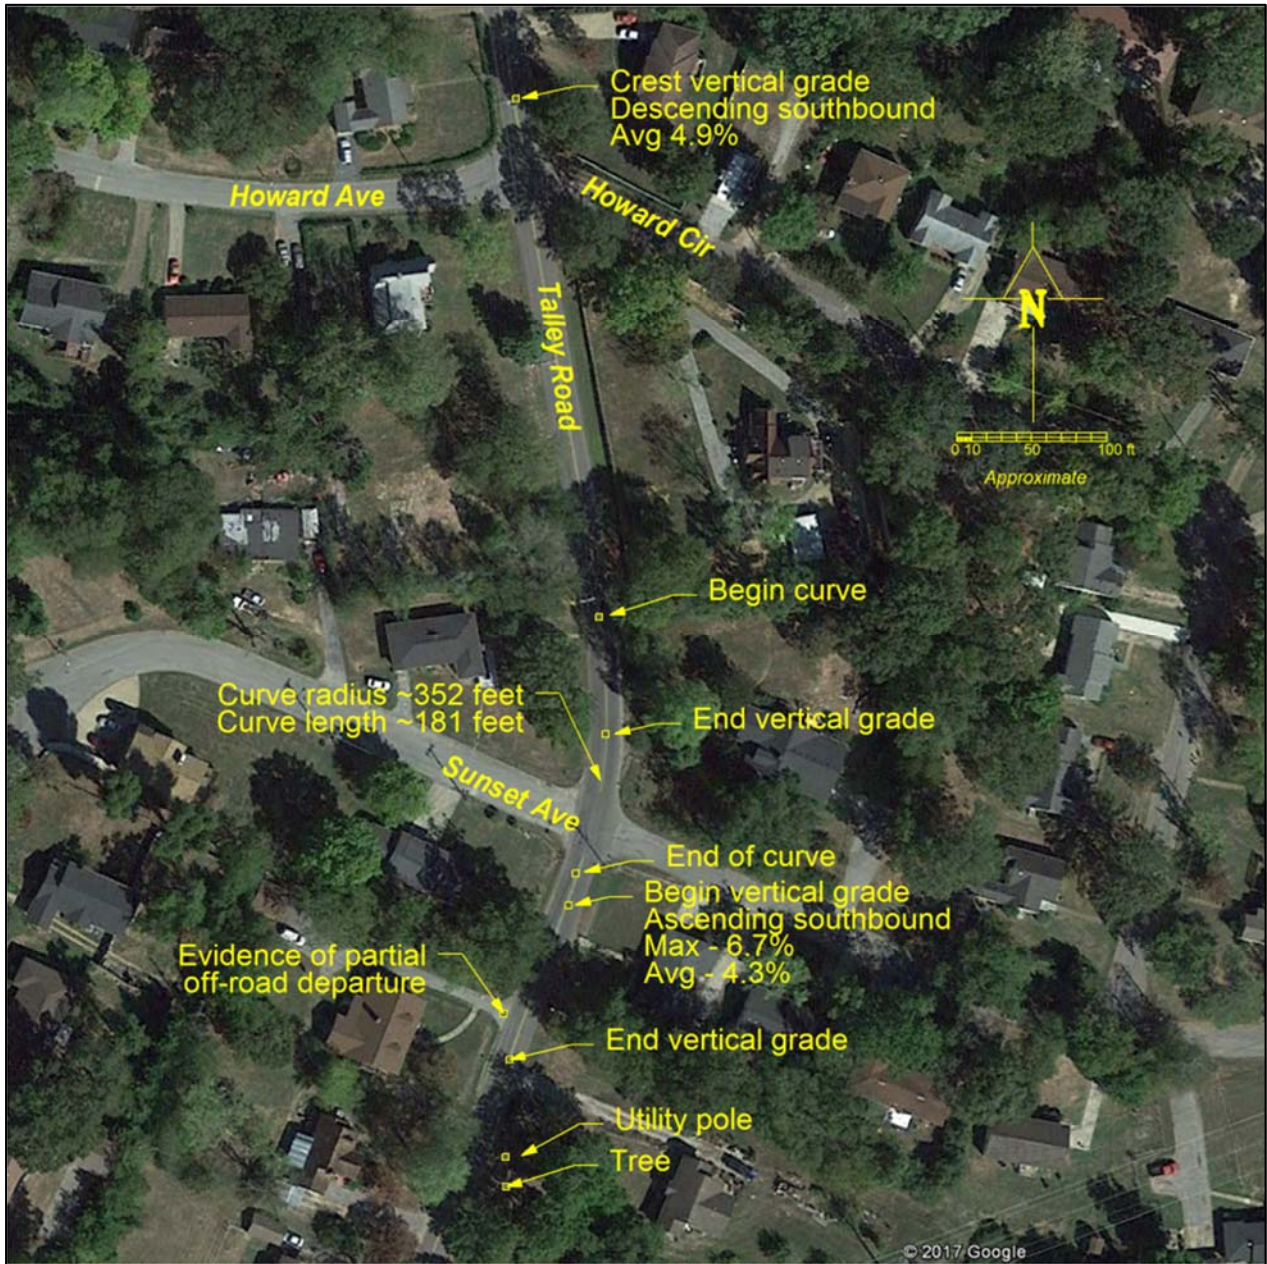
**Figure 1** depicts a Google Earth image of Talley Roads through the area of the collision. Highway features as well as fixed objects struck by the bus are illustrated.

Figure 1: Google Earth image (October 2016) of Talley Road depicting relevant features. Grade dimensions are referenced along the southbound approach (bus heading) to the collision site.

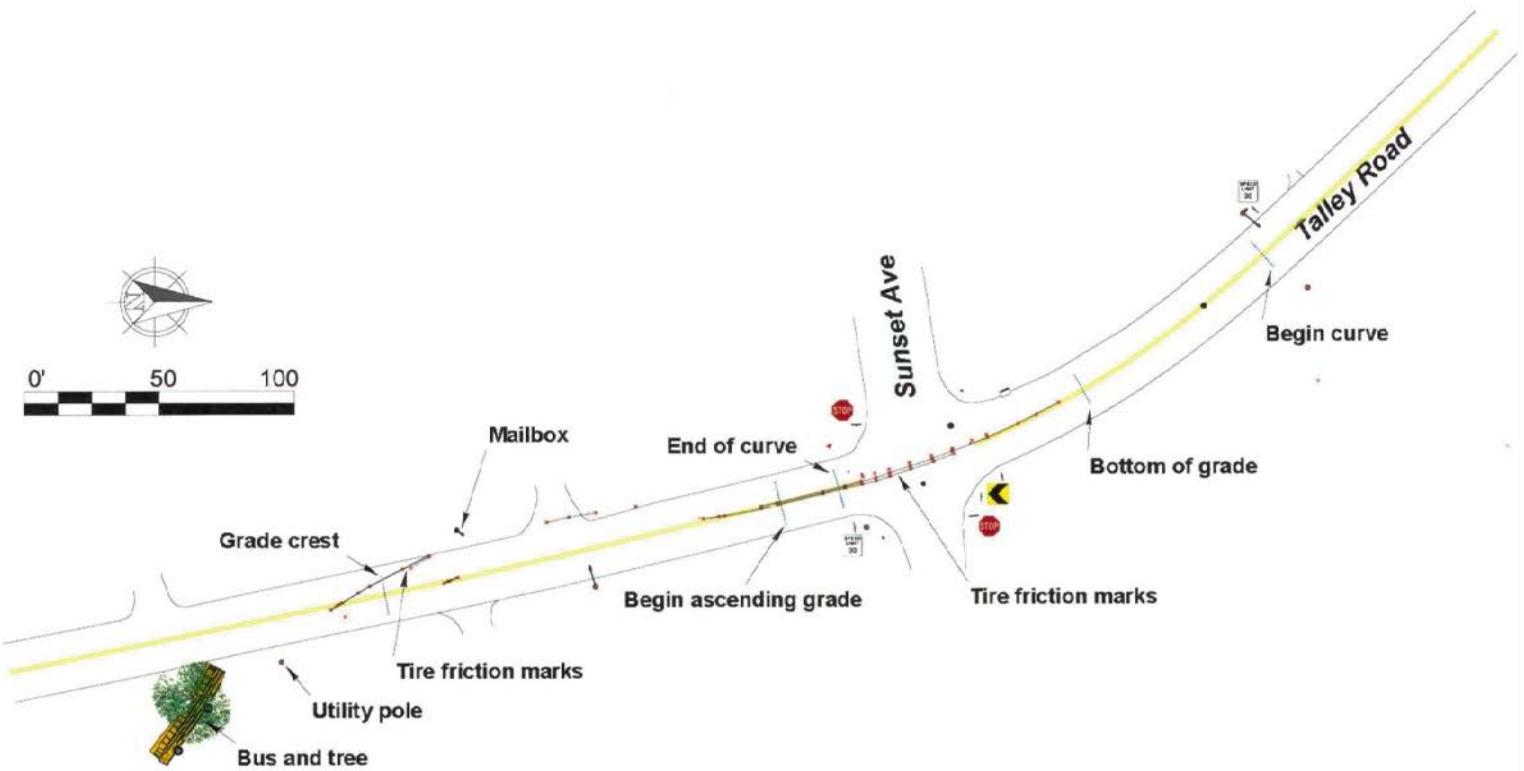
The post-collision position of rest for the bus was against a tree located about 36 feet south and slightly west of the utility pole. At final rest the bus had overturned onto its right side, oriented such that it was facing southeastward with its roof partially collapsed by impact with a tree. The bus was located about 342 feet south from the onset of the initial tire friction marks.

Figure 2: Scaled diagram depicting vehicle position of final rest, roadway evidence and other highway features along the vehicle pre-collision path of travel.

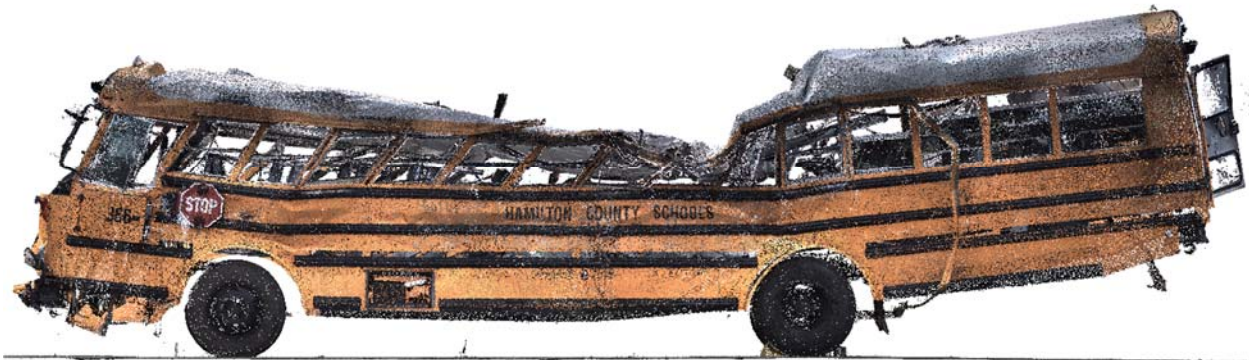
Scan images depicted that the majority of damage sustained by the bus involved the collapse of the roof and its subsequent intrusion into the passenger seating area. Displacement of the roof structure was consistent with the vehicle's impact into the tree after it overturned. Some sidewall displacement consistent with the roof displacement was also observable.

Figure 3: Image of 3D scan point cloud depicting the left (driver's side) of involved bus after removal from the scene. Scan data was provided by CPD.

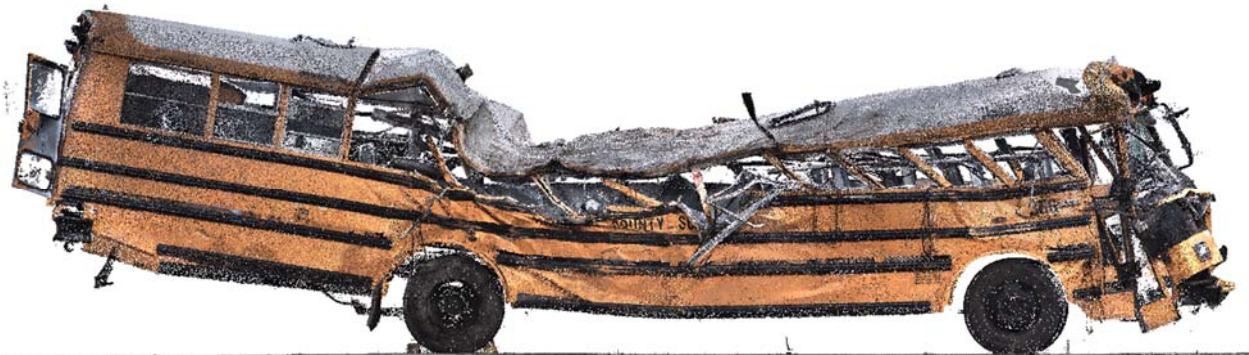
Figure 4: Image of 3D scan point cloud depicting the right (passenger's side) of involved bus after removal from the scene. Scan data was provided by CPD.

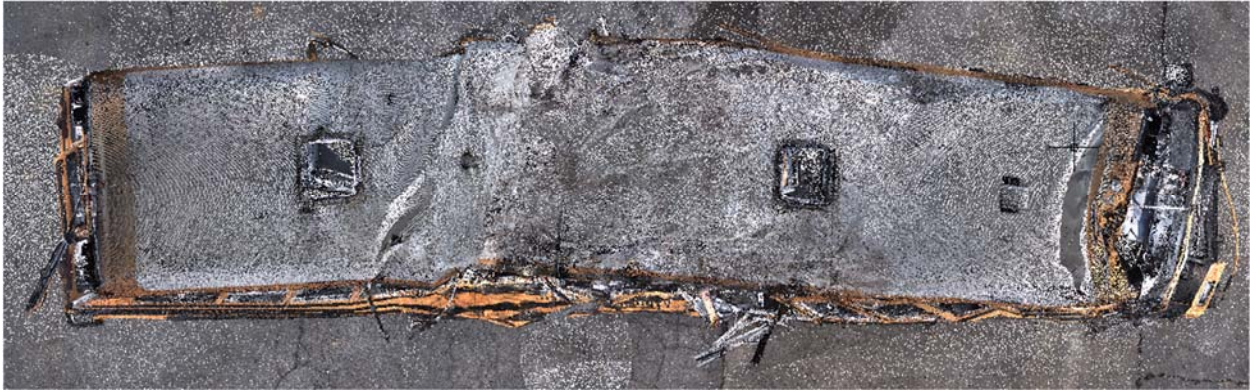
Figure 5: Image of 3D point cloud depicting an overhead view of involved bus following its removal from the scene. Scan data was provided by CPD.

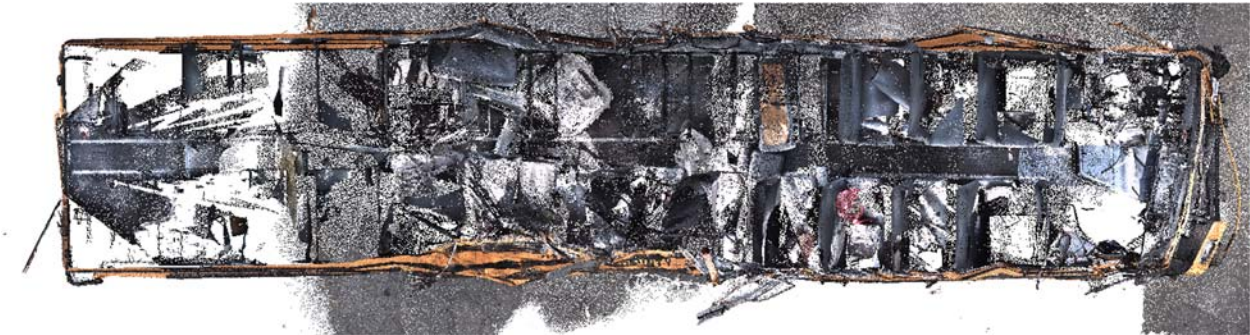
Figure 6: Image of 3D data point cloud depicting overhead view of involved with a roof sliced removed. Scan data was provided by CPD.

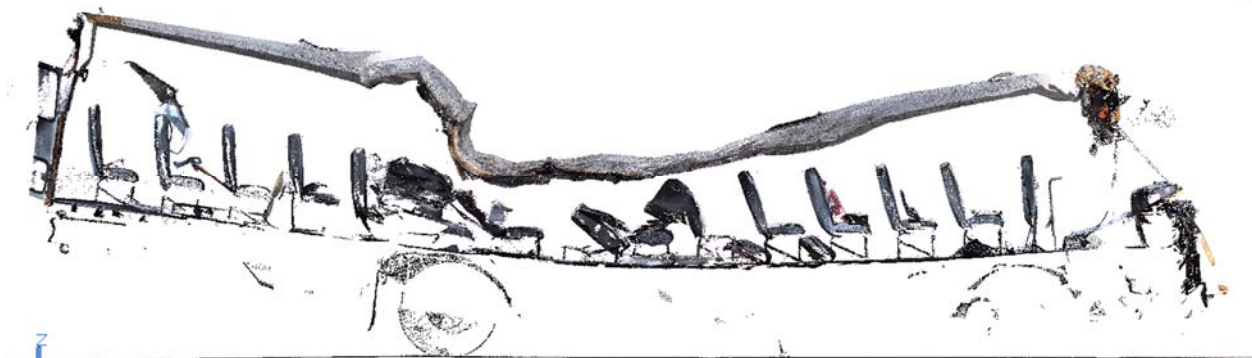
Figure 7: Image of 3D data point cloud depicting right (passenger) side seating about 20 inches inboard of the right sidewall. Scan data was provided by CPD.

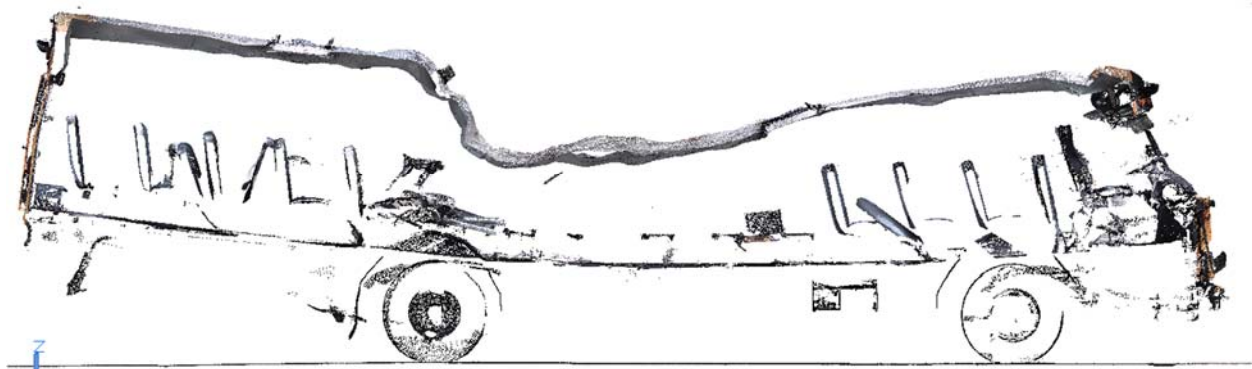
Figure 8: Image of 3D scan point cloud depicting left (driver) side seating about 20 inches inboard of the left sidewall. Note that some seating had been removed. Scan data was provided by CPD.

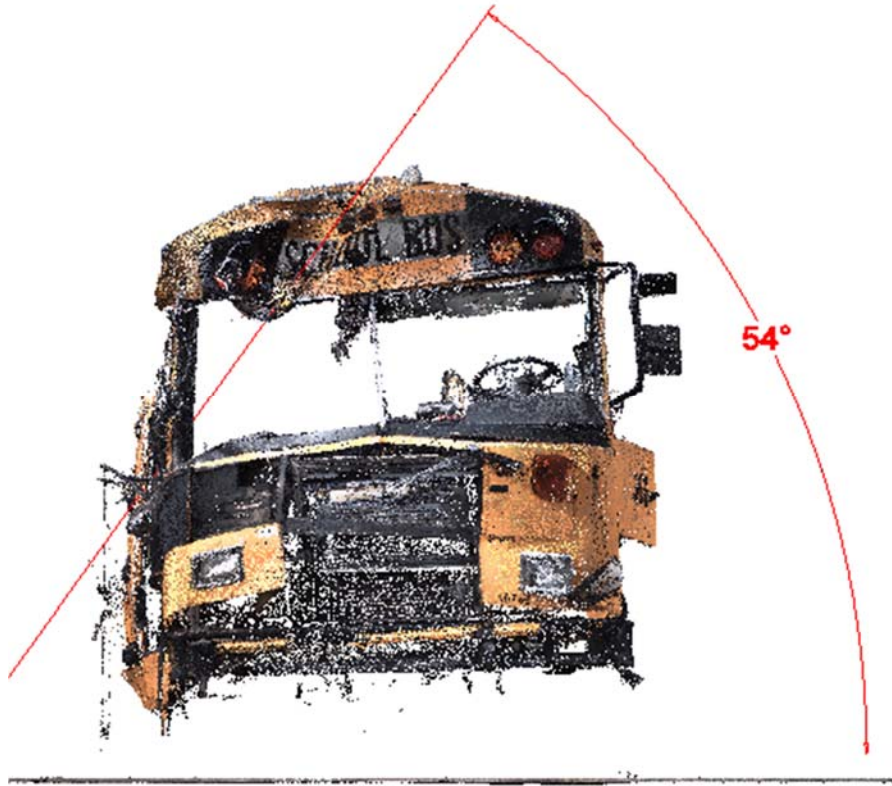
The front of the bus exhibited damage consistent with the utility pole impact. The impact fractured and displaced the wooden utility pole between ground level and the lower tier of telecommunications lines. The resulting vehicle damage exhibited an angular orientation of approximately 54-degrees relative to a horizontal ground surface. **Figure 9** depicts a point cloud image of the 3D scan sliced laterally behind the damaged area annotated with the angular dimension. The damage is consistent with vehicle rolling toward the right (passenger) side as the pole was struck.

Figure 9: 3D point cloud slice image depicting impact damage to the front of the bus consistent with striking the utility pole.
