**TECHNICAL RECONSTRUCTION GROUP CHAIRMAN'S  
FACTUAL REPORT**

**Biloxi, MS**

**HWY17MH010**

**NATIONAL TRANSPORTATION SAFETY BOARD  
OFFICE OF HIGHWAY SAFETY  
WASHINGTON, D.C.**

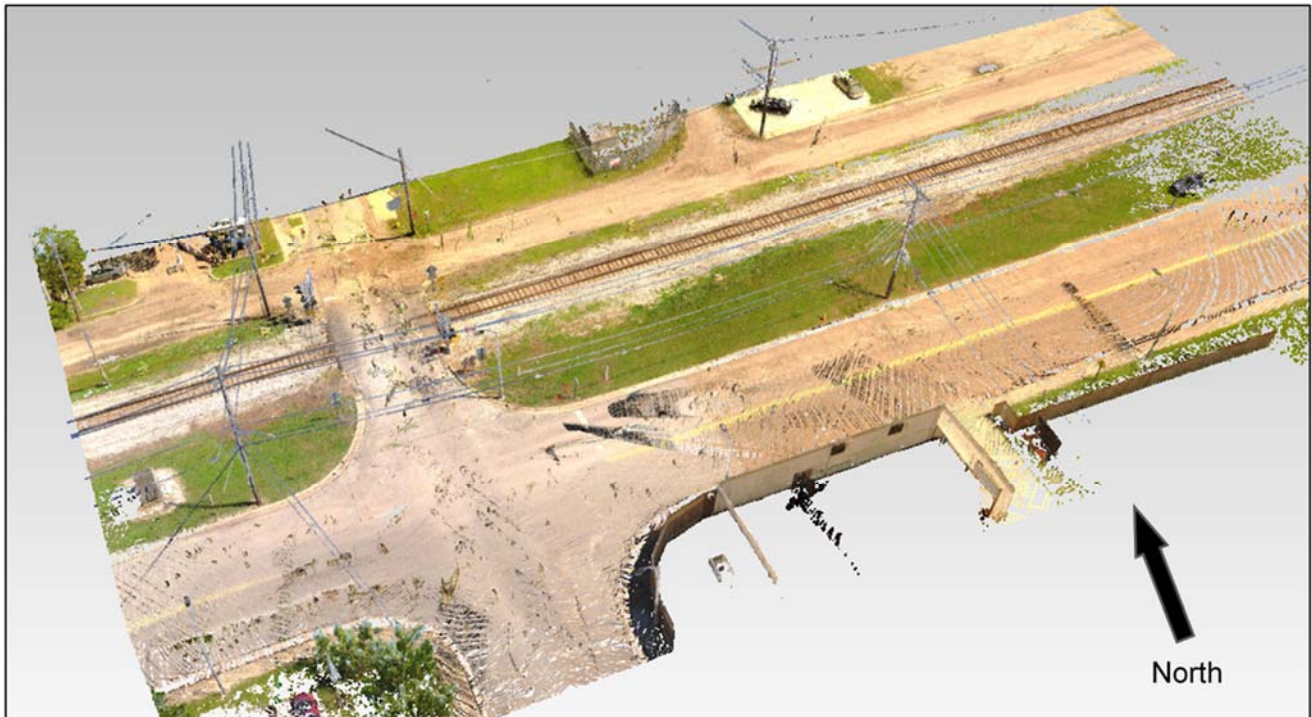
**Figure 1** depicts a colorized image of the linked 3D scans covering the highway-railroad crossing and track area extending eastward approximately 336 feet.

Figure 1: Colorized image of linked 3D scans depicting the Main Street highway-railway grade crossing and track area eastward of the crossing.

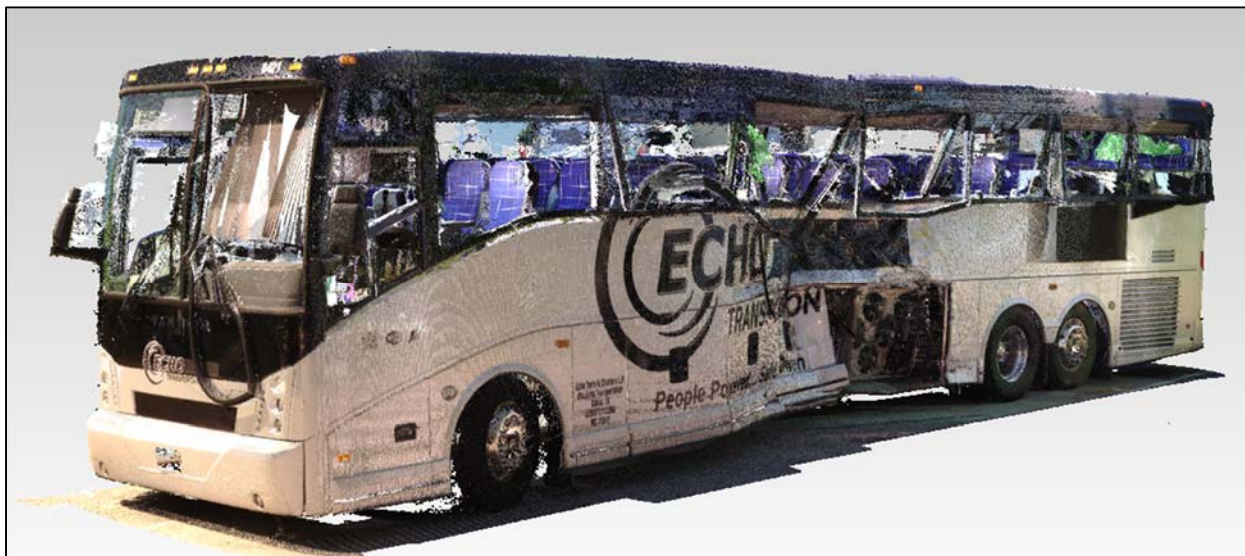
Figure 3: Colorized image of linked 3D scans depicting the involved motorcoach.

The motorcoach sustained an impact at the left (driver's) side that resulted in substantial intrusion damage. Evidence of direct contact was observed over a longitudinal distance of approximately 9.8 feet beginning about 17.5 feet rearward of the front of the motor coach. Evidence of direct contact was identified through structural damage to the motor coach and material transfer. Measurements taken of the area of direct contact correspond well with the frontal surface of the locomotive.

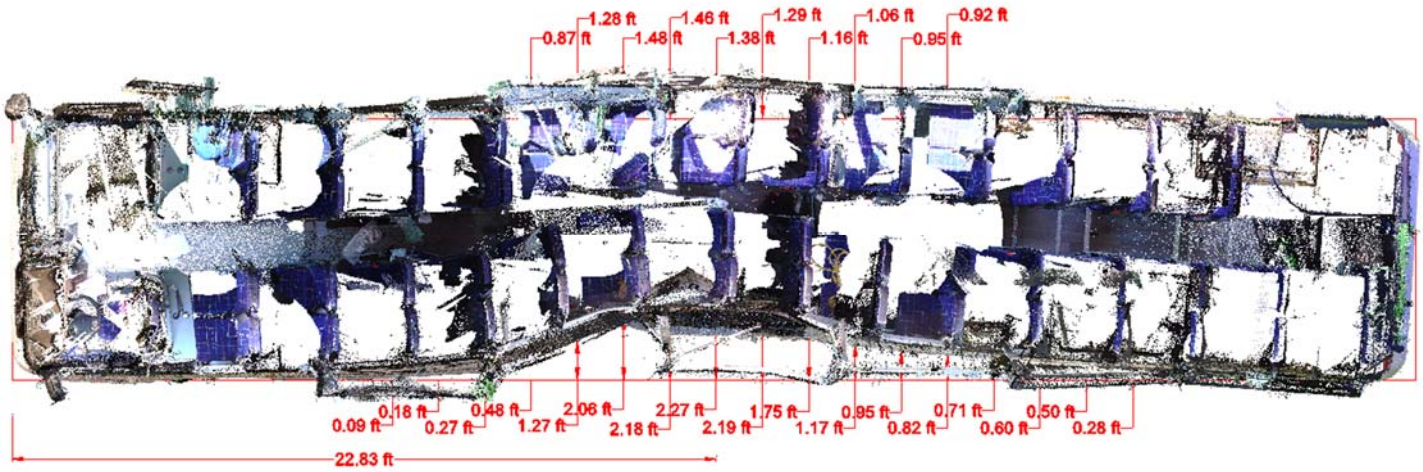
Corresponding with the left side intrusion, the right side of the motor coach exhibited an outward displacement. Overall, the vehicle body exhibited evidence of misalignment beginning approximately 12 feet aftward of the front and continuing almost to the vehicle rear. Maximum lateral displacement was observed approximately 22.8 feet aftward of the vehicle front where the left sidewall intruded approximately 2.27 feet.<sup>6</sup> The maximum corresponding outward displacement on the right side was observed about three feet further forward where the outward displacement measured approximately 1.48 feet. **Figure 4** depicts the lateral displacement of the vehicle sidewall as measured at 1.5-foot intervals from an undamaged sidewall plane. The location of the impact damage indicates that the front of the motor coach was approximately 20.4 feet past (north of) the northern rail when the vehicle was struck by the locomotive.

Figure 4: Image depicting an overhead view of the motorcoach interior based a slice of the 3D scan. The image illustrates the exterior and interior lateral displacement of the vehicle sidewalls and seating. Measurements of lateral displacement were made at 1.5-foot intervals.

The lateral displacement of the left sidewall also created a corresponding reduction in the width of the aisleway between the left- and right-side seat rows. At the front of the motor coach the aisleway appeared unaffected and had a nominal width of approximately 1.45 feet between the outboard armrests and about 1.6 feet between the seat backs. At the area of maximum sidewall displacement, the aisleway width decreased to a minimum of about 0.68 feet (8.2”) at the seat bottom and 0.88 feet (10.6”) at the seat back.

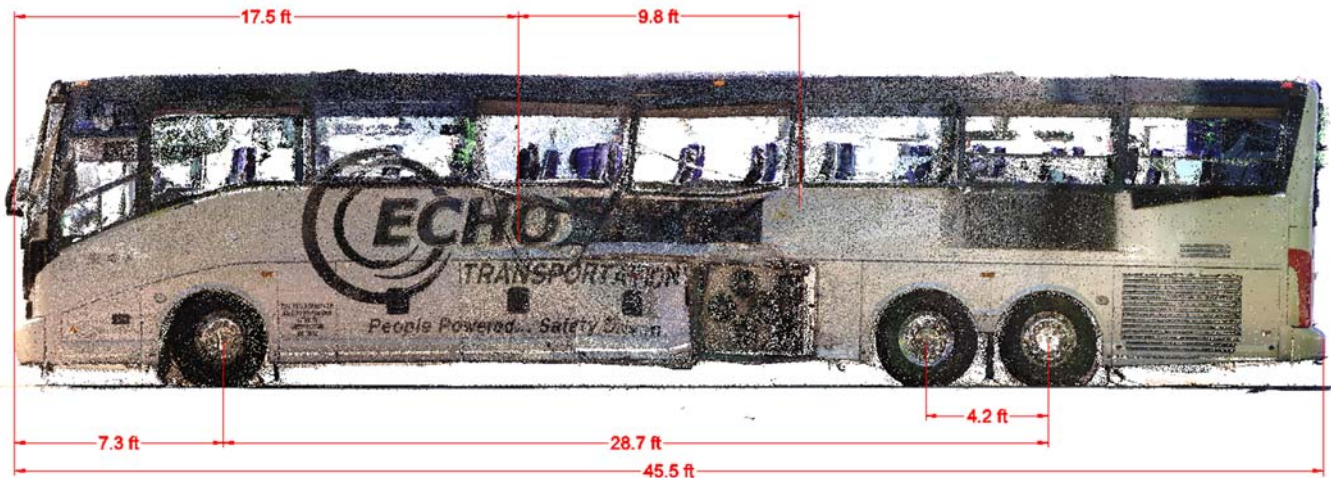
**Figure 5** depicts certain longitudinal dimensions that were acquired from the 3D scan. The post-collision measurements depict some rearward displacement of the steer axle as compared with an exemplar motor coach, as depicted in **Figure 6**.

Figure 5: Image depicts certain dimensional measurements acquired from the 3D scan of the involved motorcoach.

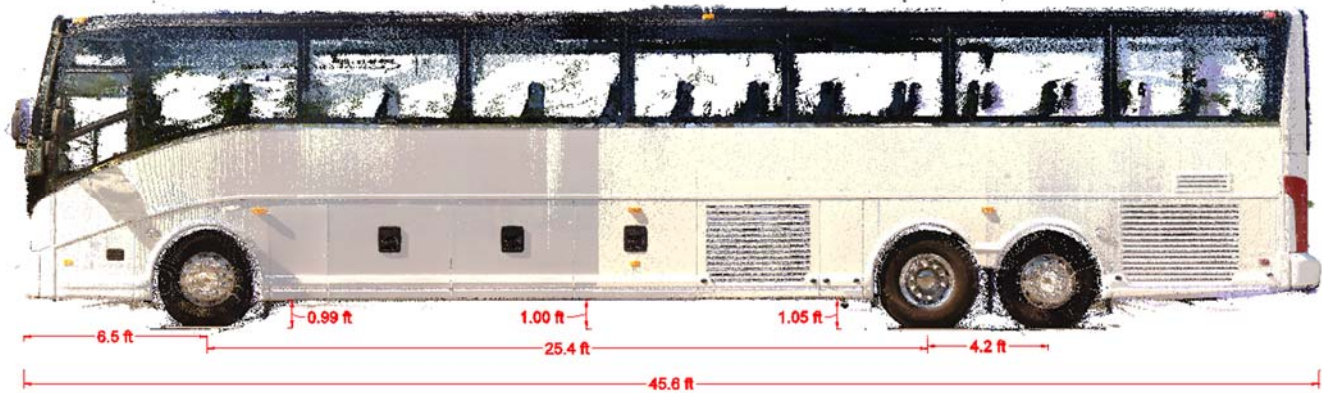
An exemplar Van Hool CX45 motorcoach was three-dimensionally scanned on May 1, 2017 from 9 positions. Certain longitudinal dimensions that were acquired from the 3D scan are depicted in Figure 6. From the scan data, the exemplar motorcoach exhibited a nominal static ground clearance 11.9 to 12.6 inches, as measured between the axles.<sup>7</sup>

Figure 6: Image depicts certain dimensional measurements acquired from the 3D scan of the exemplar motorcoach.
