**NATIONAL TRANSPORTATION SAFETY BOARD
OFFICE OF HIGHWAY SAFETY
WASHINGTON, D.C.**

**TECHNICAL RECONSTRUCTION GROUP CHAIRMAN'S
FACTUAL REPORT**

Location: US Highway 83 (US-83) near milepost 553.4 in Uvalde County, 6.5 miles north of Concan, Texas

NTSB #: **HWY17MH011**

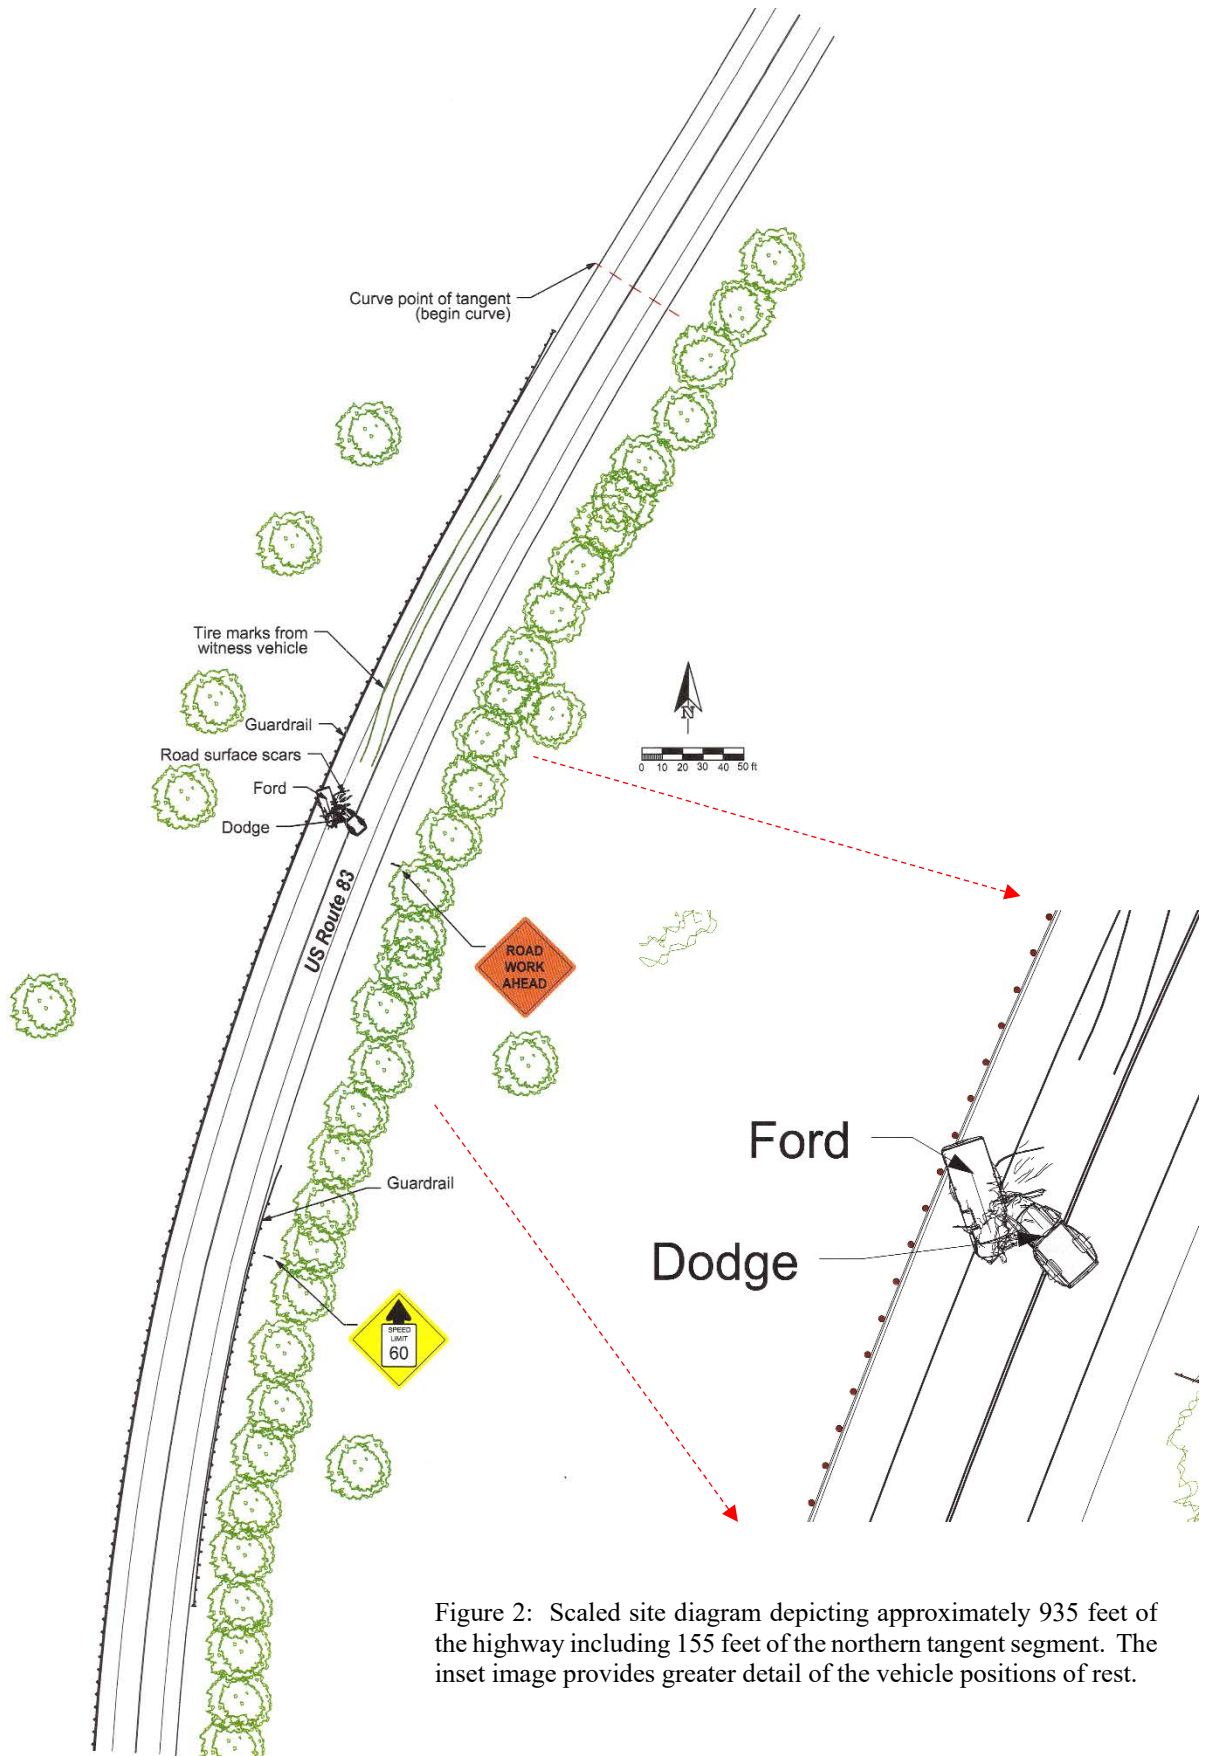
The onset of roadway evidence appeared approximately 287 feet south of the northern end of the curve (curve point of tangent) and was primarily confined to the southbound travel lane.² Excluding displaced debris, such as vehicle components, scene evidence consisted of road surface metal scars, tire friction marks and fluid debris stains that extended over a linear distance of about 13 feet, as measured from the first onset southward to the approximate midpoint of the vehicle positions of rest. The metal scars and tire friction marks exhibited a southwestward orientation that began near the center of the southbound lane and extended toward the right shoulder. Roadway evidence extended no further than approximately 6.2 feet into the southbound travel lane as measured from the edge line. The tire friction marks appeared further south from the onset of the metal scars and were related to the rotation of the Ford. Similarly, the metal scars were consistent with deformation of the Ford that resulted in the transmission case and surrounding structure to contact the pavement. All the roadway evidence was related to the post-impact movement of the vehicles. No pre-collision roadway evidence, created by either of the involved vehicles, was observed.

As depicted in TxDPS scene photographs, the two vehicles remained in contact at final rest. While the vehicles were oriented head-on at final rest, they were offset to one another by about 25°. At final rest, the Ford and Dodge exhibited headings toward the south-southeast and northwest respectively.

During post-impact movement the Ford exhibited a counter-clockwise rotation that terminated at a 39° angle relative to its initial lane of travel (southbound). At its position of final rest, the Ford occupied the entire southbound shoulder with the vehicle front occupying about half of the travel lane and its left rear corner resting atop the guardrail. The Dodge likewise exhibited a counter-clockwise rotation that ended at a 64° angle relative to its initial lane of travel (northbound). At final rest, the Dodge occupied the entire southbound lane and approximately half of the northbound lane.

Figure 2: Scaled site diagram depicting approximately 935 feet of the highway including 155 feet of the northern tangent segment. The inset image provides greater detail of the vehicle positions of rest.

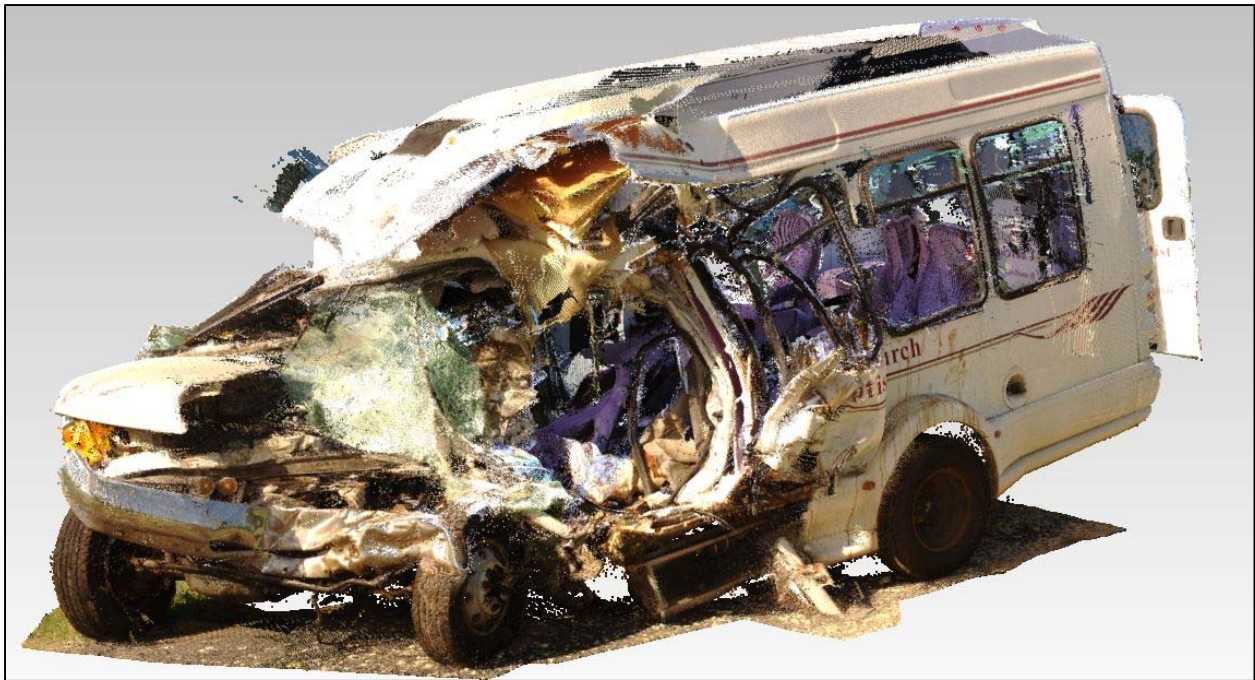
The vehicle sustained an offset frontal impact at the driver's side with direct contact damage having overlapped about 37 inches of the vehicle's lateral width, as measured relative to the sidewall at the front axle position. The damage exhibited characteristics of the Dodge having overridden the frame and bumper and then displacing the body and forward structures rearward. Some forward structures at the driver's side were displaced rearward as much as 62 inches (measurement includes free space). Additional damage and intrusion about the driver's-side cab resulted from the collision-induced rotation of the Dodge. **Figures 3 and 4** depict 3D scan images and damage patterns exhibited by the Ford.

Figure 3: The image depicts linked 3D scans of the Ford bus as viewed looking toward the left front of the vehicle where the impact damage was concentrated.

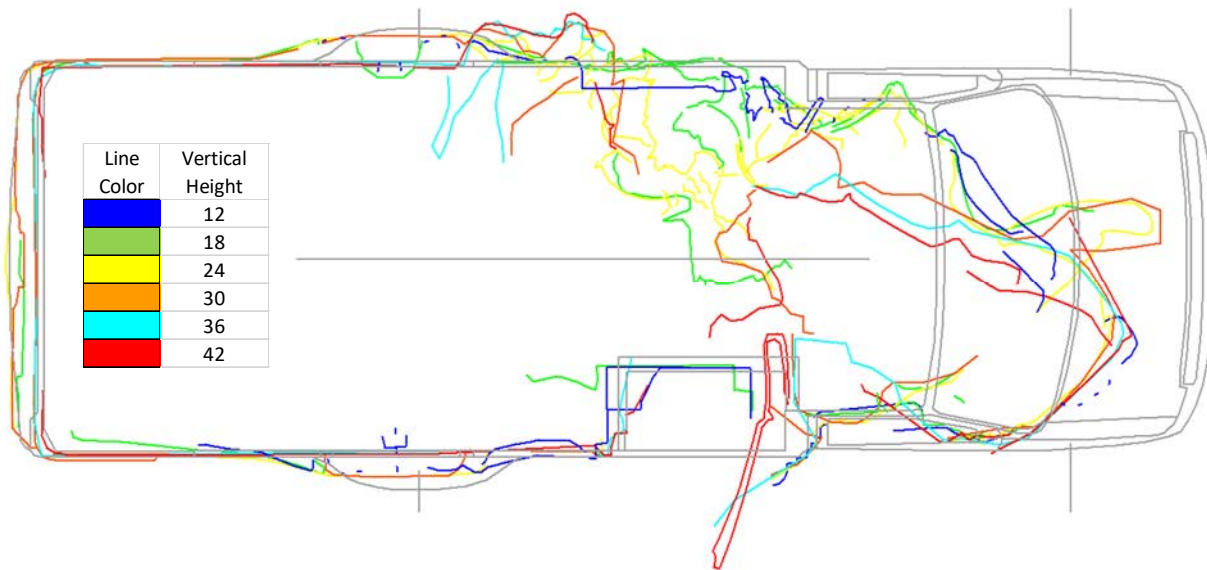
Figure 4: Image depicts a two-dimensional, top-down illustration of damage to the Ford atop an undamaged outline. Damage outlines were drawn from the 3D scan data at six-inch vertical intervals beginning at approximately the axle height.

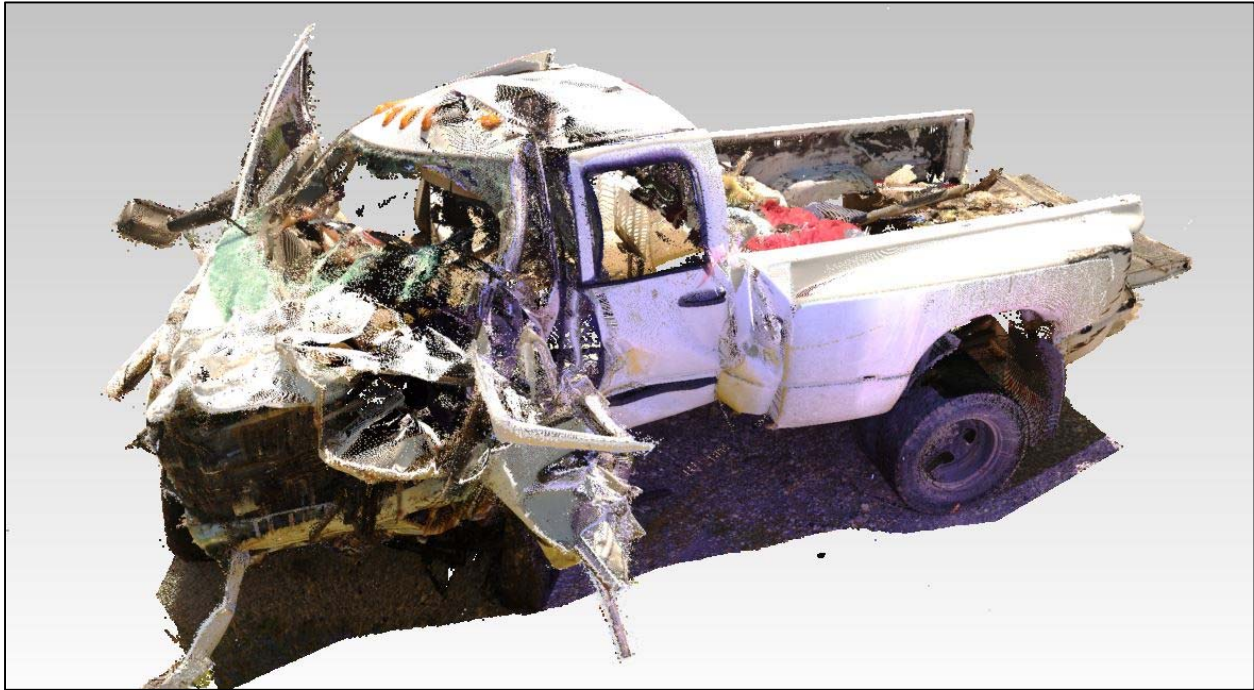
The vehicle sustained an offset frontal impact at the driver's side with direct contact overlapping about 37 inches of the vehicle's lateral width, as measured relative to the vehicle side at the front axle position. The damage exhibited characteristics of the Dodge having overridden the frame and bumper of the Ford resulting in not only the rearward displacement of components, but also a lateral offset to the frame and structures forward of the cab. Three-dimensional scan data depicted a leftward (toward driver's side) shift of the forward frame rails of about 40-42°, while other components exhibited even greater offset. Measurement of the rearward displacement of the forward structure was complicated by the lateral offset. **Figures 5 and 6** depict 3D scan images and damage patterns exhibited by the Dodge.

Figure 5: The image depicts linked 3D scans of the Ford bus as viewed looking toward the left front of the vehicle where the impact damage was concentrated.

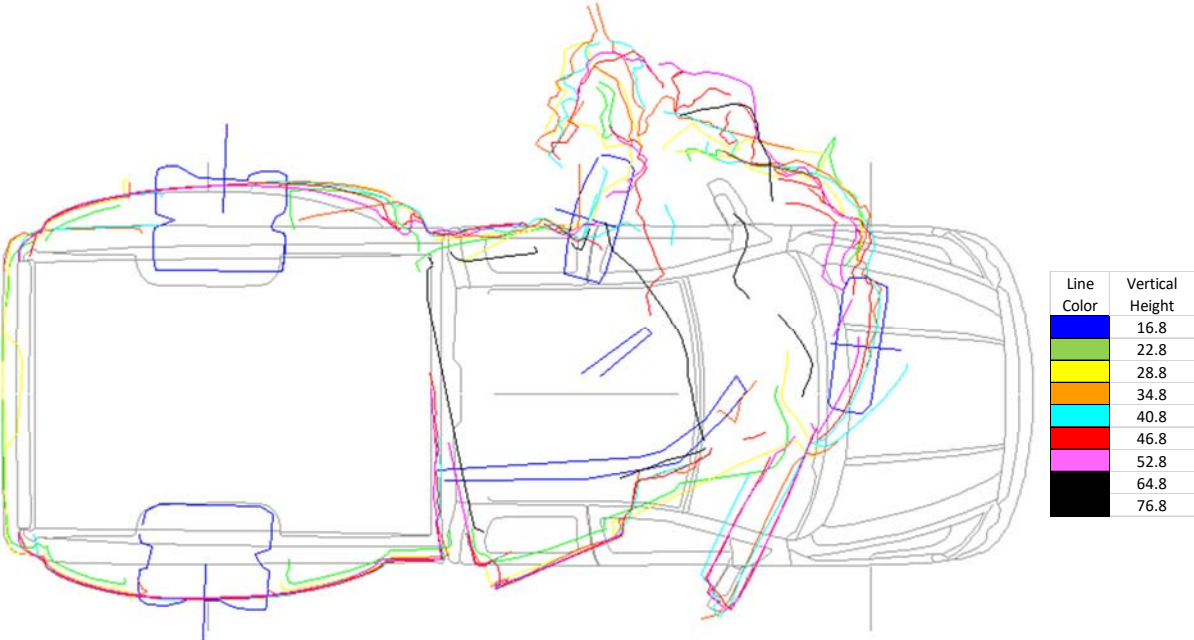
Figure 6: Image depicts a two-dimensional top-down illustration of damage to the Dodge atop an undamaged outline. Damage outlines were drawn from the 3D scan data at six-inch vertical intervals beginning at approximately the axle height.

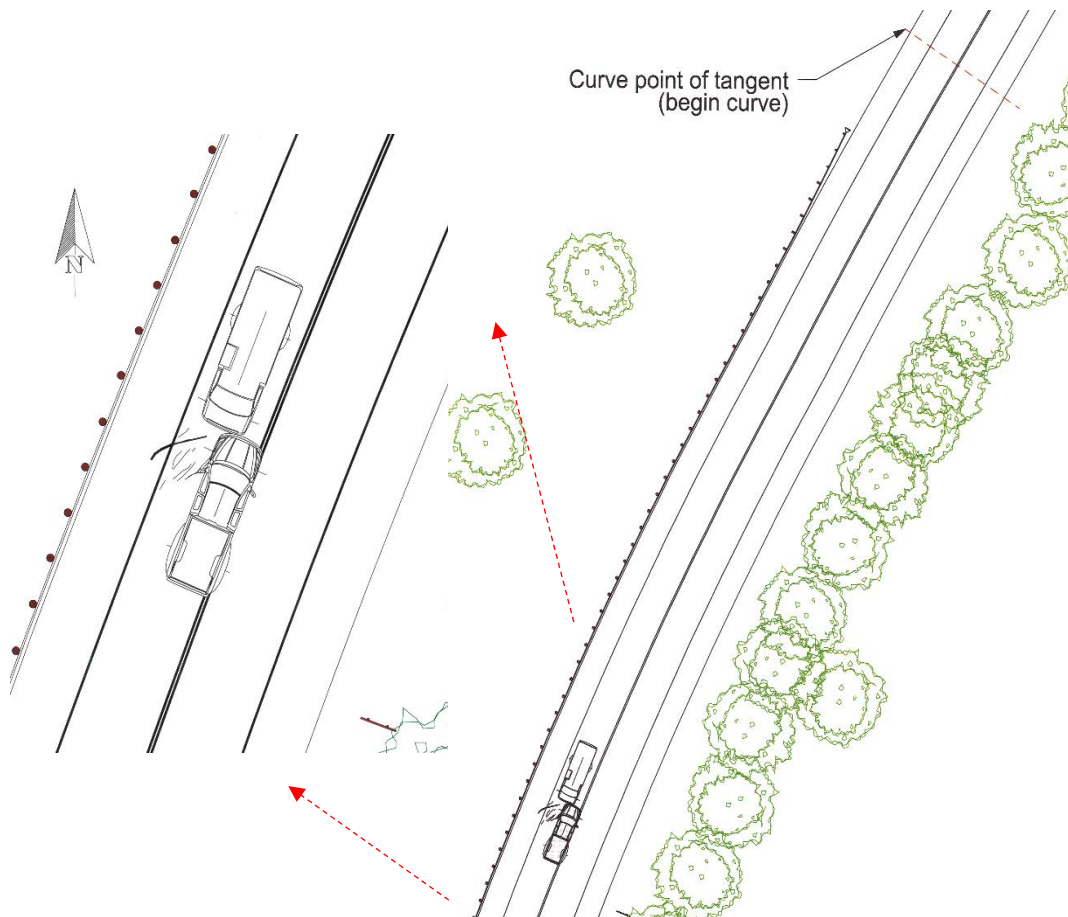
As exhibited by the vehicle damage, the collision involved a colinear, offset impact. The relative frontal overlap for both vehicles was approximately 47%. Following the impact, both vehicles exhibited a post-impact counterclockwise rotation and some southward movement. As the Ford rotated, its right rear corner impacted and overrode the guardrail that was contiguous with the road edge. The vehicles remained in contact with one another and exhibited no discernible separation following maximum engagement. The rotation appeared to pivot about the left front wheels of the two vehicles.

Figure 7 depicts a two-dimensional rendering of a colinear impact representing the offset between the two vehicles. It should be noted that the actual relative approach angle could vary slightly as well as the lateral offset within the southbound travel lane. There was no evidence to indicate the precise approach heading of either vehicle. The lateral position within the lane and distance from the onset of the roadway scars was estimated based on probable impact speed and time to maximum engagement.

Figure 7: Scaled diagram depicting lateral offset of the Ford and Dodge at impact. Also depicted is the area of impact relative to roadway evidence and the end of the highway curve.

OEM specifications indicate that a nominal five (5) inch overlap in the vertical height of the vehicle front bumpers while in a static condition should exist. The vertical height of the Ford front bumper is reported at 24 inches with a typical width of nine (9) inches, while the Dodge is reported at 31 inches high and 12 inches wide. As conveyed in the NTSB Vehicle Factors Group factual report, the combination of larger tires and a suspension lift on the Dodge may have raised the vehicle approximately five (5) inches, thereby negating the anticipated overlap.

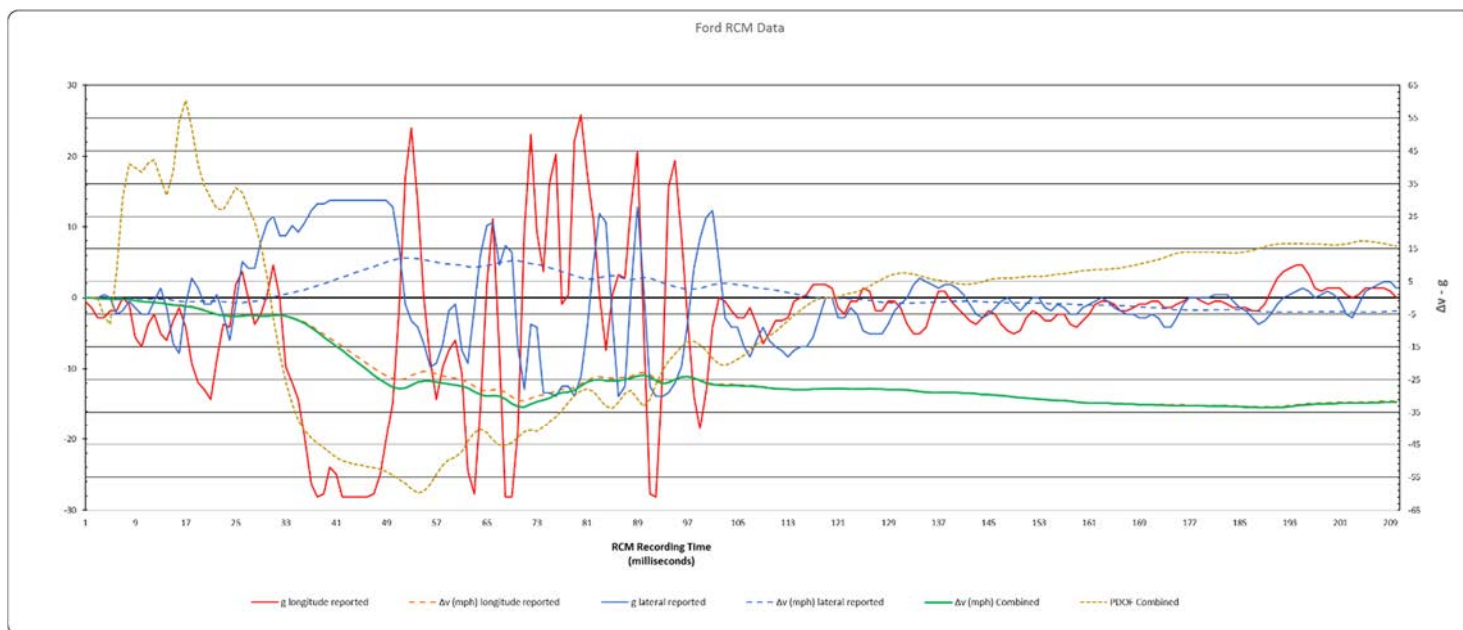
Based on the data as reported, the maximum cumulative change in velocity along the longitudinal and lateral axes were reported as 53.5 km/h (33.2 mph) and 19.4 km/h (12.0 mph) respectively. Examination of the data, however, concluded that the magnitude of the acceleration and change in velocity were underreported at certain time intervals. The graphs (combined in figure 8) depicted data clipping at certain sample times beginning around 40 milliseconds.⁸ While the data depicted maximum reported longitudinal and lateral acceleration values as 61 and 30g’s respectively, Continental advised that these are the accelerometer limits (thresholds). With the acceleration underreported, the cumulative change in velocity would likewise be underreported. The data profile indicates that without clipping the magnitude would have been greater.

Figure 8: Graph illustrating ACM reported acceleration and change in velocity as reported by the Ford's airbag control module.
