**NATIONAL TRANSPORTATION SAFETY BOARD  
OFFICE OF HIGHWAY SAFETY  
WASHINGTON, D.C.**

**TECHNICAL RECONSTRUCTION GROUP CHAIRMAN'S  
FACTUAL REPORT**

Location: Intersection of Northern Boulevard and Main Street, Flushing, NY  
Vehicle #1: 2015 Motor Coach Industries Motorcoach  
Operator #1: Dahlia Group Inc., of Flushing, NY  
Vehicle #2: 2015 New Flyer Transit Bus  
Operator #2: New York City Transit  
Vehicle #3: 2009 Honda Odyssey  
Operator #3: Parked at curb, not running, unoccupied  
Vehicle #4: 2002 Toyota Sequoia  
Operator #4: Parked at curb, not running, occupied by two passengers (one in the driver's seat, and one in the right-front passenger seat)  
Date: Monday, September 18, 2017  
Time: 6:16 a.m. Eastern Daylight Time (EDT)  
NTSB #: **HWY17MH015**

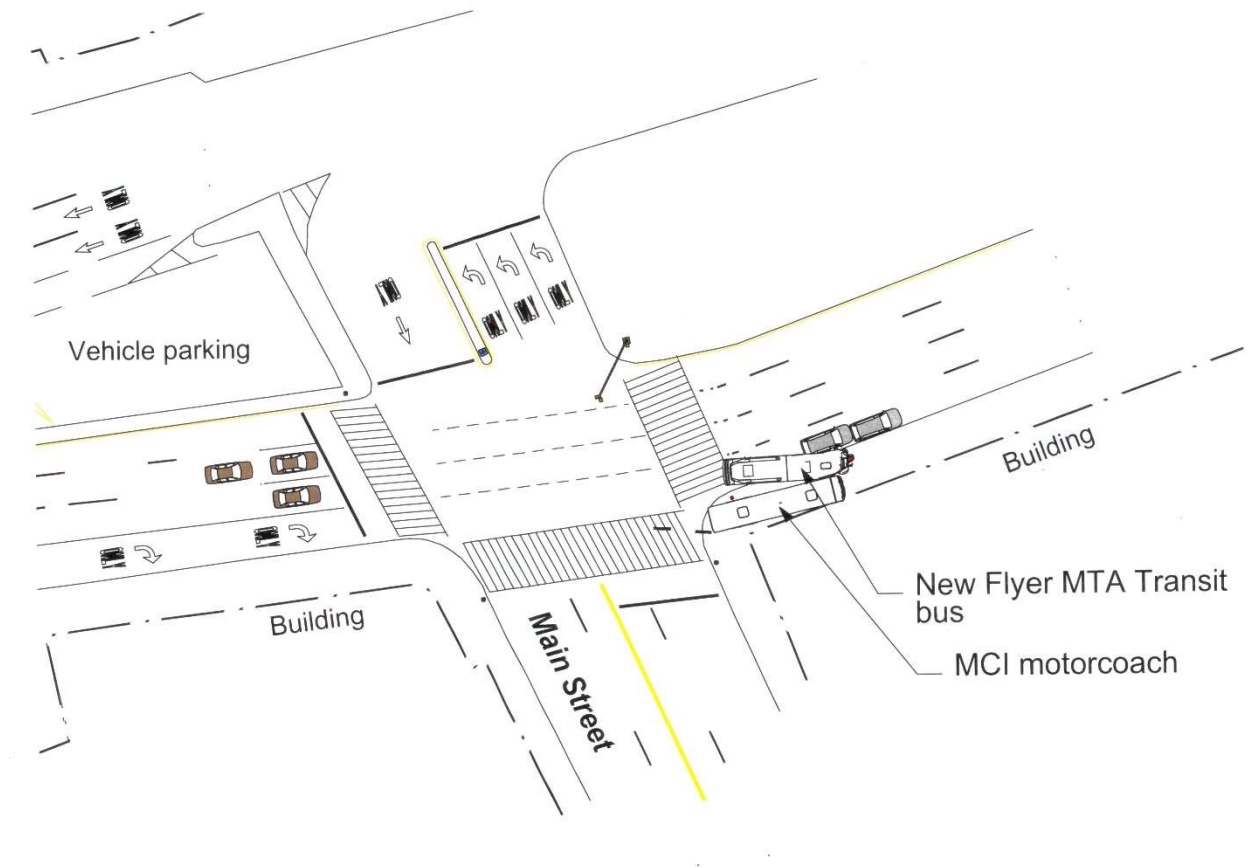
Figure 3: Illustration depicting post-collision position rest for the involved vehicles.

The photographs depicted the presence of tire friction marks and metal scars on the roadway and sidewalk surfaces. The tire friction marks were observed atop portions of the painted crosswalk on the southern leg of Main Street. The tire marks appeared to project an angular heading toward the southeast corner of the intersection. The most prominent mark, that remained clearly visible when the site was scanned by the NTSB, appeared as a single linear mark that exhibited characteristics of parallel tread grooves and an over-deflection of the tire. The mark

appeared consistent with the heading of the MCI and was approximately located between nine and 17 feet from the curb (also depicted in Figure 3). About 30 feet from the curb near the northern edge of the crosswalk, less prominent tire friction marks likewise angled toward the southeast corner were observed. These marks were characteristic of a single set of dual wheels and were predominantly only visible atop three to four of the white crosswalk lines covering a distance of about 8.5 feet. The tire marks were located primarily with the northbound lane of Main Street, near the roadway centerline. The location and heading of these tire marks were consistent with MCI path of travel immediately following impact with the transit bus.

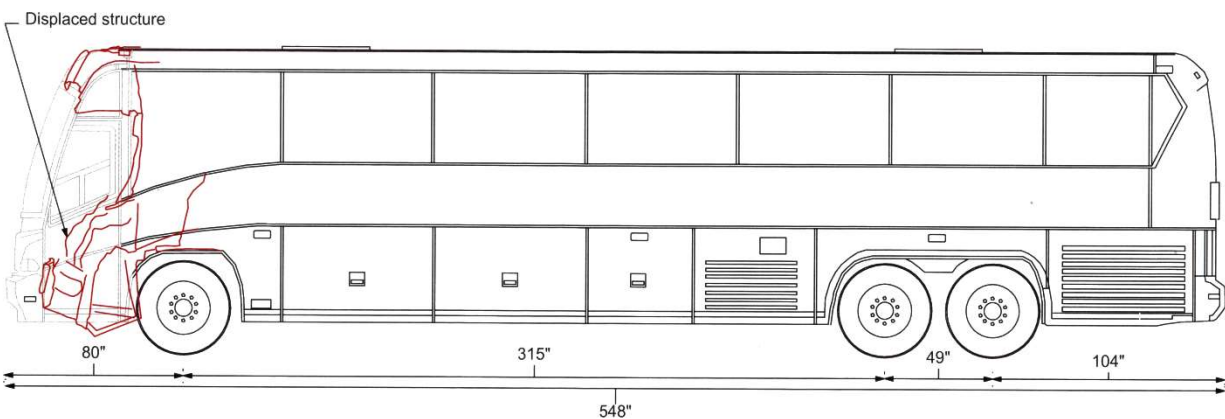
The MCI exhibited frontal impact damage with additional contact and induced damage extending rearward to the steer axle tires. During the examination, both steer axle tires were found deflated and unable to rotate due to impingement from structural displacement. Impact damage across the front the vehicle appeared relatively uniform from ground level to a vertical height of about six feet. The frontal structure at about the level of the interior floor was displaced rearward approximately 27 inches, while the structure at the bumper level exhibited a rearward displacement of about 17 inches. Vertically above the approximate six-foot level, structures on the right (passenger) side exhibited slightly more rearward displacement than on the left (driver) side due to contact with the building. **Figure 7** is a line drawing depicting the rearward displacement of the frontal structure as observed from the left (driver) side.

Figure 7: Illustration of collision damage to the MCI motorcoach as viewed from the left (driver) side.

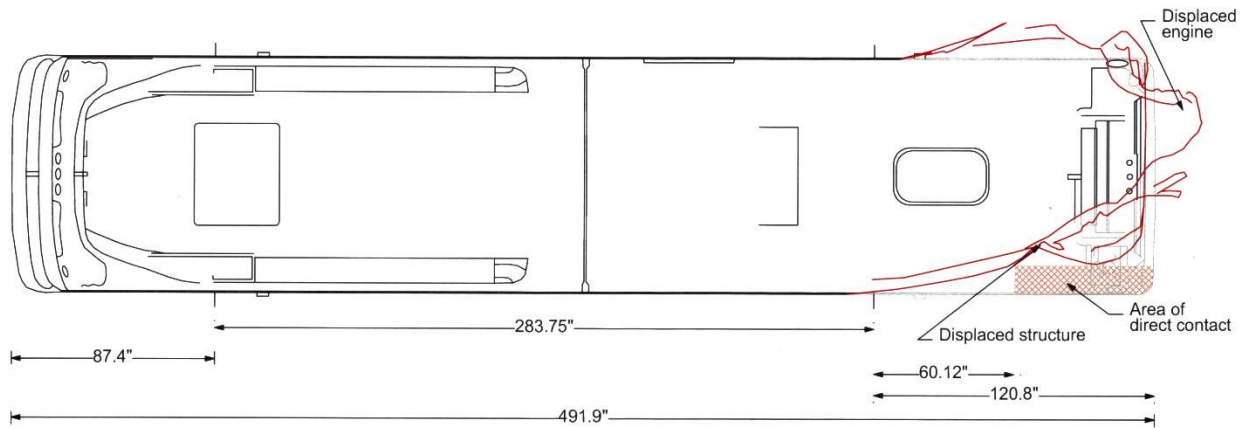
The transit bus exhibited evidence of impact damage to the left (driver) side rear beginning approximately five feet aft of the drive axle. The impact force displaced the entire body aft of the drive axle toward the right (passenger) side of the vehicle approximately 16 inches and partially ejected the engine through the rear of the vehicle. **Figure 10** is a line drawing depicting the area

of direct contact and lateral displacement of the vehicle body as observed from an overhead perspective.

Figure 10: Illustration of collision damage to the New Flyer transit bus as viewed from an overhead perspective.

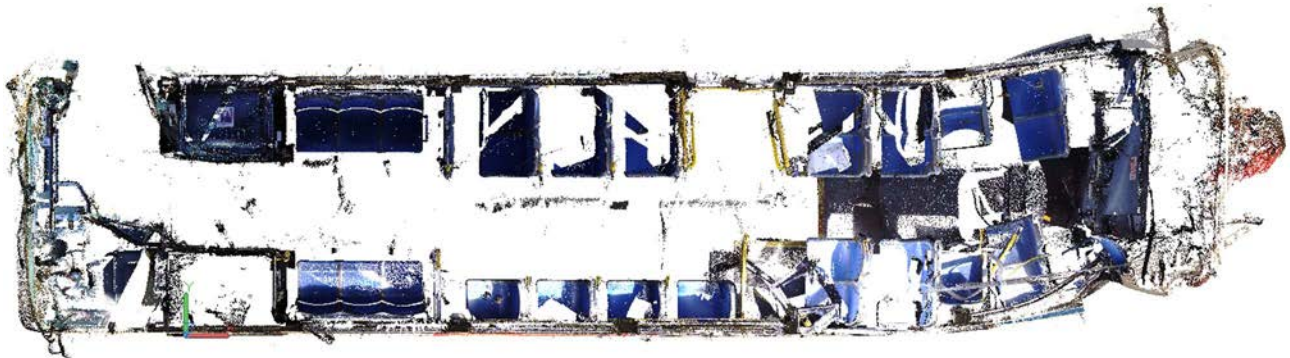
The vehicle interior exhibited similar lateral displacement at the rear of the vehicle. **Figure 11** depicts a 40-inch thick longitudinal cross section of the 3D scan covering the interior of the New Flyer. The cross section depicted covers an area just below the axle line to about the lower side window sills.

Figure 11: Longitudinal cross section of the 3D scan depicting the interior of the New Flyer transit bus.
