**NATIONAL TRANSPORTATION SAFETY BOARD
OFFICE OF HIGHWAY SAFETY
WASHINGTON, D.C.**

**TECHNICAL RECONSTRUCTION GROUP CHAIRMAN'S
FACTUAL REPORT**

Location: Seabreeze Boulevard (State Route A1A) north of Harbor Beach Parkway,
Broward County, Florida

NTSB #: **HWY18FH013**

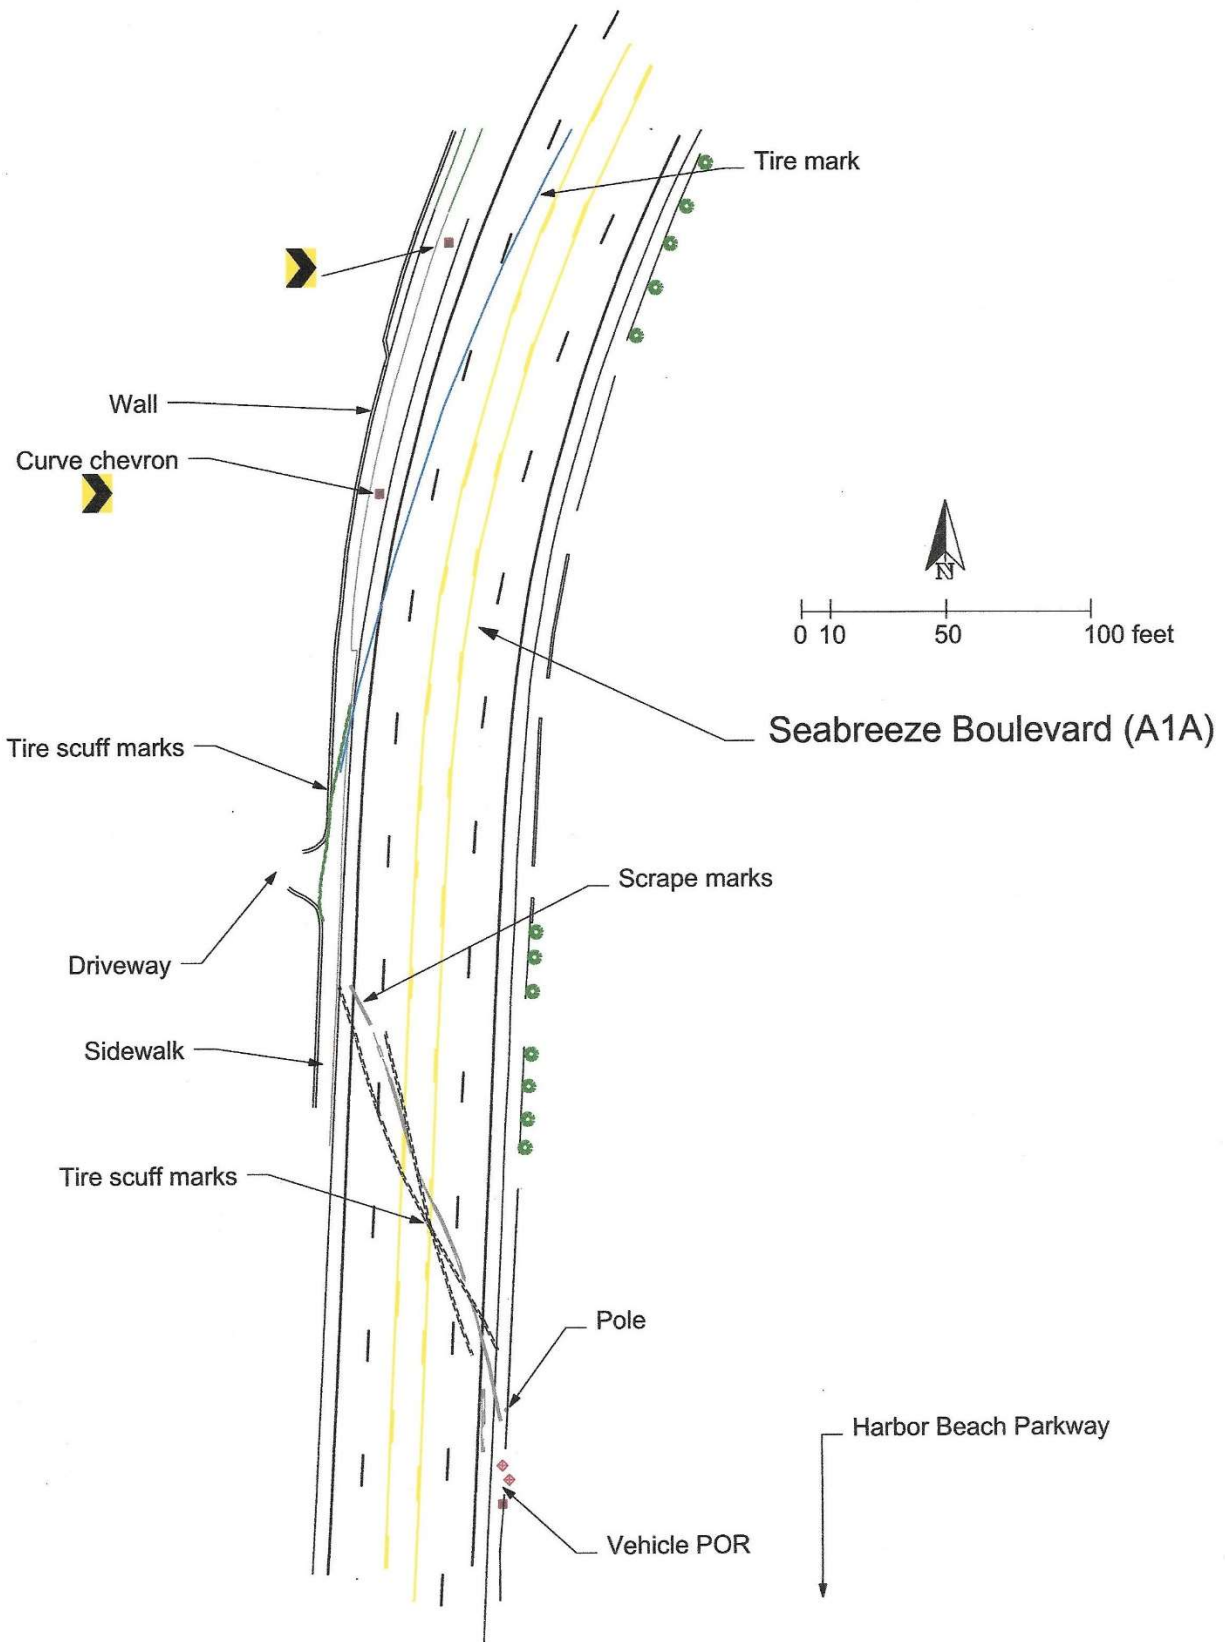
Figure 1: Scaled diagram of collision location depicting total station measurement data provided by FLPD investigators.

The arced mark angled toward the outside of the curve, where it passed through the right travel lane and bike lane. Approximately 213 feet after onset of the documented tire mark, the mark intersected and surmounted the raised curb and sidewalk. Additional tire friction scuff marks were observed on the vertical face of the curb. About 34-35 feet after the tire mark encounters the raised curb, evidence of contact from the vehicle with the concrete wall bordering adjacent property was observed. This evidence consisted of paint and other material transfer.

Material transfer continued along the wall about 10.5 feet to a point where the wall face became rounded and curved away from the roadway to form a driveway entrance. On the opposite side of the driveway, a distance of about 27 feet, additional material transfer and surface damage was observed to the rounded face of an opposing wall that bordered the sidewalk and curved to parallel the driveway. Vehicle parts were deposited at the base of the wall and were further displaced into the roadway.

Tire friction scuff marks and roadway surface metal scars were observed extending southeastward across the highway from this second wall impact. Documentation of the scuff marks began at the curb and extended across the highway over a distance of about 157 feet where a downed luminaire pole had been located. The total distance from wall impact to pole was approximately 182 feet. The separation distance between parallel tire marks and metal scars varied and exhibited a crossover near the middle of the highway indicating the vehicle was in a spin.

Tire friction marks, parallel with the curb, were observed to extend southward of the downed luminaire pole over a distance of about 26 feet. This point was marked as the position of final rest for the Tesla. At rest, the Tesla was atop the sidewalk on the northbound side of the highway with its right axle ends partially in the bike lane.⁵

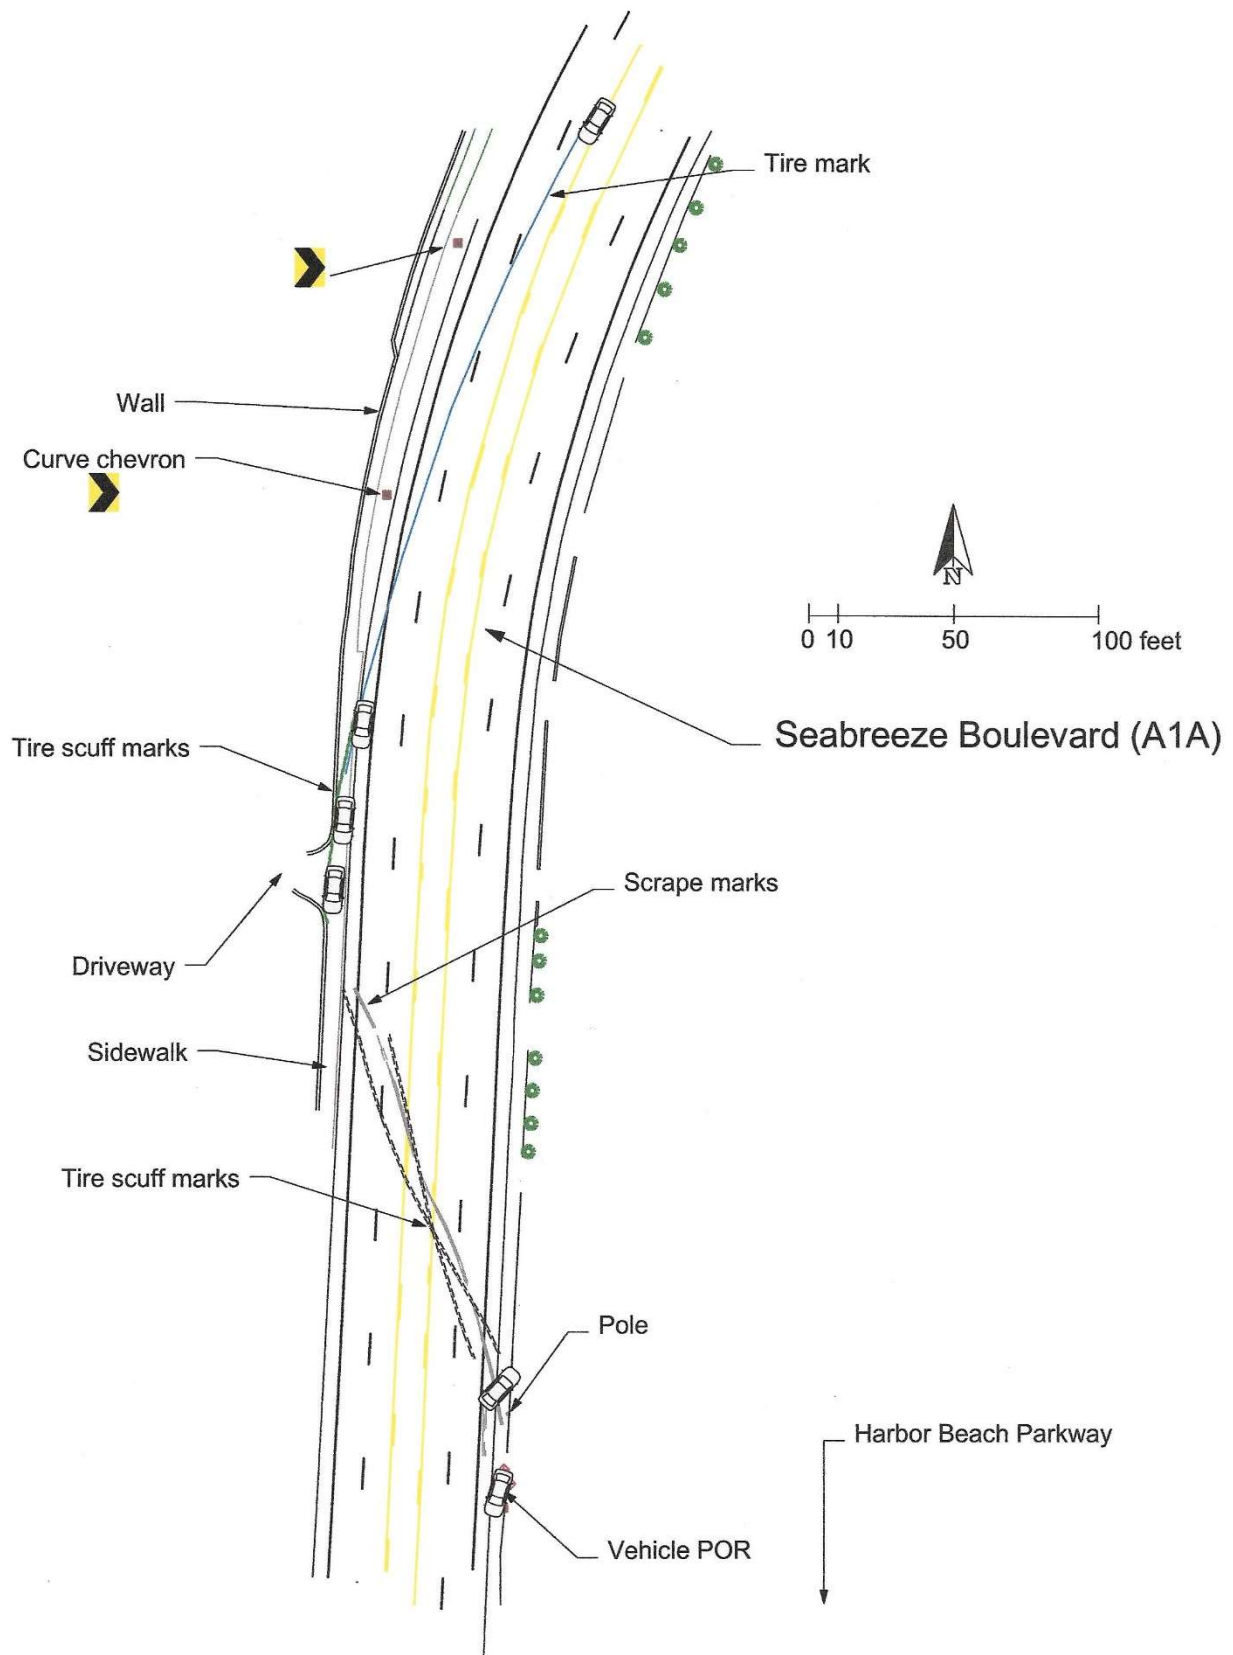
Figure 2: Scaled diagram of collision location depicting vehicle path of travel based upon total station measurement data provided by FLPD investigators.

The Tesla departed the southbound travel lane as it neared the end of the curve at a high rate of speed. The vehicle ascended a raised curb and sidewalk, then sideswiped a masonry/concrete wall that paralleled the highway and bordered the contiguous residential property. After crossing a driveway, the vehicle sustained a significant impact with the wall on the opposing side of the driveway. The vehicle rotated off the wall and traveled southeastward across SR-A1A where it collided with a luminaire pole on the opposite side of the highway. The vehicle separated from the pole and came to rest further south atop the sidewalk and a post-collision fire ensued.

The onset of curvilinear tire scuff mark appeared about 247-248 before the initial wall impact and between -2.0 and -1.5 seconds before algorithm enable. This time period corresponds with the substantial increase in a leftward steering angle and the engagement of the vehicle stability control. **Table 1** provides a summary of the EDR pre-crash data.
