**TECHNICAL RECONSTRUCTION GROUP CHAIRMAN'S  
FACTUAL REPORT**

**Palm Springs, CA**

**HWY17MH005**

**NATIONAL TRANSPORTATION SAFETY BOARD  
OFFICE OF HIGHWAY SAFETY  
WASHINGTON, D.C.**

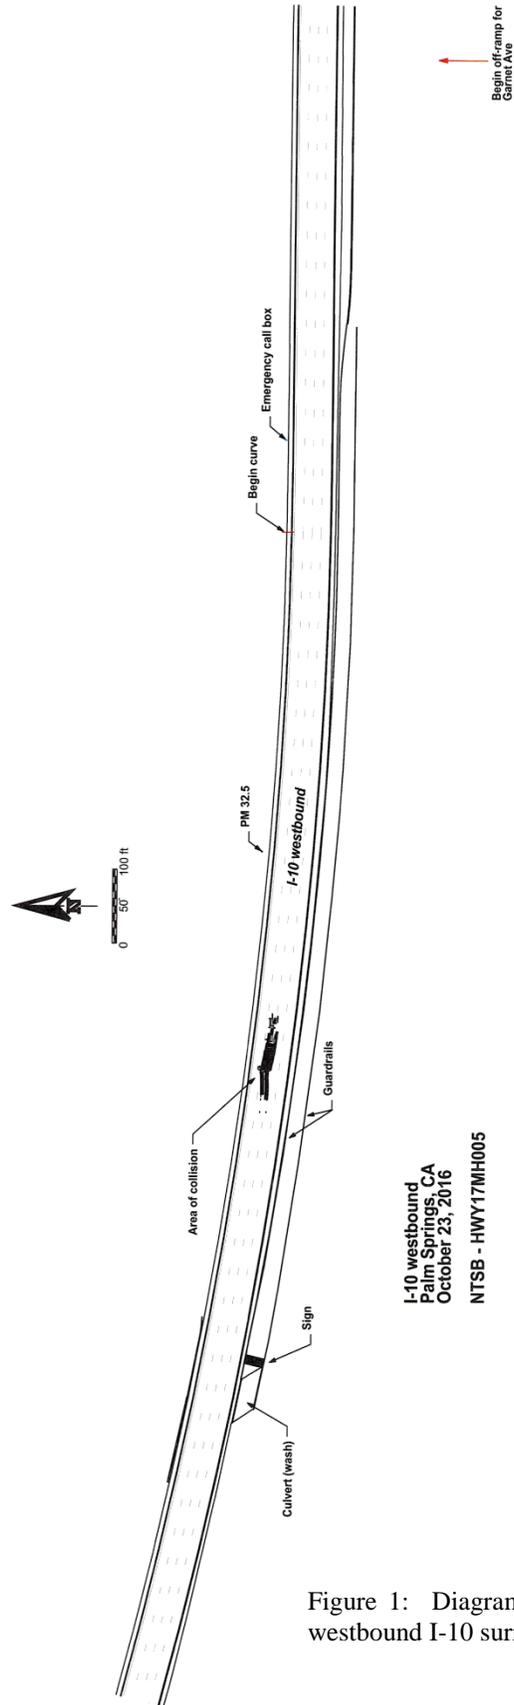
Roadway evidence from the collision was mostly confined to the right-center lane of the westbound roadway. Excluding displaced debris, such as vehicle components and cargo, roadway scene evidence consisted of tire friction marks, roadway surface metal scars, and fluid debris stains that extended over a linear distance of about 110.6 feet. Some tire and metal scar marks exhibited a leftward movement partially entering the left-center travel lane. The leftward movement represented the movement of the vehicles as they came to rest. At final rest, the International truck tractor and the MCI partially occupied the left-center lane. Fluid debris stained the roadway pavement beneath the front of the MCI at its position of final rest. **Figure 1** is a scaled two-dimensional diagram that was created from the CHP 3D scan.

While there was overlap of the tire friction marks during the vehicle post-impact travel, the source of the marks could be distinguished. All the roadway marks were created post-impact; there was no evidence of pre-collision tire friction marks (such to indicate an evasive maneuver). The tire marks, as interpreted through the scan data, indicated that the MCI collided with the semitrailer at a slight angle and was offset toward the left (driver's) side. Post-impact, the tractor, which was undamaged, moved approximately 70-72 feet in a westerly direction.

Figure 1: Diagram depicting approximately 2,000 feet of westbound I-10 surrounding the collision.

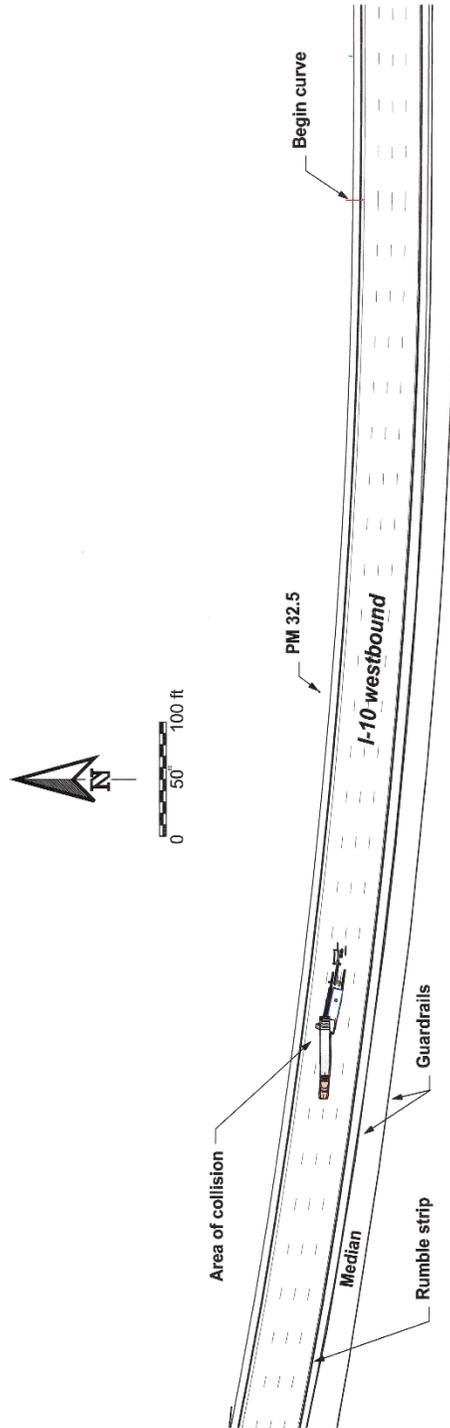
**Figure 2** is a scaled two-dimensional diagram depicting the post-collision positions of rest for the vehicles. Vehicle placement was based on vehicle dimensions and scene evidence markings applied by CHP investigators.

Figure 2: Diagram depicting positions of rest for International combination and the MCI motorcoach.

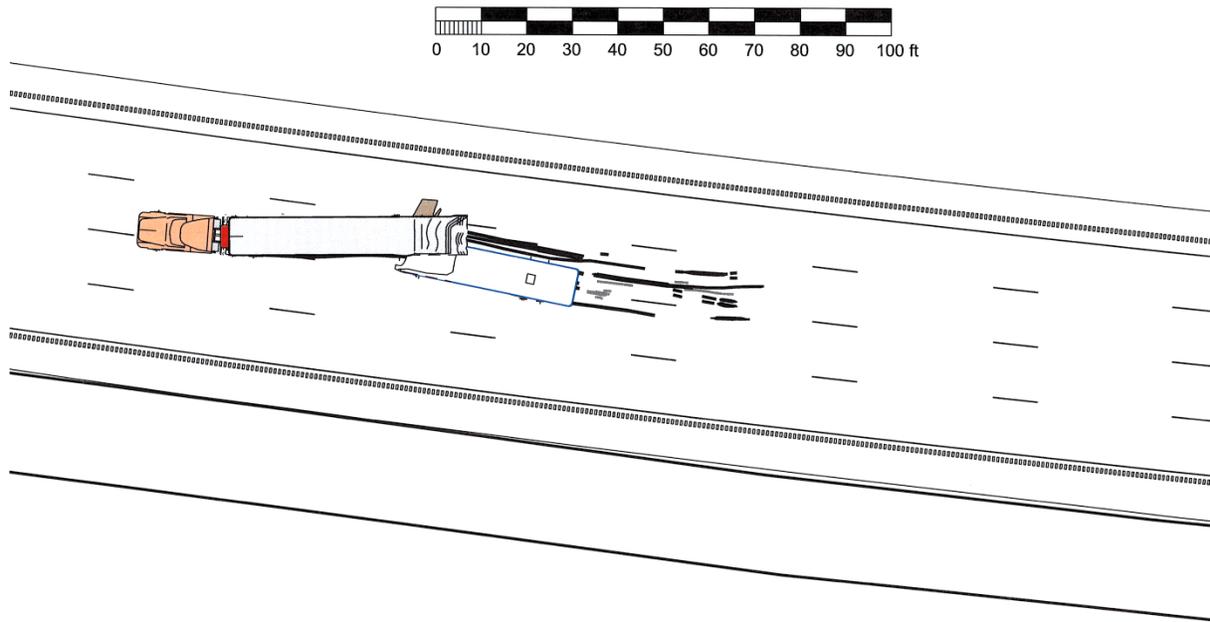
Figure 3: Diagram depicting post-collision positions of rest for the International combination and MCI motorcoach. Note – the depiction of vehicle damage is approximated and does not represent the full structural displacement.

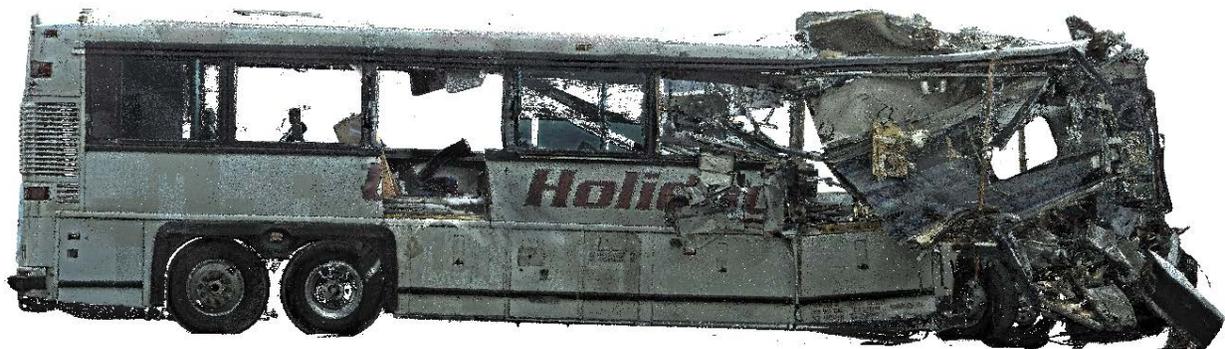
The motorcoach sustained a frontal impact that resulted in substantial damage. Impact damage was offset toward the right (passenger) side of the vehicle. Based on the manufacturer specified maximum overall length, structural displacement at the right front extended rearward by about 3.4 feet.<sup>4</sup> Toward the left (driver's) side, rearward structural displacement diminished with the base structure at left front corner of the motorcoach remaining intact. Evidence of underride with the semitrailer was observed above the frontal damage resulting in additional intrusion into the vehicle cabin. Approximately 13.7 feet of the roof panel separated along the left side, inboard

Figure 5: Depiction of 3D point cloud of the motorcoach right side. (Scan data provided by CHP)

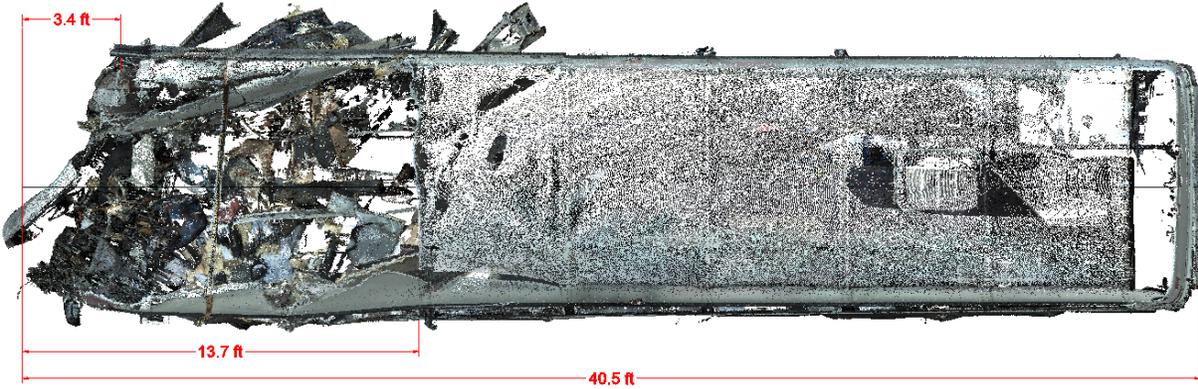
**Figure 6** is a 3D point cloud image depicting an overhead view of the MCI and the forward roof breach. The left side (bottom in the image) was sheared by the semitrailer sidewall. Following separation of the vehicles for recovery, the roof panel folded inward toward the right side (top in the image).

Figure 6: 3D point cloud image of motorcoach depicting frontal displacement and roof intrusion relative to original overall length. (Scan data provided by CHP)

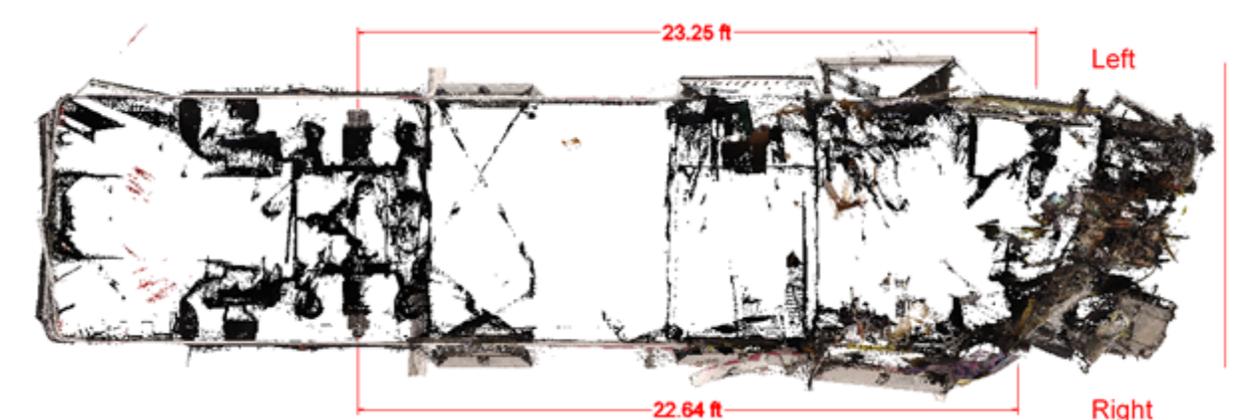
**Figure 7** is a 3D point cloud image depicting a slice of the scan at about the level of the interior floor of the motorcoach approximating the area of greatest structural damage. The image depicts the rightward offset and rearward displacement of the damage. The wheelbase measurements depicted in the scan represent some shifting as the vehicle was elevated for inspection and subsequent scanning. Scan data provided by CHP investigators where the vehicle was positioned at ground level indicated wheelbase measurements of approximately 23.5 feet and 21.6 feet on the left and right sides respectively.

Figure 7: Image of 3D point cloud sliced at approximate floor level for motorcoach depicting structural displacement relative to overall vehicle length. The vehicle's undamaged overall length is depicted by the red vertical line. (Note: vehicle was elevated for inspection, which resulted in some alteration of the wheelbase dimensions as compared with the vehicle resting on the ground.)

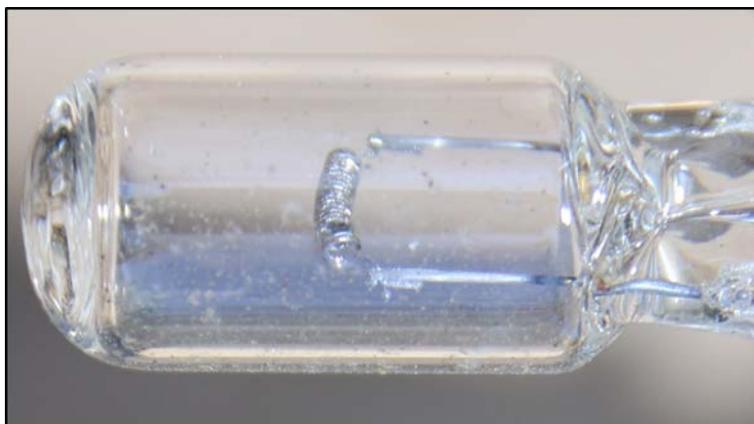
The headlighting system on the motorcoach consisted of four sealed beam halogen lamps, with two lamps – one dual filament low/high beam and one high beam – on each side of the vehicle.<sup>7</sup> The low beam lamps occupied the outer-most position. Following the crash, the left dual filament low/high beam headlamp was found intact and was recovered for analysis. Although the housing, lens and reflector for left high beam lamp were destroyed, the bulb envelope and filament, with some exception, remained intact. As depicted in **Figure 8**, while the filament exhibited no distinct indication of deformation consistent with having been incandescent (lit) at the time of impact (i.e., hot shock) it did, however, exhibit a clean separation within the coil. The age of the separation could not be discerned and the lamp would otherwise be nonfunctional at the time of examination. See the NTSB Vehicle Factors Group Factual Report for additional information.

Figure 8: Photograph depicting post-collision condition of the left (inboard) high beam bulb filament and glass envelope located on the MCI.

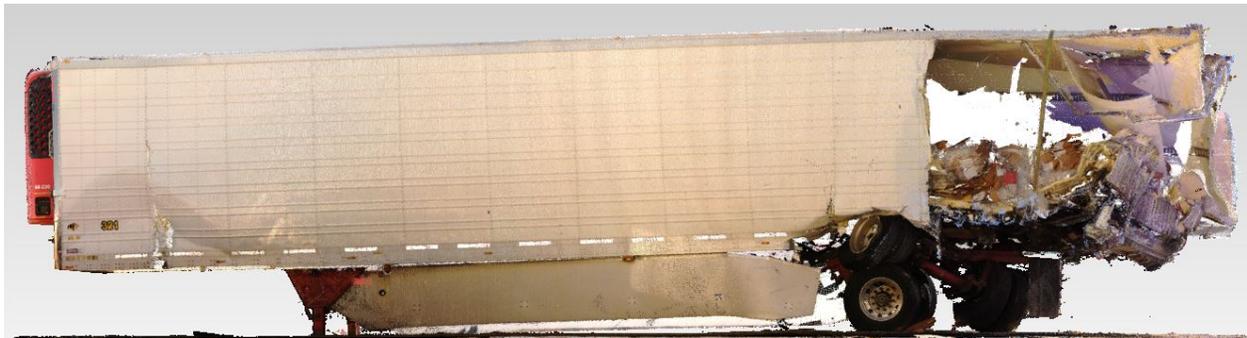
The semitrailer sustained a rear impact that resulted in substantial damage and displacement of the deck (floor) and tandem axles. The aft portion of both sidewalls and roof likewise exhibited damage. Incidental bowing of the sidewalls was also observed near the front of the vehicle, rearward of the upper 5<sup>th</sup> wheel plate. Upon impact, the motorcoach intruded into the semitrailer displacing the deck and tandem axles forward. The motorcoach intruded inboard

Figure 9: Image of linked 3D scans depicting left side of Utility semitrailer. Note that the aft portion of the left (driver side) sidewall had been removed during recovery of the vehicle. The right sidewall remained intact, although the image above is incomplete.

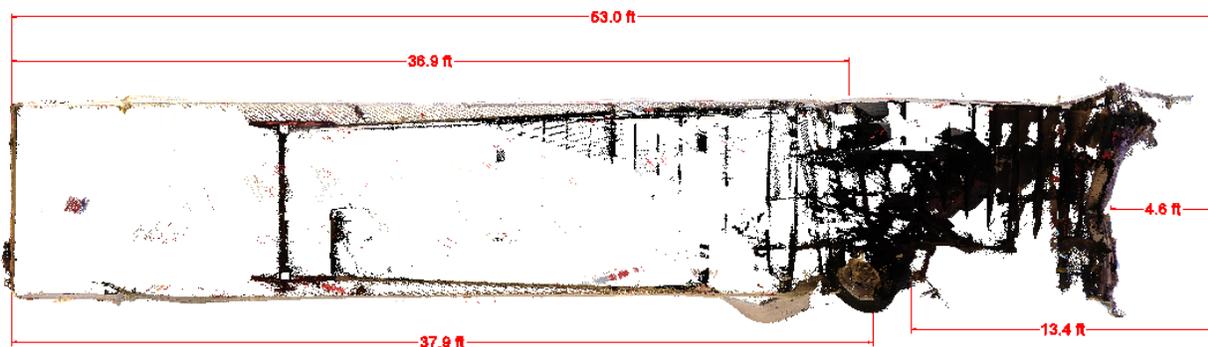
**Figure 10** is a 3D point cloud image depicting a slice of the scan at about the level of the interior floor of the semitrailer approximating the area of greatest structural damage. The image depicts the leftward offset and forward displacement of the damage, as well as displacement of the axles. The displacement of the undercarriage components was consistent with a potential heading offset of less than 5 degrees between the motorcoach and semitrailer.

Figure 10: Image of 3D point cloud sliced at approximate floor level for semitrailer depicting structural displacement relative to overall vehicle length.

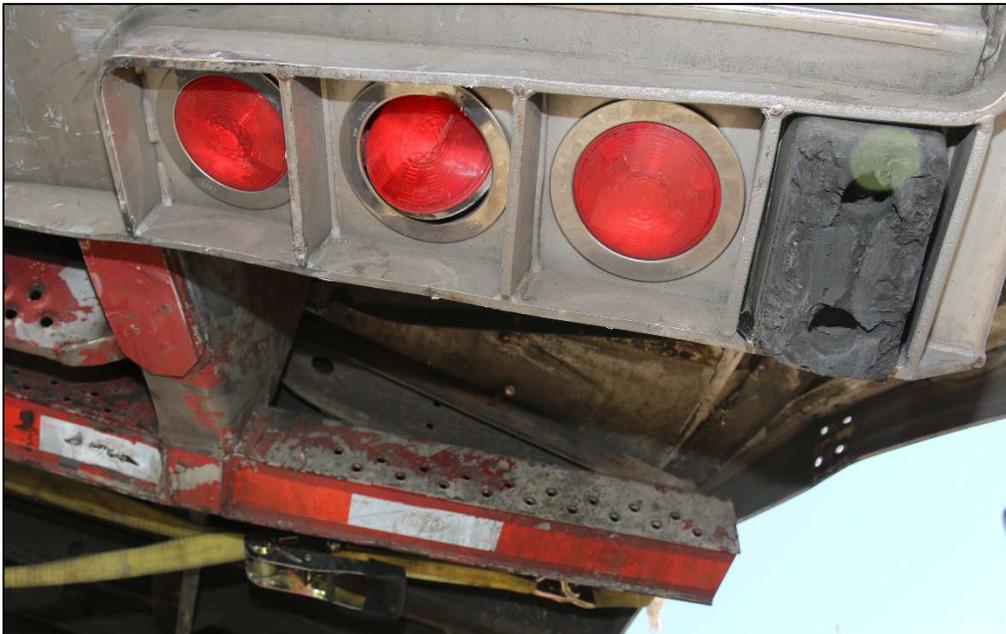
Rearward lighting on the semitrailer was configured to be consistent with the requirements of applicable federal regulations.<sup>8</sup> The trailer exhibited a group of three (3), four-inch circular, grommet-mount, lamps on both sides of the vehicle.<sup>9</sup> The lamps were combination stop-turn-tail assemblies with the light source being light-emitting diodes (LED) behind a red colored filter. The tail lamps extended laterally inboard over a distance of about 13.2 inches at a nominal vertical height above ground of 41 inches, as measured at their centers. The outboard lamp was centered about 9.5 inches inboard of the respective sidewall. **Figure 11** is a photograph that depicts the stop-turn-tail lamp configuration on the right side of the semitrailer. The assembly is depicted in its post-collision condition after the rear-end structure had been displaced by the impact.

Figure 11: Photograph of rear stop-tail-turn signal lamp placement on rear of Utility semitrailer. Photograph depicts the post-collision condition of the right (passenger) side lamps after folding under the trailer floor deck.

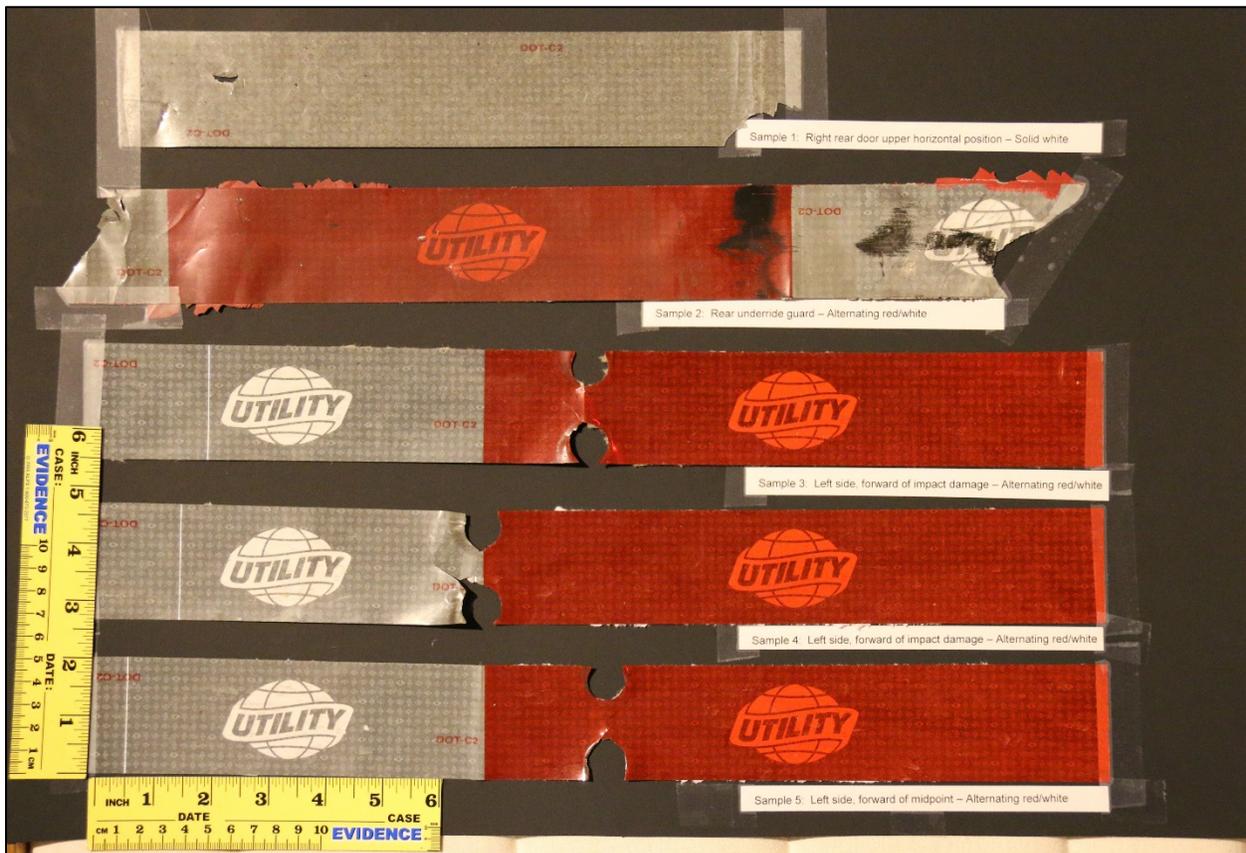
Visual examination of the semitrailer’s conspicuity treatment concluded that the material complied with applicable installation standards (see FMVSS 108, S8.2). While photometric standards for the conspicuity sheeting specific by FMVSS 108 are applicable at the time the vehicle is manufactured, samples were acquired from the vehicle for evaluation. Although the sheeting applied to the underride guard and bottom door edges exhibited significant collision damage, samples were acquired for examination, including a segment of sheeting approximately 16 inches in length that had been applied to the right side of underride guard. That strip contained a full red segment and partial white segments on both sides of the red. The sample exhibited collision damage, but less than other areas of the underride guard. A sample of the white sheeting applied to the upper corners of the rear doors was also collected with an approximately 12-inch-long segment was removed from the horizontal position on the right door. For comparison, three samples strips, each consisting of a single red and white segment were acquired from the left sidewall, forward of the area damaged by the collision.

Figure 12: Retroreflective sheeting samples acquired from the semitrailer for photometric measurement.

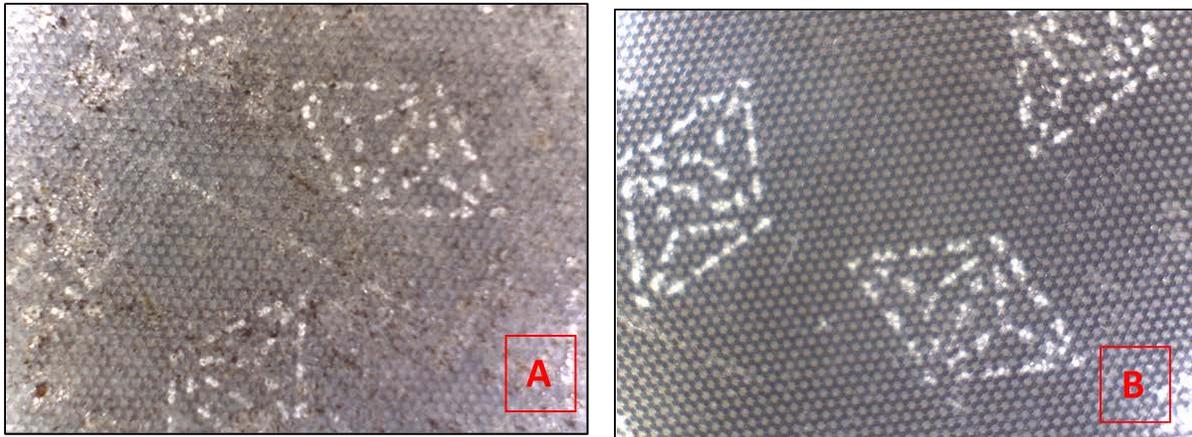
As exhibited in Tables 1a and 1b, the majority of samples met FMVSS 108 standards in an “as recovered” condition. Prior to cleaning certain samples of white sheeting on both the side and rear failed to meet the standard. Likewise, the red sheeting acquired from the rear underride guard failed to meet the standard except for one combination of entrance/observation angles. After cleaning, only a few white colored samples failed to meet the specifications, and then not under all entrance and observation angle combinations. The white sample that exhibited the poorest compliance was acquired from the upper rear door. Closer examination of the sample revealed damage to the microprismatic surfaces, which may have occurred during the collision and post-collision recovery. The doors were heavily damaged in the collision and deposited to a debris pile when recovered. **Figure 13** depicts a photographic comparison of the sheeting surface illustrating the damage.

Figure 13: Photographic comparison of the white retroreflective sheeting acquired from semitrailer rear door (A) and sidewall (B). Sample A exhibited clear surface damage and failed to meet photometric requirements post-collision.

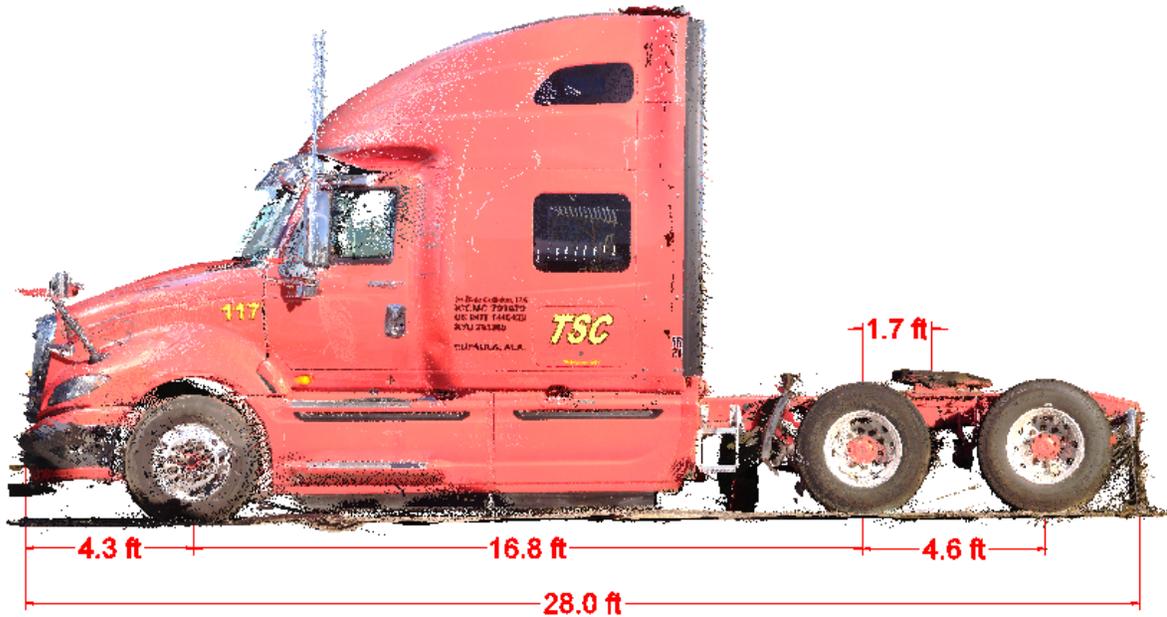
**Figure 16** depicts the 3D scans rendered as a point cloud with certain dimensional data. When coupled with the semitrailer, the overall length of the combination vehicle was calculated to be about 73 feet.

Figure 16: 3D point cloud image of the International truck tractor depicting certain dimensional information.

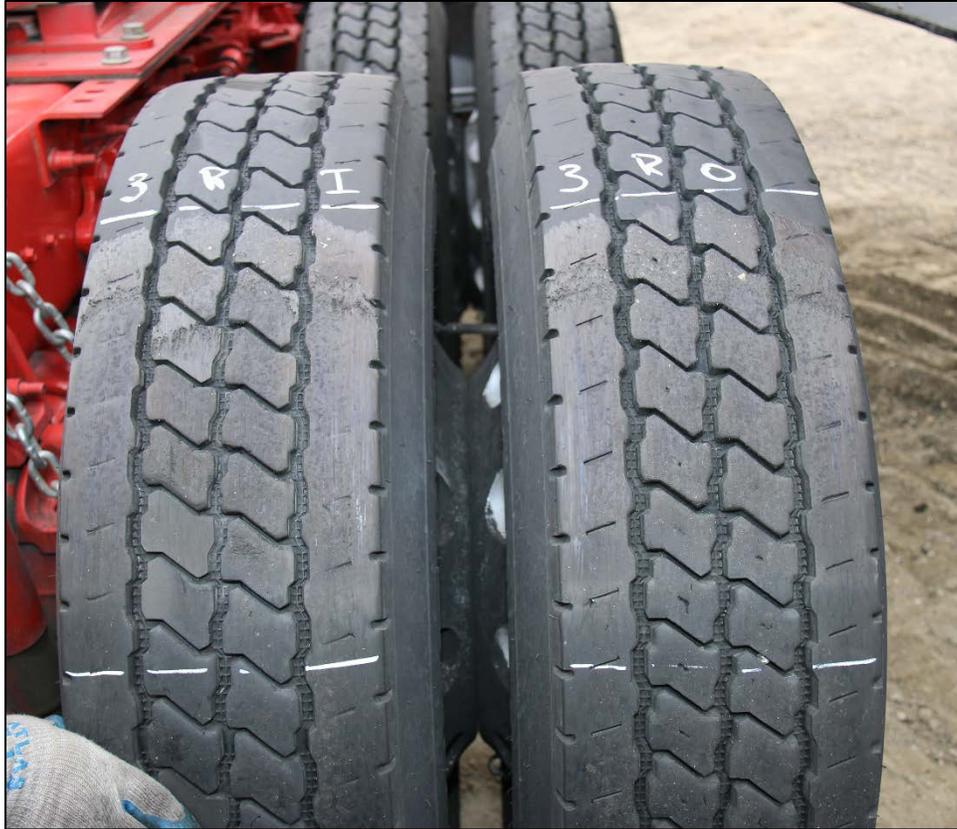
Post-collision examination of the highway surface at the crash scene revealed the presence of tire friction marks that terminated at the International's drive axle tires (also referenced as axle 2 and 3) and extended eastward from this point. The post-collision examination of the International revealed longitudinal scuffing and abrasions to the tread block on the eight tires of the two drive axles. The abrasions represented a patch on each tire that covered the full width of the tread and extended longitudinally over a distance of 10-14 inches. The scuffing was consistent across all the tires and was indicative of the wheels having been locked and then sliding on the pavement. **Figure 17** is a photograph of the right side aft drive axle dual tires exhibiting the scuffing. The physical appearance depicted in the photograph is consistent the three other sets of dual tires.

Figure 17: Post-collision photograph of longitudinal scuffing observed on the tires of both truck tractor drive axles. While the right side aft drive axle is depicted, the appearance is consistent with that observed on the remaining tires for both drive axles.
