**TECHNICAL RECONSTRUCTION GROUP
SELECT PHOTOGRAPHS**

**Bridge Collapse
Mount Vernon, WA - 05/23/2013**

HWY-13-MH-012

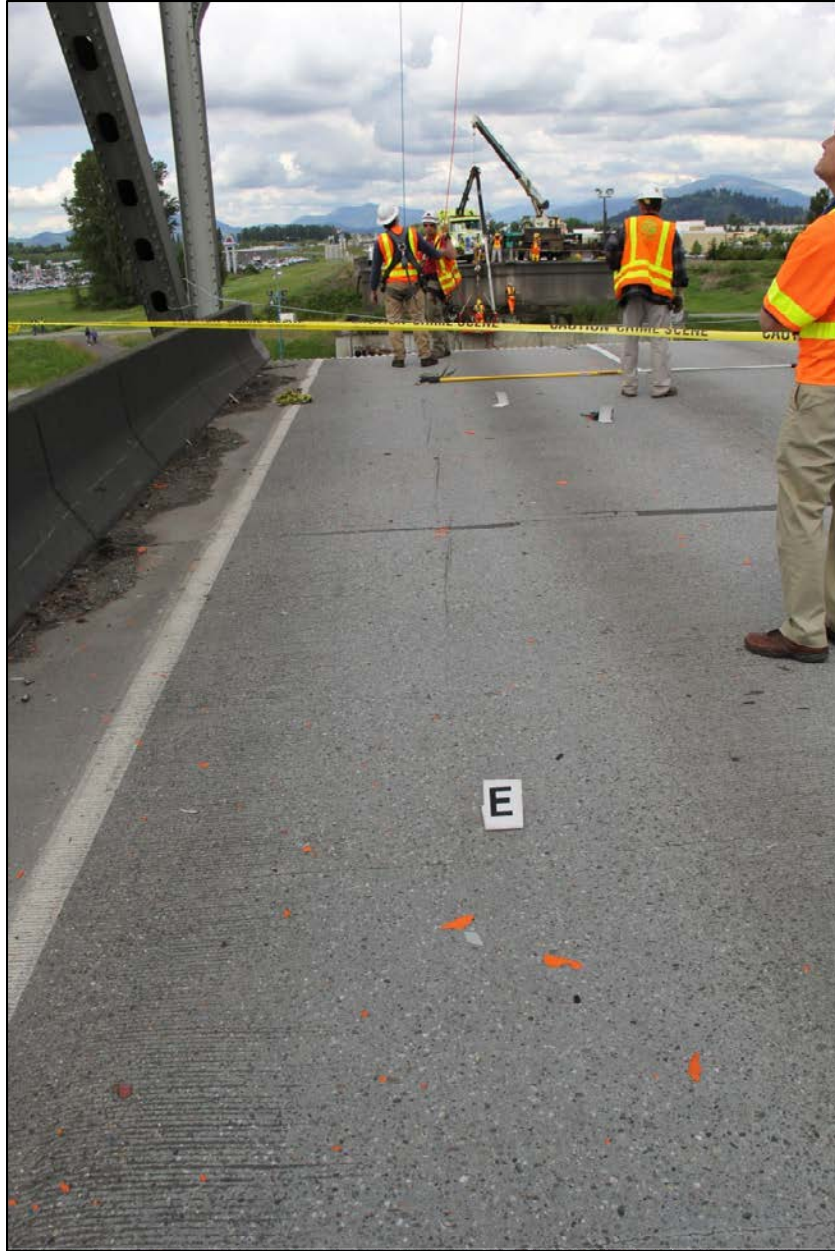
- Photograph 1: Northward view of narrow tire friction marks atop the road surface in the southbound right lane of span number 7 beginning immediately south of the expansion joint separating spans 7 and 8.

Photograph 1: Tire friction marks on span number 7 in right lane south of the expansion joint between spans 7 and 8.

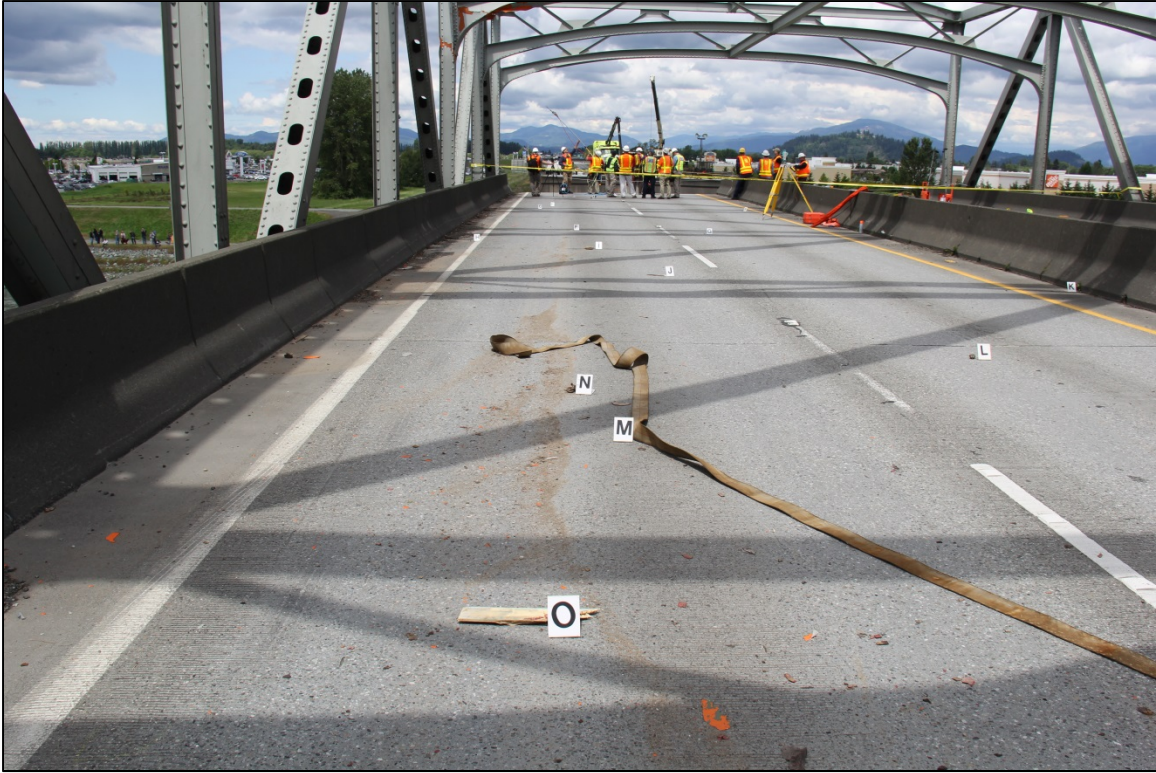
- Photograph 2: Northward view of debris displaced from oversized load vehicle atop the road surface in the southbound right lane of span number 7. Debris depicted in the photograph includes dirt, a small piece of wood, bridge paint fragments and a segment of synthetic webbing that been attached to the load.

Photograph 2: Debris deposited on span 7 in right lane of southbound roadway.

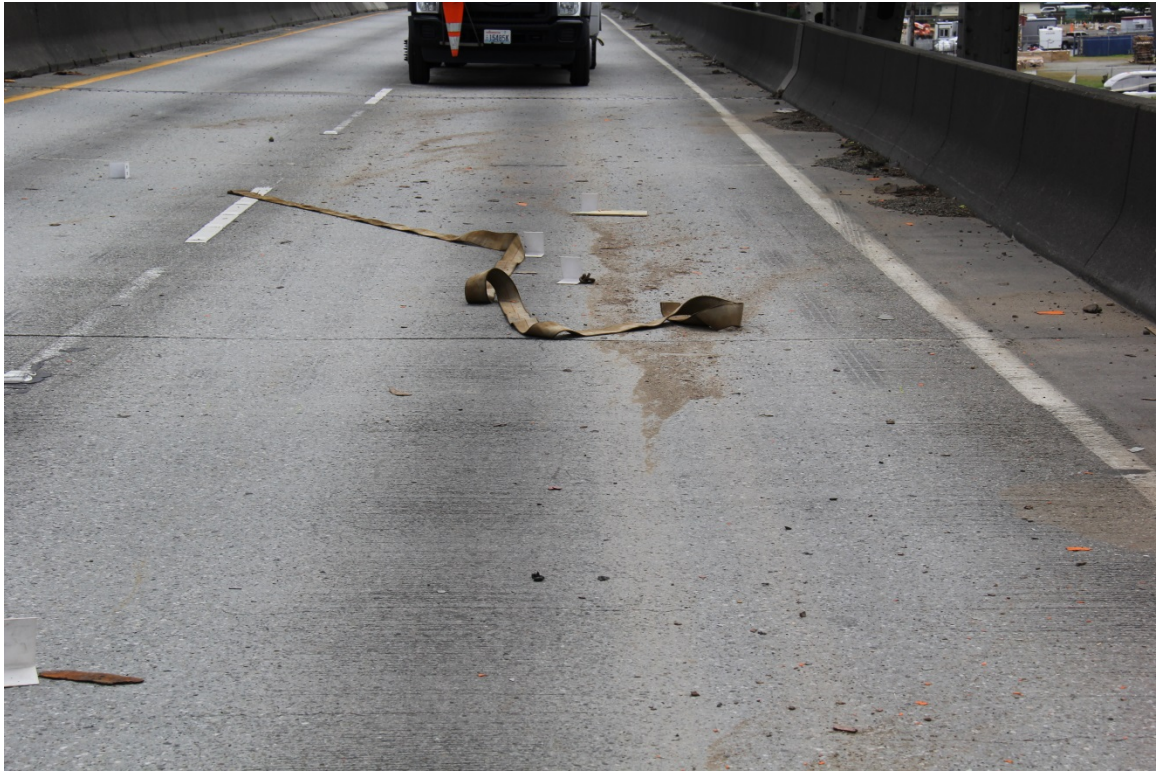
- Photograph 3: Southward view of debris displaced from oversized load vehicle atop the road surface in the southbound right lane of span number 7. Debris depicted in the photograph includes dirt, a small piece of wood, bridge paint fragments and a segment of synthetic webbing that been attached to the load. Additional tire friction marks are also visible toward the outer edges of the debris.

Photograph 3: Debris in right lane of southbound roadway on span number 7.

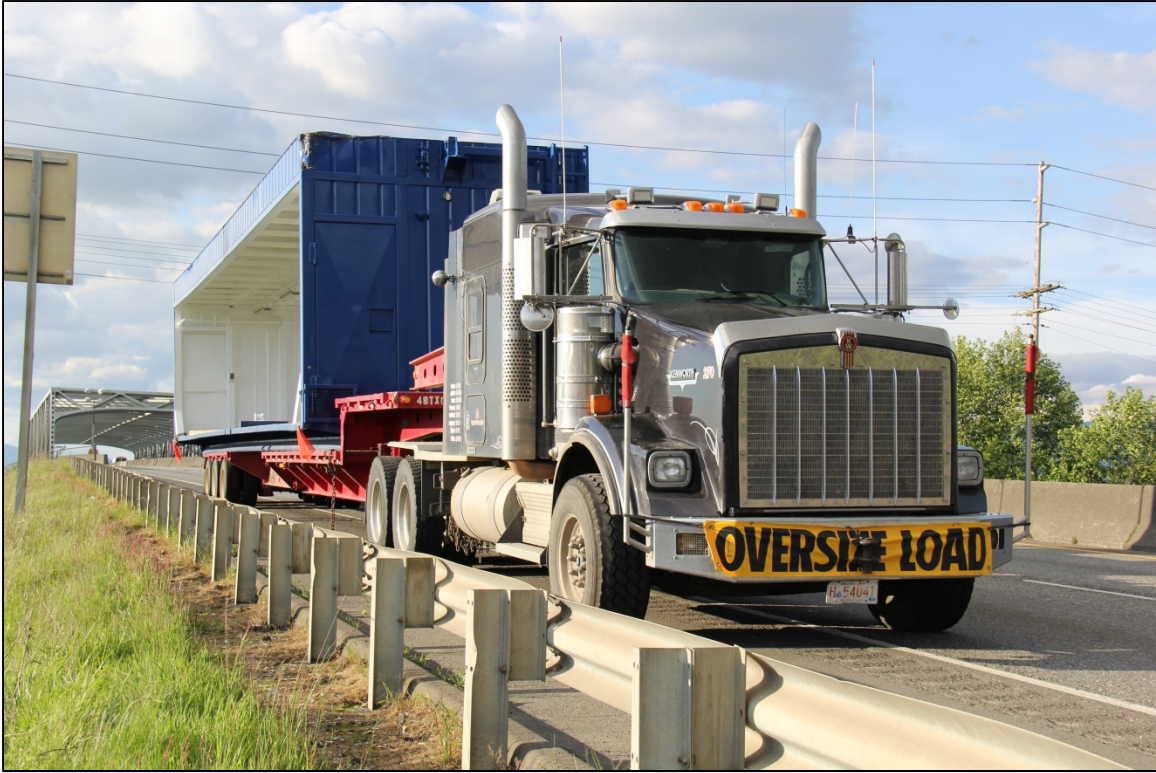
- Photograph 4: Northward view of oversized load and transport vehicle from the right front corner. The vehicle is parked in the southbound roadway straddling the shoulder and right travel lane facing south. The bridge truss structure on span number 5 of the bridge is visible in the background.

Photograph 4: Oversized load combination stopped on south side of bridge.

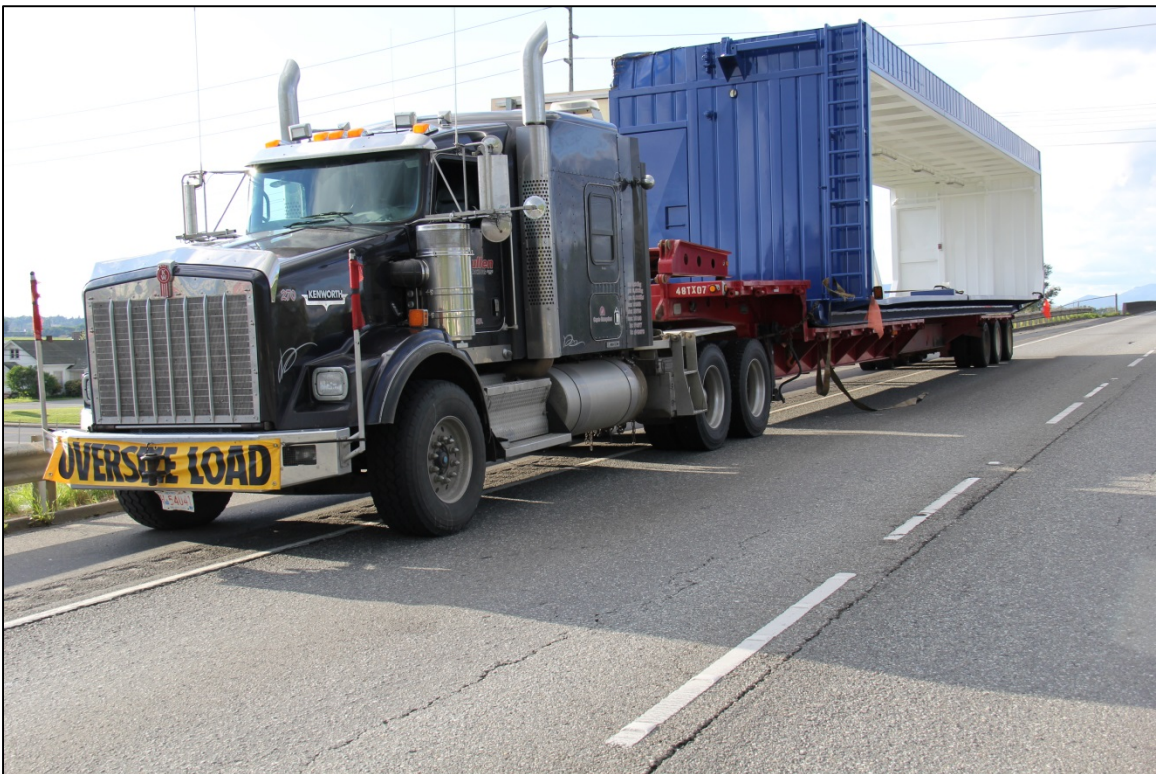
- Photograph 5: Northward view of oversized load and transport vehicle from the left front corner. The vehicle is parked in the southbound roadway straddling the shoulder and right travel lane facing south.

Photograph 5: Oversized load combination stopped on south side of bridge.

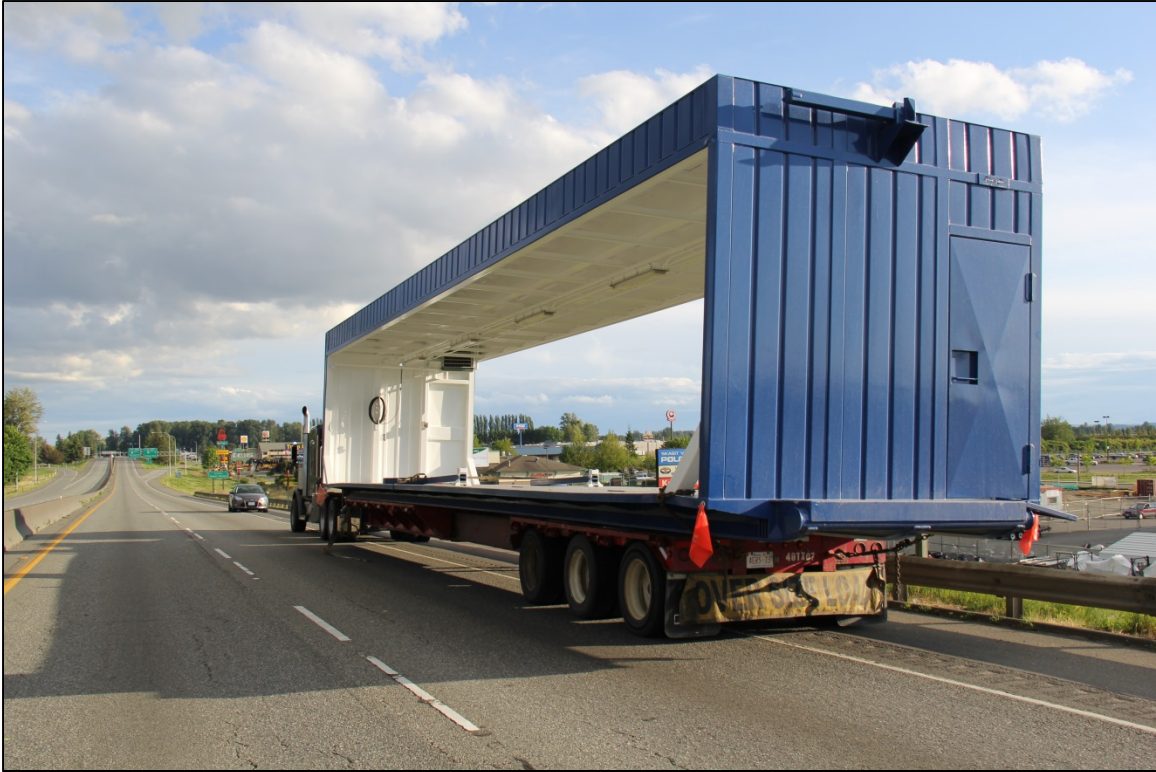
- Photograph 6: Southward view of oversized load and transport vehicle from the left rear corner. The vehicle is parked in the southbound roadway straddling the shoulder and right travel lane facing south.

Photograph 6: Oversized load combination stopped on south side of bridge.

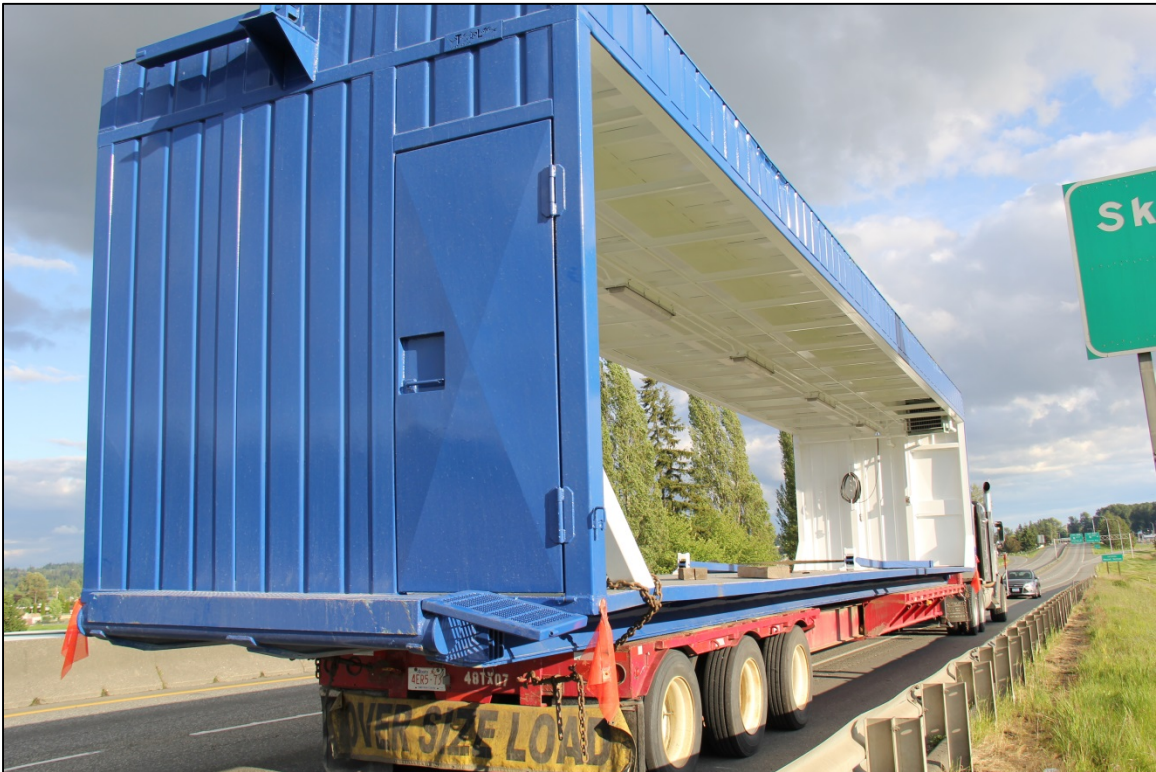
- Photograph 7: Southward view of oversized load and transport vehicle from the right rear corner. The vehicle is parked in the southbound roadway straddling the shoulder and right travel lane facing south.

Photograph 7: Oversize load combination stopped on south side of bridge.

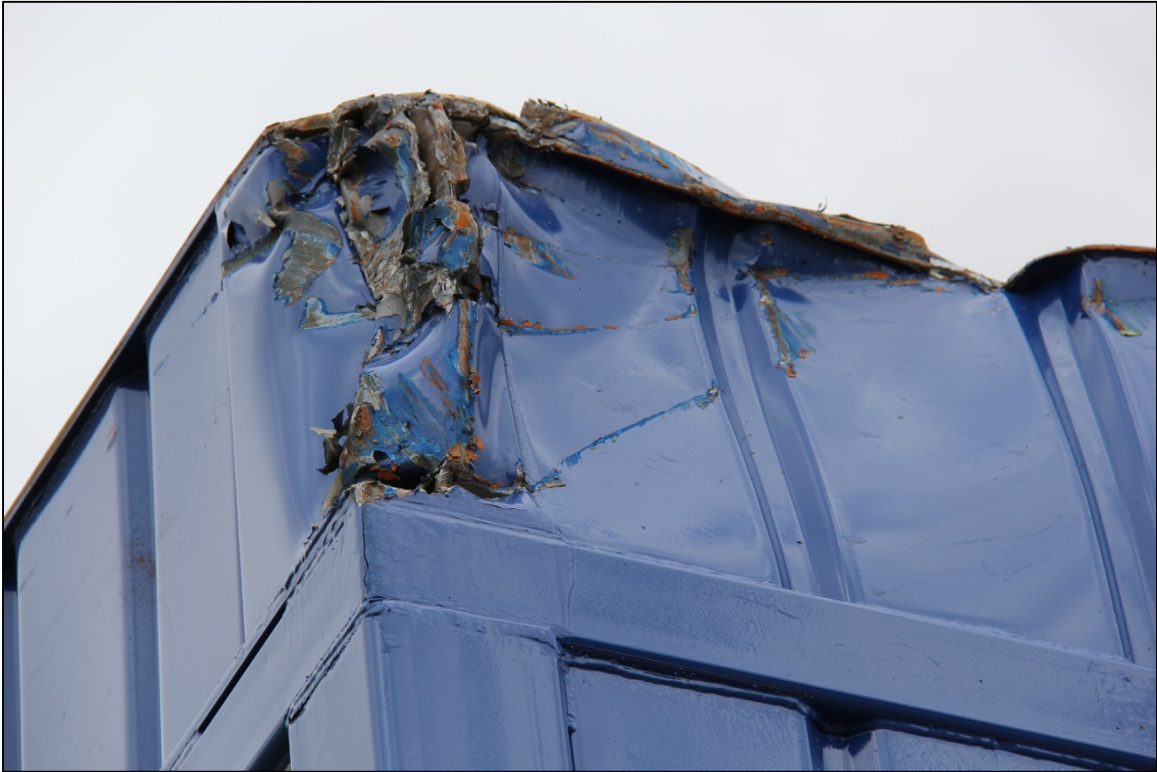
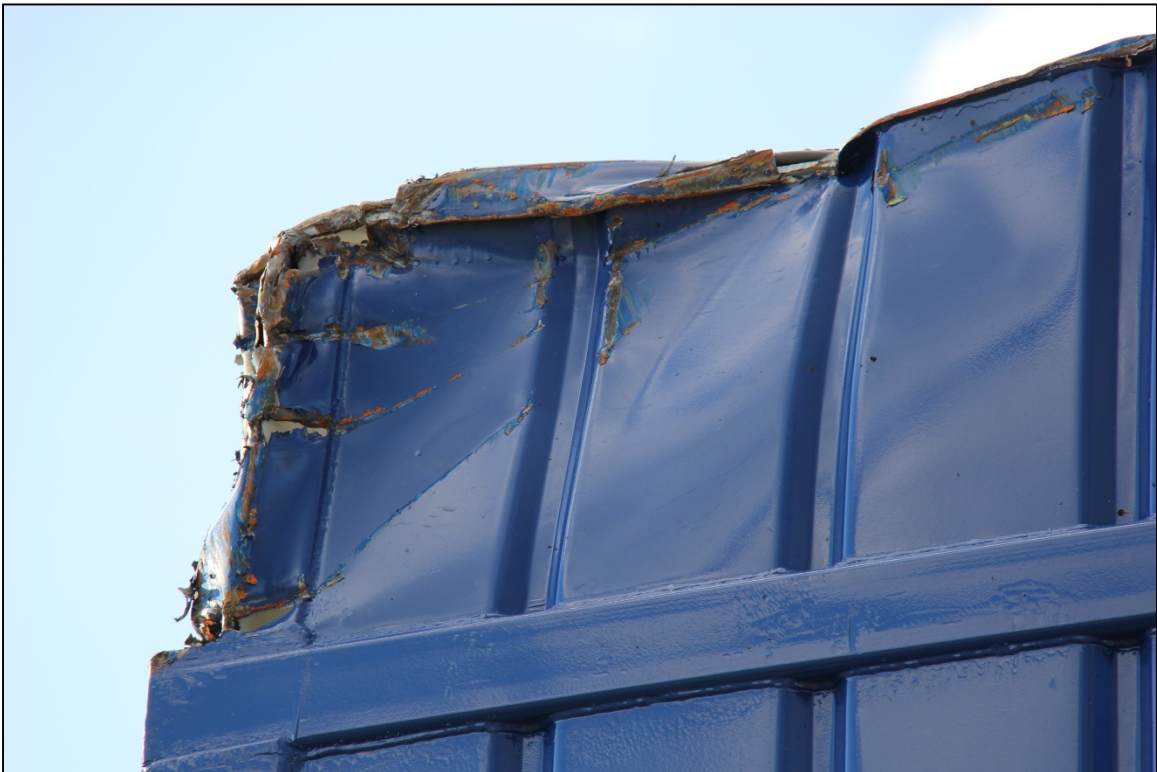
- Photograph 8: View of impact damage to upper right corner of casing shed. Damage exhibits multiple impacts.
- Photograph 9: View of impact damage to upper right corner of casing shed. Damage exhibits multiple impacts. Image taken from below and to the left of the damage.

Photograph 8: Impact damage to upper right corner of casing shed.

Photograph 9: Impact damage to upper right corner of casing shed.

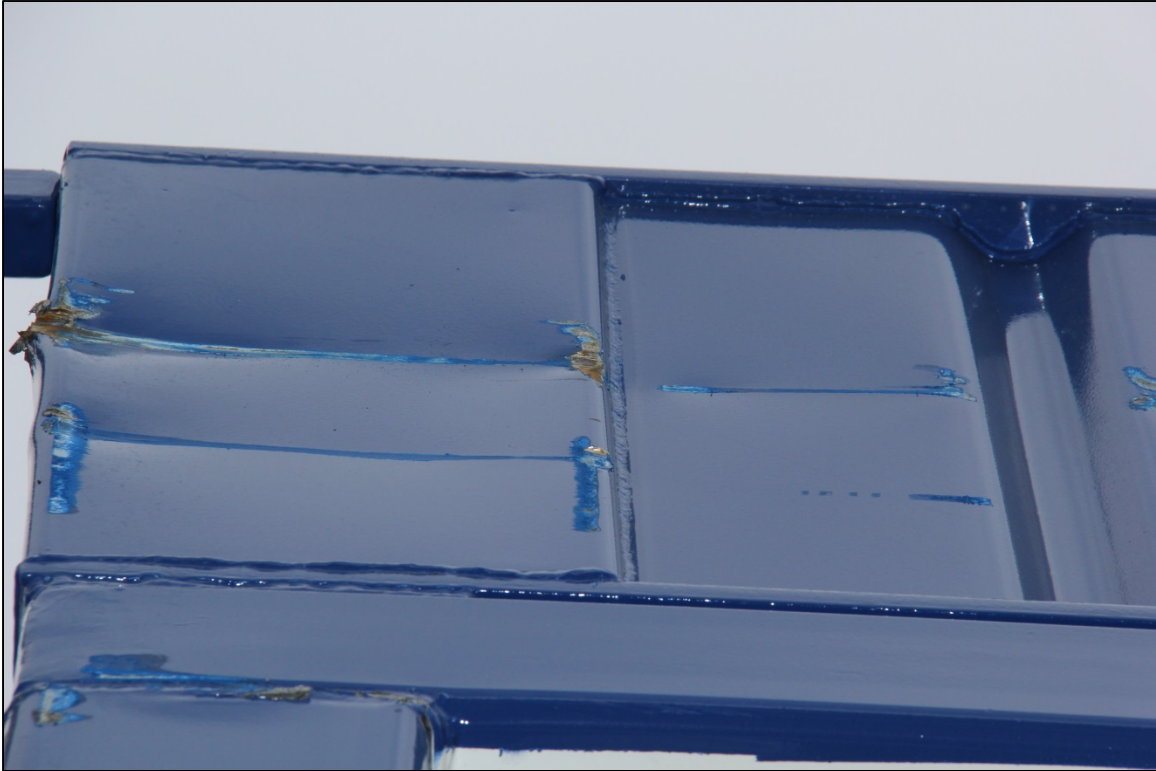
Photograph 10: View of scrapes and long indentations to upper left side of casing shed toward the front. Damage shown is due to contact with the passing tractor-trailer combination.

Photograph 10: Impact damage to upper forward left side of casing shed.

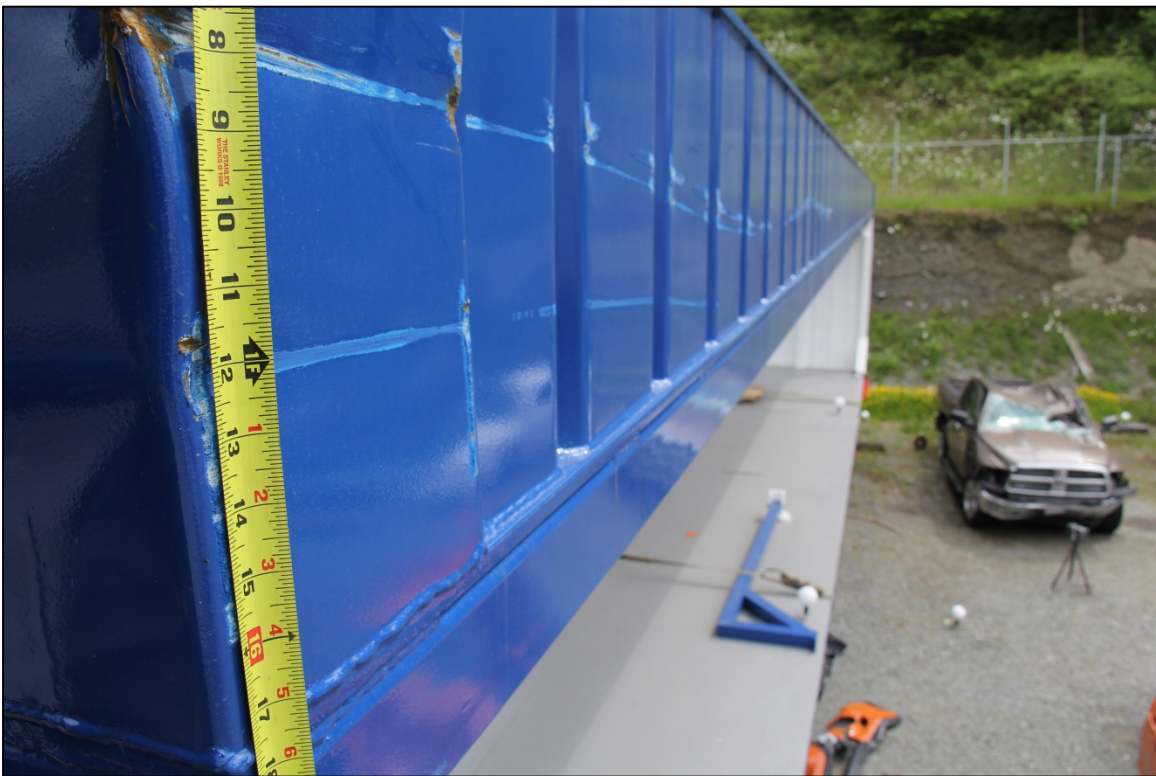
Photograph 11: View of scrapes and long indentations to upper left side of casing shed toward the front. Tape measure depicted in photographs extends downward from the top to illustrate the vertical position the scrape marks and the separation distance between them.

Photograph 11: Impact damage to upper forward side of casing shed.

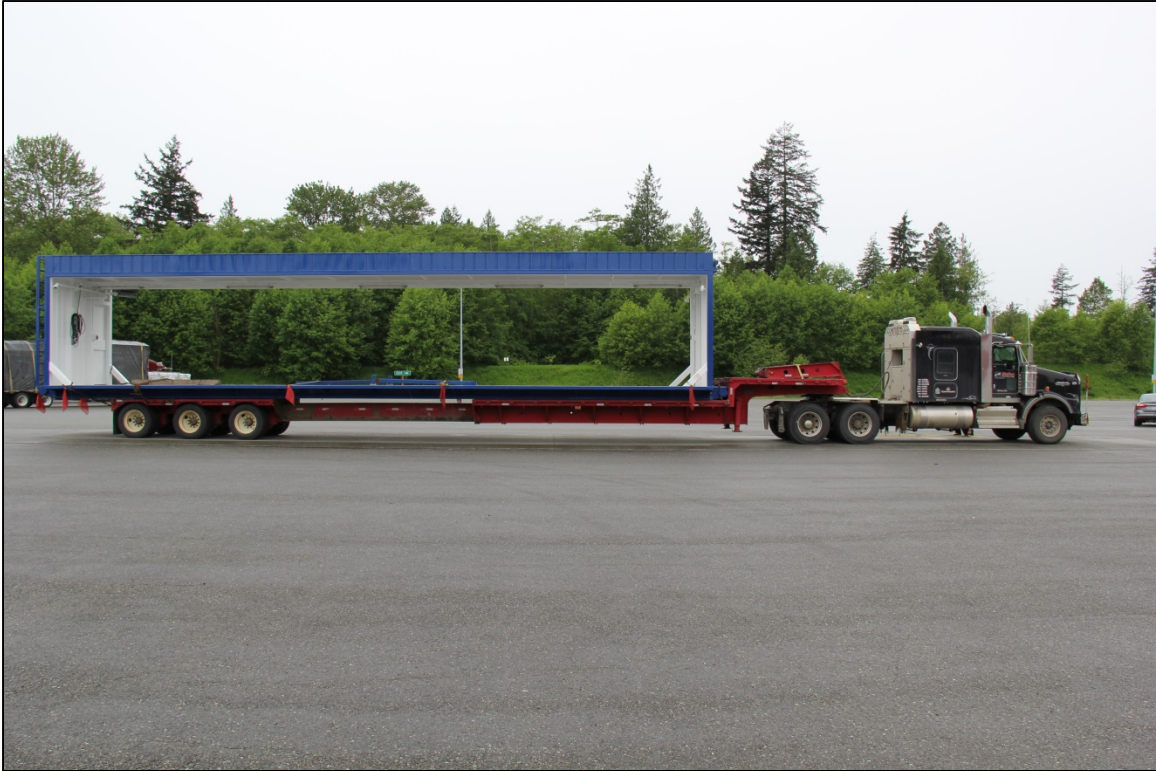
Photograph 12; Photograph depicts right side of exemplar oversized load and transport vehicle. Photograph taken during post-crash examination at a state police facility.

Photograph 12: Exemplar oversize load combination.

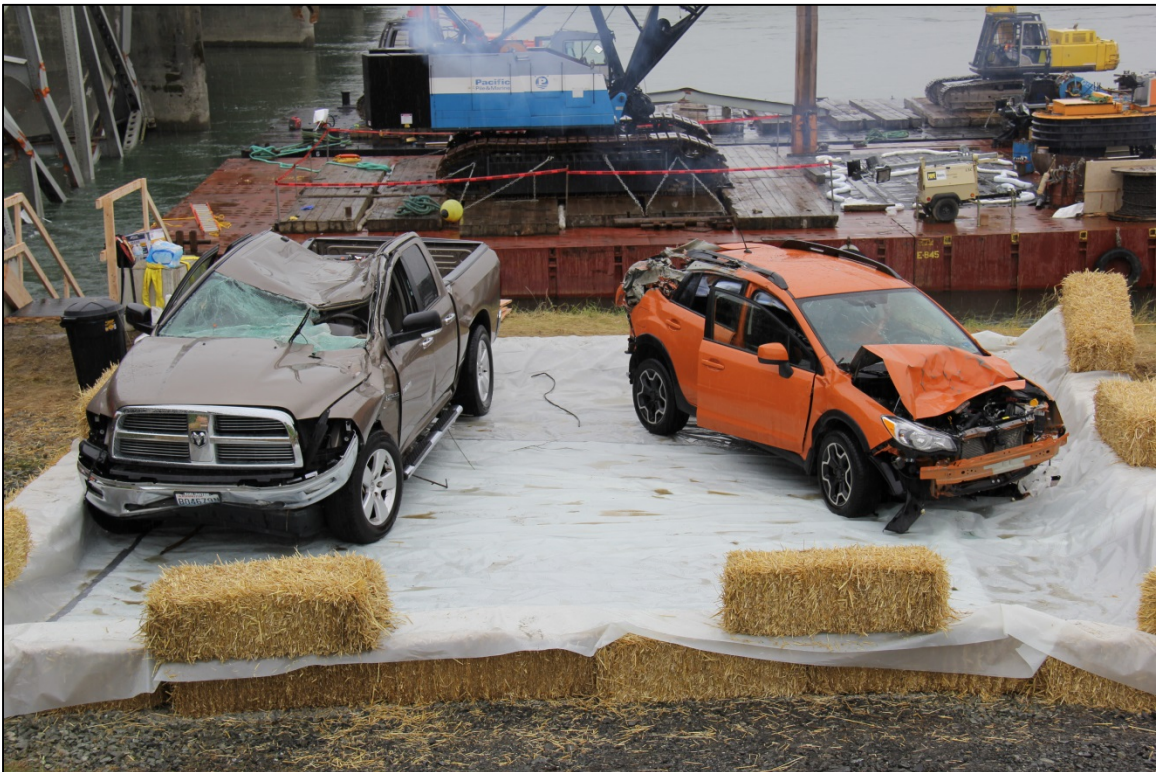
Photograph 13: Photograph depicts Subaru Crosstrek passenger vehicle and Dodge Ram pickup truck immediately after their recovery from the Skagit River. Both vehicles are sitting atop plastic sheeting a recovery area along the north bank of the river. A dredging barge is visible in the background.

Photograph 13: Subaru Crosstrek and Dodge Ram pickup after recovery from river.
