NTSB Report#: MIA02LA108

Registration: N697MA
Date of Accident: 06/07/02
A/C: Piper PA32R-301
Location: Meridian, MS

Report No. 13463

**INVESTIGATION OF BROKEN CRANKSHAFT
GEAR BOLT, P/N STD-2209, FROM IO-540-K1G5
ENGINE, S/N L-25968-48A**

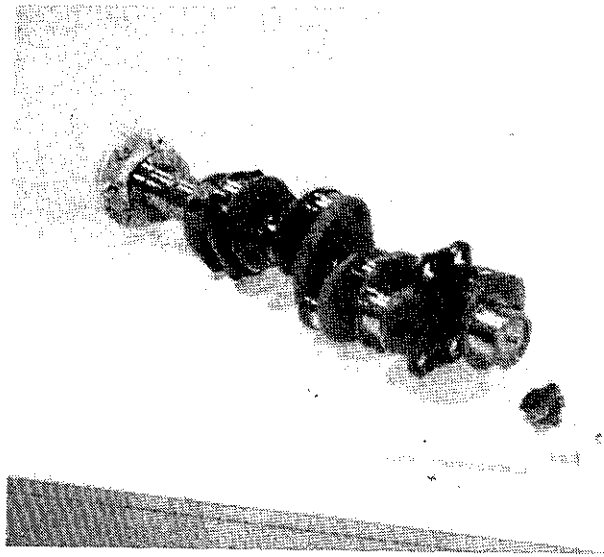
Figure 1

The as-received components.

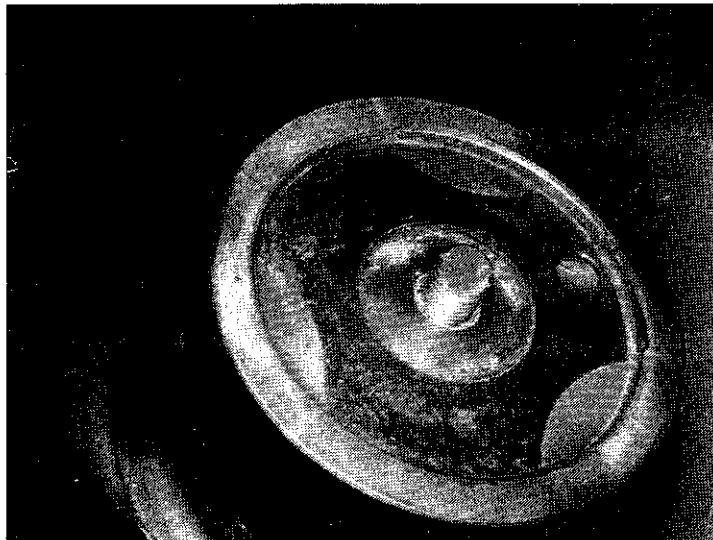
Figure 2

The bolt fractured through the unengaged threaded area of the bolt and the dowel fractured at the gear/crankshaft interface.

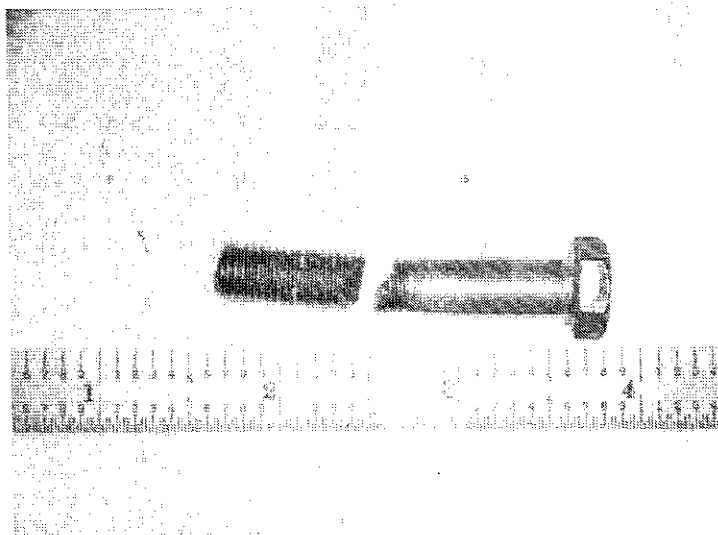
Figure 3

Visual examination revealed the crankshaft gear bolt fractured through the 2nd to 5th threads from the shank, see Figure 3. Two overlapping cracks extending through approximately 270° of the circumference were also observed in the 12th and 13th threads from the shank, see Figure 4. A possible crack was observed in the radius under the head, see Figure 5, and was confirmed by fluorescent magnetic particle inspection. The marking on the head indicated the bolt had been manufactured by Rebco Fasteners, Inc., and had a Grade 8 bolt identification marking. For reference purposes, the fracture in the 2nd to 5th threads will be referred to as crack X, the crack in the 12th and 13th threads as crack Y, and the crack under the head as crack Z.

The bolt fractured through the 2nd to 5th threads from the shank of the bolt.

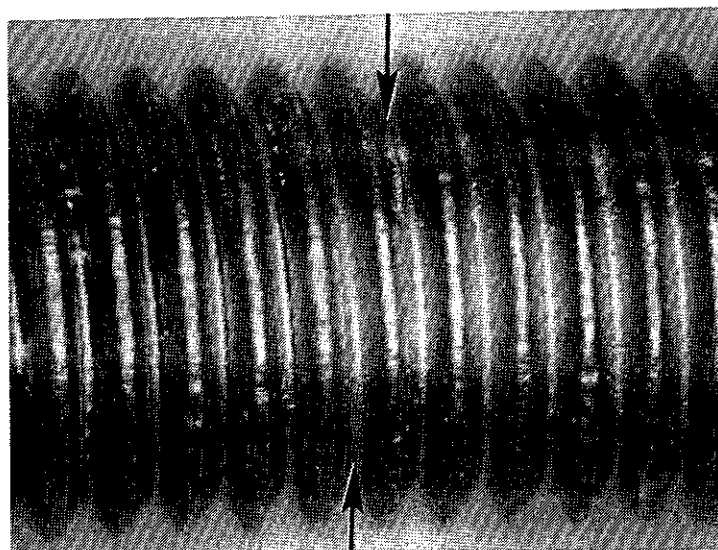
Figure 4

Crack Y corresponds to the first partial and first full thread engaged with the threads in the crankshaft. The crack was mechanically opened and fractographically examined. Examination of the fracture revealed crack initiation throughout 330° of the fracture along the root of the thread, see Figure 12. The remaining 30° is laboratory produced overload. The fracture also revealed intergranular separation throughout the fracture, see Figure 13, with the exception of two small areas of fatigue similar to that seen in crack X.

Two overlapping cracks were also observed in the roots of the 12th and 13th threads from the shank, which corresponded to the first partial and full thread engaged in the crankshaft.

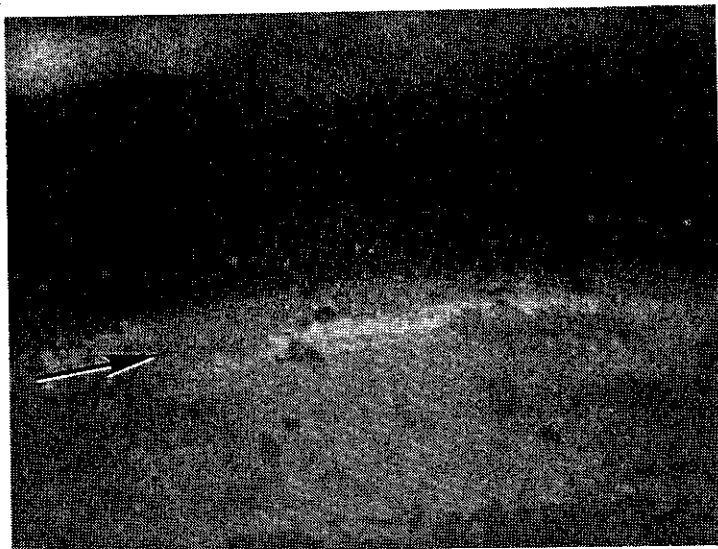
Figure 5

A crack was also observed in the radius under the bolt head.

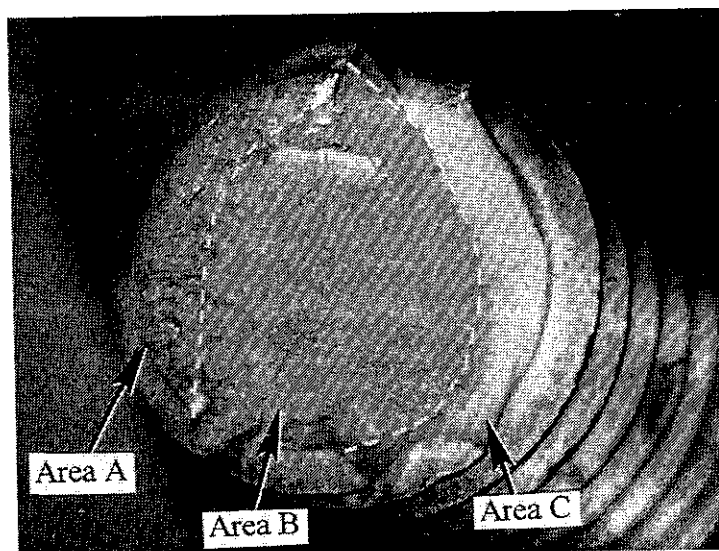
Figure 6

Fractographic examination revealed that crack X initiated from along an approximate 140° portion of the second thread, see Figure 6. Scanning electron microscope (SEM) examination of the fracture revealed intergranular separation, see Figure 7, along the origin area and throughout area A in Figure 6. Area A propagated perpendicular to the axial direction of the bolt to a maximum depth of approximately 0.06 inch. Area B propagated approximately 45° to the axial direction then perpendicular at the root of the fifth thread and at a slightly adjusted radial direction across the bolt compared to Area A. SEM examination of area B revealed predominantly intergranular separation with very small localized areas of transgranular separation, see Figure 8. A small area of a rather high stress low cycle fatigue, as indicated by the beach marks and rough transgranular topography, was also observed within area B, see Figures 6 and 9. Area C was perpendicular to the axial direction at the root of the fifth thread, angled through the fourth and fifth threads, propagated through the root of the fifth thread, and at a slightly more adjusted radial direction across the bolt compared to Area B. Area C exhibited beach marks, see Figure 10, and a rough transgranular topography, see Figure 11, indicating a rather high stress low cycle fatigue. A narrow shear lip at the

Crack X initiated along the root of the second thread and exhibited three areas of propagation.

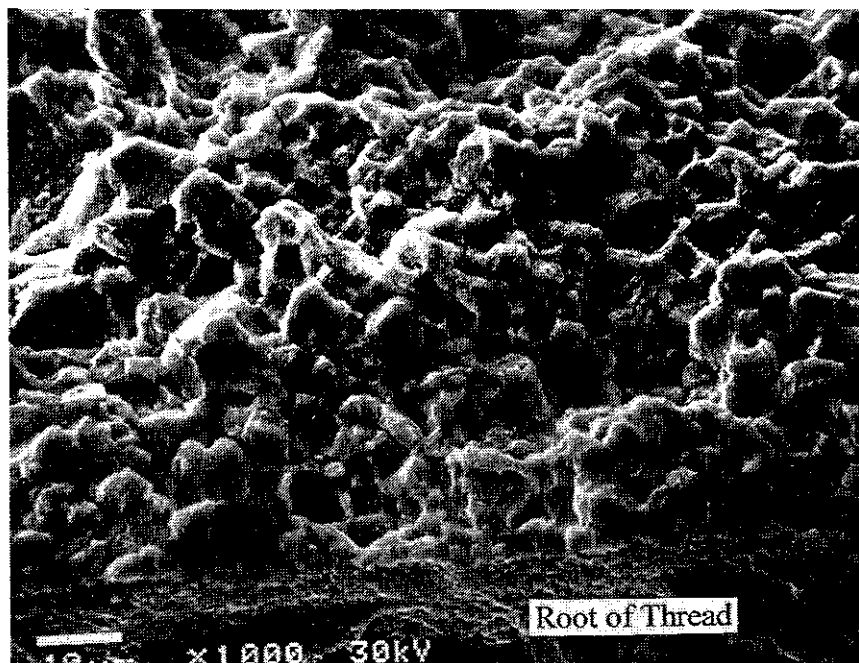
Figure 7

Area A exhibited intergranular separation.

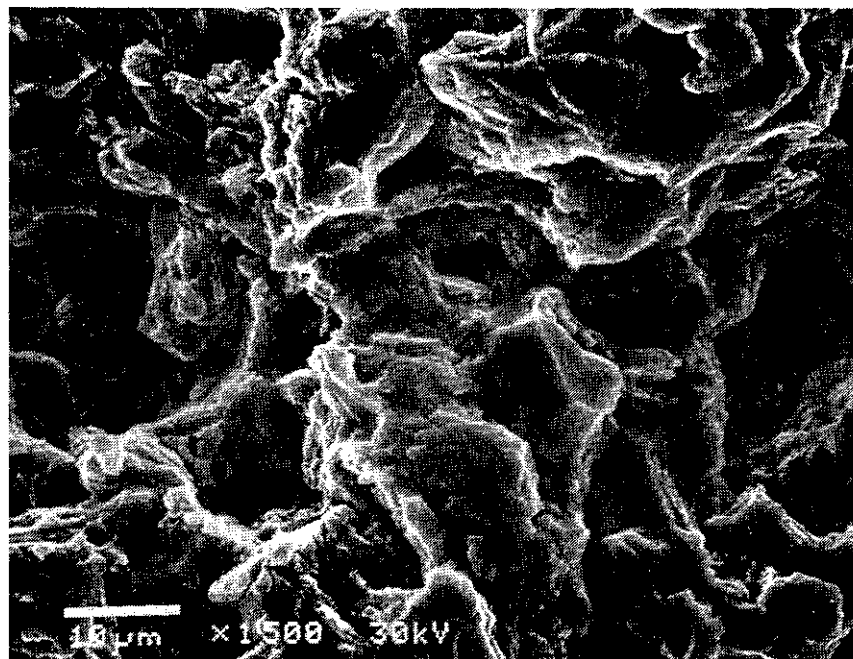
Figure 8

Area B was predominantly intergranular separation, however, small localized areas of transgranular separation were also observed.

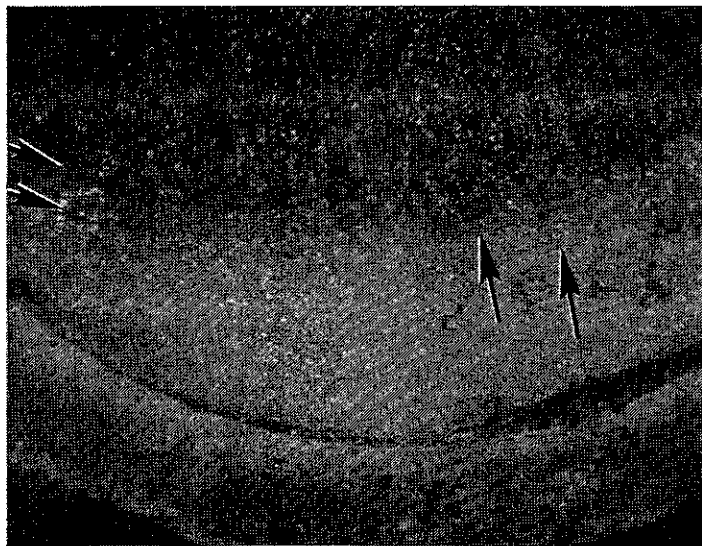
Figure 10

Area C exhibited a transgranular topography and beach marks and a narrow shear lip at the end of propagation.

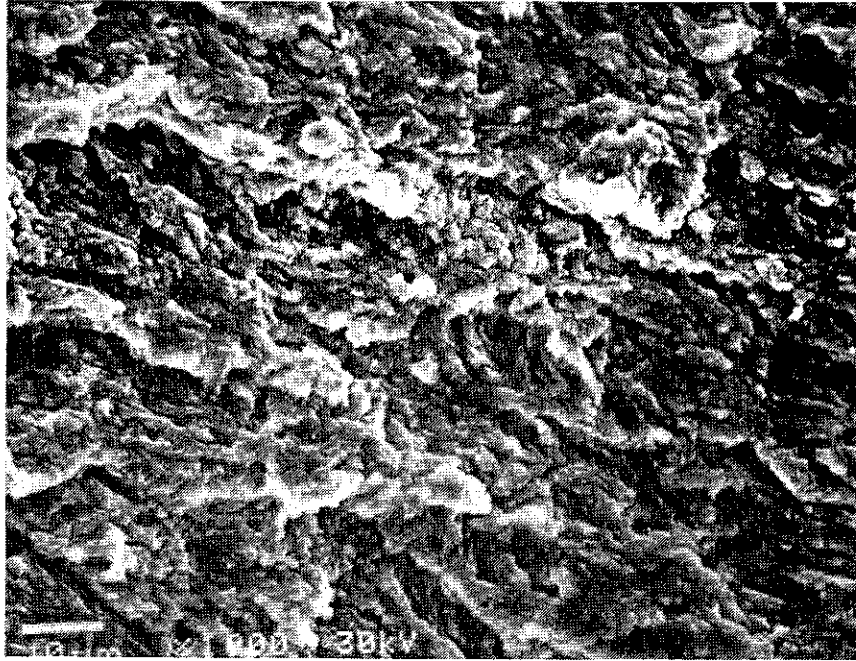
Figure 11

back of area C revealed dimple rupture indicating overload. The direction of crack propagation indicates bending loading.

Area C exhibited a somewhat rough transgranular topography.

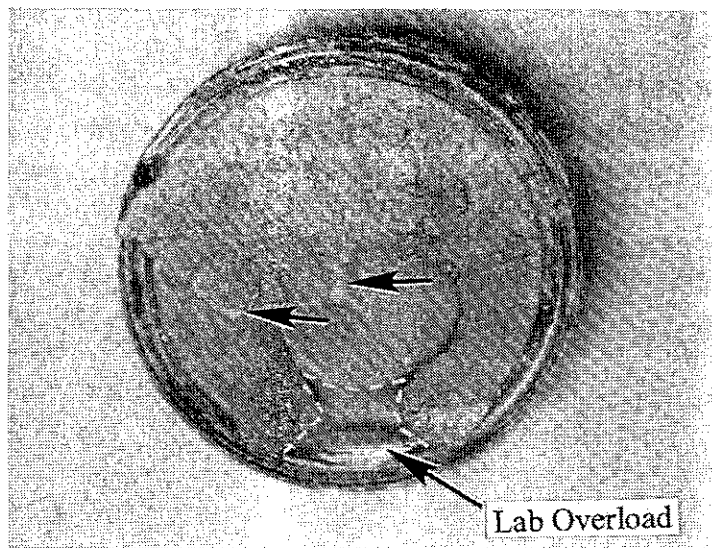
Figure 12

Crack Y exhibited an intergranular topography throughout the fracture with the exception of two small areas of HSLC fatigue, see arrows. The laboratory produced overload is indicated at the bottom of the picture.

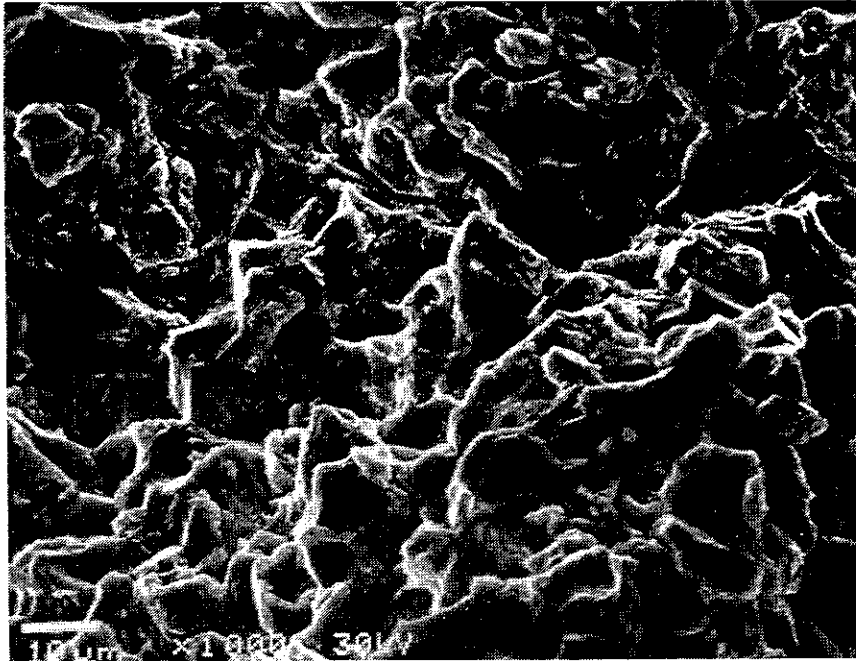
Figure 13

Crack Y exhibited predominantly intergranular separation throughout the fracture.

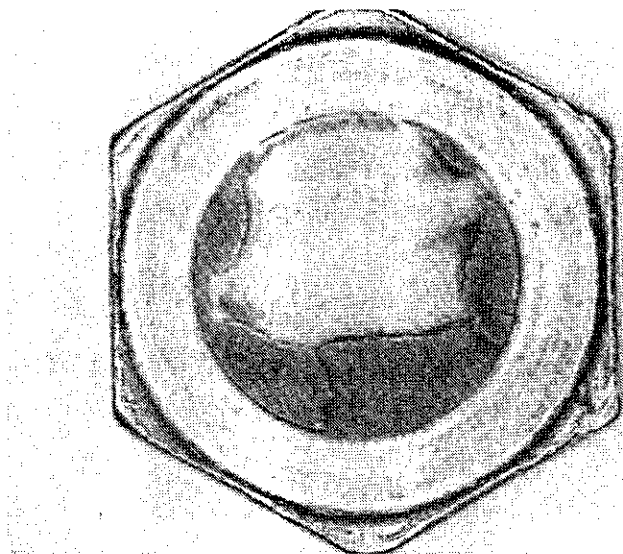
Figure 14

Crack Z was located in the radius under the head. The crack was mechanically opened and fractographically examined. Examination of the as-opened fracture, see Figure 14, revealed a darkened area, the extent of crack propagation, and a lighter central portion, the laboratory produced overload. The darkened area extended along the entire outer circumference of the fracture and varied in depth. Examination in the SEM revealed predominantly intergranular separation, see Figure 15, throughout the darkened area in Figure 14. The depth of intergranular separation varied from only a few grains to approximately 0.1 inch

Prior to cleaning, crack Z exhibited a darkened area indicating the crack propagation. The darkened area extended along the entire outer circumference of the crack with varying depth. The lighter central area is the laboratory produced overload.

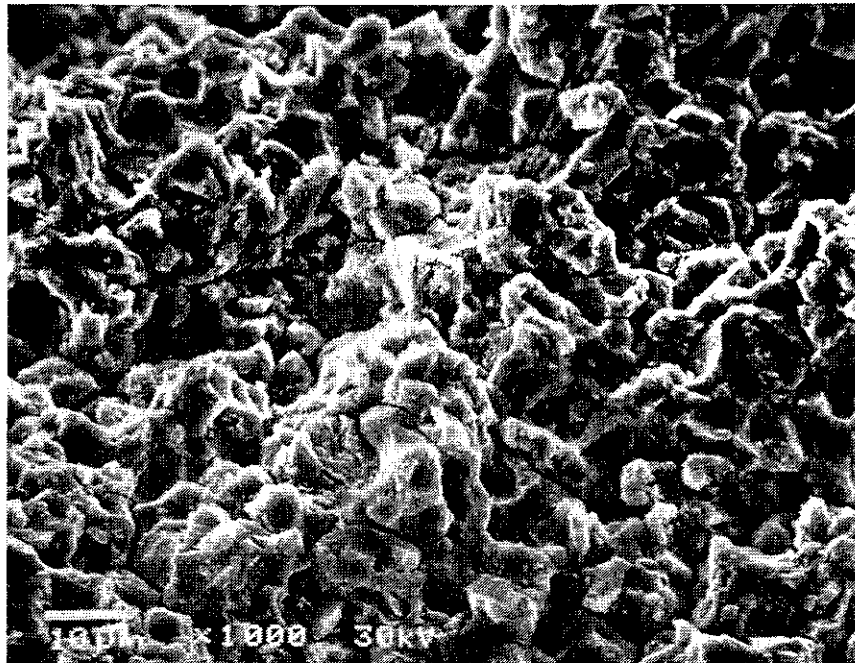
Figure 15

Crack Z exhibited intergranular separation throughout the propagation area.

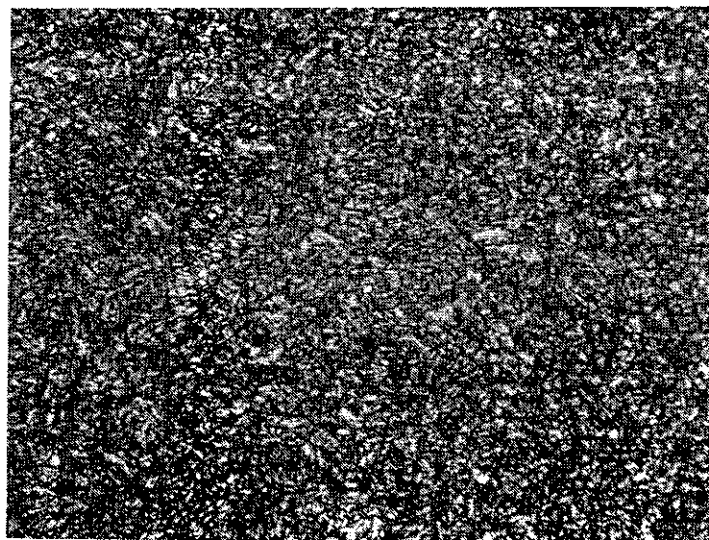
Figure 16

The microstructure of the bolt was tempered martensite which is typical for properly heat treated SAE J423 steel.

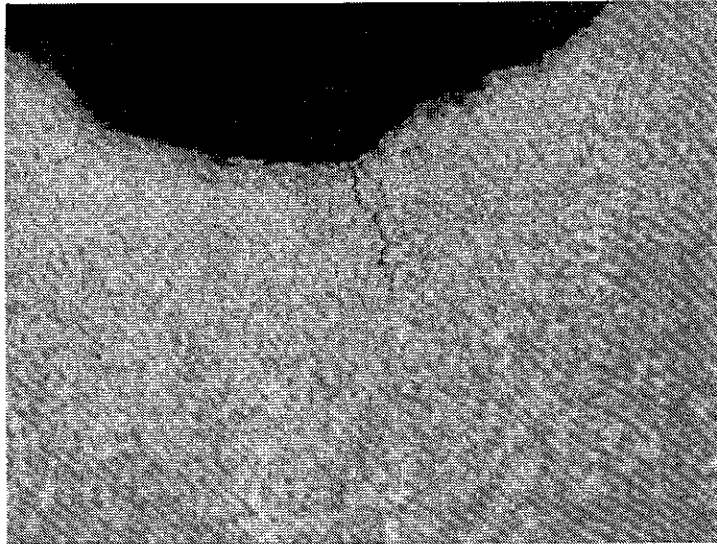
Figure 17

The hardness of the bolt was 36-37 HRC, which conforms to the engineering drawing requirement of 33-39 HRC. The zinc plating thickness was 0.00025 – 0.00030 inch which conforms to the specification requirement of 0.0001-0.0004 inch. The chemistry of the bolt conformed to SAE J429 Grade 8. A metallographic cross-section was made through the shank side fracture surface of crack X. The microstructure of the bolt consisted of tempered martensite, see Figure 16, which is typical for properly heat treated SAE J429 steel. The metallographic cross-section also revealed small cracks in thread roots adjacent to the crack X, see Figure 17.

The metallographic cross-section revealed shallow cracks in the thread roots adjacent to crack X.

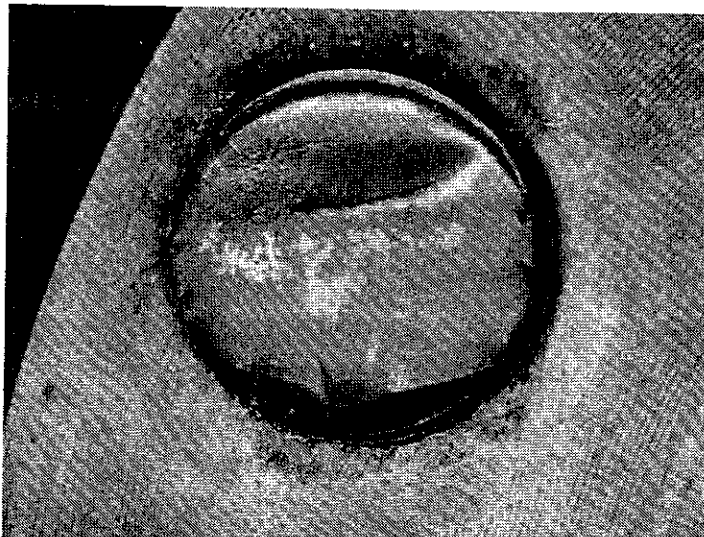
Figure 18

The dowel broke at the interface between the crankshaft gear and the crankshaft. Fractographic examination revealed a smooth transgranular topography with beach marks and ratchet marks indicating fatigue propagation from multiple origins, see Figures 18 and 19. The more central portion exhibited a slightly rougher transgranular topography and the remaining one third was overload as indicated by the dimple rupture. These results indicate the dowel fractured in rotational bending fatigue as a result of high overloading. The hardness of the dowel was 28 HRC, which conforms to the engineering drawing requirement of 28-32 HRC. The microstructure consisted of

The dowel fracture exhibited beach marks and ratchet marks along the circumference and an off-centered area of overload.

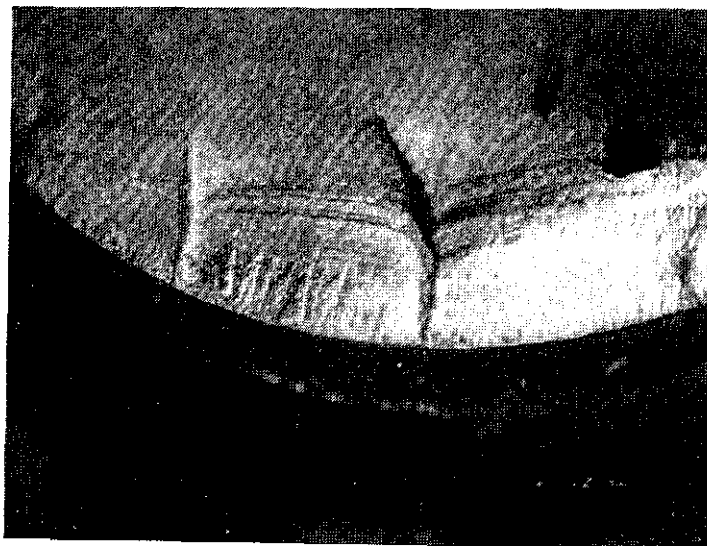
Figure 19

Numerous ratchet marks and beach marks were observed along the circumference of the dowel.
