ENGINE ANALYSIS REPORT

ENGINE MODEL IO-470-U (Right)

ENGINE SERIAL 118267-R

REGISTRATION NUMBER N8145M

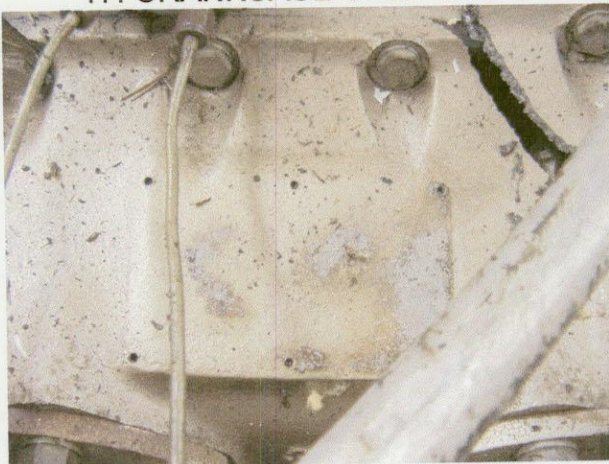
The crankcase exhibited massage damage at the nose from impact. The crankshaft was bent upward breaking away the front main bearing area. Fretting was observed at the number 2 and 3 main bearing boss parting surfaces. No bearing movement was observed at these areas.

17. CRANKCASE SPLIT OPEN

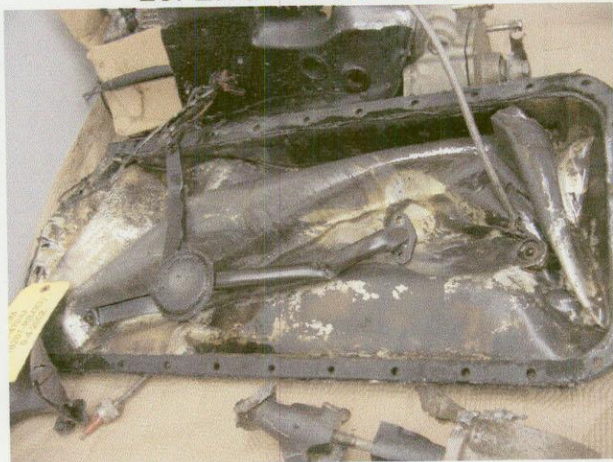
23. ENGINE OIL SUMP

The oil sump was crushed from impact. The sump contained some dirt and debris. The inside color was dark. No metallic debris was observed.

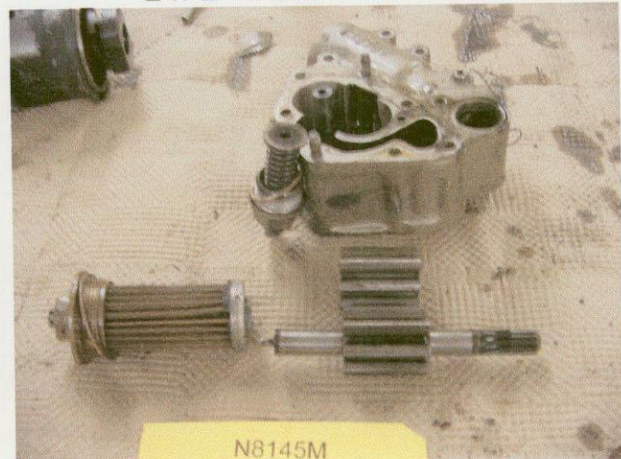
24. ENGINE OIL PUMP

The oil pump drive shaft was intact. The pump cavity and gear edges were scratched from particle passage during service. The oil pressure relief valve was unobstructed. The tachometer generator pad was broken off the pump housing.

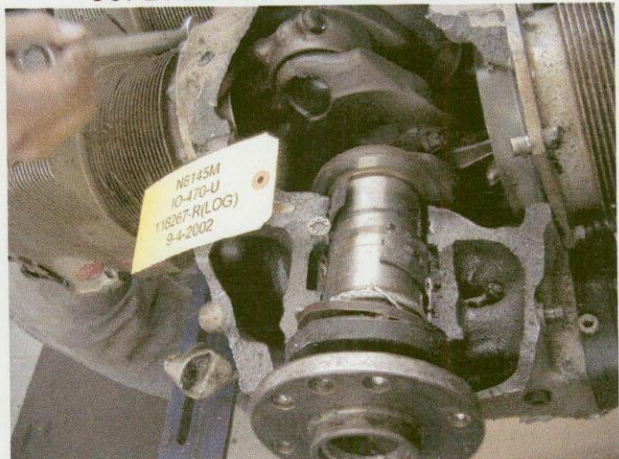
The crankshaft was bent and fractured at the rear thrust face surface, due to impact. The number 1 connecting rod was removed to inspect its bearing and journal condition. All main journals and number 1 connecting rod journal exhibited normal lubrication signatures.

30. DAMAGED CRANKSHAFT

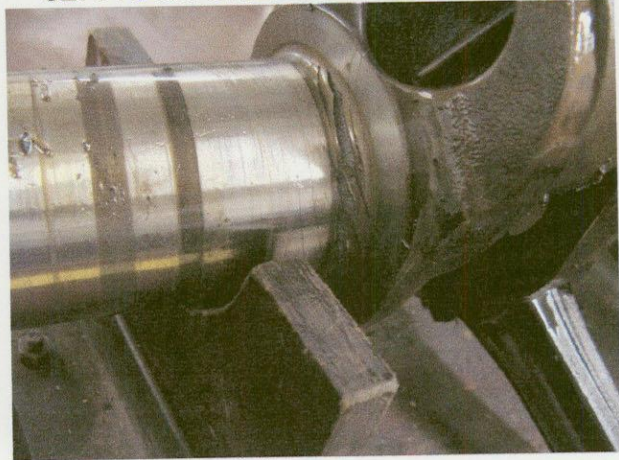
32. FRACTURED AT THRUST FACE

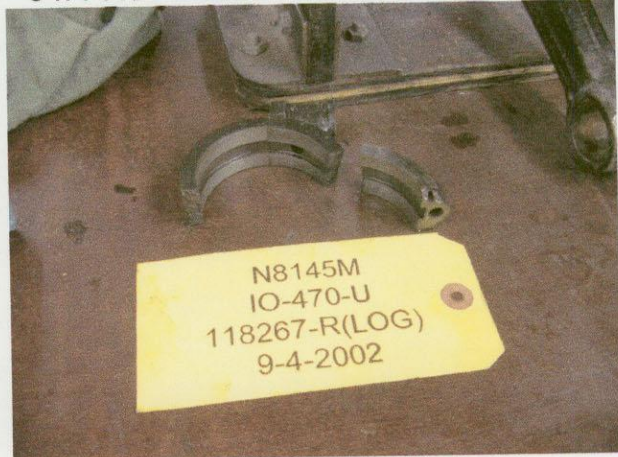
The transfer collar was broken as a result of the nose impact damage.

34. PROPELLER TRANSFER COLLAR

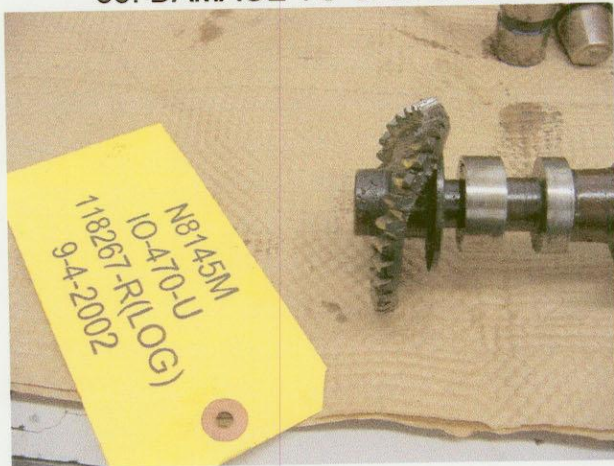
The camshaft front governor bevel gear was bent due to the nose impact on the engine. The camshaft lobes exhibited normal operational signatures.

35. DAMAGE TO CAM GEAR

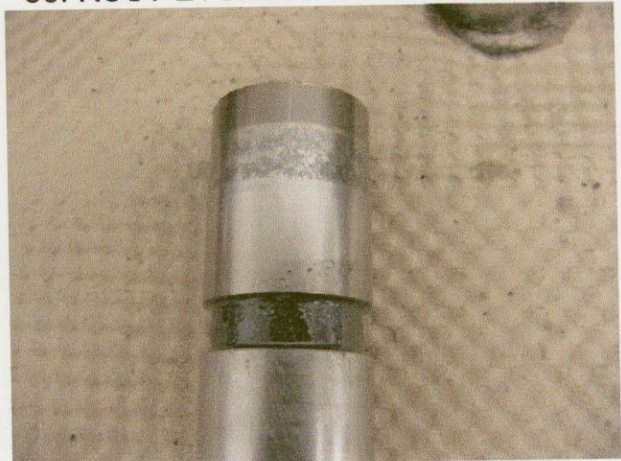
The lifter bodies exhibited rust etching signatures. The faces exhibited some pitting. No spalling had occurred at time of this inspection.

36. RUST ETCHING ON LIFTER BODY

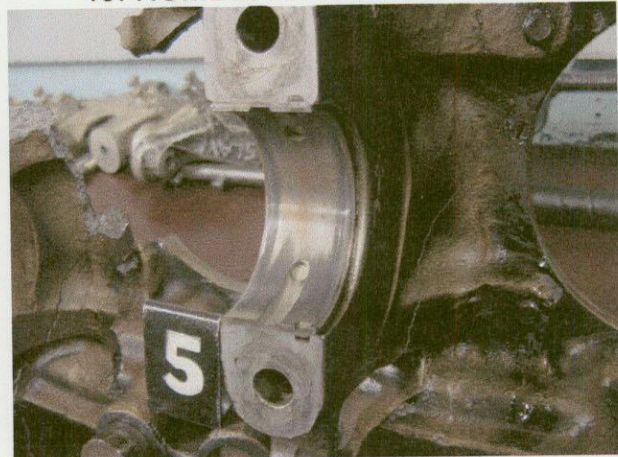
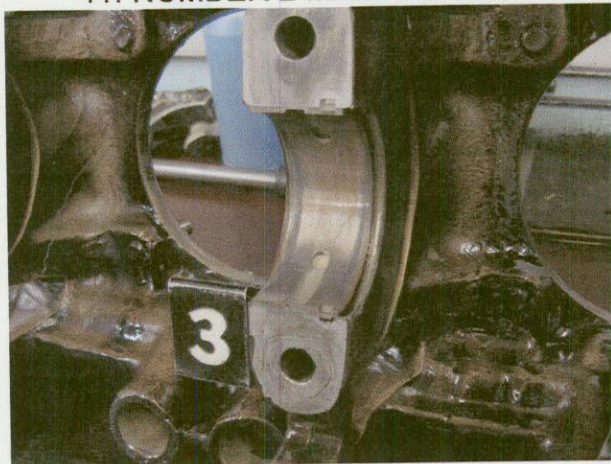
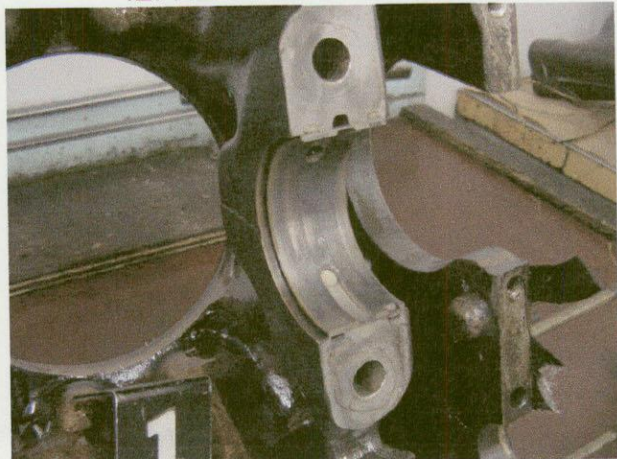
Main bearing exhibited wear exposing some of the copper layer. The surfaces were mostly intact except for the slightly worn areas.

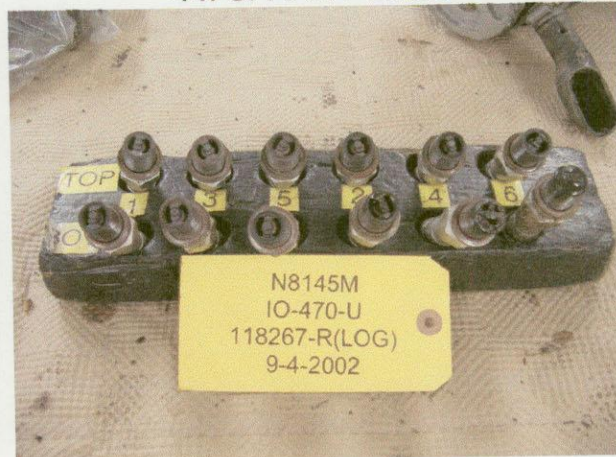
44. SPARK PLUGS

Number 2, 4 and 6 lower sparkplugs were oily. Number 4 bottom exhibited foreign debris around electrode. Plug electrodes appeared normal to worn out normal as compared to Champion Check-a-plug chart.

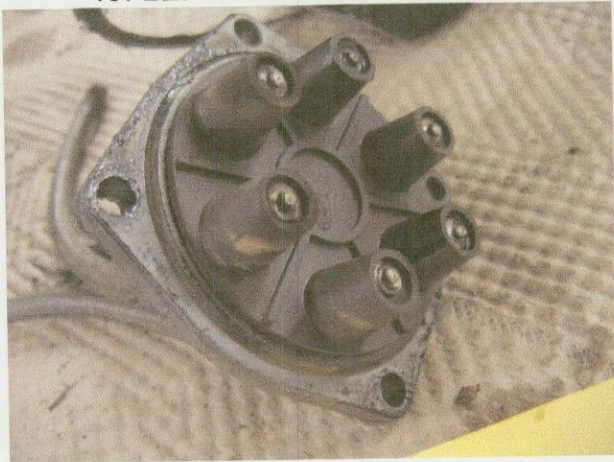
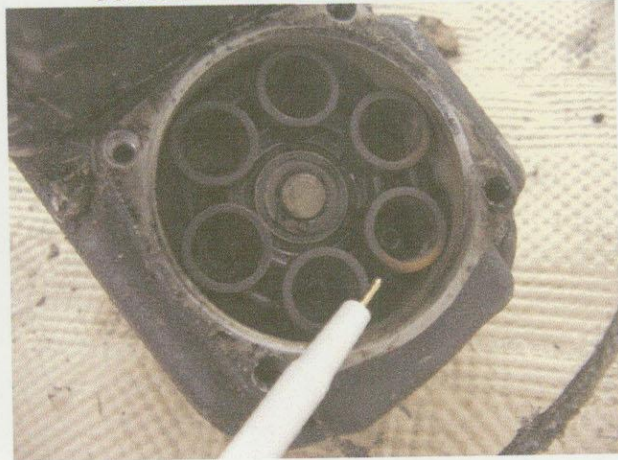
The "P" leads attached to both magnetos were separated from the wire shielding. Silicone material was on one lead, see attached photolog. The left magneto mounting flange was broken at the attachment points. Both magnetos were tested on the magneto Test stand and functioned normally across a 7MM sparkgap. The Left magneto exhibited arcing signatures at the rear ignition harness connection to distributor block. See pictures in photolog.

49. LEFT MAGNETO ARCING

50. LEFT MAGNETO ARCING

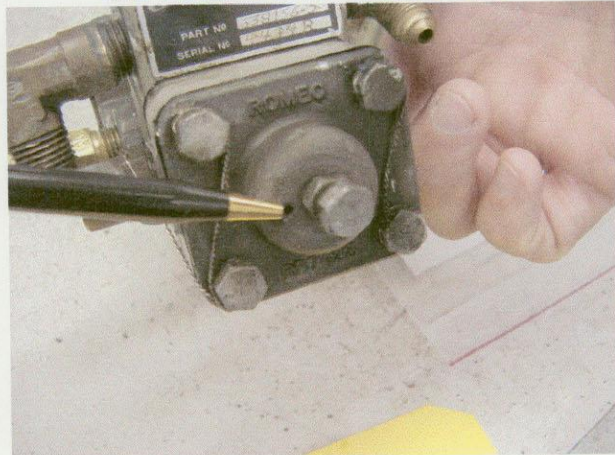
The fuel pump exhibited damage at the rear low pressure adjustment screw.

58. FUEL PUMP DAMAGED

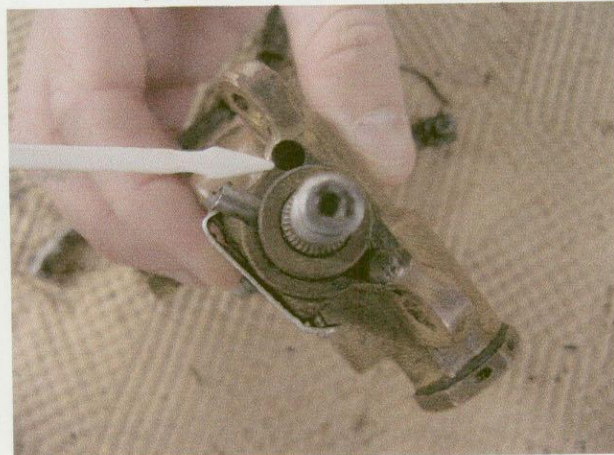
The mixture control lever stop pin was missing as received. The hole was oval shaped and the pin appeared to be missing for some time. The first test was made with fluid leaking from mixture shaft. Test number 2 was made after replacing the "O" ring on the mixture shaft. Due to impact damage the "O" ring was damaged. There was no fuel stain around the shaft as received.

64. MISSING STOP PIN

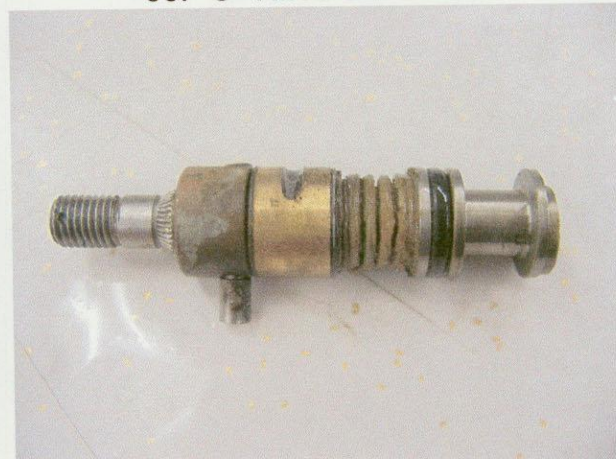
66. "O" RING LEAKING

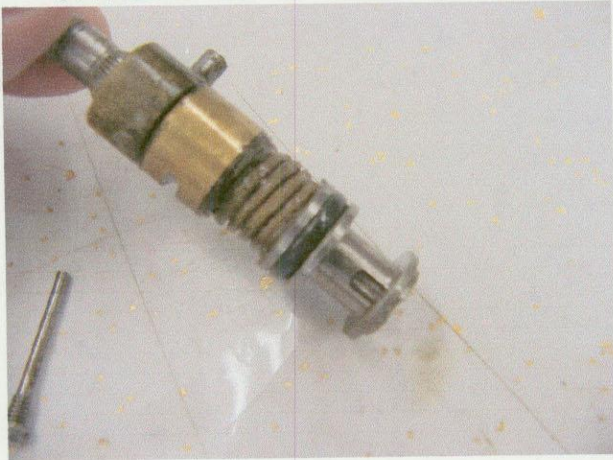
67. REPLACE "O" RING TO FLOW
