NATIONAL TRANSPORTATION SAFETY BOARD

Terrain Awareness Warning System (TAWS)

Specialist's Factual Report

Location: Wichita, Kansas
Date: October 30, 2014
Aircraft: Raytheon Aircraft Company King Air B200
Registration: N52SZ
Operator: Gilleland Aviation, Inc.
NTSB Number: CEN15FA034

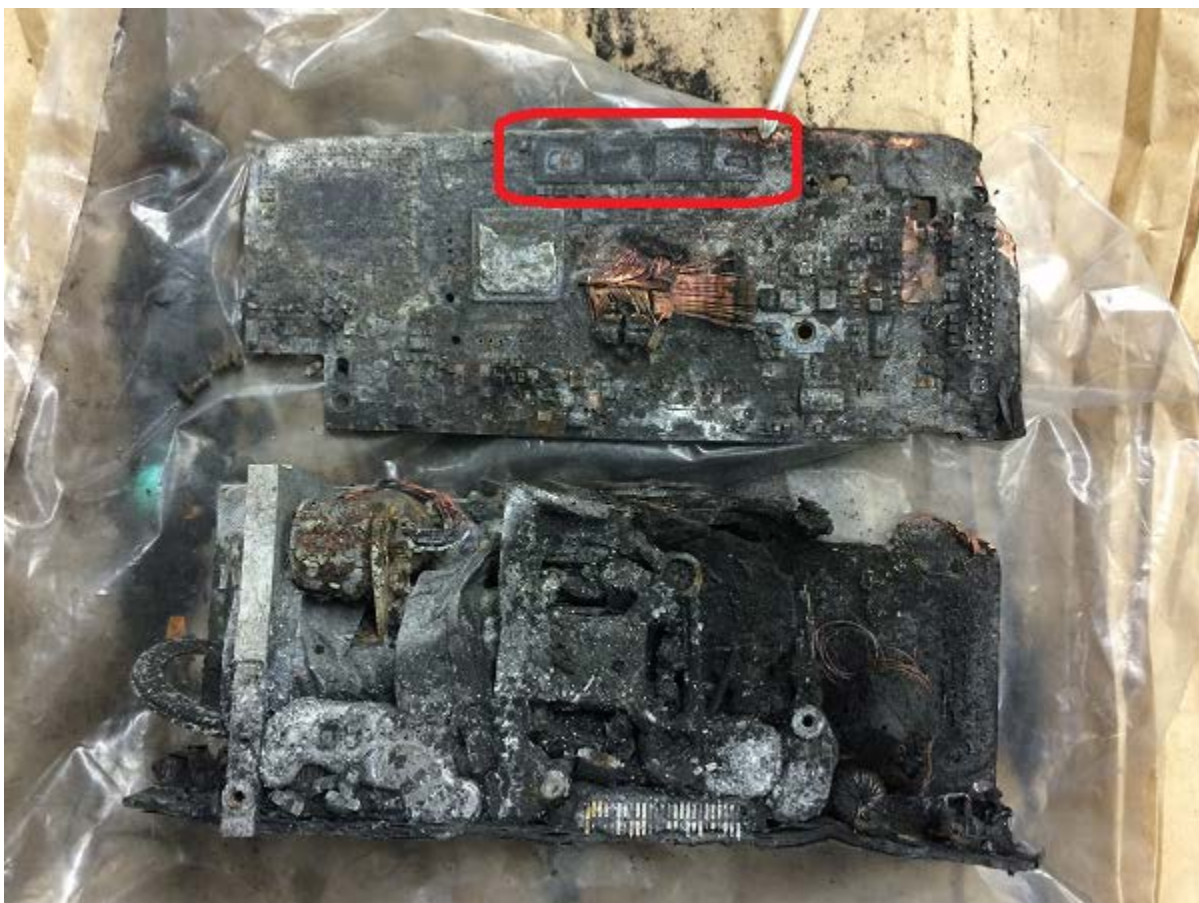
Upon arrival at the NTSB's Vehicle Recorder Division, it was evident the unit has sustained severe heat and impact damage, as shown in figure 1. Figure 1 shows the four NVM chips where parametric data was recorded.

Figure 1. Disassembled unit with NVM highlighted.

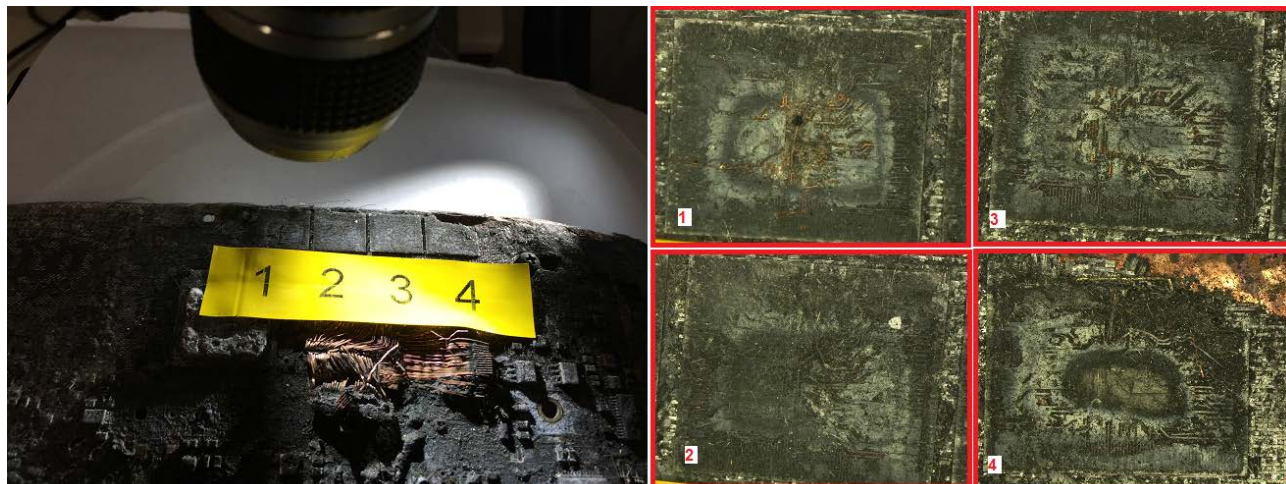
The NVM chips were inspected. Figure 2 shows the labelling of the four NVM chips under a microscope, and microscopic details of the four chips on the right. The packaging and dye of each chip was damaged, exposing the interior wire bonding. Due to the damage, it was determined the memory contents were destroyed.

Figure 2. Internal board with NVM chips annotated.
