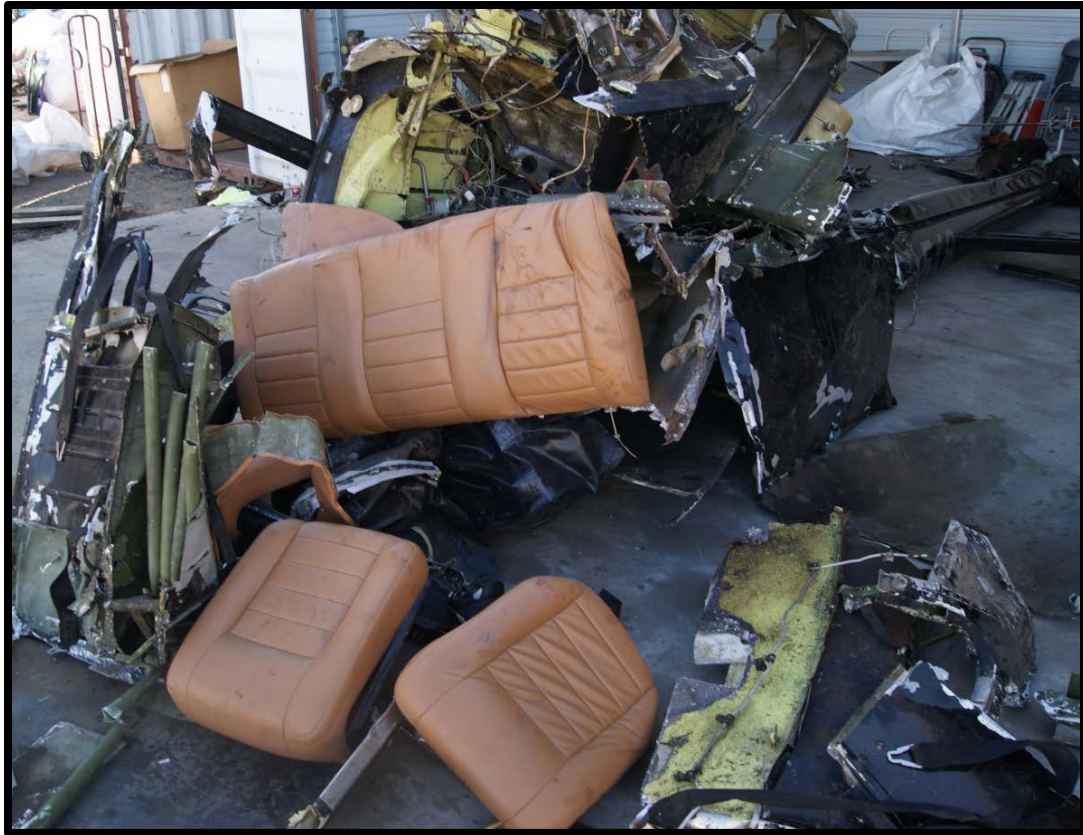
Picture 1: Wreckage

Following recovery, the wreckage was examined at a storage facility and the engine and fuel control unit (FCU) were sent to their respective manufacturers for teardown examinations. Investigators accounted for all major airframe components with the exception of two doors, which were removed prior to the flight.

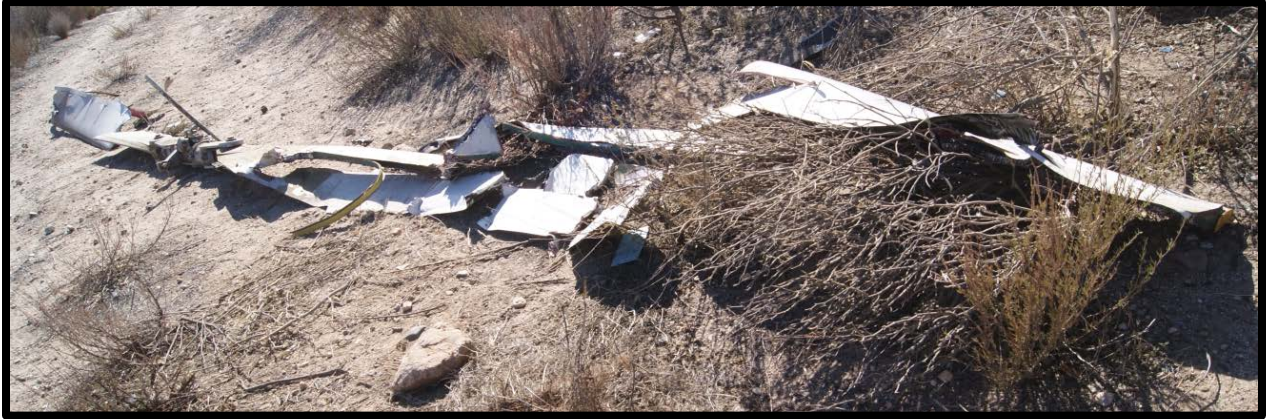
Picture 2: Main Rotor Blades

Multiple main rotor control tube and pitch link fractures were observed, and all appeared to be consistent with overload. Both cyclic servos and the collective servo were observed in the cylinder support; the mounts for the servos were fractured. Manipulation of the swashplate inner ring (non-rotating swashplate) resulted in a corresponding movement of the cyclic control tubes and respective bellcranks. When the collective lever on the support assembly was manipulated, movement of the collective control tube and bellcrank were observed. The main rotor mast was fractured slightly below the main rotor hub assembly. One main rotor blade was fractured in two places; the other exhibited multiple fractures. The freewheeling unit was removed, and no anomalies were found.

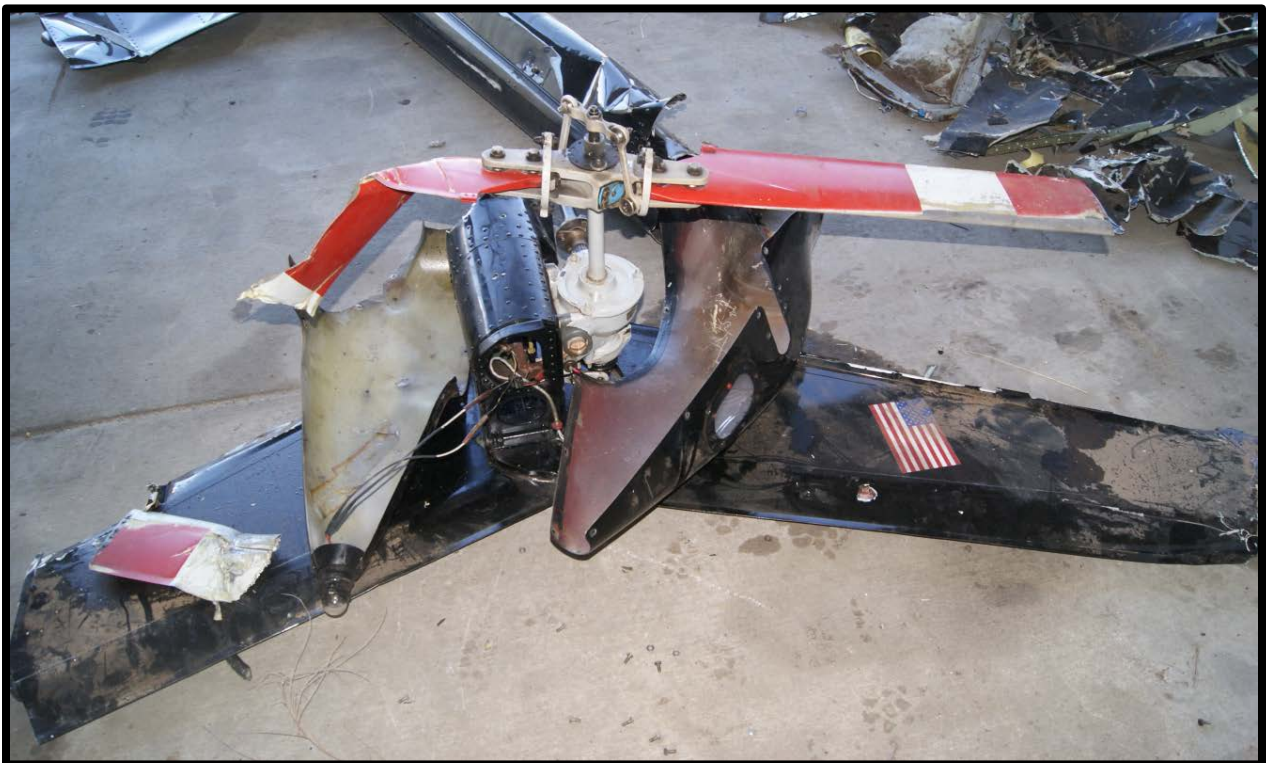
Picture 3: Tail Rotor

Examination of the tail rotor drive system revealed that the drive shaft fractures were consistent with overload. The tail rotor gear box chip detector contained no visible particulate matter. The tail rotor rotated freely in both directions when spun by hand, and corresponding rotation of the tail rotor gear box input shaft was observed. Oil was visibly present in the tail rotor gear box and on the lower portion of the vertical fin. One of the tail rotor blades was bent about 45 degrees and fractured in a manner consistent with overload.

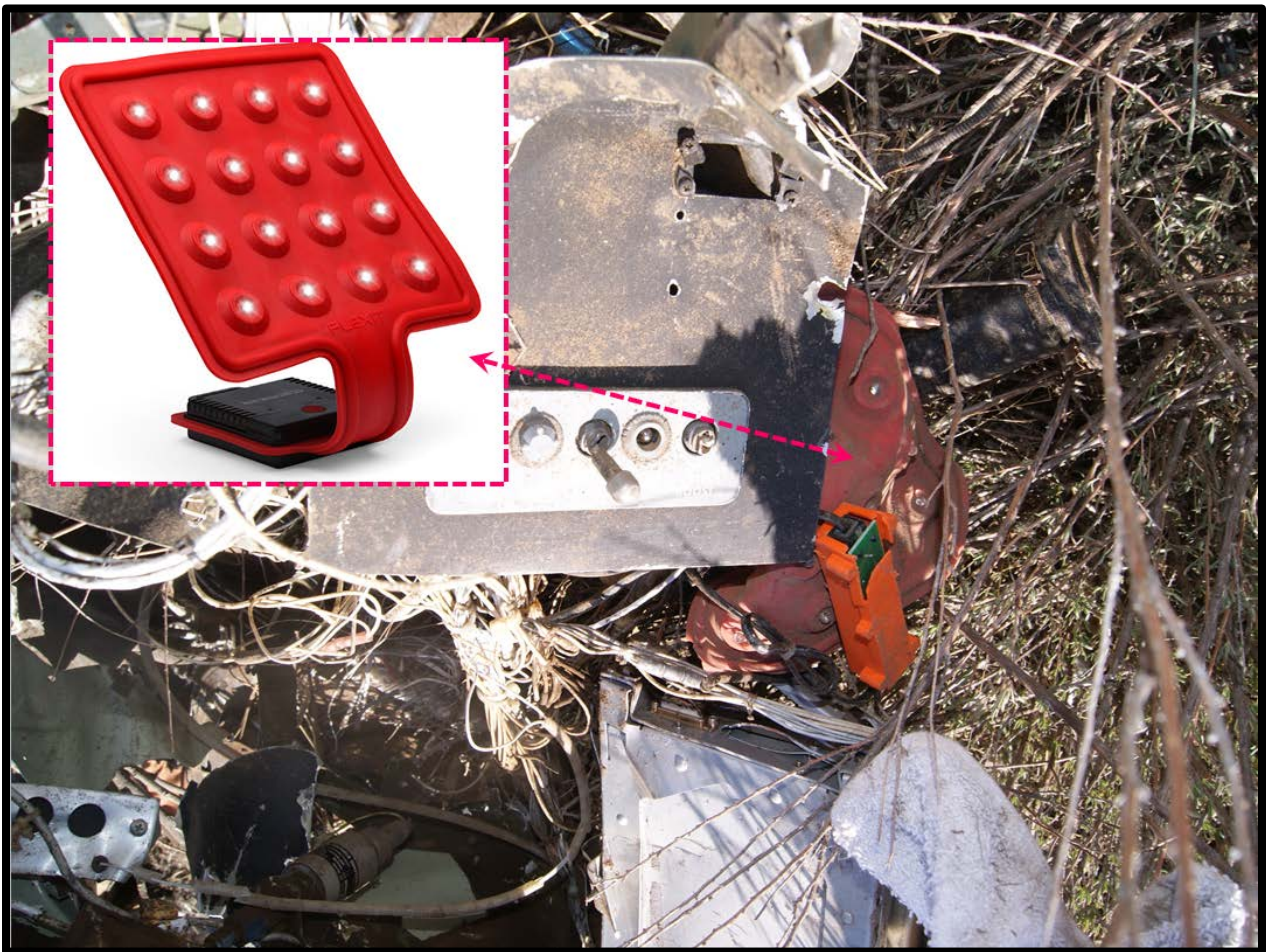
Picture 5: FLEXiT Light in Wreckage

The light placed in the cockpit for the purpose of illuminating the actor for the mounted GoPro camera was found with in the wreckage. The Stiker FLEXiT Light was a flat red flexible silicone panel measuring 13 in by 7 in that contained 16 white 5mm LED lights. The light was equipped with 2 magnets for mounting and powered by AA batteries. The light was operated by depressing a 3-mode electronic switch (button) that would activate a low (2 lights illuminated), medium (4 lights illuminated), high setting (16 lights illuminated), of which the highest setting would emit 128 lumens. Osteopathic 503-224-8399
