## TESTS AND RESEARCH

Investigators from the Safety Board, Federal Aviation Administration and Cessna examined the wreckage on April 14, 2015, at the facilities of SP Aircraft, Boise, Idaho.

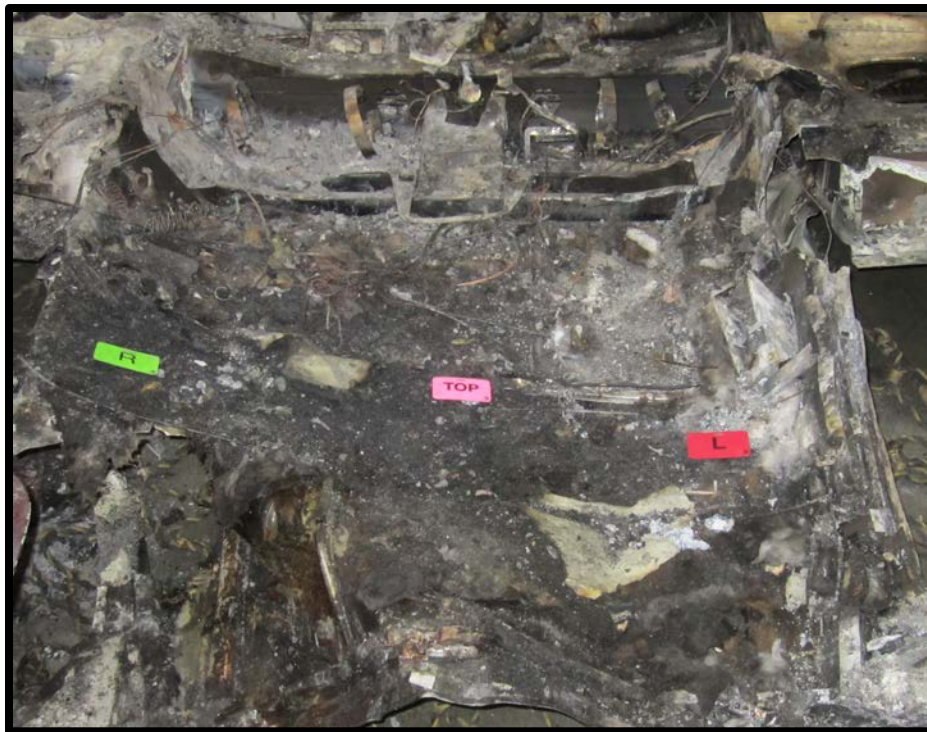
Picture 01: Upper Cabin Area

The main wreckage came to rest partially submerged in a creek had been subjected to severe thermal damage. The main wreckage consisted of the wings, empennage, engine and the mostly ashen remains of the fuselage. The cabin was completely consumed by fire.

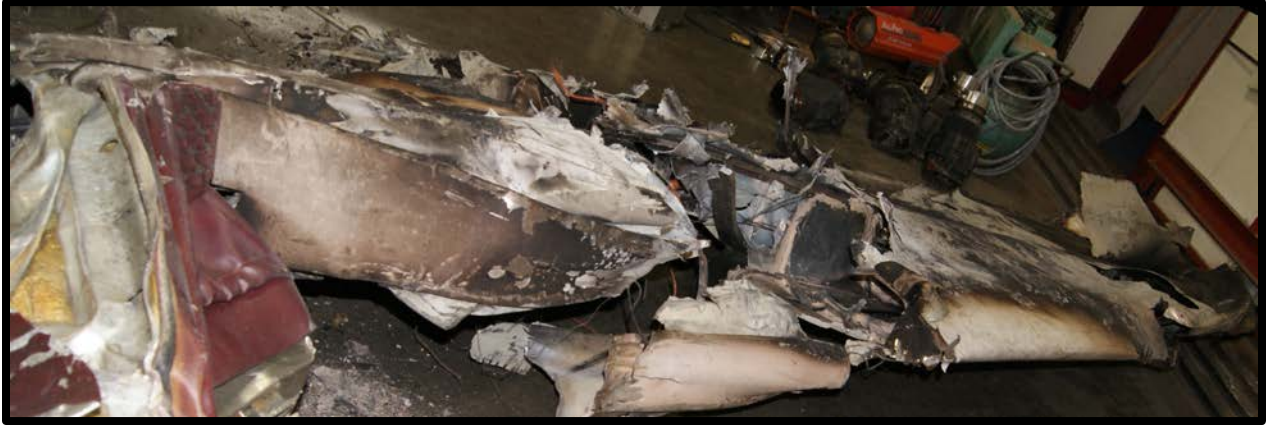
Picture 02: Upper Left Wing

The left wing remained affixed to the fuselage with the aileron and wing flap control surfaces still attached at their respective hinges. The left wing had sustained thermal damage with the most concentrated damage to the inboard upper area. The wing sustained aft crush deformation to the inboard section that consisted of the leading edge skin being folded into itself giving it an accordianed appearance. The crush began at the inboard root and continued about 5 ft to the area with the greatest crush deformation present and the skin was fragmented from the leading edge back toward the trailing edge; the flap was additionally bent upward in that area. Further crush deformation was found to the left wing's outboard area, with the last 1 foot area folded aft about 6 inches. The wing tip, located about 35 ft upstream of the wreckage in the bush bordering the creek, was not attached and had burned; pieces of the red navigation lens were found near the wingtip. The bottom of the left aileron control surface was whiter than the surrounding flap and wing skin, consistent with it being subjected to less thermal exposure.

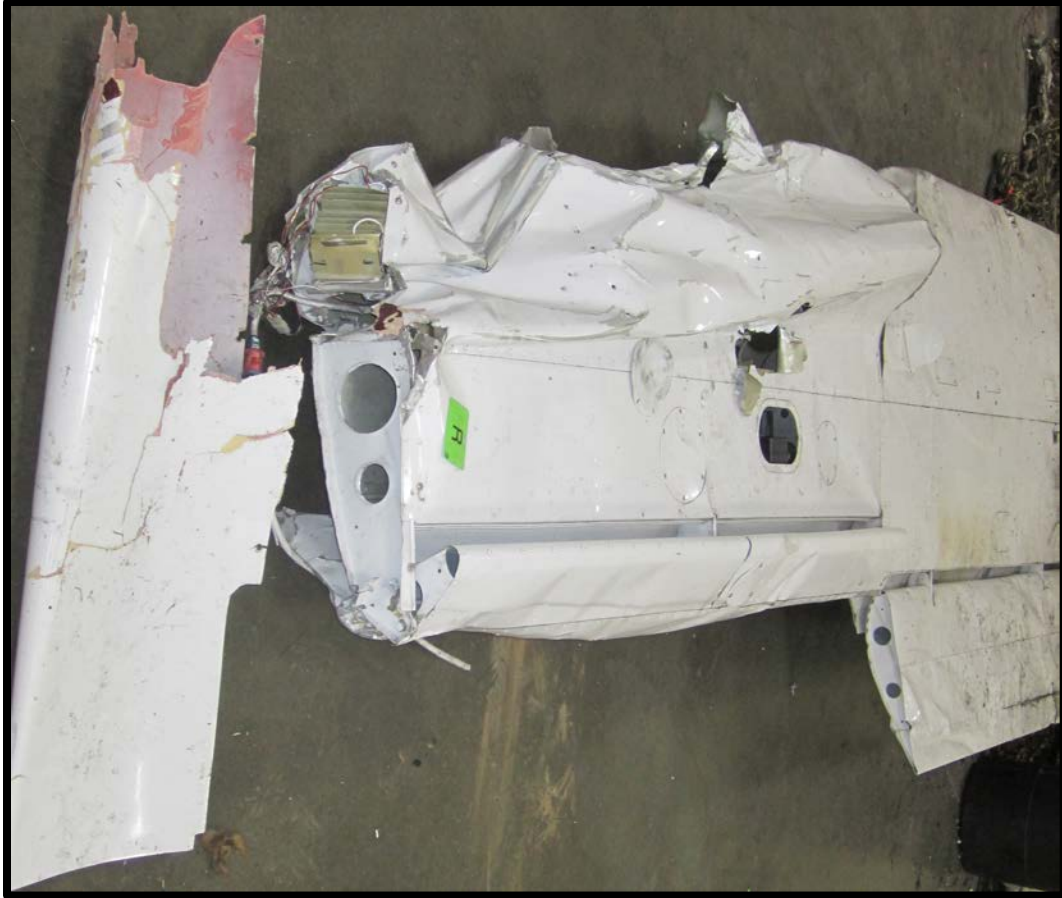
Picture 03: Bottom Right Wing

The right wing remained affixed to the fuselage with the aileron and wing flap control surfaces still attached at their respective hinges. The inboard 3 ft of the wing had sustained thermal damage and the remaining outboard area was not burned consistent with it being partially submerged in the creek. The outboard half of the leading edge displayed crush deformation with the skin folded into itself giving an accordianed appearance with three distinct divots noted. The wing tip, found about 10 feet upstream in the creek, was not attached and the leading edge was absent. The left aileron was hyper-extended upward and was found pinned under the wing, which had come to rest inverted.

The flap control surfaces were found in the retracted (flush) position. The actuator jackscrew was examined by measuring the exposed threads, which totaled 2.625 in. A representative from Cessna stated that the position of the jackscrew was consistent to the flaps being extended between 5 and 10 degrees. Flap cable continuity was established from the control surface to the cockpit area. The aileron cable continuity was established from the control surfaces to the control yoke assembly. The bell crank arms were all lodged past their respective stops.

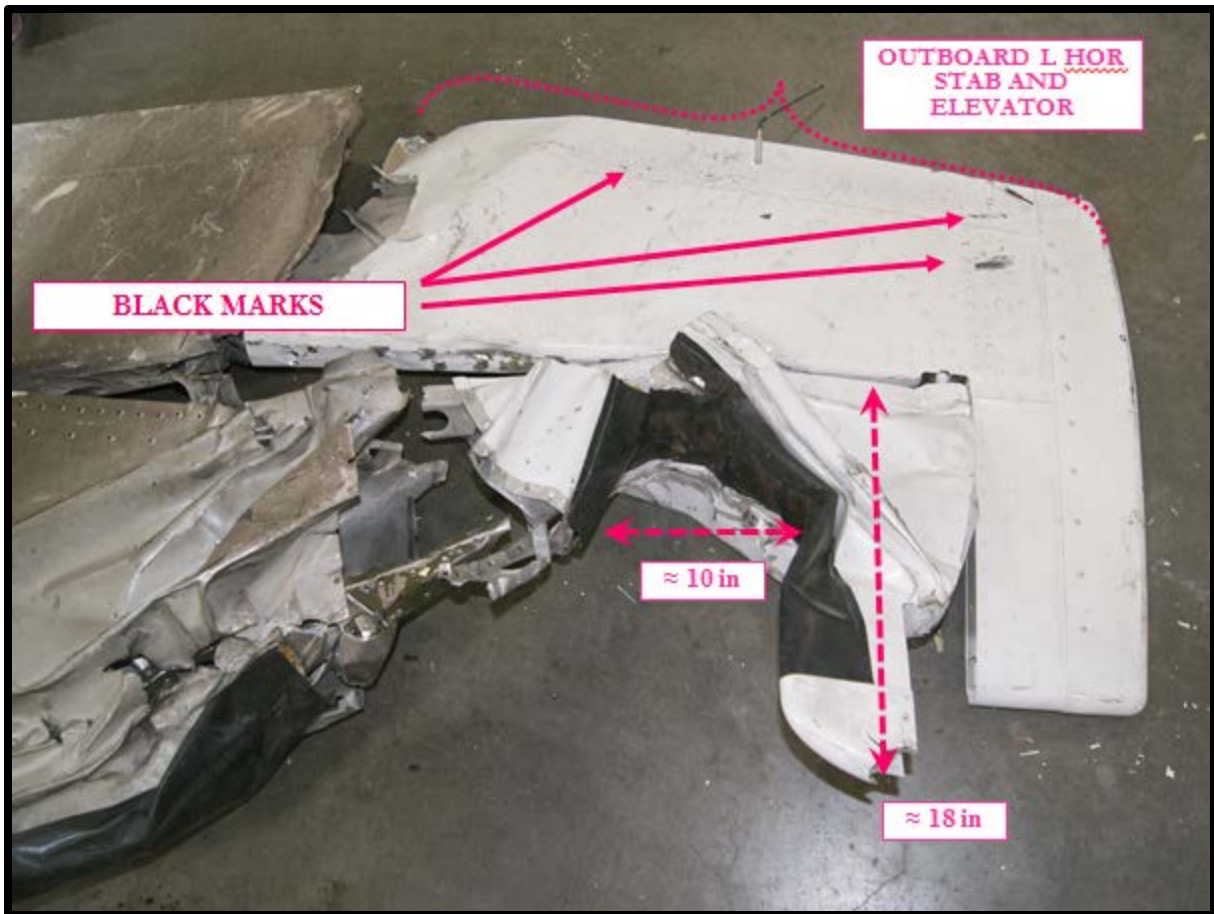
Picture 04: Divot in outboard left horizontal stabilizer and elevator

The right elevator control surface was intact and remained attached to the horizontal stabilizer and could be moved freely. Investigators established continuity of the elevator control cables to the aft baggage compartment through a series of pullies and runs through lightning holes; the ends of the cables were thermally deteriorated. From the ashen remains of the cockpit, the cables that remained, measuring about 36 in, were traced and found to be attached to their respective cockpit control assemblies. The left inboard half of the horizontal stabilizer and elevator remained attached to the empennage. The outboard section was found about 450 ft upstream in the river. The outboard section of the horizontal stabilizer was deformed aft about 18 in from the leading edge creating an accordion appearance, with the aluminum skin folded over on itself and the boot surface flat. This u-shaped divot that was about 10 inches in diameter. There were several black rub markings and splatter found on the elevator control surface positioned aft of the divot.

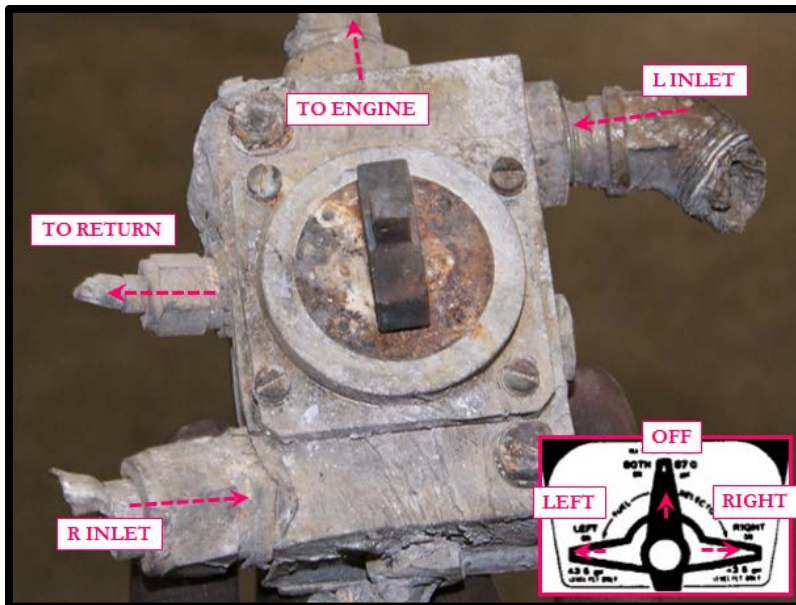
Picture 05: Fuel Selector

Fuel system continuity could not be established due to the amount of impact and thermal damage that the airplane had sustained. No fuel was present in either wing tank. The fuel selector valve was found in the "LEFT" position. Trace amounts of fuel were recovered from the fuel manifold and the gascolator.

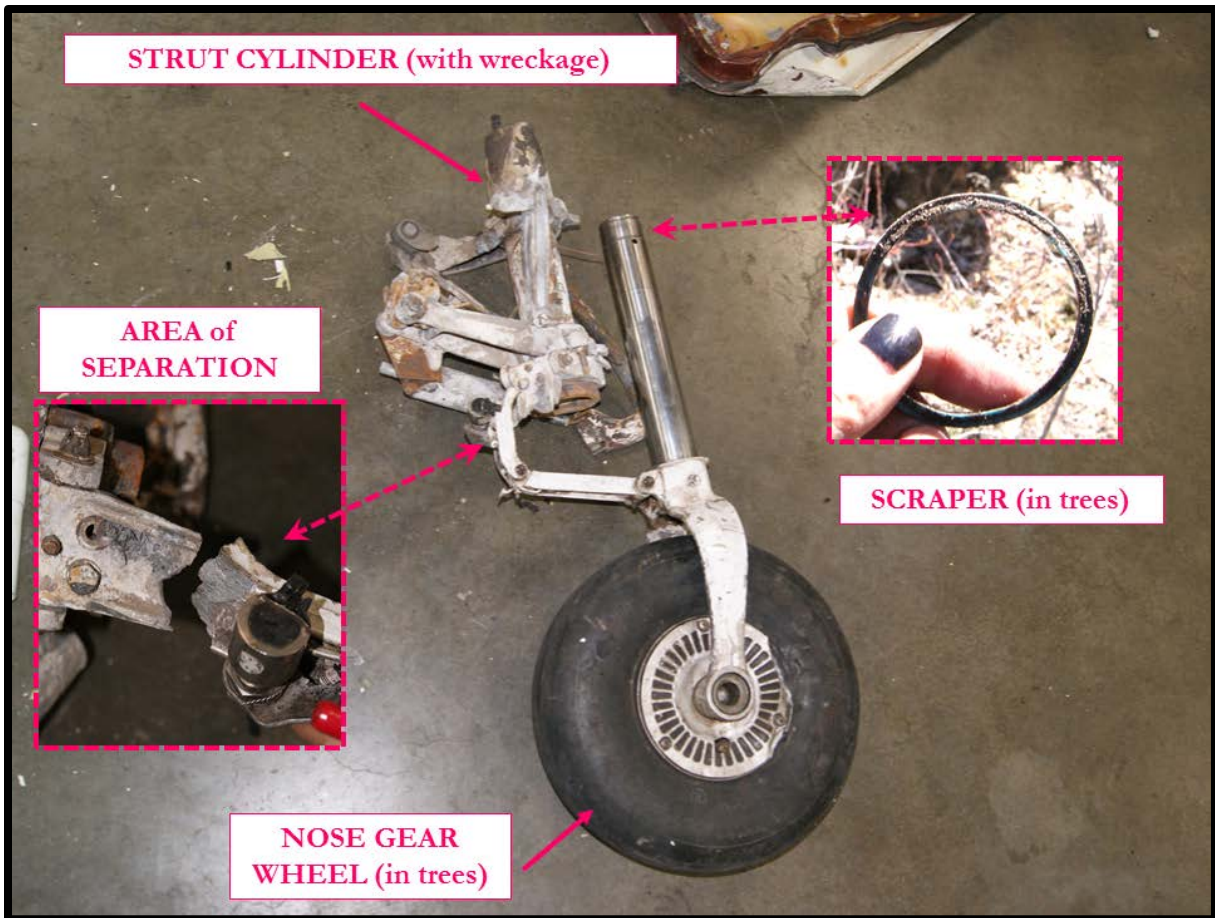
Picture 06: Nose Landing Gear

The nose landing gear (NLG) doors were located about 30 ft upstream from the main wreckage. The doors were fragmented and sustained severe crush damage. The NLG wheel was separated at the strut and found near the initial impact. A two inch portion of the rim's flange had fragmented on both sides of the NLG, both approximately 180-degrees from one another.

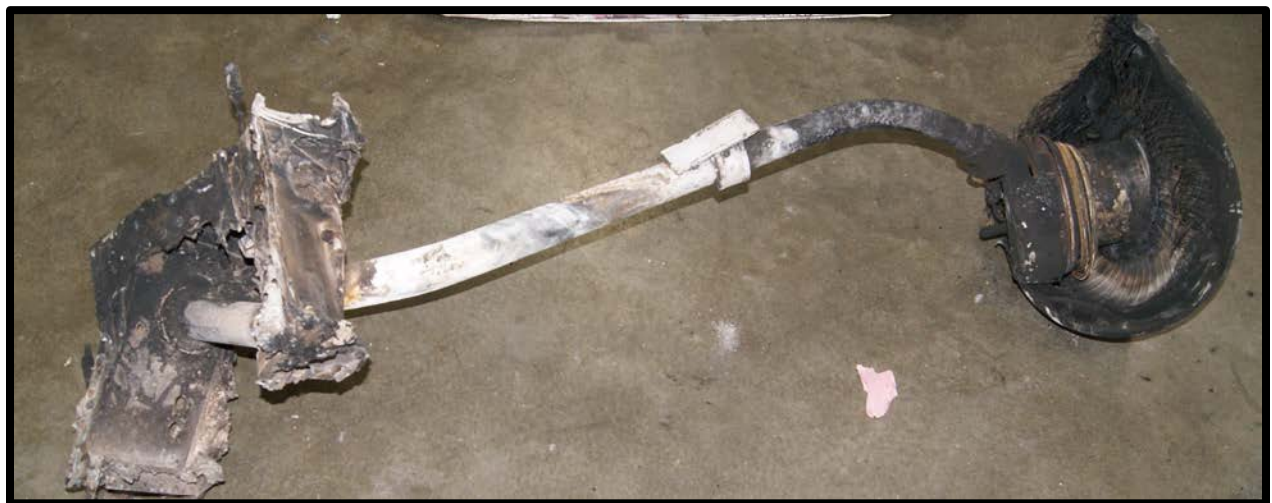
Picture 07: Right main Landing Gear

The right main landing gear was found in the wreckage. The gear was locked and the tire/wheel assembly was attached and burned.

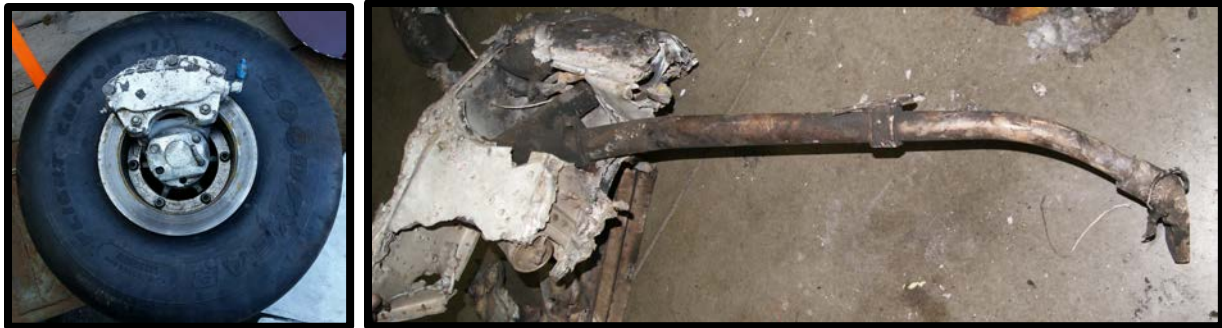
Pictures 08 and 09: Left Main Landing Gear

The left main landing gear was found in the wreckage. The gear was unlocked and the tire/wheel assembly was separated. The step was fractured.

According to the manufacture, Goodyear Aviation Tires, the left main landing gear, (p/n 606C86-6) had an outside diameter between 17.5 and 16.8 in depending on the inflation. The section width was between 6.3 and 5.9 in.
