TESTS AND RESEARCH

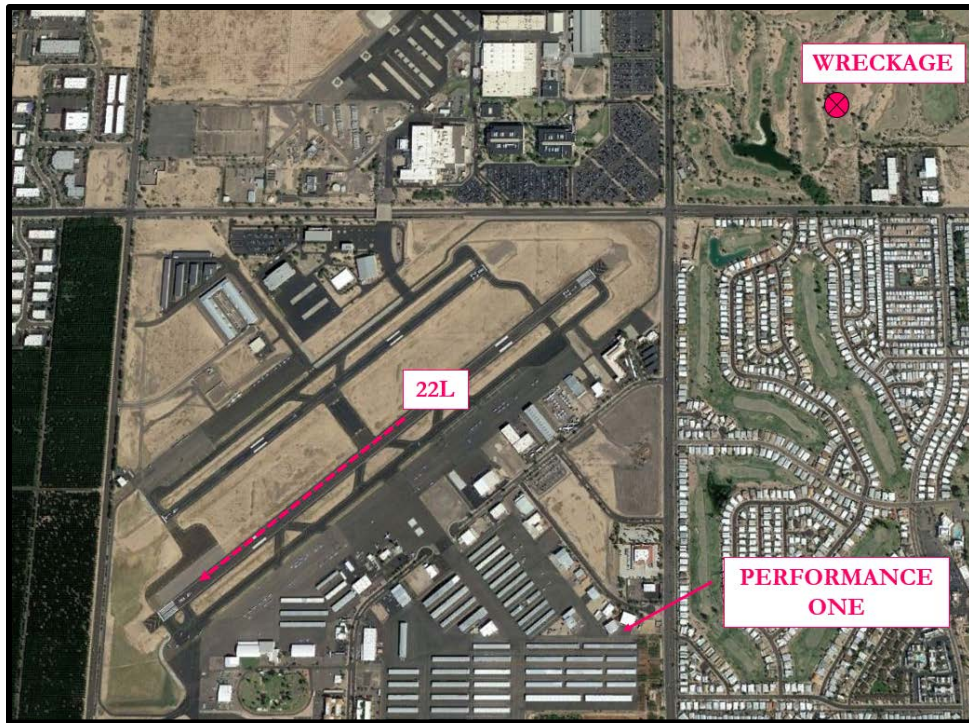
Picture 1: Wreckage Overview

The wreckage was located about 0.5 nm northeast from the end of runway 22L situated in a green area of a golf course at 1,410 feet msl.

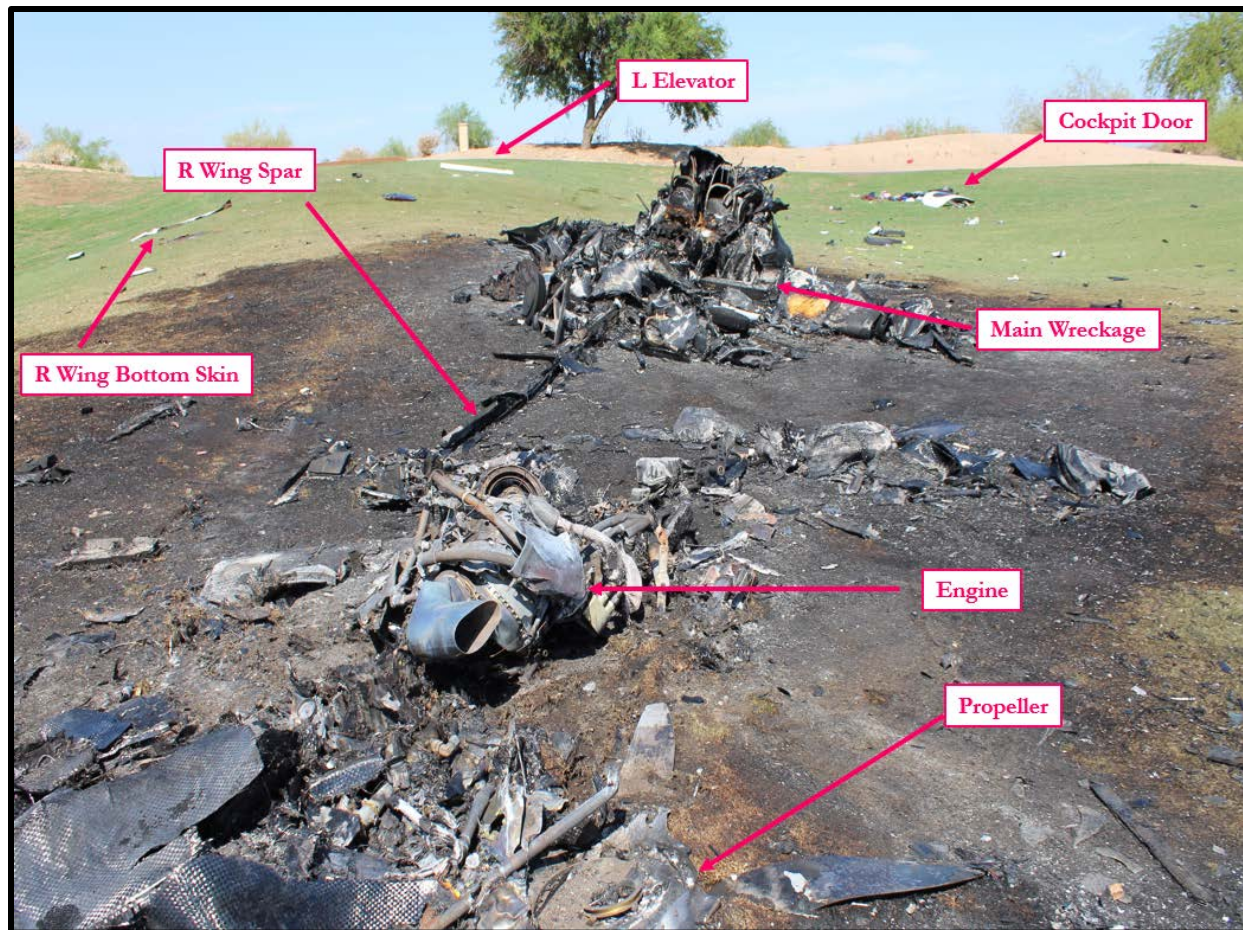
Picture 3: Main Wreckage

The first identified point of impact consisted of a crater in the soft terrain where the propeller blades were embedded. The engine and numerous portions of the airframe were located in the debris field leading from the initial impact to the main wreckage. The main wreckage was located in an upright position about 25 feet from the initial impact point on a magnetic heading of 115 degrees. The main wreckage had sustained thermal damage and consisted of a majority of the airframe's ashen remains. The farthest piece of wreckage were the fuel caps, consistent with them ejecting from the wings at impact.

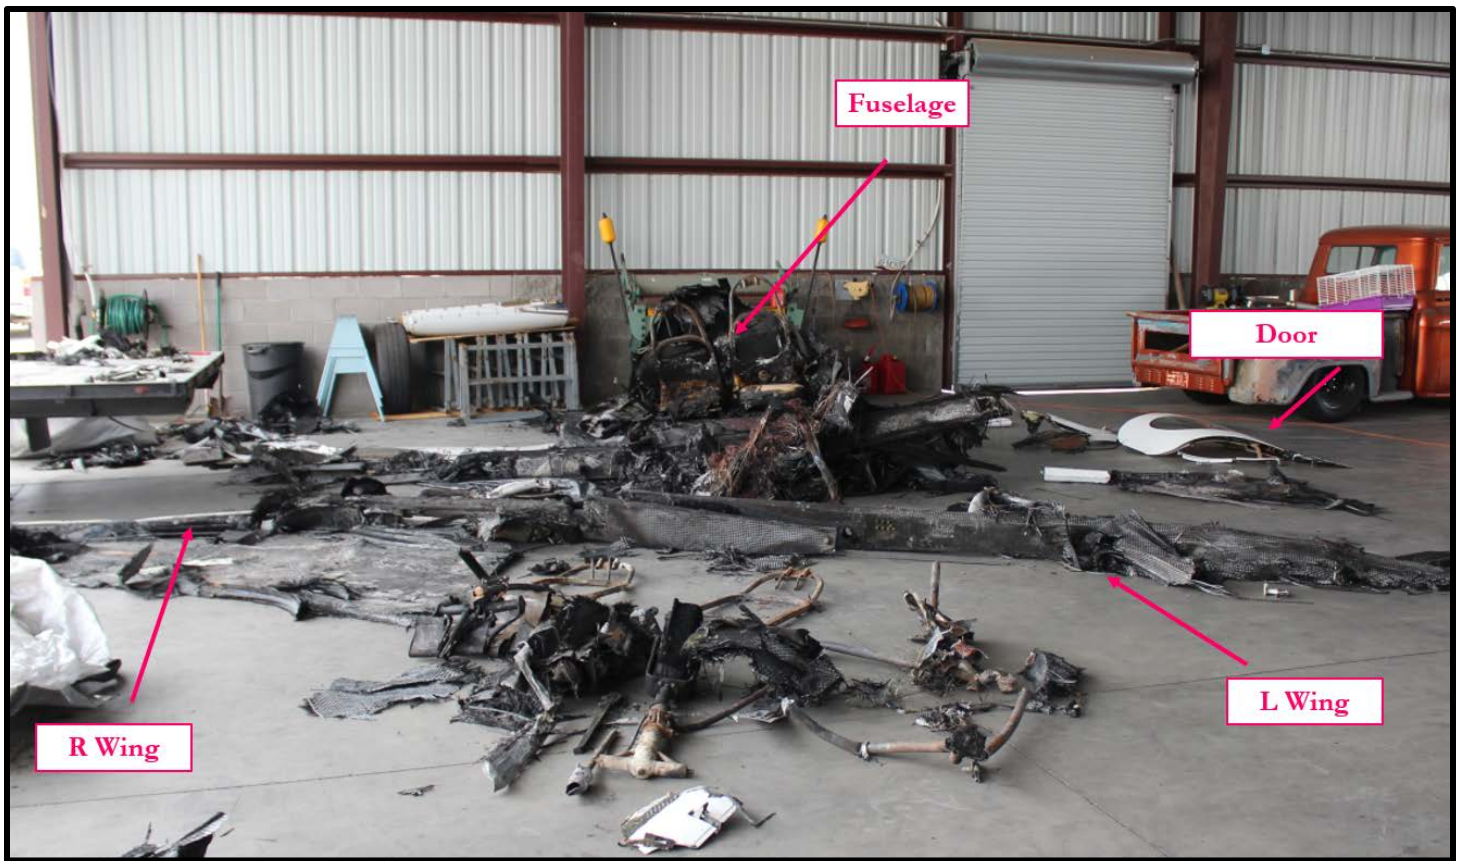
Picture 4: Main Wreckage Layout

The firewall and engine mounting brackets had sustained crush damage and were thermally deformed. Several pieces of the cowling were distinguishable from the latches; there was no oil or smoke signatures on those pieces. The cockpit area had sustained severe thermal damage. The avionics were charred with wire bundles exposed and partially melted. The front seat frames were not attached and the floor section at the forward spar was mostly consumed by fire.

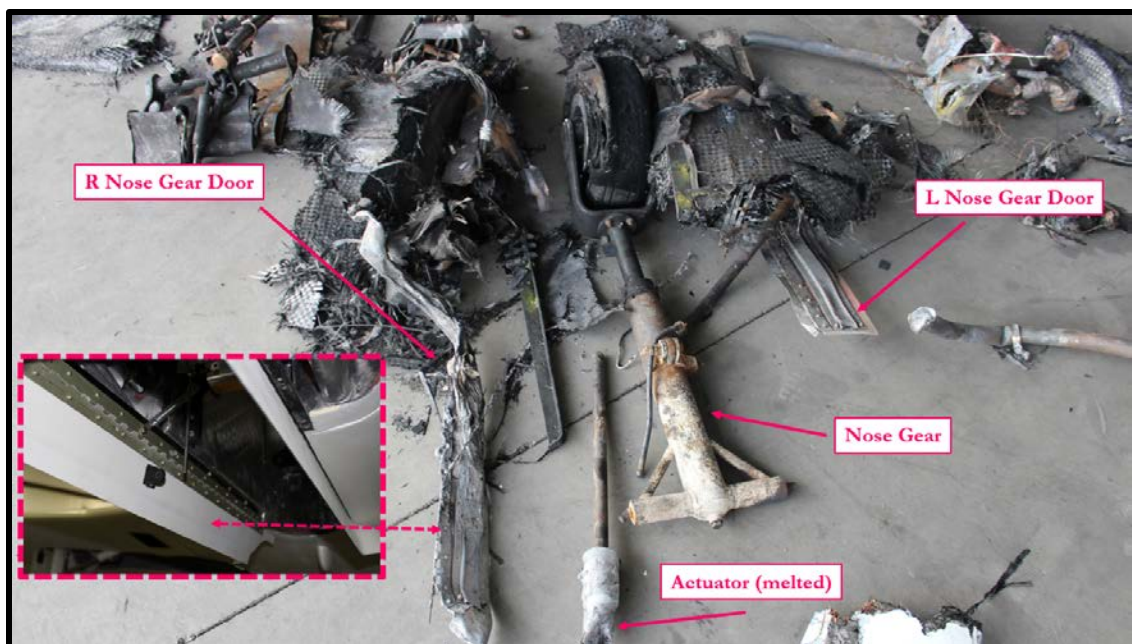
Picture 5: Nose Landing Gear

The landing gear indicator was up and locked. The batteries were consumed by fire.
