Air Safety Investigations Aircraft Incident/Accident Technical Report

Aircraft Incident/ Accident Information	Year: 1979	Make: Cessna	Model: 421C
	Serial number: 421C0601		Registration: N421TK
Location: Huntsville, TX		Date: 04-25-17	Time: 1035 CDT
Aircraft Owner		Aircraft Operator	
Klass Enterprises, LLC [REDACTED] Conroe, TX 77302-3146		Kermit Greer Faulkner, Jr. [REDACTED] Conroe, TX 77203-3146	
Report Information			
Senior Air Safety Investigator: Henry J. Soderlund		Report #: ASI-17-BF-T	Report date: 11-07-17

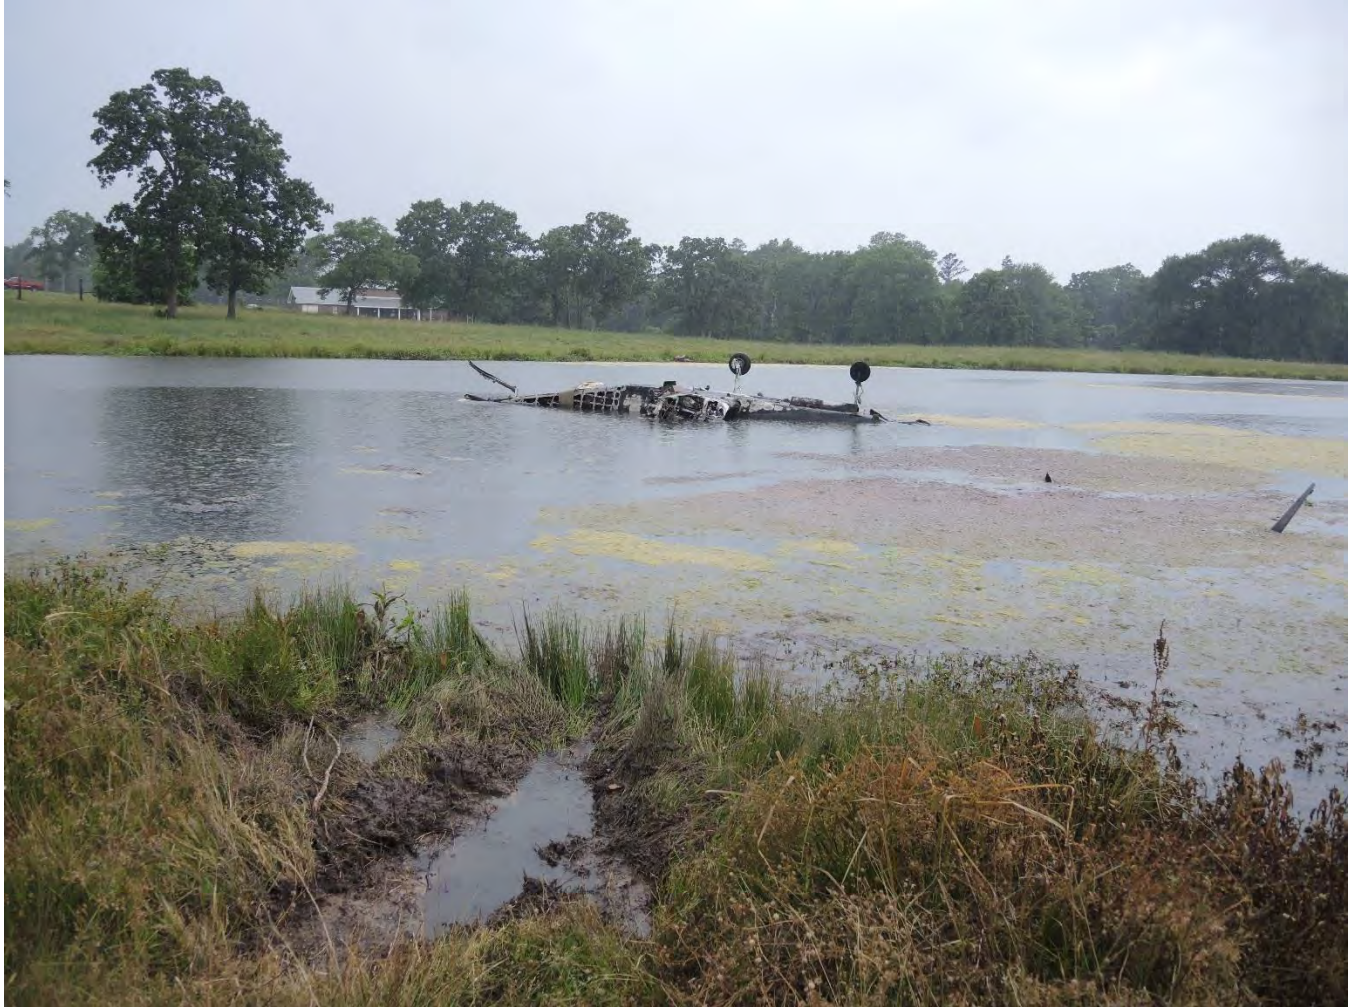
On Site ASI-17-BF-025

The aircraft impacted trees and terrain before coming to rest inverted and half submerged in a farm pond. A tree along the wreckage path exhibited leaf damage consistent with fuel spray.

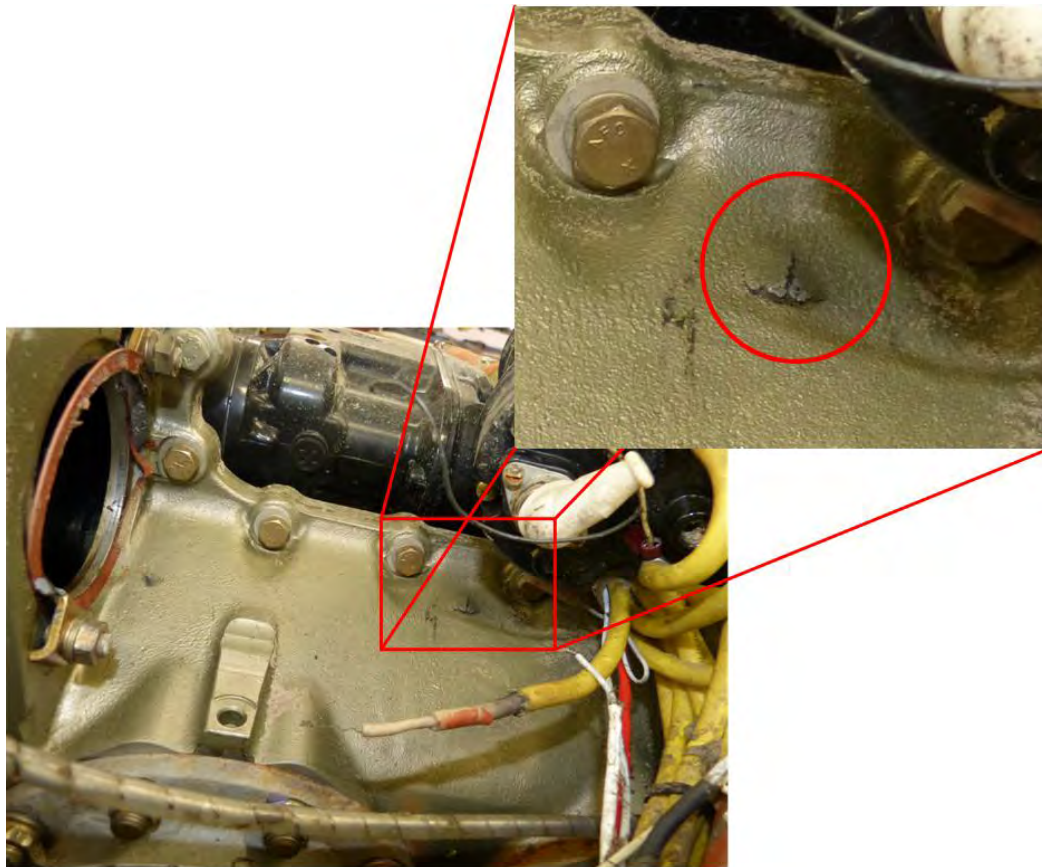
CMI Photograph P1090246.JPG

An external examination of the engines was conducted during the wreckage exam and an inside to outside "dent" was observed on the left engine. No further examination was done during the wreckage review.

During the examination of the engines at the manufacturer's facility it was found that the #2 connecting rod on the left engine had separated from the crankshaft. All of the connecting rod attachment hardware was installed. All of the cylinder base nut torques were within limits. The #1 and #3 connecting rods exhibited heat distress at their crankshaft ends. The #1 connecting rod bearings exhibited heat discoloration and one half had extruded to the side. The #3 connecting rod bearing exhibited heat discoloration, and both halves had extruded.
