Air Safety Investigations Aircraft Incident/Accident Technical Report

Aircraft Incident/ Accident Information	Year: 1973	Make: Cessna	Model: T310Q
	Serial number: 310Q0611		Registration: N301JA
Location: Wichita, KS		Date: 09-25-15	Time: ~1550 CDT
Aircraft Owner		Aircraft Operator	
Celestial Knights, LLC ████████████████████ Parker, CO 80134		Aaron Wisley Waters ████████████████████ Parker, CO 80134	
Report Information			
Air Safety Investigator: Ernest C. Hall		Report #: ASI-15-DK-T	Report date: 01-28-16

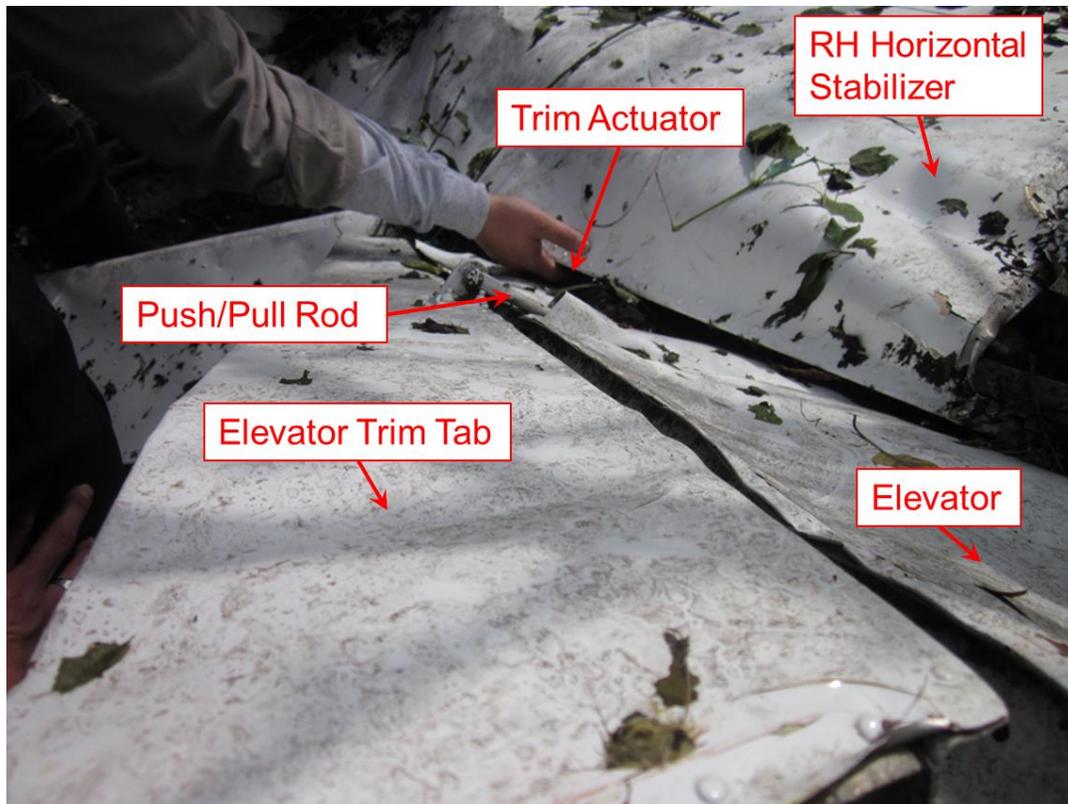
Elevator Trim Tab

The elevator trim actuator push/pull rod was found disconnected from the elevator trim actuator, but remained attached to the elevator trim tab. The attachment bolt was not observed. The right elevator, with attached trim tab, push/pull rod, and trim actuator, was retained by the NTSB for further examination at Textron Aviation Material and Process Laboratory. The elevator trim actuator extension was 5/8" which corresponds to a position exceeding travel limits for the trim tab trailing edge DN.

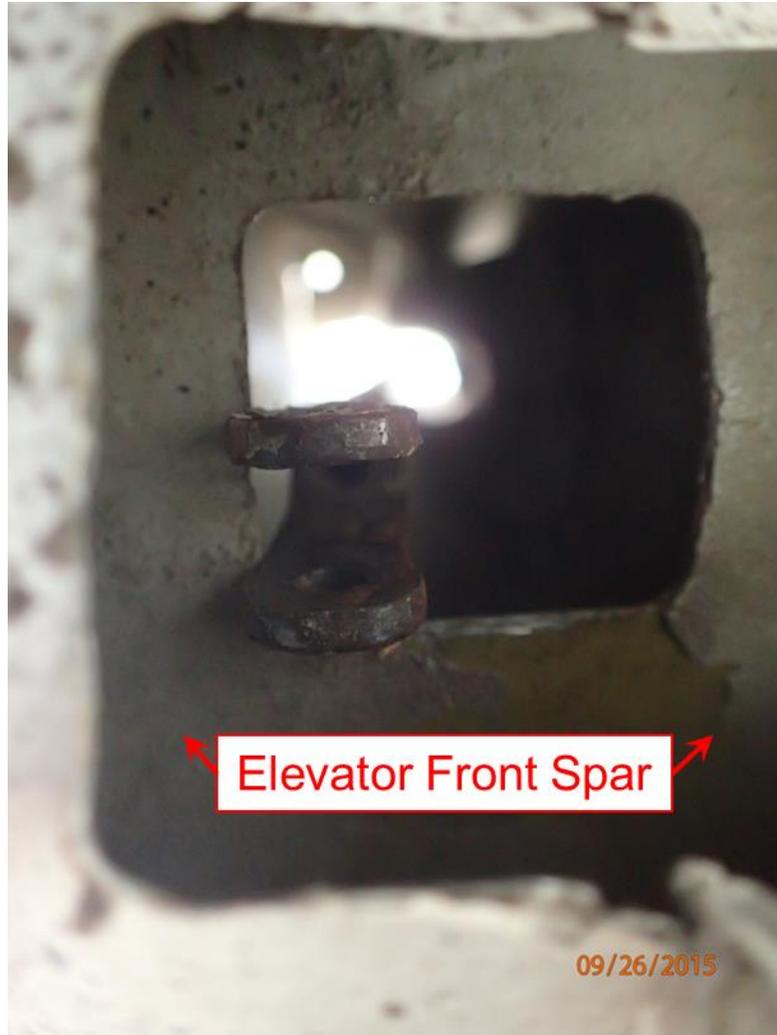
Elevator Trim Actuator Push/Pull Rod

The right elevator, trim tab, and trim actuator were removed from the scene and taken to Textron Aviation's laboratory for further examination. A section of the elevator upper skin was removed to examine witness marks in the leading edge spar of the elevator. Witness marks matching the forward push/pull rod clevis were consistent with the clevis hitting against the aft side of the front elevator spar after separation from the actuator. Additionally, the elevator push/pull rod guide hole edge exhibited signs of wear on the interior face, consistent with rubbing from the hardware of the connecting bolt. The forward end and bottom side of the trim tab push/pull rod clevis had impact marks consistent with contact with the elevator trim actuator eye-end.
