Report Title: Examination of Fractured Torque Knee, P/N 50-810032-4, from Beechcraft E90 Aircraft A/C LW-76

Report No.: 19-359-091

Date: 08/20/2019

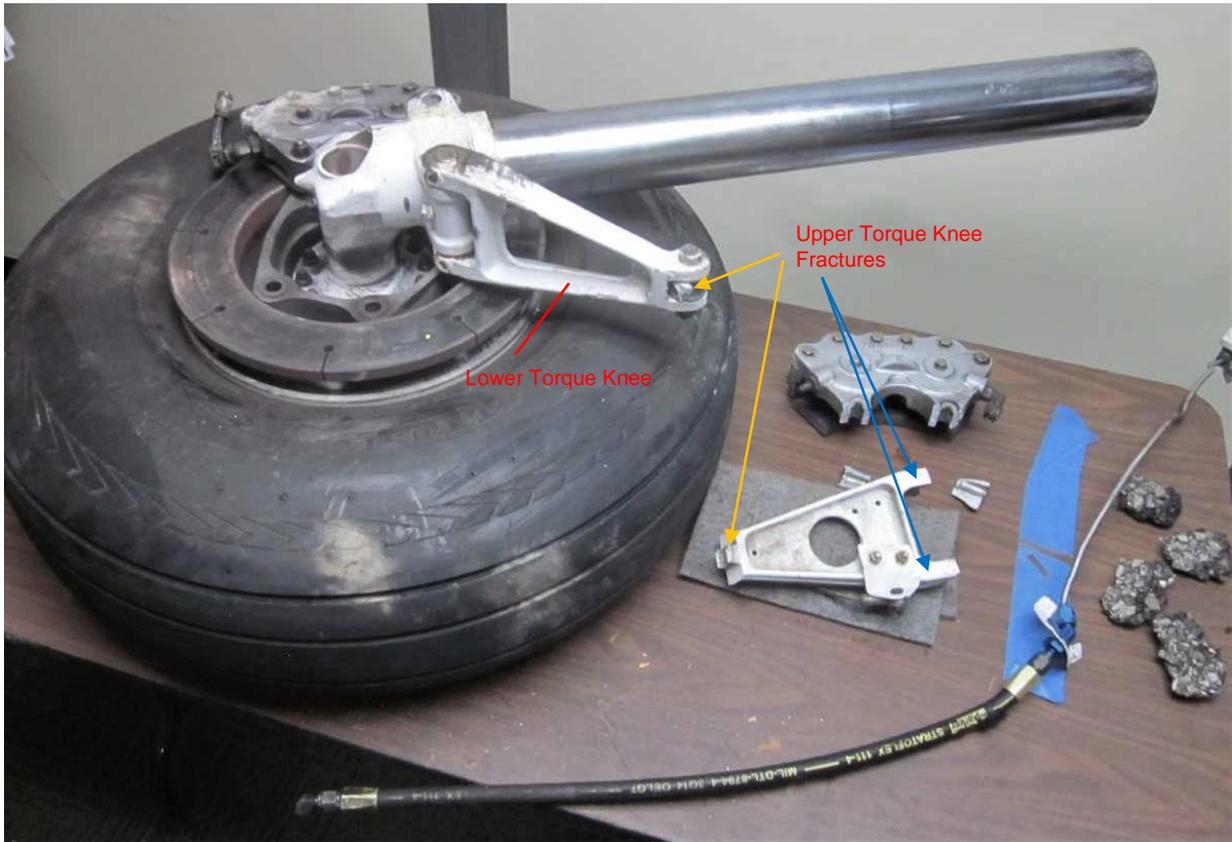
LW-76's RH MLG is shown in Figure 1 after fracture was found and assembly was removed from the aircraft. The lower torque knee (P/N 50-810295-17) remains intact and the upper torque knee (P/N 50-810032-4) has fractures at all three connection points. An image from the Illustrated Parts Catalog shows the MLG assembly and the locations of each of the fractures (Figure 2). Due to historical evidence of this occurrence a mandatory service bulletin (SB 32-3134) was released requiring nondestructive inspection of the torque knees at reduced intervals. An additional Service Bulletin (SB 32-3116) was released recommending a steel torque knee replacement for the upper and lower knees.

Figure 1: RH main landing gear after fracture was identified and assembly was removed from the aircraft. Lower torque knee (P/N 50-810295-17) remains intact; upper torque knee (50-810032-4) fractured at all connecting points from assembly.

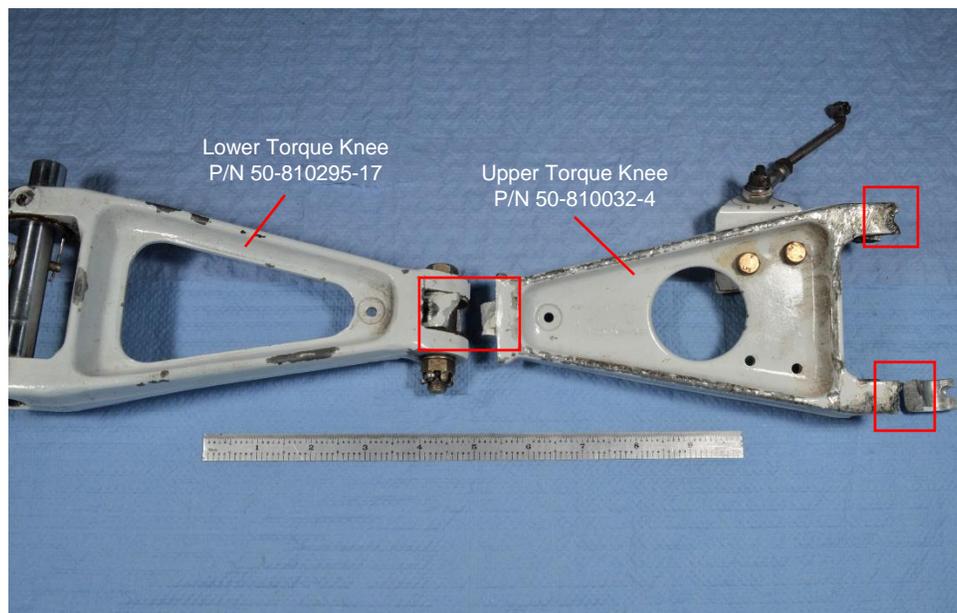
Figures 3 and 4 show the upper and lower torque knees as received by M&P; pieces from two of the fractures on the upper torque knee are missing. All fracture surfaces were inspected at higher magnification using optical and scanning electron microscopy (Figures 5-14). Fracture piece #1 showed

Figure 3: Torque knees as received by M&P. Boxes show fracture locations. Some fracture pieces are missing from the upper torque knee.

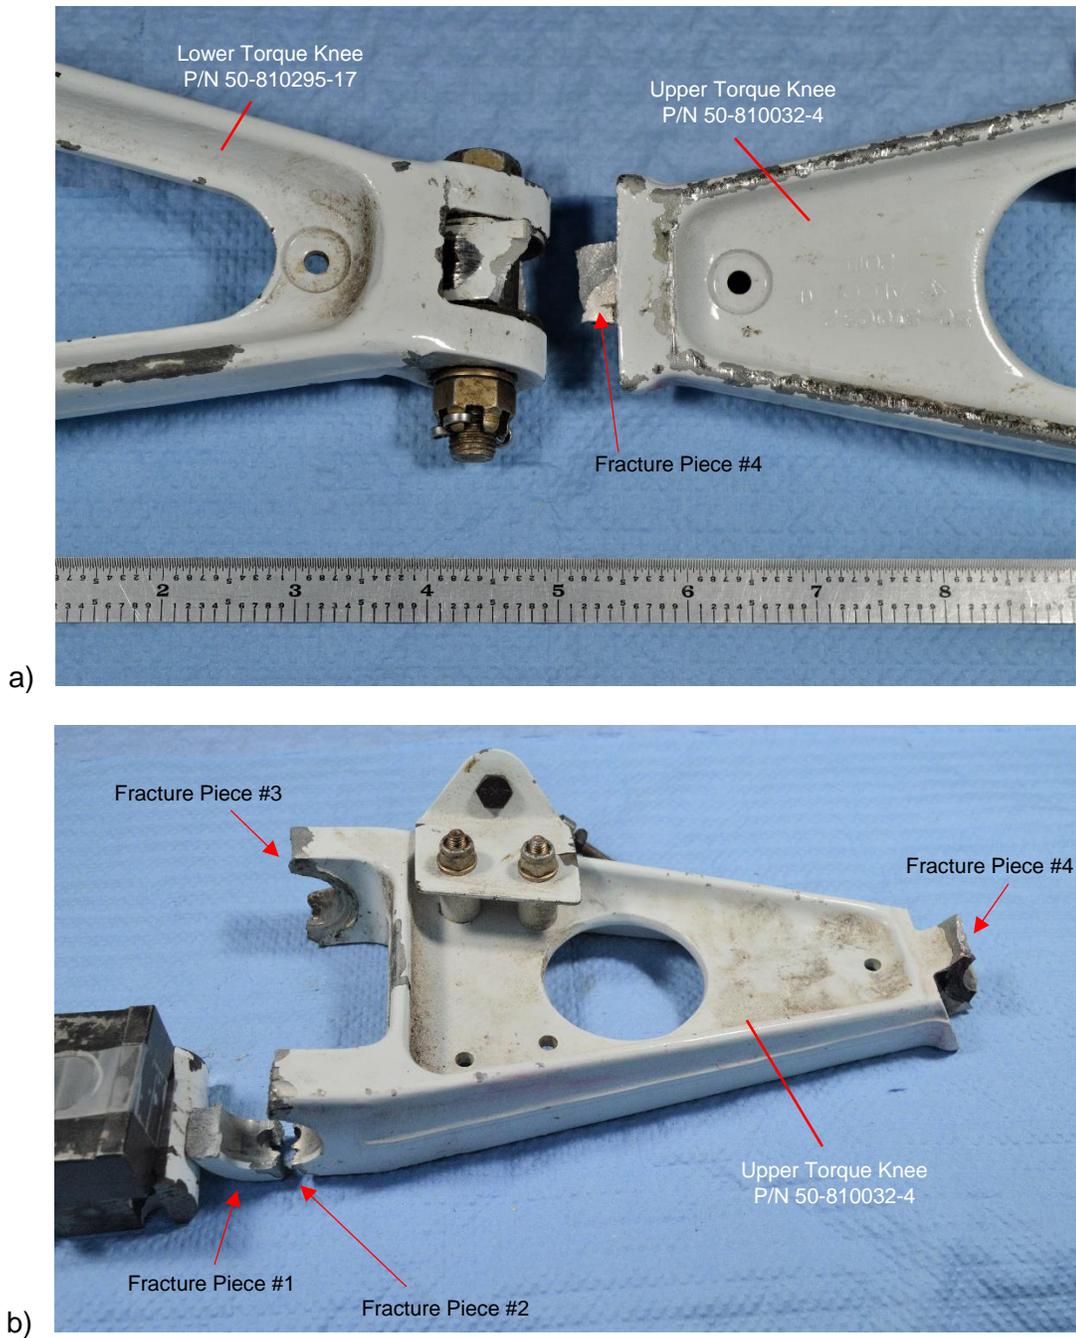
Figure 4: Close-up of fracture areas on the upper torque knee. Fractures are arbitrarily labeled for easy identification during analysis.

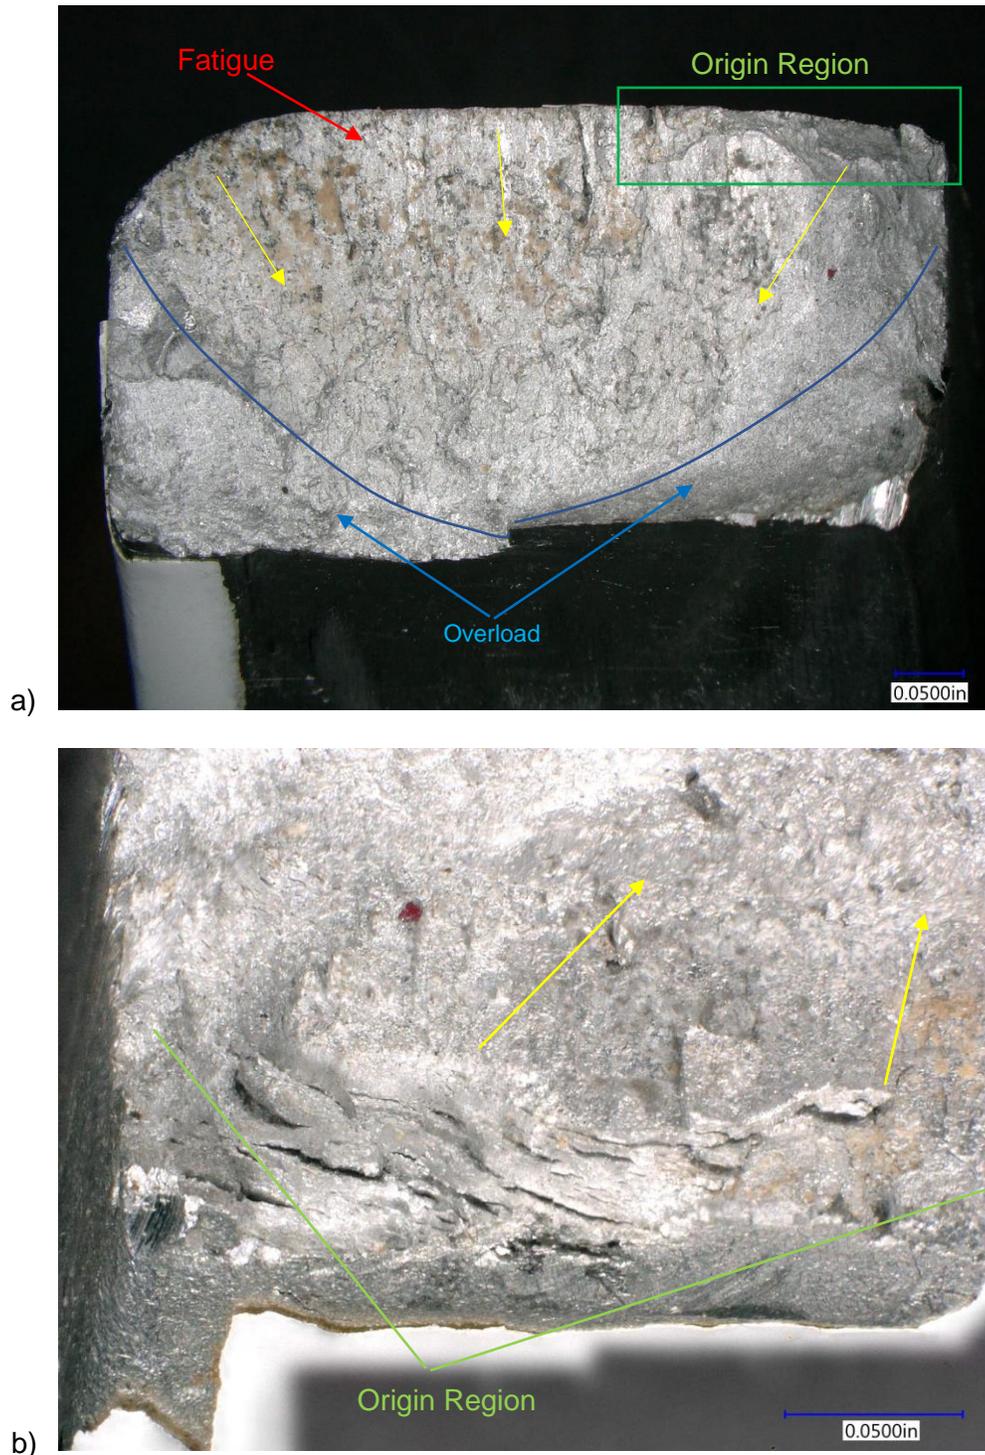
evidence of corrosion assisted crack initiation. The material on the outside face of the fracture had begun to separate in layers. This type of layer separation is common in 2xxx series aluminum alloys and is indicative of a corrosive attack on the metal. The crack propagated through fatigue until a critical crack size was reached. Final fracture occurred through ductile overload. The rest of the fracture pieces showed evidence of ductile overload. Fracture piece #1 likely fatigued and fractured first; after fracture the other two connections experienced an increase in loading which caused them to separate from the assembly.

Figure 5: Fracture Piece #1 a) Fracture shows regions of fatigue and overload. Yellow arrows represent the direction of crack propagation, 7x magnification b) Upper right corner of fracture surface shows separation of material layers. Yellow arrows show crack propagation direction, 19x magnification

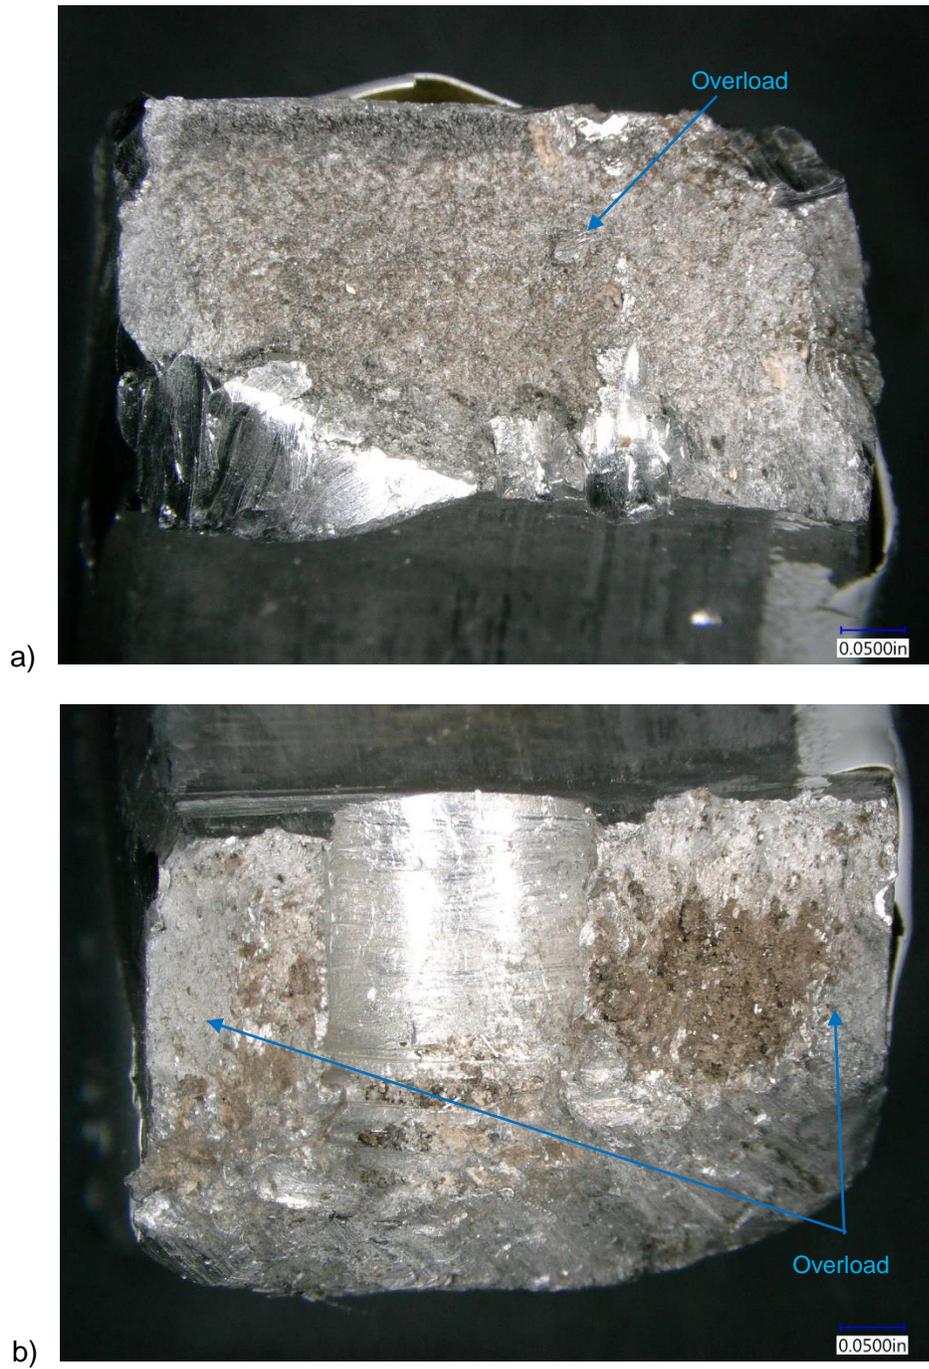
Figure 6: Fracture Piece #2, significant portions of the fracture are damaged or covered in corrosion a) 7x magnification b) 7x magnification

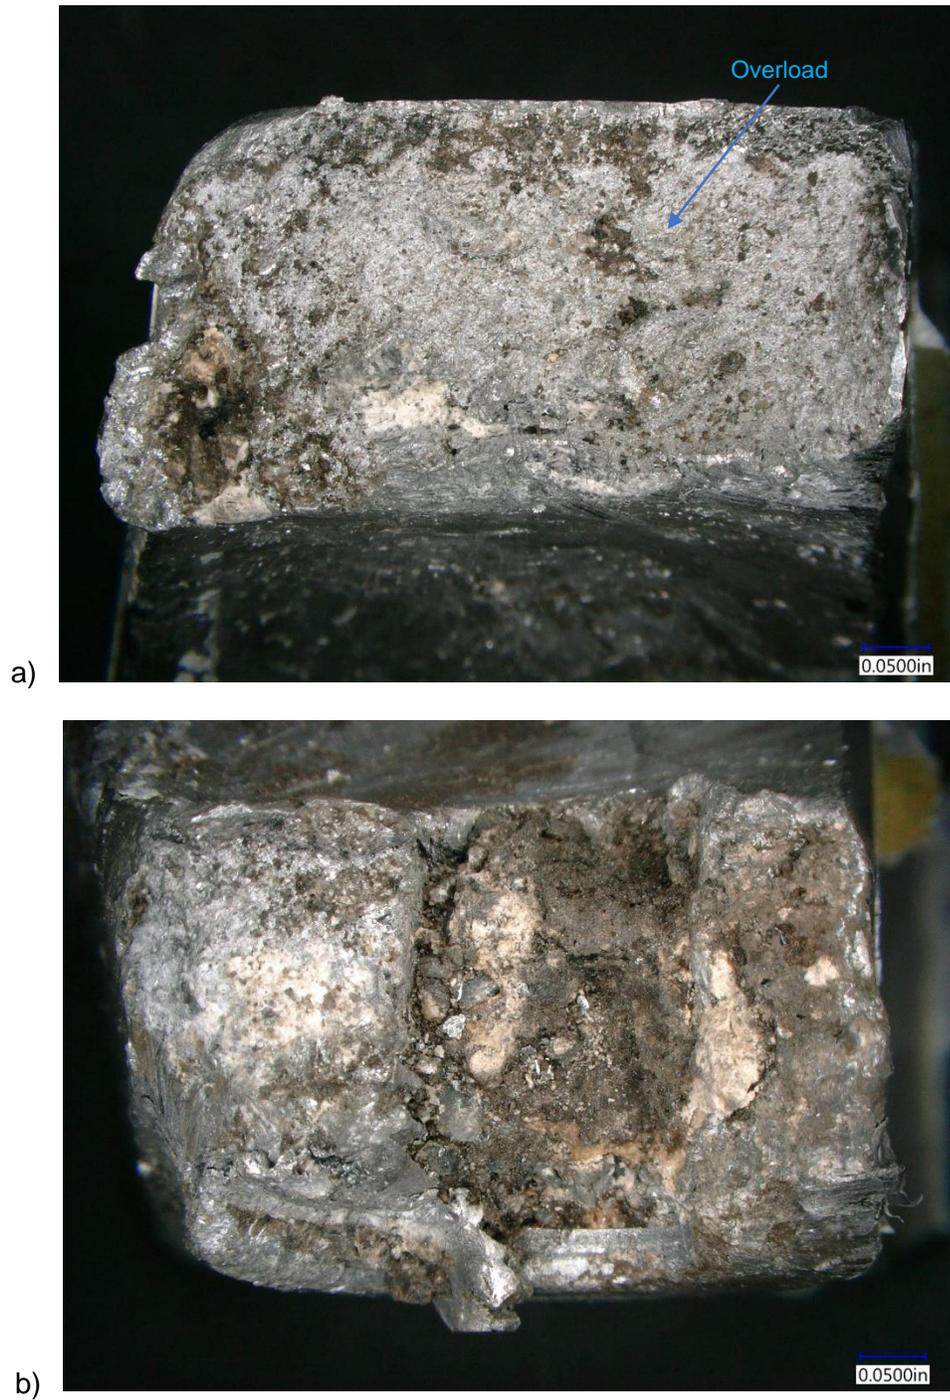
Figure 7: Fracture Piece #3, significant portions of the fracture are damaged or covered in corrosion a) 7x magnification b) 7x magnification

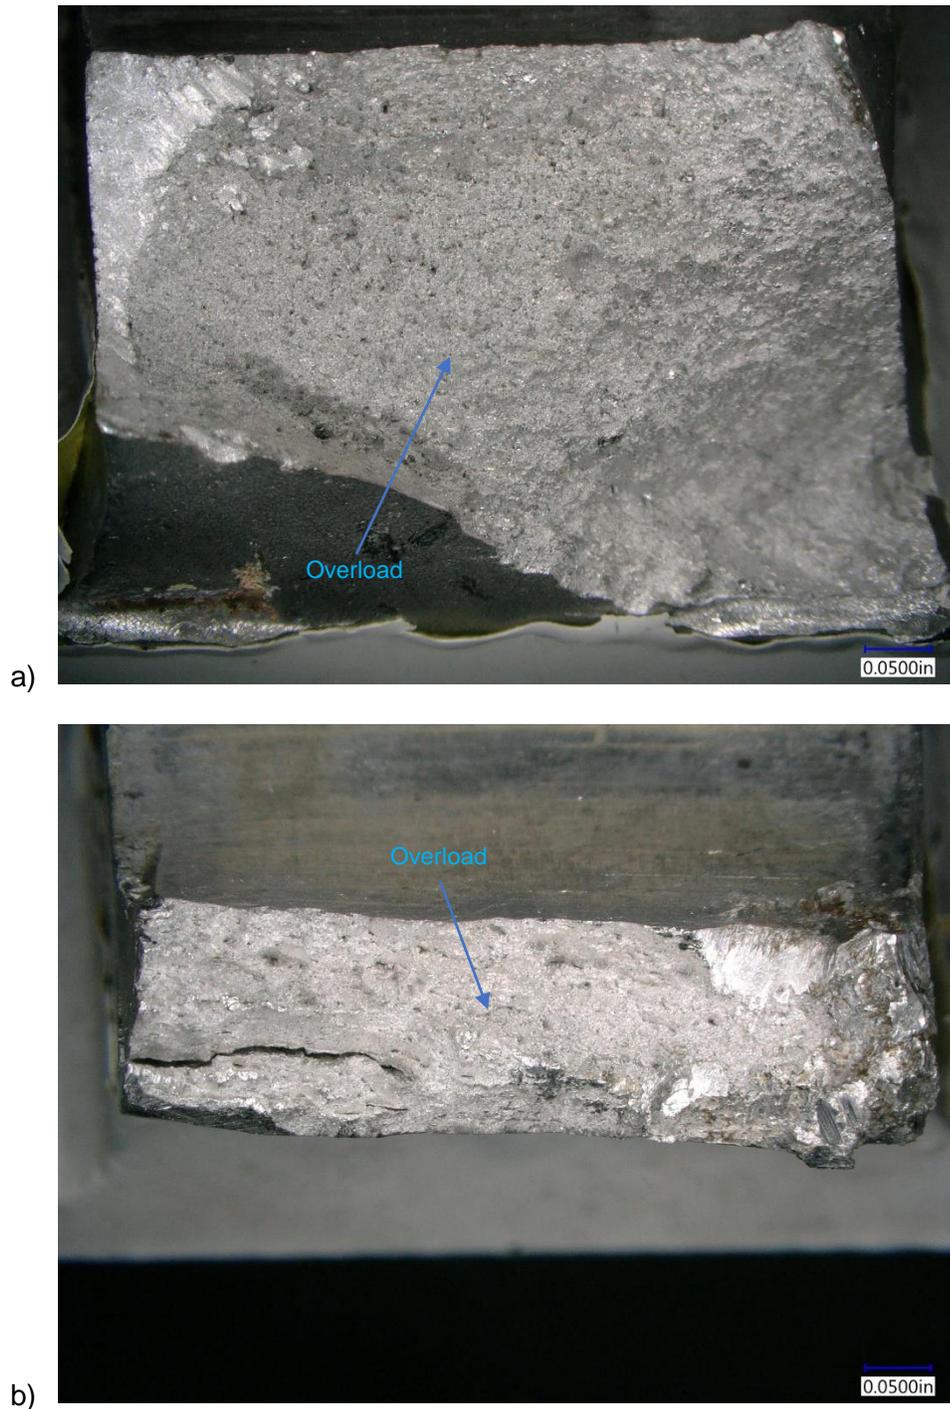
Figure 8: Fracture Piece #4, connection piece between upper and lower torque knees. a) 7x magnification b) 7x magnification

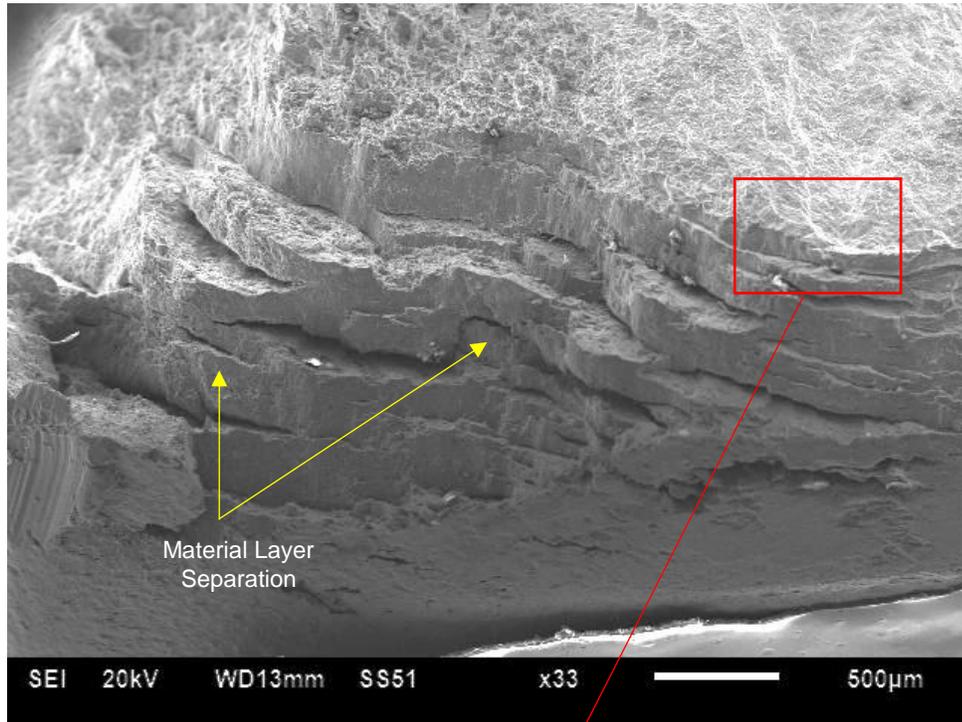
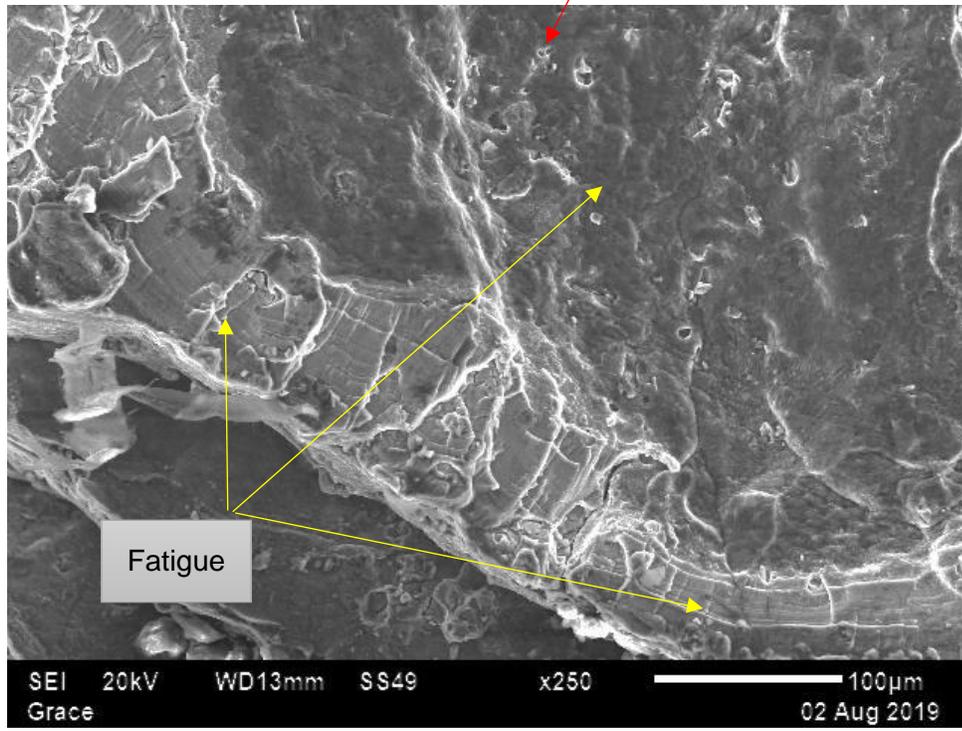
Figure 9: Fracture Piece #1 origin region

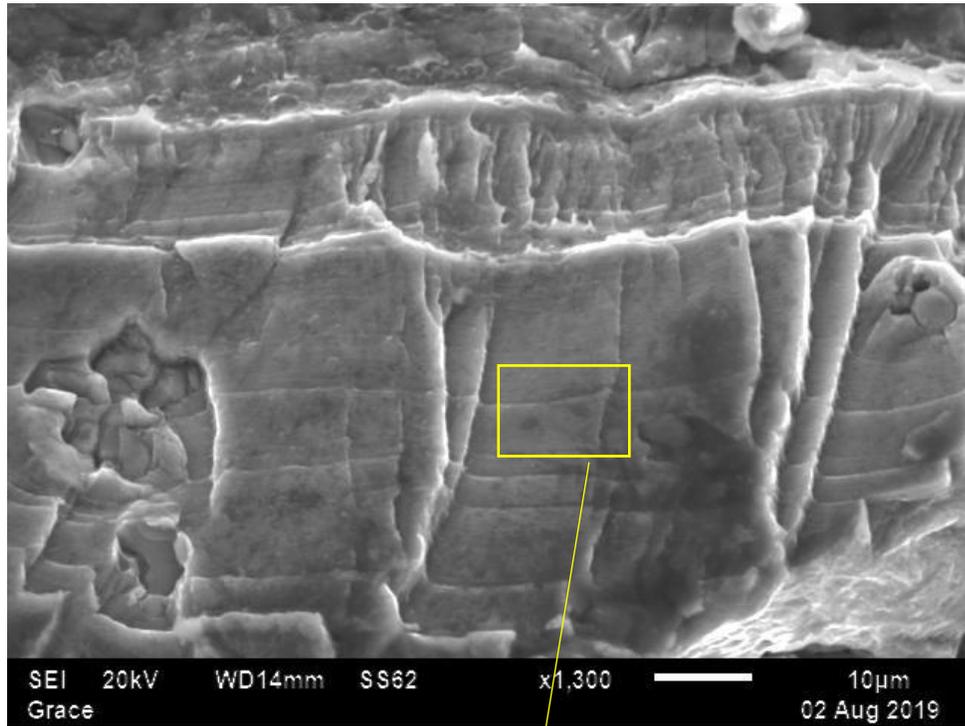
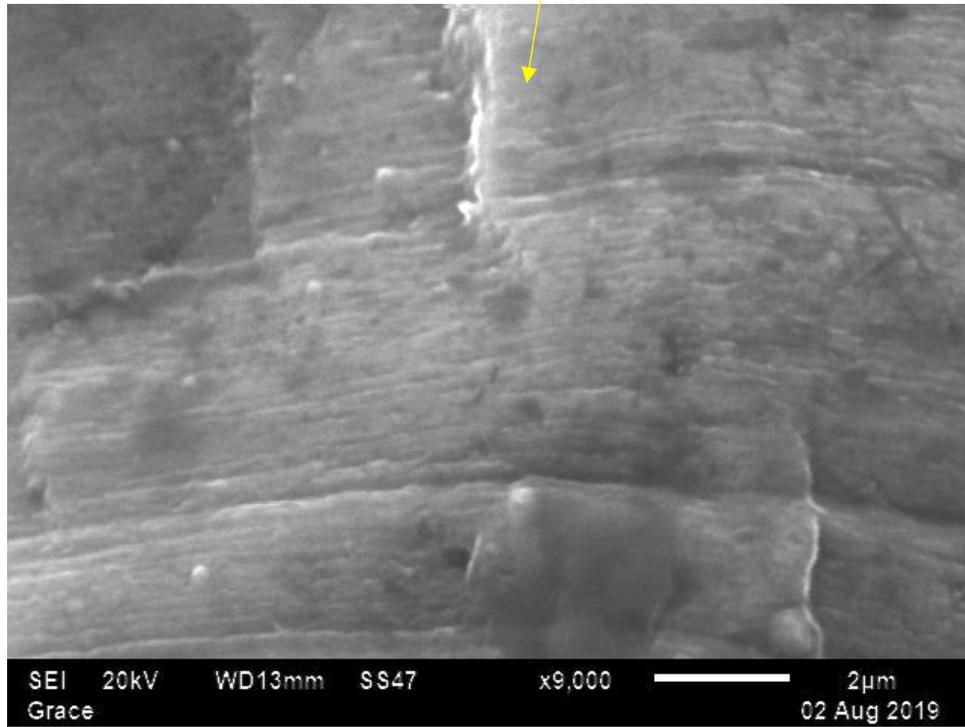
Figure 10: Fracture Piece #1, Visible fatigue striations

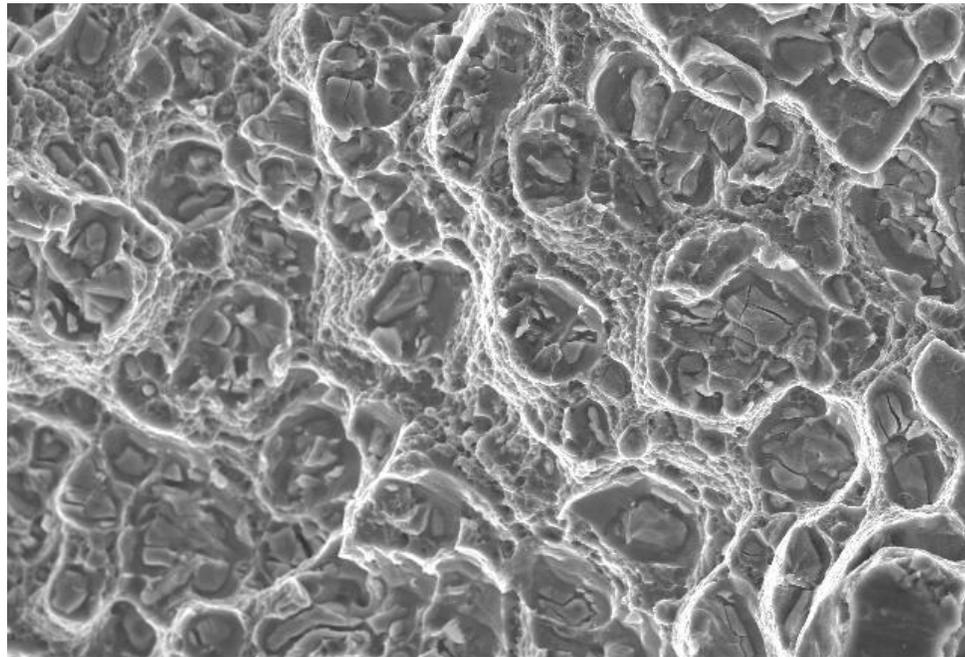
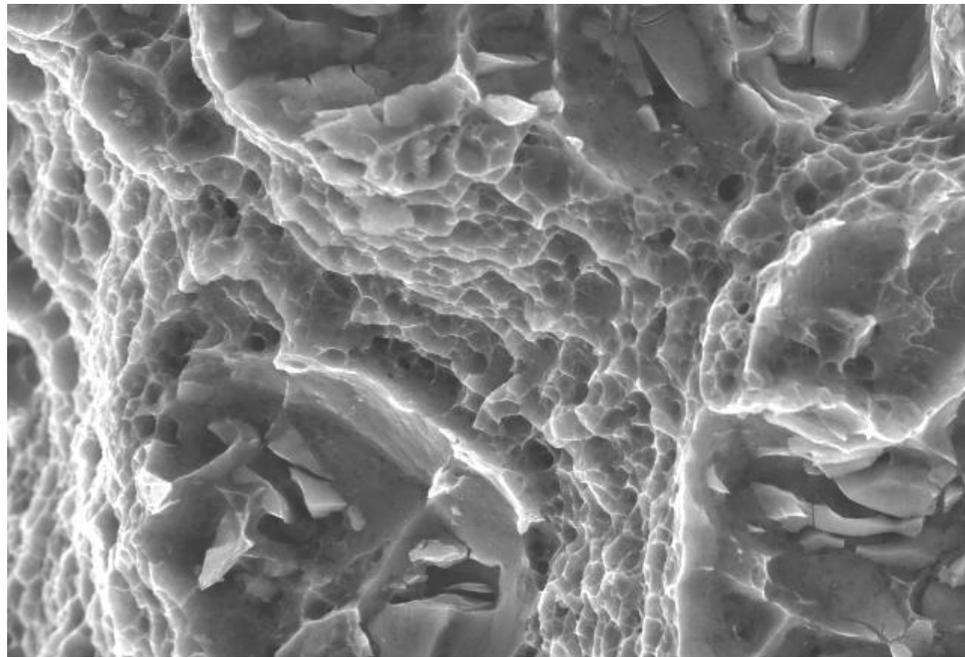
Figure 11: Fracture Piece #1, Overload

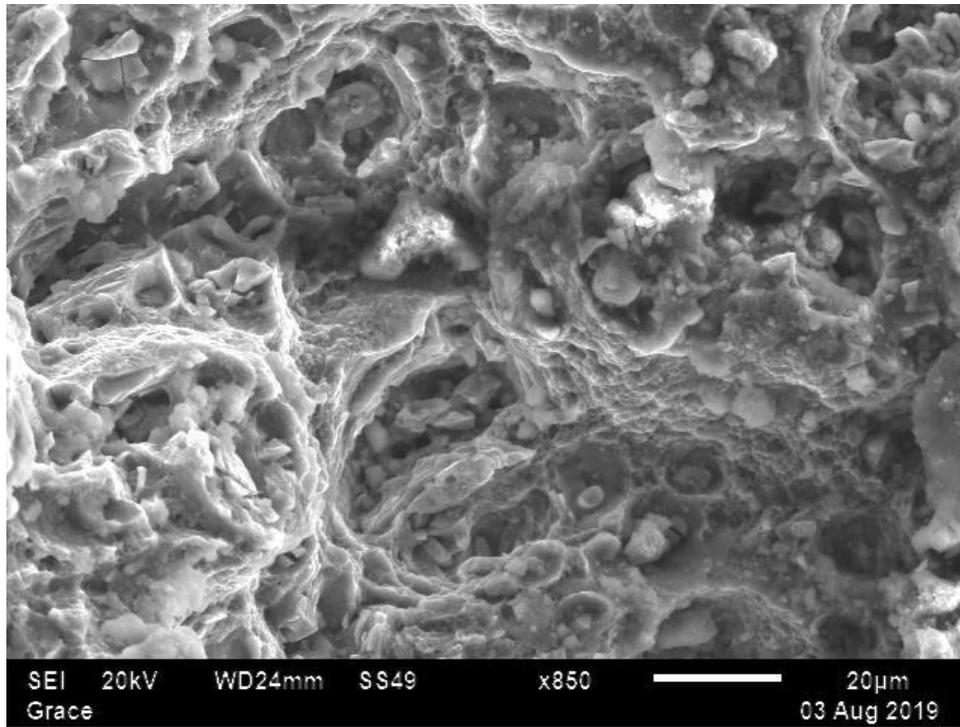
Figure 12: Fracture Piece #2, overload

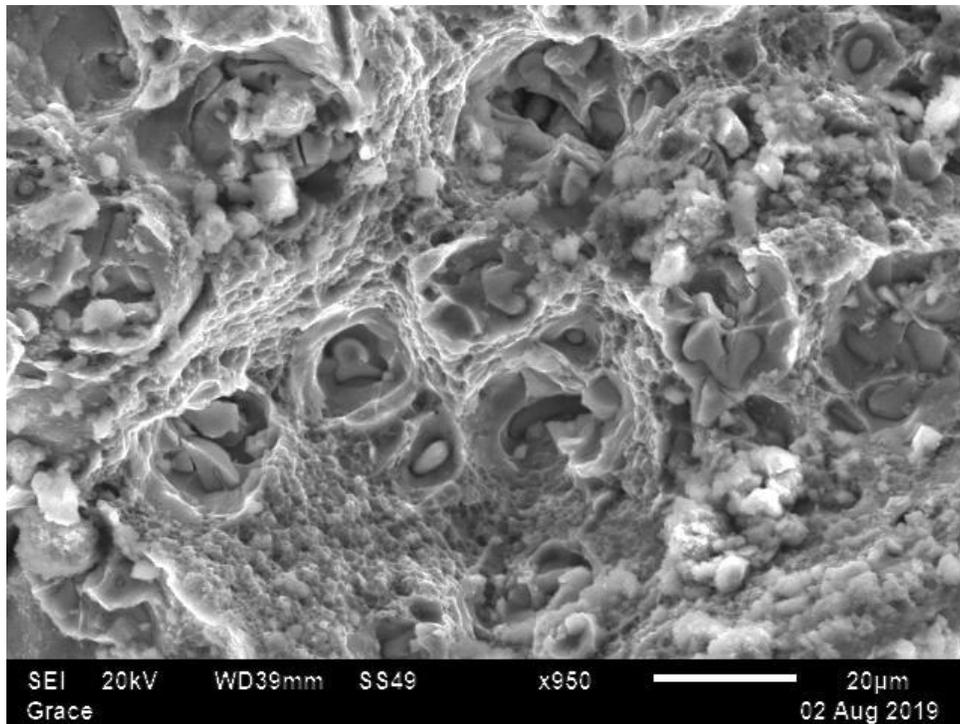
Figure 13: Fracture Piece #3, overload

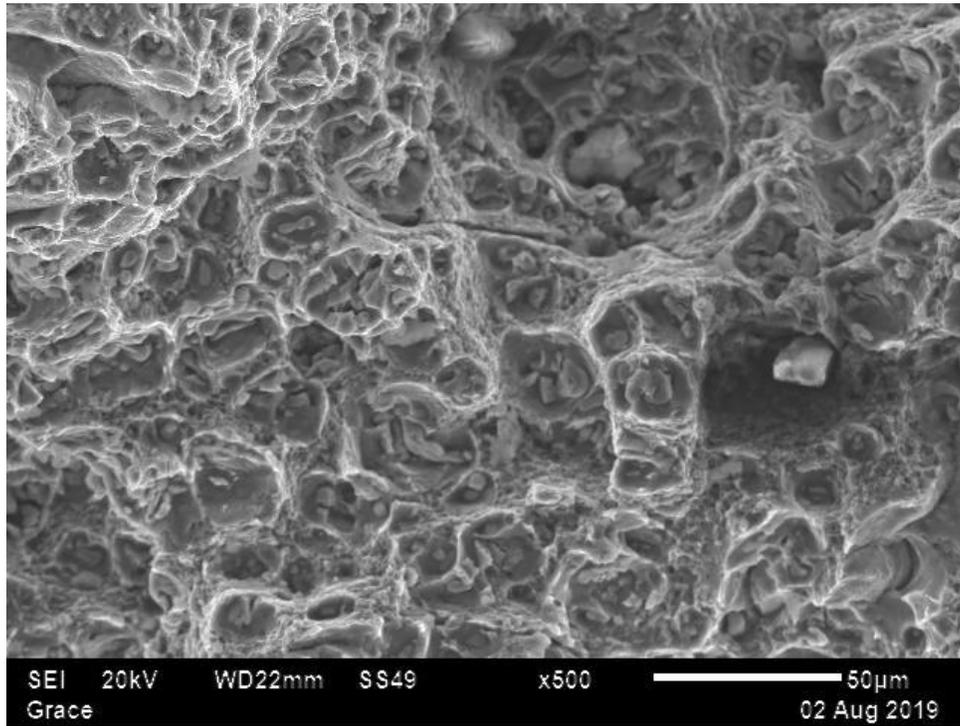
Figure 14: Fracture Piece #4, overload

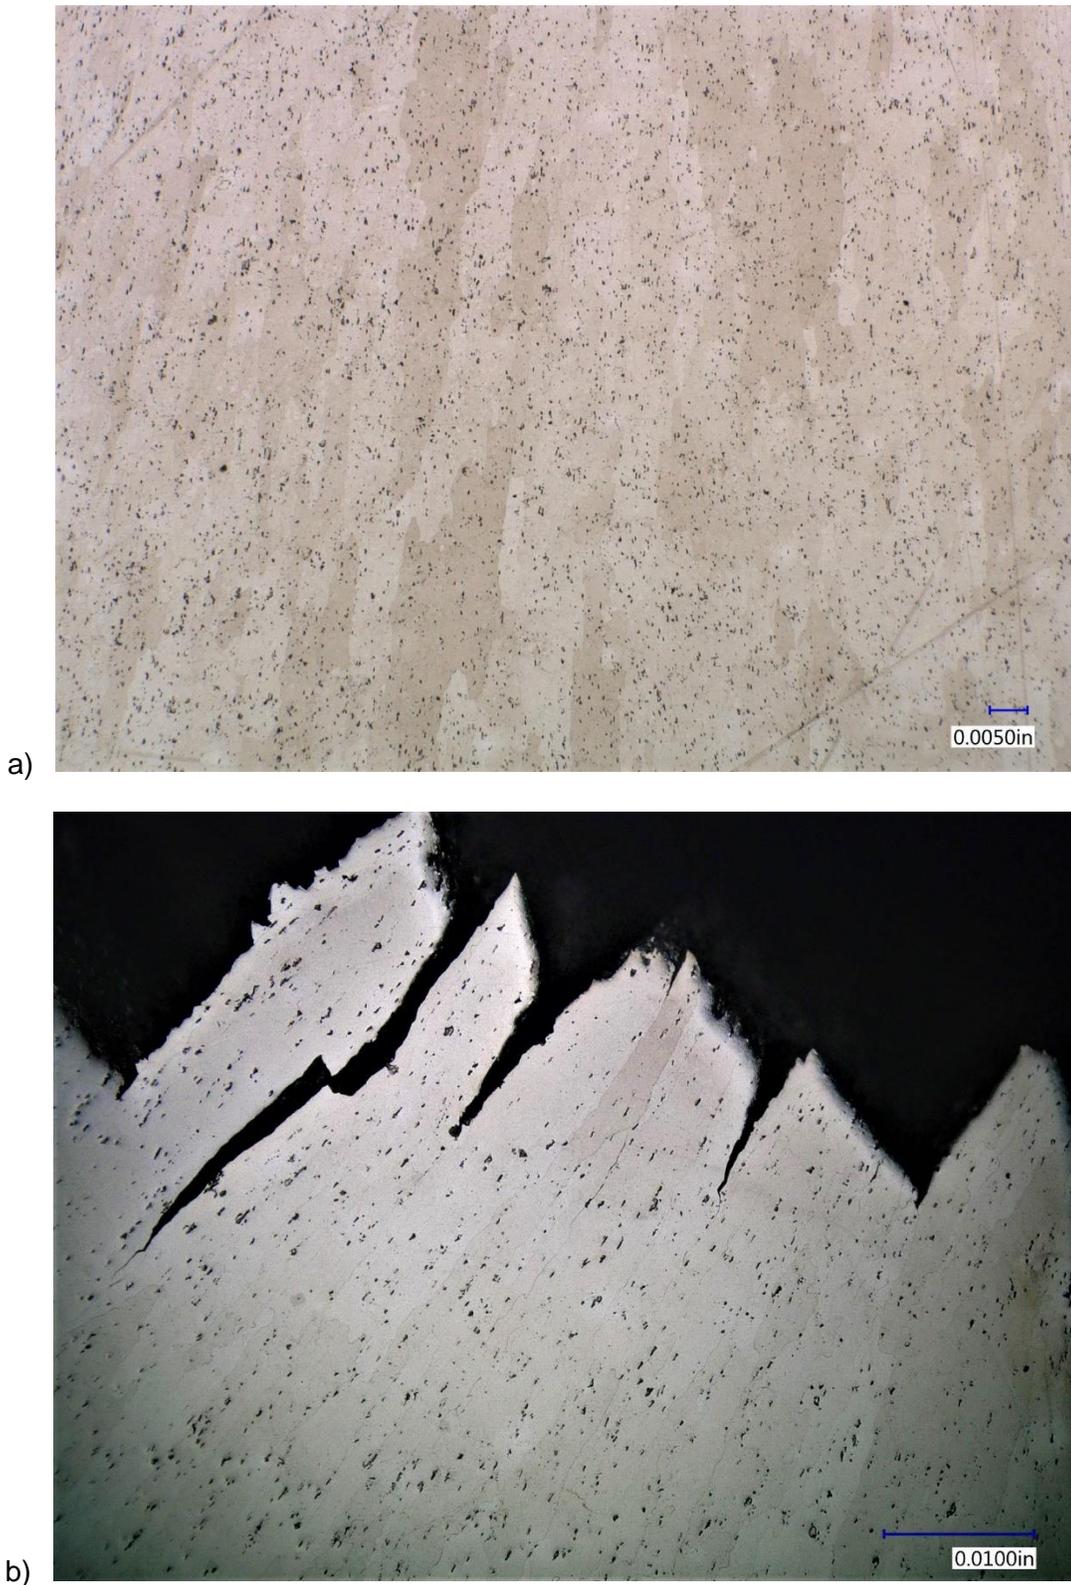
Figure 15: Cross section of upper torque knee a) microstructure is consistent with heat treated 2000 series aluminum. (Etchant: Keller's; Magnification:40x; Mount Index No. 4360) b) Cross section through origin region showing layer separation along grain boundaries (Etchant: Keller's; Magnification: 78x magnification; Mount Index No. 4362)
