SERVICE BULLETIN

TITLE: LANDING GEAR - TORQUE KNEE INSPECTION

Beech King Air Model 65-90, 65-A90, B90, C90, C90A, Serials LJ-1 through LJ-1559;
Model E90, Serials LW-1 through LW-347.

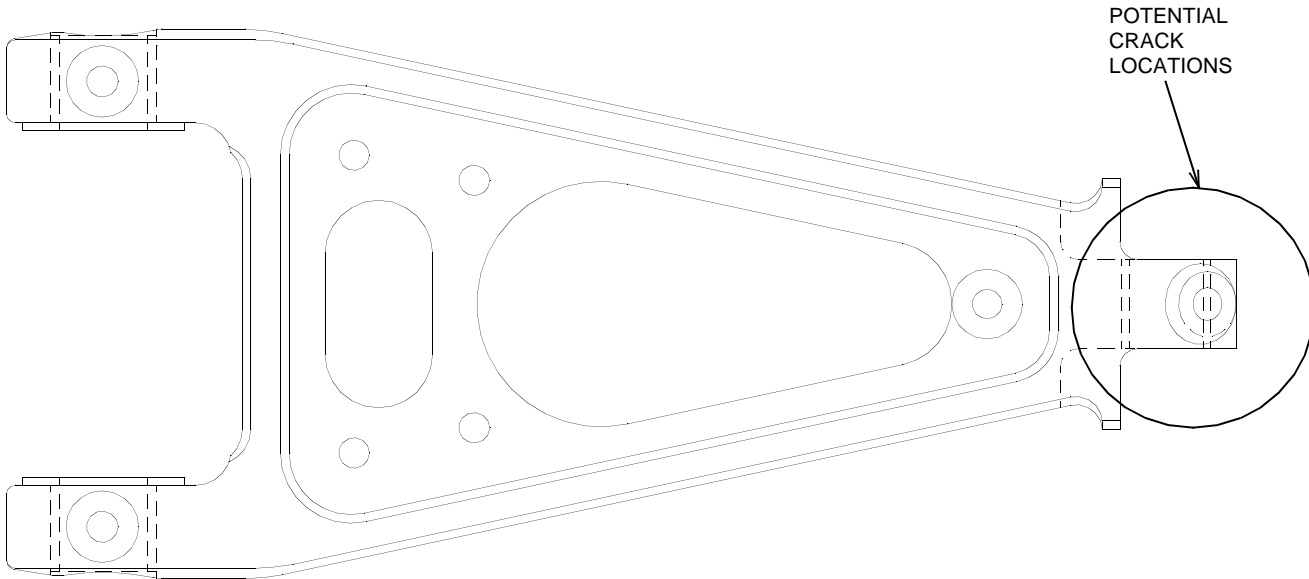
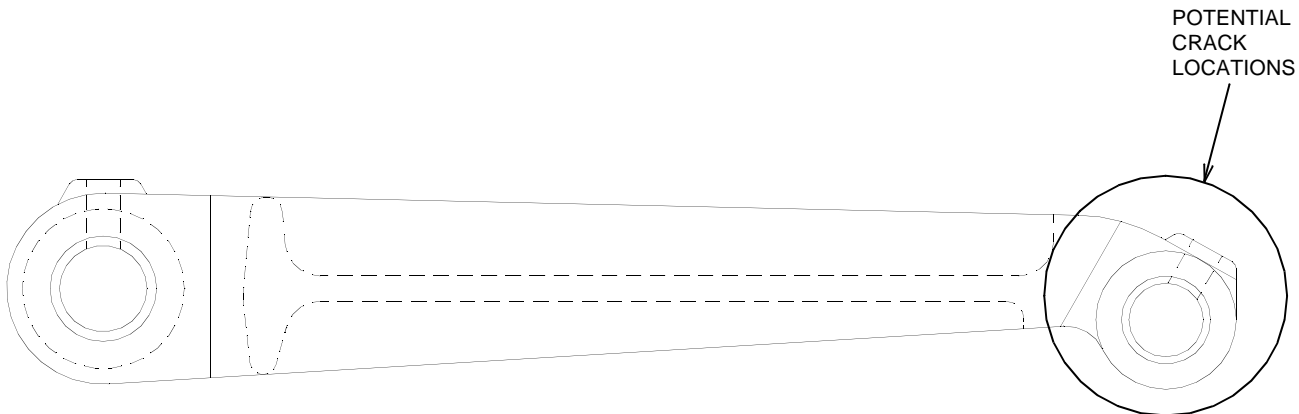
**P/N 50-810032-4 Upper Torque Knee
Figure 1**

This Service Bulletin is being issued to require a Nondestructive Inspection (NDI) of the main landing gear upper and lower torque knees at reduced intervals and to prevent the loss of the main landing gear lower piston and wheel assembly. Undetected fatigue cracks in the main landing gear torque knees have caused separation of the lower piston and wheel assembly from the upper landing gear cylinder assembly, which may result in damage to the aircraft or personal injury.

- (4) Release the air pressure entirely before removing the valve core from the shock strut.
- (5) Remove the upper torque knee from the airplane. Refer to Chapter 32-10 of the Maintenance Manual for removal procedures. Carefully inspect the complete torque knee for fatigue cracks using the FLUORESCENT PENETRANT INSPECTION methods listed on page 8. Pay particular attention, but not limited to, areas pointed out in Figure 1. Replace any torque knee when fatigue crack indications are found. If no fatigue crack indications are found, repaint the inspected torque knee with epoxy polyamide primer and urethane topcoat paint in accordance with the appropriate Maintenance Manual, Chapter 20-08.
