Air Safety Investigations Aircraft Incident/Accident Technical Report

Aircraft Incident/ Accident Information	Year: 2015	Make: Textron Aviation	Model: 680
	Serial number: 680A0010		Registration: N8JR
Location: Elizabethton, TN		Date: 08-15-19	Time: 1537 EDT
Aircraft Owner		Aircraft Operator	
JRM Air LLC [REDACTED] Mooresville, NC 28115-0330		Same as Aircraft Owner	
Report Information			
Air Safety Investigator: Peter J. Basile		Report #: ASI-19-CB-T	Report date: 01-21-20

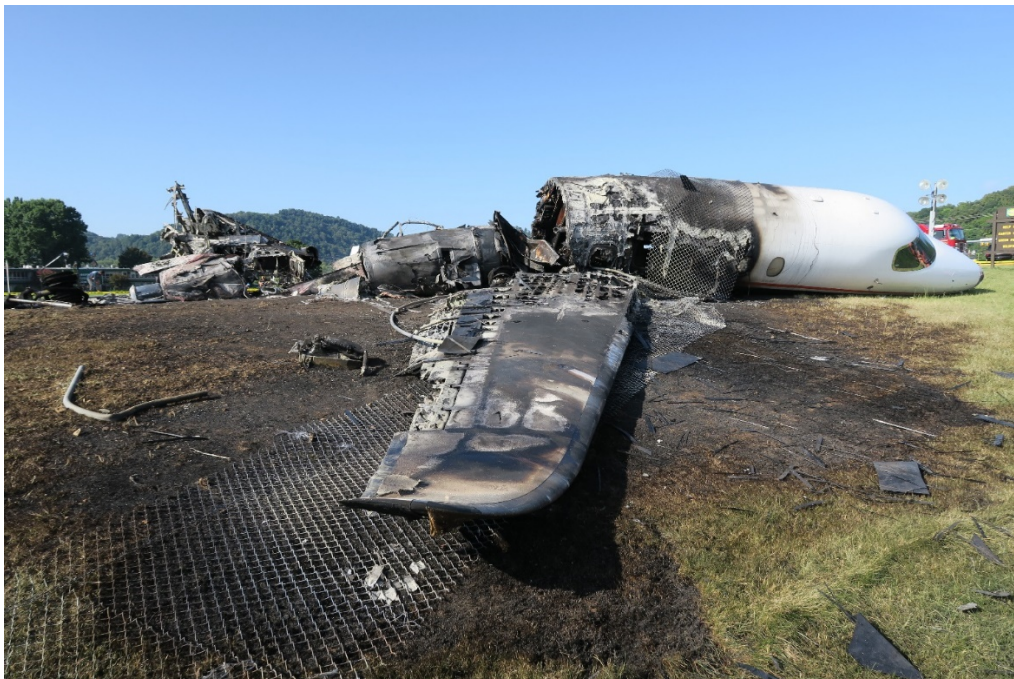
Per security video, the aircraft touched down on the runway and bounced. The aircraft appeared to climb back up to about 25' AGL before it descended rapidly and landed hard on the runway. The right main landing gear collapsed, and the right wing tip contacted the runway. Skid marks from the right main gear and right main gear door indicated the aircraft traveled slightly to the left before it turned back to the right. The aircraft departed the end of the runway on center line and traveled down a grass covered hill for approximately 400'. The aircraft traveled over an approximately 25' wide creek. The left main landing gear and nose gear separated from the aircraft when it struck the opposite creek bank. The aircraft traveled up a small grassy hill and came to rest next to the west bound lanes of Highway 91. The aircraft came to rest on a heading of 285° at an elevation of 1,551'. A post-impact fire consumed the aft portion of the fuselage and inboard wing areas.
