The ShakeOut Scenario

Oil and Gas Pipelines

By
Donald Ballantyne
MMI Engineering, Inc.
Tacoma WA
May 2008

M7.8 Southern San Andreas Fault Earthquake Scenario: Oil and Gas Pipelines

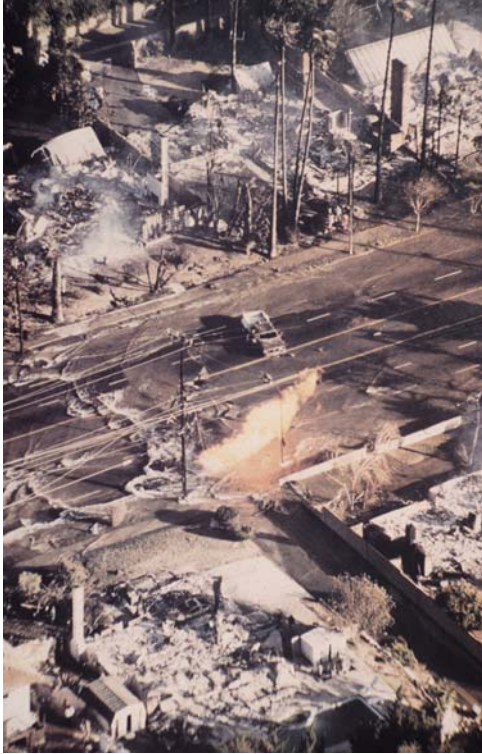
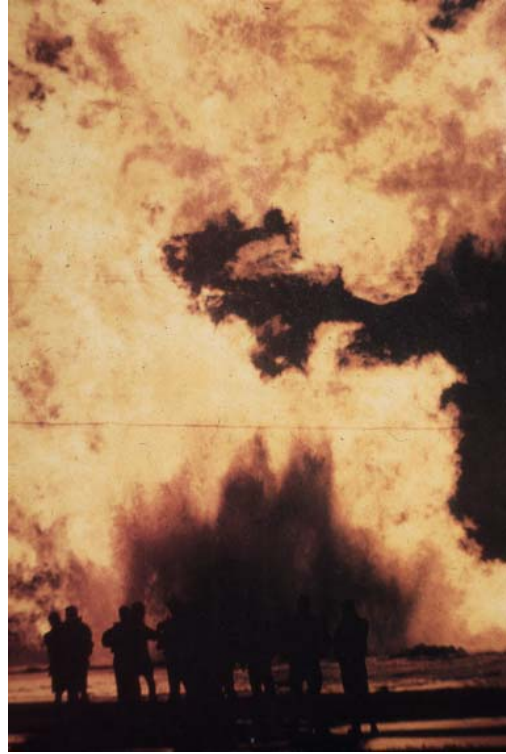
In the 1994 Northridge earthquake, there were 209 repairs required to metallic distribution lines, and 27 to polyethylene lines. There were 35 non-corrosion –related transmission pipeline repairs of which 27 occurred on pipe joint with oxy-acetylene girth welds in pre-1930 pipelines. At one of those failures, gas leaked from a failed 56-cm line on Balboa Boulevard and was ignited by the ignition system on a nearby truck (T. O'Rourke, 1994). The fire resulted in burning nearby houses (Figure 1).

Figure 1. Balboa Neighborhood Burned by Exploding Gas Line in Northridge Earthquake (left); Fire ball that Burned the Neighborhood.

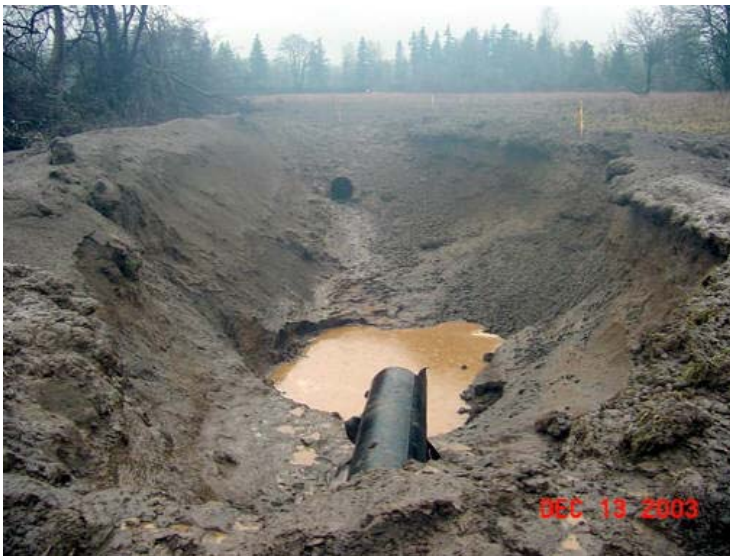
One of the two Southern California Gas transmission pipelines at Cajon Pass will rupture at the fault and explode (See Figure 3) resulting in a large crater (see Figure 4). The Southern California Gas pipeline-fault interface occurs where the pipeline intersects the CalNev 14-inch product pipeline, so when the explosion occurs the CalNev pipeline ruptures. The CalNev pipeline is transporting gasoline, so the gasoline adds to the fire (see Figure 5). Power transmission lines are overhead, and the fire reaches the lines causing them to fail.

Figure 4. Crater Resulting from Williams 26-inch Pipeline Explosion in Washington State, December 13, 2003. (Photo Credit - Washington Utilities and Transportation Commission)

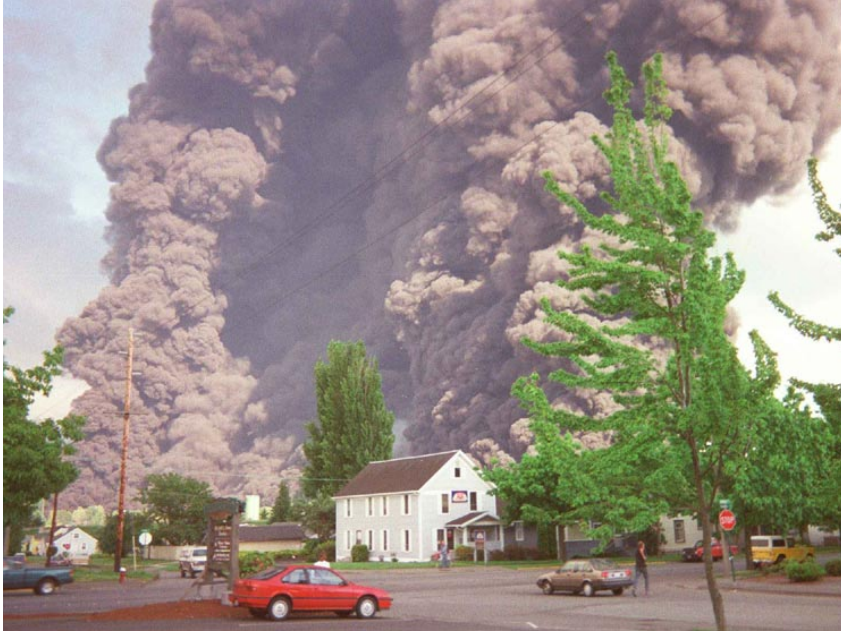
In Washington State, two high pressure gas transmission line failures occurred in 1997, both resulting from ground movement. Another failure occurred in 2003. One of the 1997 failures resulted in an explosion. In 1999, a pipeline carrying gasoline failed due to damage caused by a third party during construction on adjacent facilities. The pipeline failure resulted in discharging 277,000 gallons of product into a creek bed. In the ensuing fire, two boys burned to death, and one young man was killed after he was overcome by fumes.

Figure 5. Smoke Plume from 1999 Gasoline Fire in Bellingham Washington resulting from Product Pipeline Failure due to Third Party damage. (Photo Credit – City of Bellingham)

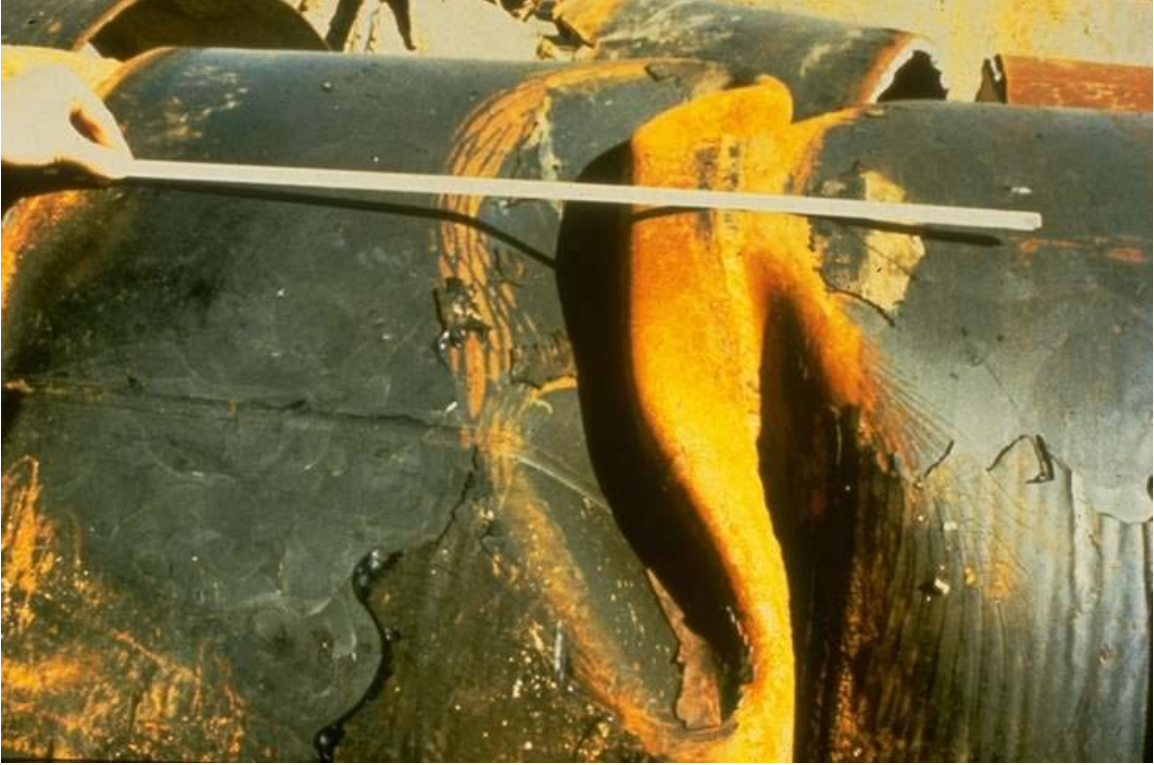
The 20-inch Kinder Morgan product line is ruptured in Palm Springs (Figure 6). The pipeline is aligned directly over the fault. When the earthquake occurs, the pipeline is shortened five meters causing it to wrinkle and rupture (Figure 7). The pipeline is carrying diesel which is sprayed into the air. Ultimately 200,000 gallons of product is discharged into the local drainage until the line can be isolated. A smaller natural gas distribution pipeline is located in the same right-of-way. The fault displacement also ruptures this line. Although the volume of discharging gas is much smaller than that coming from the break at Cajon Pass, the gas hampers response efforts. The Kinder Morgan Pipeline fails at an additional 15 locations due to shaking at locations along the 60 km alignment paralleling the fault trace. Each failure location requires environmental cleanup of the discharged diesel product.

Figure 7. Wrinkled Pipeline Failed in Compression

To mitigate damage due to permanent ground deformation (fault movement, landslide, liquefaction) use modern welded steel pipe with butt electric arc welded joints. Replace old pipe that has oxy acetylene welded joints within the fault zones and several thousand feet beyond. The pipeline geometry should be designed so the pipe will go into tension when the fault moves. Install the pipe with a coating/covering to minimize soil-pipe friction allowing the pipe to easily slide through the ground. Avoid use of “anchors” (valves, sharp bends, etc.) to allow the pipe to move so that pipe stresses can be distributed along the pipe. Design the backfill to allow the pipe to move laterally in the trench if required to accommodate the fault movement.

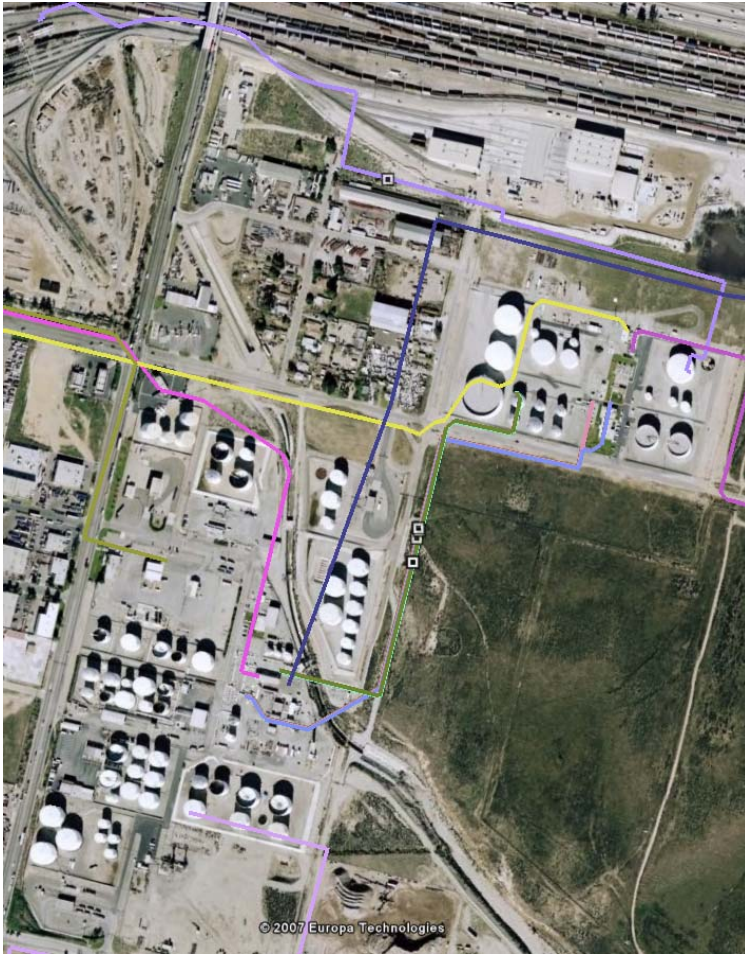
The Colton Receiving Station (Figure 8) is subjected to 40 percent g shaking. The receiving station is a node for distribution of gasoline, diesel and jet fuel. The facility also controls flow of jet fuel to March Air Force Base. Unanchored tanks bounce around breaking connecting pipe. Fuel discharges into the retaining dikes, and is ignited by passing vehicle ignition system.

Figure 8. Colton Receiving Facility with Tank Farm Vulnerable to Earthquake Ground Motion
