NATIONAL TRANSPORTATION SAFETY BOARD
OFFICE OF RAILROAD, PIPELINE AND HAZARDOUS
MATERIALS INVESTIGATIONS
WASHINGTON, D. C. 20594

Track & Engineering Factual Report

Location: Texarkana, Texas

Accident No.: DCA15FR014

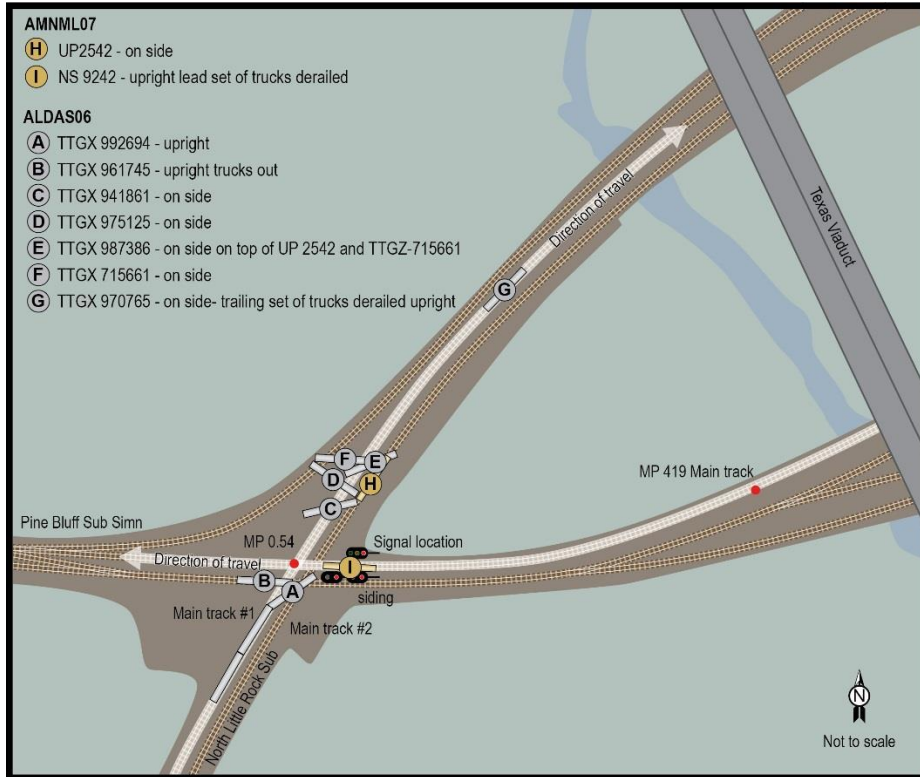
Figure 1 - post accident site survey

The geographic location of the accident is within Bowie County in Texarkana, Texas. The side collision occurred at a railroad crossing diamond located at the intersection of the UP Pine Bluff Subdivision, and the UP Little Rock Subdivision.² The crossing diamond intersection angle was 59°36'28".

The UP Pine Bluff Subdivision single main track and siding track crosses with the Little Rock Subdivision two main tracks at Texarkana Interlocking located in Texarkana, Texas. The Texarkana Interlocking is at milepost (MP) 419.1 on the Pine Bluff Subdivision and at MP 0.54 on the Little Rock Subdivision. The point of collision (POC) was located at 33°24'55.83' latitude and -94°3'3.14' longitude at MP 419.1 on the Pine Bluff Subdivision. See figure 1 for a depiction of the postaccident site survey.

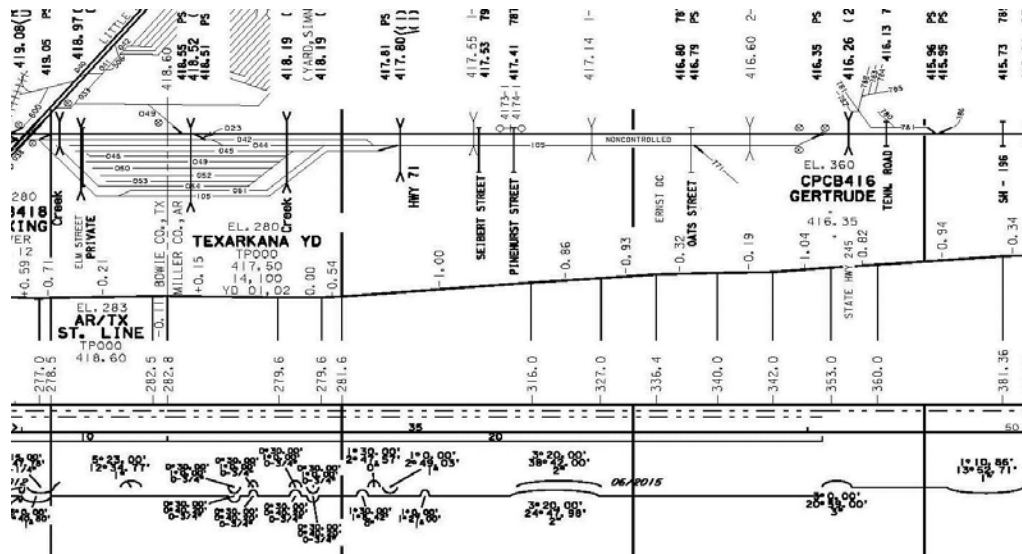
Figure 2 - track configuration leading to and through Texarkana Yard

The ten tracks in Texarkana Yard are sandwiched between the main track on the north side and the siding track on the south side. Texarkana Yard is designated between MP 417.5 and MP 419.1. See figure 2 for a general idea of the track configuration.
