**NATIONAL TRANSPORTATION SAFETY BOARD
OFFICE OF RAILROAD, PIPELINE AND HAZARDOUS
MATERIALS INVESTIGATIONS
WASHINGTON, D. C. 20594**

Track & Power Group Factual Report

Location: Commerce Street Grade Crossing on the Metro-North Harlem Line,
Valhalla, Westchester County, New York

NTSB #: **DCA15MR006**

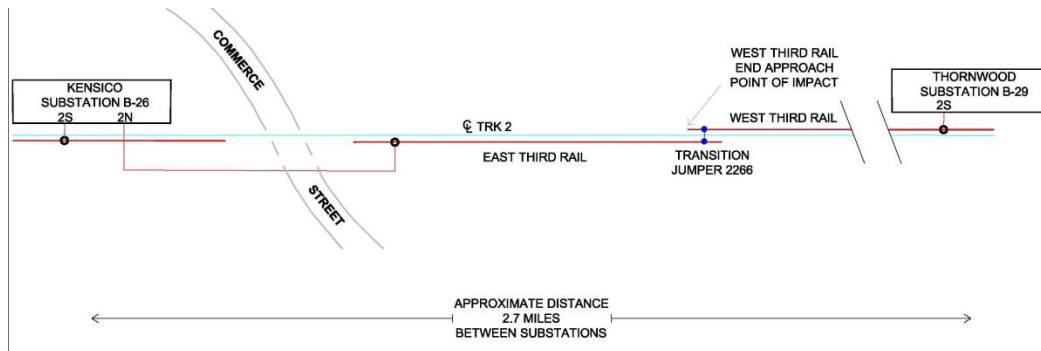
- The SUV struck the west third rail of track 2 at time 18:26:17.191. (See above item 1 and Figure 3). The fault was detected by the protective relaying circuit at substation B26 and substation B29. At substation B26 the track 2 circuit breaker tripped on an instantaneous protective relay target (see Attachment 1 [picture B26] and Attachment 1A [oscillography B26 breaker 2N]). As the train continued and the SUV physically damaged the west third rail and transposition jumper 2266 causing the east and west third rails to become electrically disconnected. This in turn resulted in substation B26 to become electrically isolated from the damaged, faulted west third rail. As a result of this damage the load measuring circuitry at substation B26 for the track 2 north circuit breaker identified clear, good third rail on the east side of the train. This east third rail was then re-energized when the track 2 north breaker reclosed. When this occurred, the last four cars (two married pairs), which were contacting the east third rail, was re-energized.

Figure 3-Sketch of substations B-26 and B-29 locations with respect to the third rail electrical transmission rail for main track 2

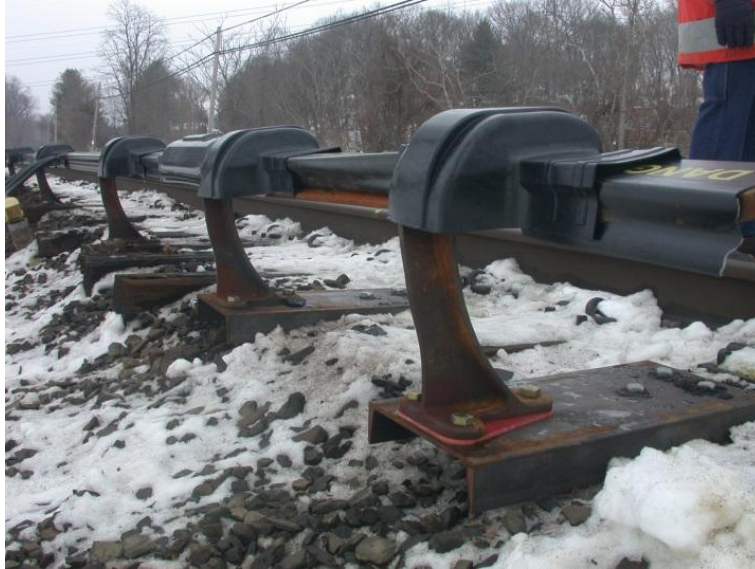
Figure 4-Northward view of the third rail assembly that replaced the damaged sections.

Metro-North replaced approximately 468 feet of third rail, one 6-foot end approach [nose piece], one transposition jumper and ancillary components.

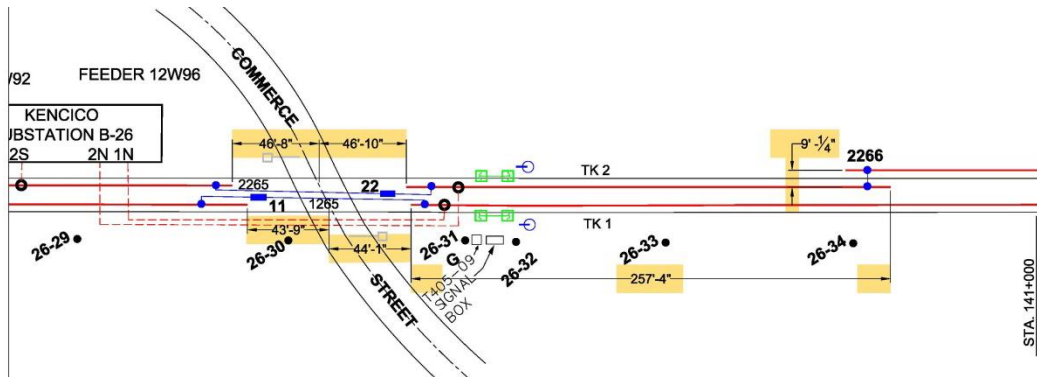
The third rails that supply electrical power (highlighted in red) to both main tracks 1 and 2 are located in areas between the tracks at Commerce Street. See Figure 7 for the north and south distances the third rails are from the centerline of Commerce Street and the location where the third rail jumpers [2266] over to the west side of main track 2.

Figure 7-Sketch of the 3rd rail locations referenced from the centerline of Commerce Street

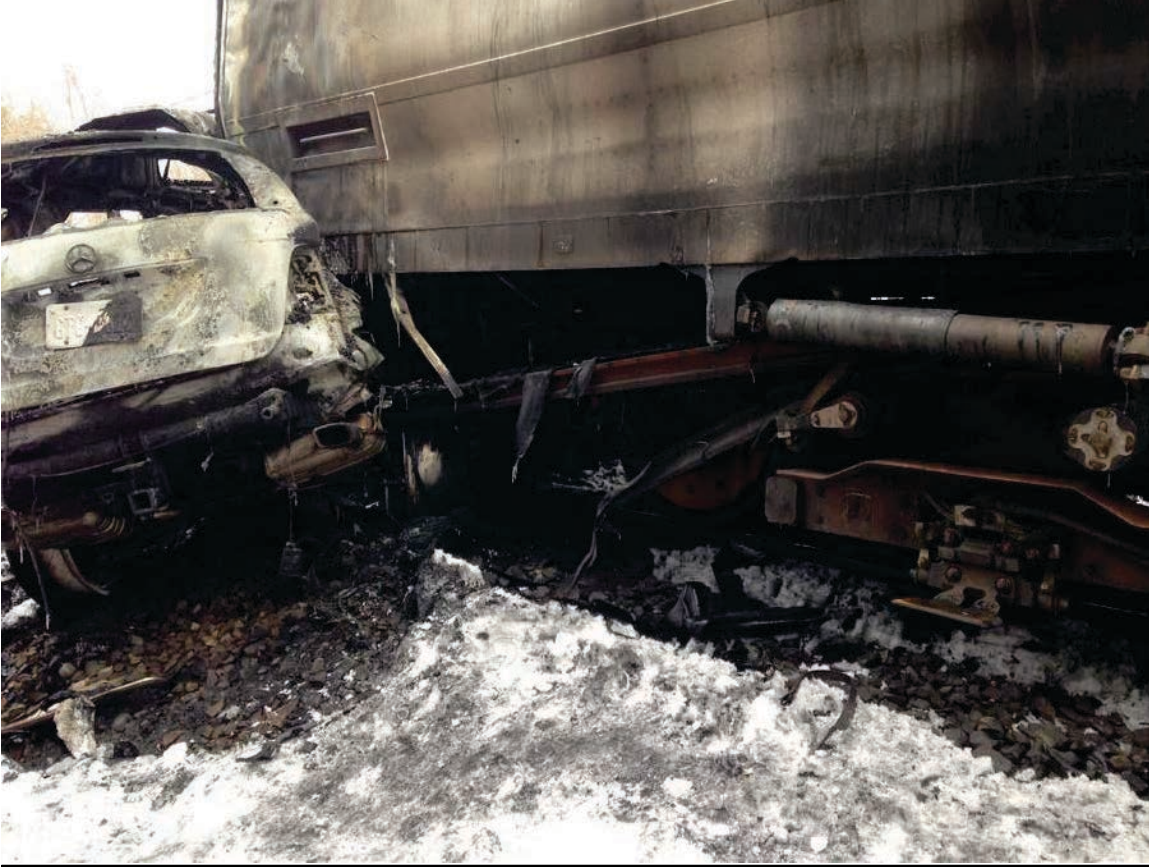
During the grade crossing crash sequence of events, the third rail entered the two lead transit cars of vehicle 2, (MN 4333 and MN 4332) respectively, and vehicle 1, the SUV. See Figure 8 to view the third rail passing through the SUV and entering the passenger car. Prior to removal, the rail segment locations were documented within their respective vehicles. After the rails were removed from the vehicles, they were measured and rebuilt in sequence of entry from their railroad wayside location. The following is a description of the third rail segments;

Figure 8-West side view of the third rail passing through the SUV and entering passenger car MN 4333.
